SECTION 14 INCIDENT REPORT (*Waste Management and Pollution Control Act*)

Date and Time of Notification:	Initial notification (Call) – 12 January 2025 2:56 pm																		
Person / Company:	McArthur River Mining Pty Ltd (MRM)																		
Incident:	A total of approximately 10 kilograms (kg) of bulk concentrate was inadvertently released at five locations along the Carpentaria Highway. The source of the spill originated from a road train travelling from McArthur River Mine (the Mine) to the Bing Bong Loading Facility (BBLF).																		
(a) the incident causing or threatening to cause pollution	A total of approximately 10 kg of bulk concentrate was released at five locations on the Carpentaria Highway, between the Mine and the BBLF. All concentrate was confined to the road and roadside.																		
(b) the place where the incident occurred	<p>The Global Positioning System (GPS) points for the length of the spill is provided in Table 1 below and shown in Figure 1.</p> <p style="text-align: center;"><i>Table 1 – GPS Coordinates of spill end and start.</i></p>

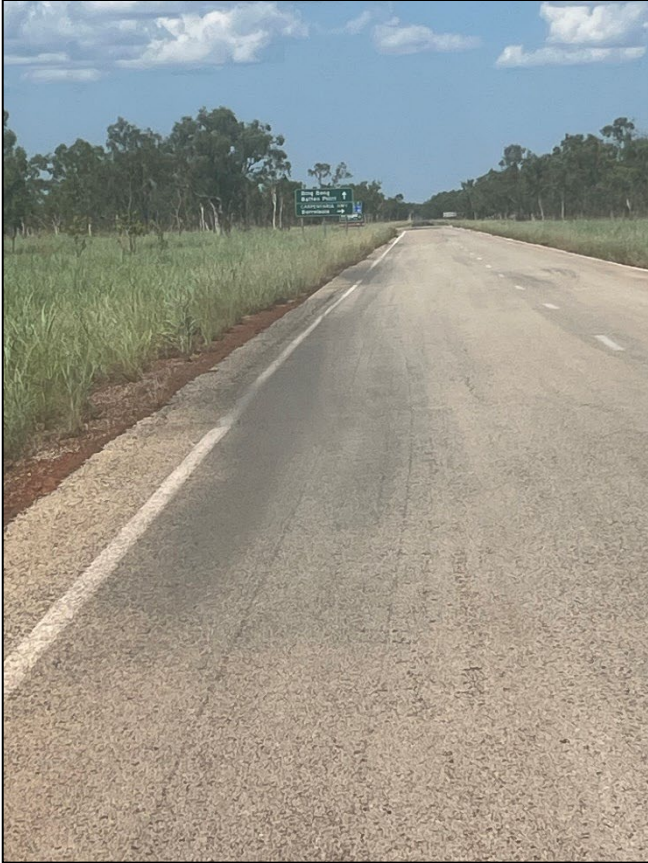
<p>d) how the pollution has occurred, is occurring or may occur</p>	<p>A road train transporting concentrate along the Carpentaria Highway from the Mine to the BBLF inadvertently released approximately 10 kg of bulk concentrate to the road and roadside, across three locations.</p> <p>An investigation is being undertaken to determine how the incident occurred.</p> <div data-bbox="608 584 1259 1444" data-label="Image">

</div> <p><i>Figure 2: Extent of the first spill heading North towards BBLF (5kg)</i></p>
--	--

A pressure hose and vacuum truck was used to collect the concentrate from the road and roadside at the incident locations. A grader was used to collect all potentially contaminated material on the roadsides.

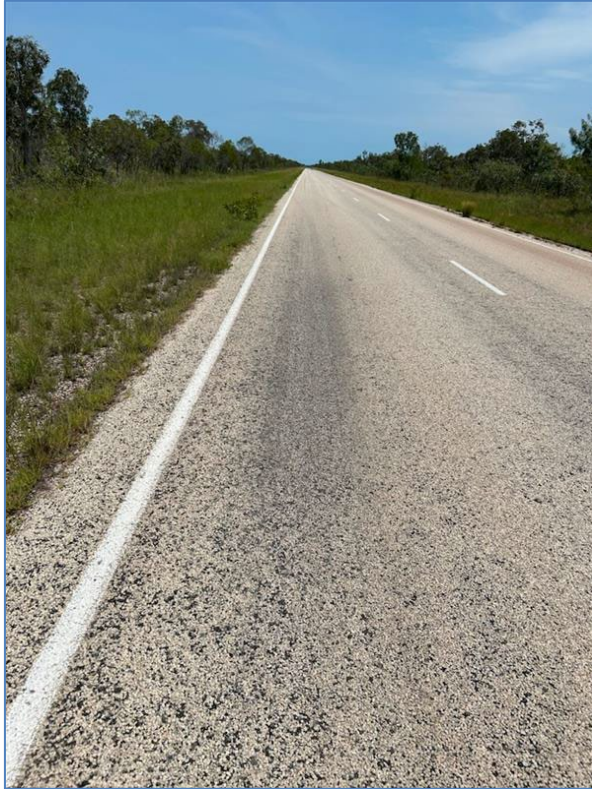
Figure 3: Extent of the second spill heading North towards BBLF (1kg)

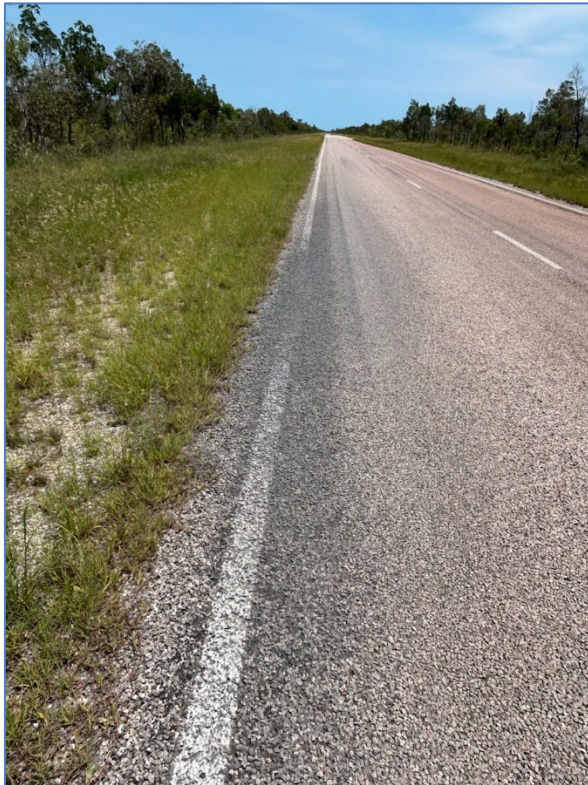
Figure 4: Extent of the third spill heading North towards BBLF (1kg)

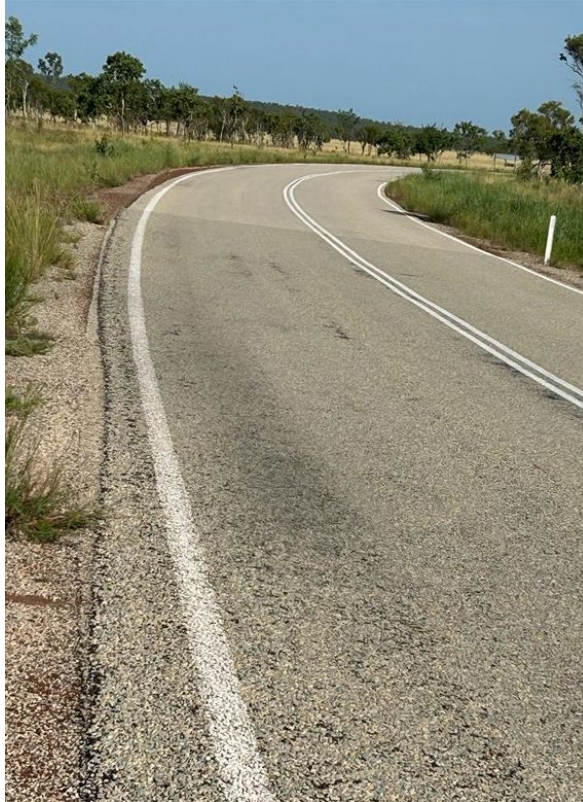
Figure 3: Extent of the fourth spill heading North towards BBLF (<1kg)

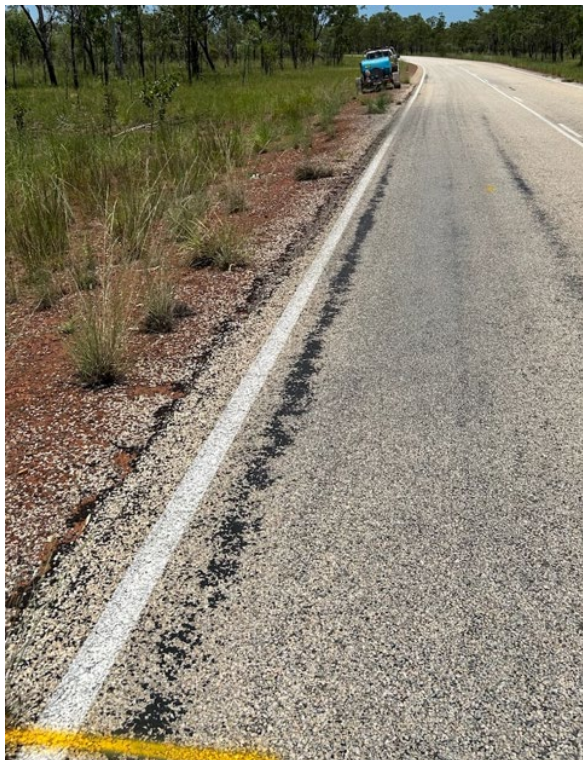
Figure 4: Extent of the fifth spill heading North towards BBLF (2kg)

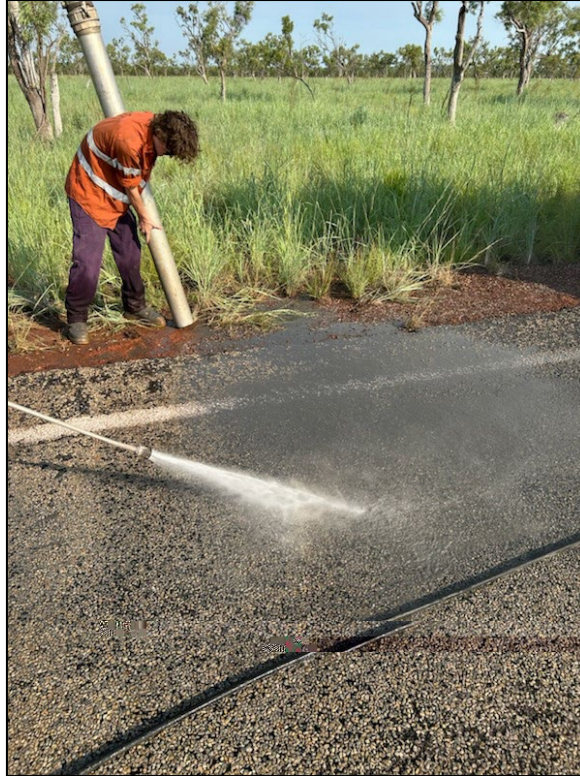
Figure 5: Removal of concentrate by a pressure hose and a vacuum truck.

All concentrate and removed material was appropriately disposed of at the Tailings Storage Facility.

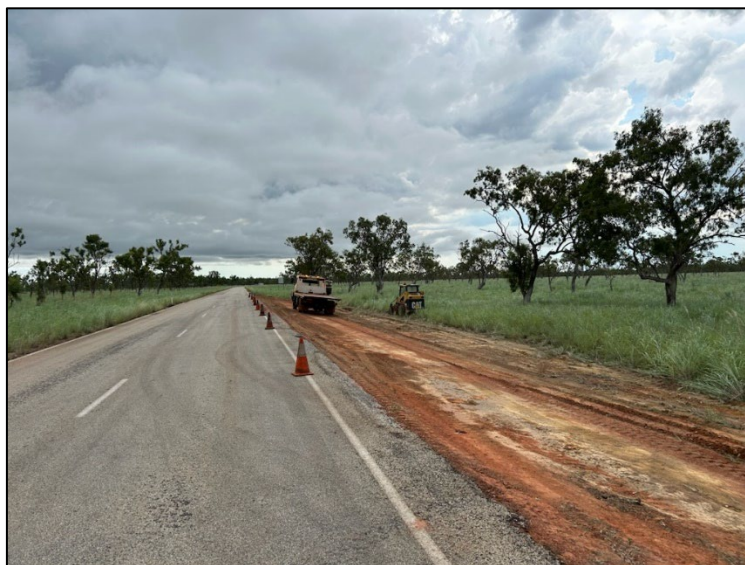
Figure 6: Grading of potentially contaminated material from the roadside.
