## SECTION 14 INCIDENT REPORT (*Waste Management and Pollution Control Act*)

<b>Date and Time of Notification:</b>	Friday 7 <sup>th</sup> March 2025, 13:30hrs
<b>Person / Company:</b>	Power and Water Corporation
<b>Incident:</b>	Discharge of sewage effluent from sewage infrastructure

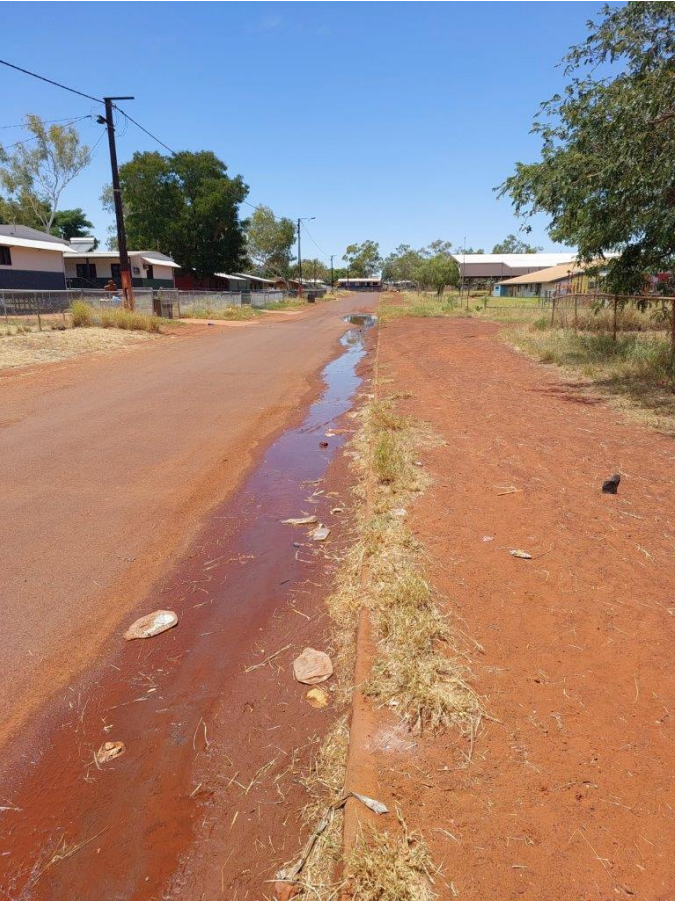
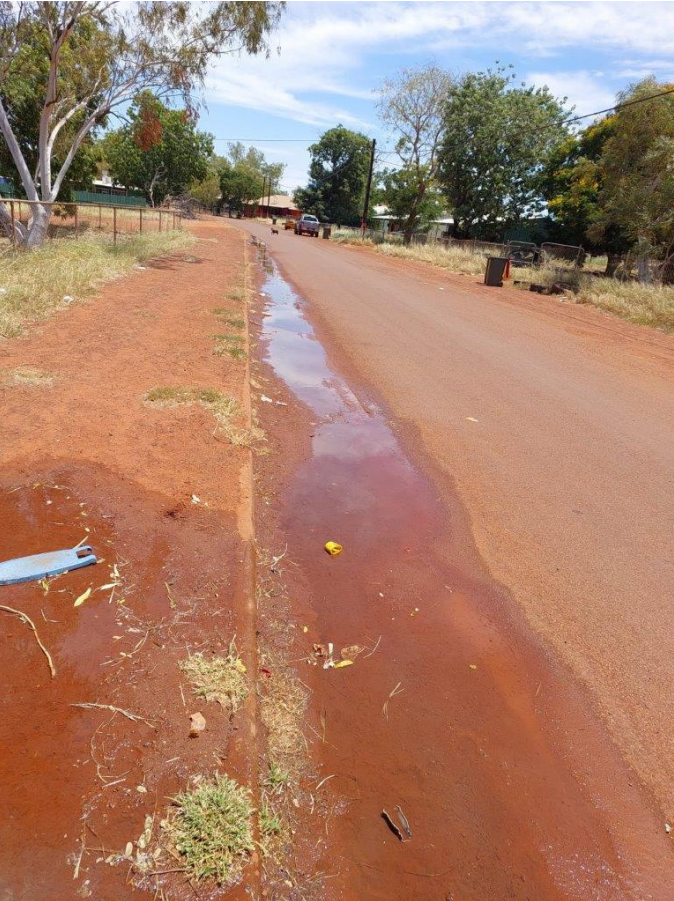
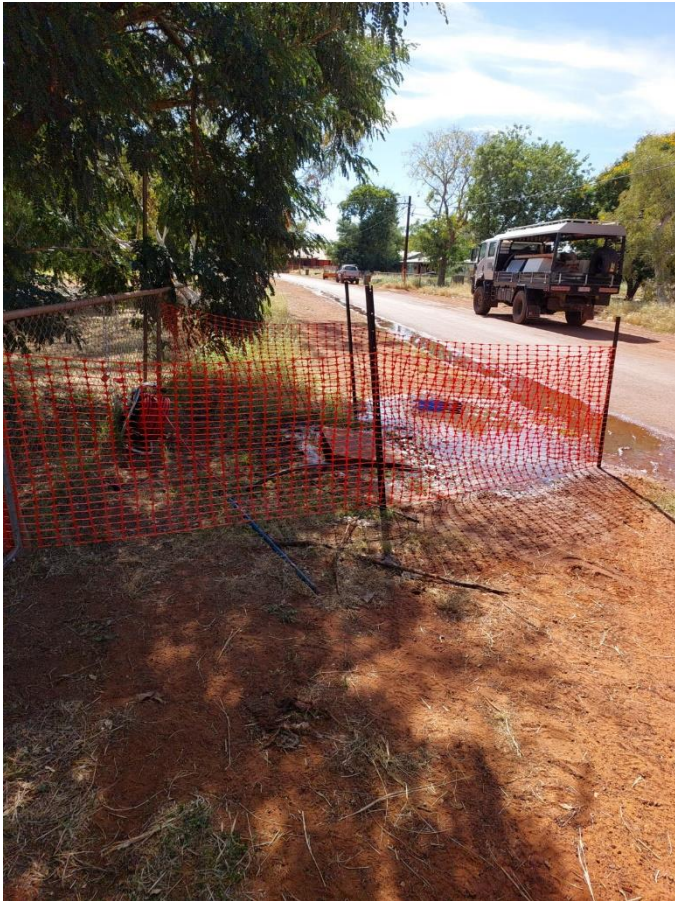
Appendix B – Location Photographs

<p><i>iii. Volume of the waste that was discharged.</i></p> <p>The volume of wastewater discharged is unknown, no telemetric monitoring occurs in this location. The spill is estimated to be &lt;5KL.</p>	Sample Date	Description	E. coli (MPN/100 mL)	Ammonia as N (mg/L)	Nitrate as N (mg/L)	Nitrate Nitrite as N (mg/L)	22/01/2025	KALKARINDJI POND 1 INLET	98,700.0	7.3	0.1		23/10/2024	KALKARINDJI POND 1 INLET	190,400.0	9.8	0.1		17/07/2024	KALKARINDJI POND 1 INLET	81,600.0	7.5	0.1		22/05/2024	KALKARINDJI POND 1 INLET	20,100.0	5.9	0.1	
	Sample Date	Description	E. coli (MPN/100 mL)	Ammonia as N (mg/L)	Nitrate as N (mg/L)	Nitrate Nitrite as N (mg/L)																									
22/01/2025	KALKARINDJI POND 1 INLET	98,700.0	7.3	0.1																											
23/10/2024	KALKARINDJI POND 1 INLET	190,400.0	9.8	0.1																											
17/07/2024	KALKARINDJI POND 1 INLET	81,600.0	7.5	0.1																											
22/05/2024	KALKARINDJI POND 1 INLET	20,100.0	5.9	0.1																											
<b>(b) the place where the incident occurred</b>	<p><i>i. Description of the Power &amp; Water asset from which the discharge occurred.</i></p> <p>Manhole cover 'D' (labelled FTP)</p> <p><i>ii. GPS coordinates of the discharge point from the Power &amp; Water asset, and the final coordinates of the final discharge point.</i></p> <p>Discharge Point 1: 130.6382723E, 18.3355463S            Final Discharge Point 1: 130.6386727E, 18.3355875S            Final Discharge Point 2: 130.6375135E, 18.3354169S</p> <p>Discharge occurred from a manhole cover, after there was a blockage of the sewer main.</p>

<b>(d) how the pollution has occurred, is occurring or may occur</b>	<p>As per (c) iii &amp; (c) iv.</p>
<b>(e) the attempts made to prevent, reduce, control, rectify or clean up the pollution or resultant environmental harm caused or threatening to be caused by the incident</b>	<p><i>i. Confirmation signage and fencing has been erected, as appropriate.</i></p> <p>Barricading was erected in this instance, to the best ability of the utility services contract worker, in the community.</p> <p><i>ii. Decontamination of the site as appropriate.</i></p> <p>Clean up consistent with Sewage Spills/Overflow Response Work Instruction as appropriate to the location, all gross pollutants will be cleaned up.</p>
<b>(f) the identity of the person notifying the NT EPA</b>	<p>Power and Water's Environmental Team on behalf of Water Services</p>
