SECTION 14 INCIDENT REPORT (*Waste Management and Pollution Control Act*)

Date and Time of Notification:	Friday 30 th May 2025, 13:00hrs
Person / Company:	Power and Water Corporation
Incident:	Discharge of diluted and fully treated sewage effluent from the Finke wastewater treatment ponds

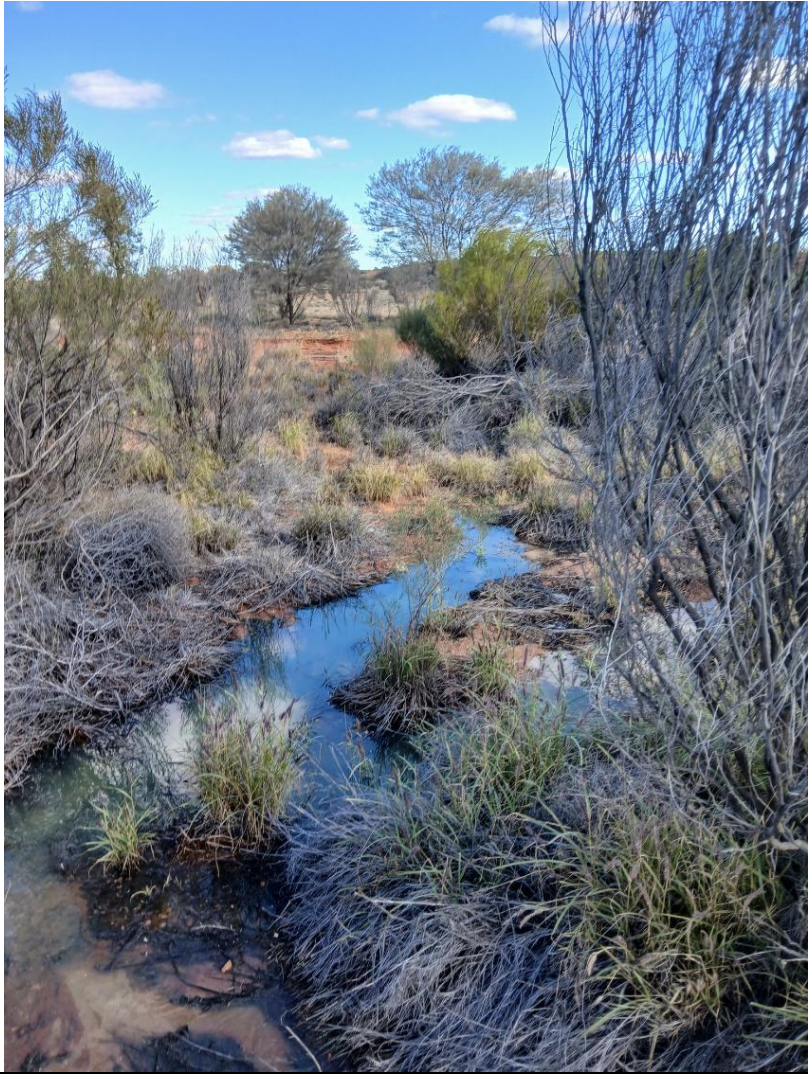
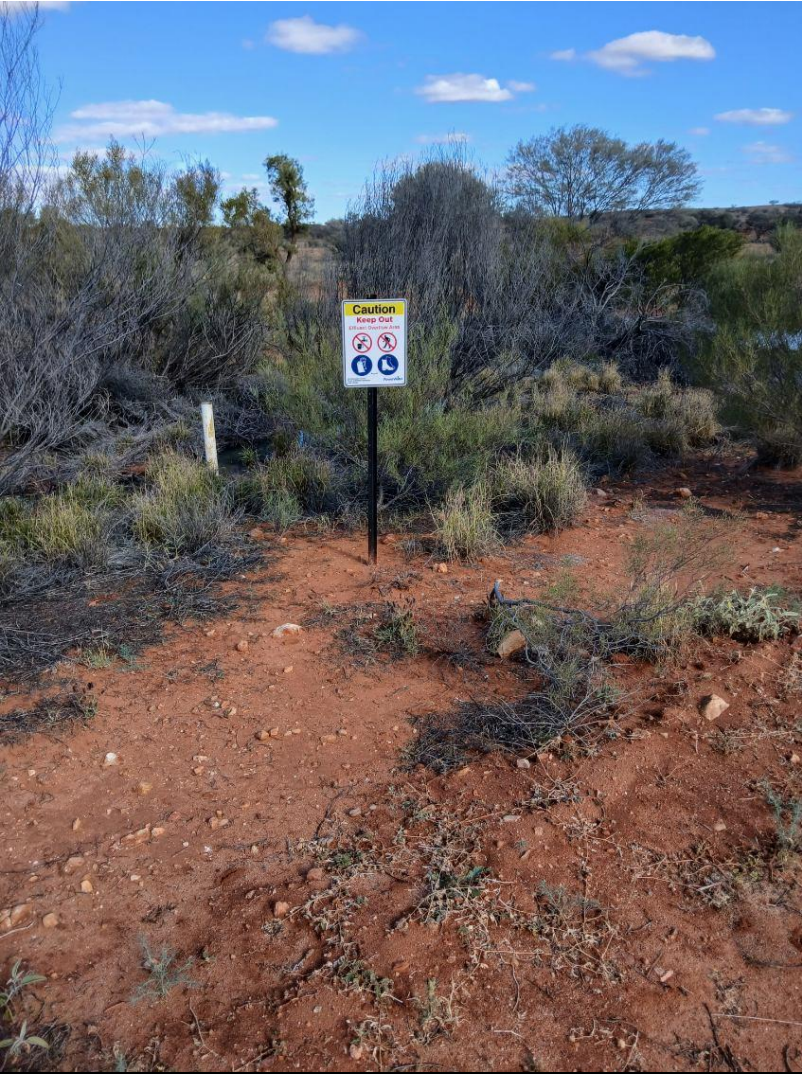
Appendix B – Location Photographs

(b) the place where the incident occurred	<p><i>i. Description of the Power & Water asset from which the discharge occurred.</i></p> <p>Finke wastewater stabilisation pond 3.</p> <p><i>ii. GPS coordinates of the discharge point from the Power & Water asset, and the final coordinates of the final discharge point.</i></p> <p>Discharge Point: 134.5728930E, 25.5639374S Final Discharge Point: 134.5725931E, 25.5642729S (approximate final discharge point)</p> <p>Discharge occurred from the lowest point of the final treatment pond, meaning it was fully treated effluent.</p> <p><i>iii. Indicate any locations nearby to the discharge point where public can gain ready-access, such as public open spaces through which the discharge moves.</i></p> <p>Access by the public to the spill is possible but unlikely. The area is not frequently visited by people other than the Utility Services Contract Worker (USCW). The Technical Co-ordinator will be requesting that the USCW closes off the small track leading up to pond 3 for a period of time.</p>

<p>(c) the date and time of the incident</p>	<p><i>i. The time and date of commencement and cessation of the discharge.</i></p> <p>The timing of the overflow is unknown. The USCW, responsible for this community advised the Alice Springs Power & Water Technical Co-ordinator at around 14:00hrs 29/05/2025 of the spill. The spill has ceased since valves were adjusted 30/05/2025.</p> <p><i>ii. How Power & Water were notified or became aware of the discharge.</i></p> <p>The UCSW found that the ponds were overflowing, during a routine site inspection.</p> <p><i>iii. The process by which the discharge occurred.</i></p> <p>The cause of the overflow is a combination of wet weather events and an increasing population due to an event starting 06/06/2025 (Finke Desert Race), which attracts around 20,000 plus people to the area.</p> <p><i>iv. The reason why the discharge occurred.</i></p> <p>As per (c) iii,</p>

<p>(d) how the pollution has occurred, is occurring or may occur</p>	<p>As per (c) iii & (c) iv.</p>
<p>(e) the attempts made to prevent, reduce, control, rectify or clean up the pollution or resultant environmental harm caused or threatening to be caused by the incident</p>	<p><i>i. Confirmation signage and fencing has been erected, as appropriate.</i></p> <p>Signage has been erected near the facility, to prevent or reduce the possibility of the public contacting the spill.</p> <p><i>ii. Decontamination of the site as appropriate.</i></p> <p>Clean up consistent with Sewage Spills/Overflow Response Work Instruction as appropriate to the location, and to minimise risk to the Environment. Site was inspected for any wastewater gross pollutants, of which none were observed, as the wastewater effluent had already gone through 3 treatment ponds.</p>
<p>(f) the identity of the person notifying the NT EPA</p>	<p>Power & Water's Environmental Team on behalf of Water Services</p>
