## SECTION 14 INCIDENT REPORT (*Waste Management and Pollution Control Act*)

<b>Date and Time of Notification:</b>	Initial notification (Call) – 12 January 2025 2:56 pm												
<b>Person / Company:</b>	McArthur River Mining Pty Ltd (MRM)												
<b>Incident:</b>	A total of approximately 7 kilograms (kg) of bulk concentrate was inadvertently released at three locations along the Carpentaria Highway. The source of the spill originated from a road train travelling from McArthur River Mine (the Mine) to the Bing Bong Loading Facility (BBLF).												
<b>(a) the incident causing or threatening to cause pollution</b>	A total of approximately 7 kg of bulk concentrate was released at three locations on the Carpentaria Highway, between the Mine and the BBLF. All concentrate was confined to the road and roadside.												
<b>(b) the place where the incident occurred</b>	<p>The Global Positioning System (GPS) points for the length of the spill is provided in Table 1 below and shown in Figure 1.</p> <p style="text-align: center;"><i>Table 1 – GPS Coordinates of spill end and start.</i></p>

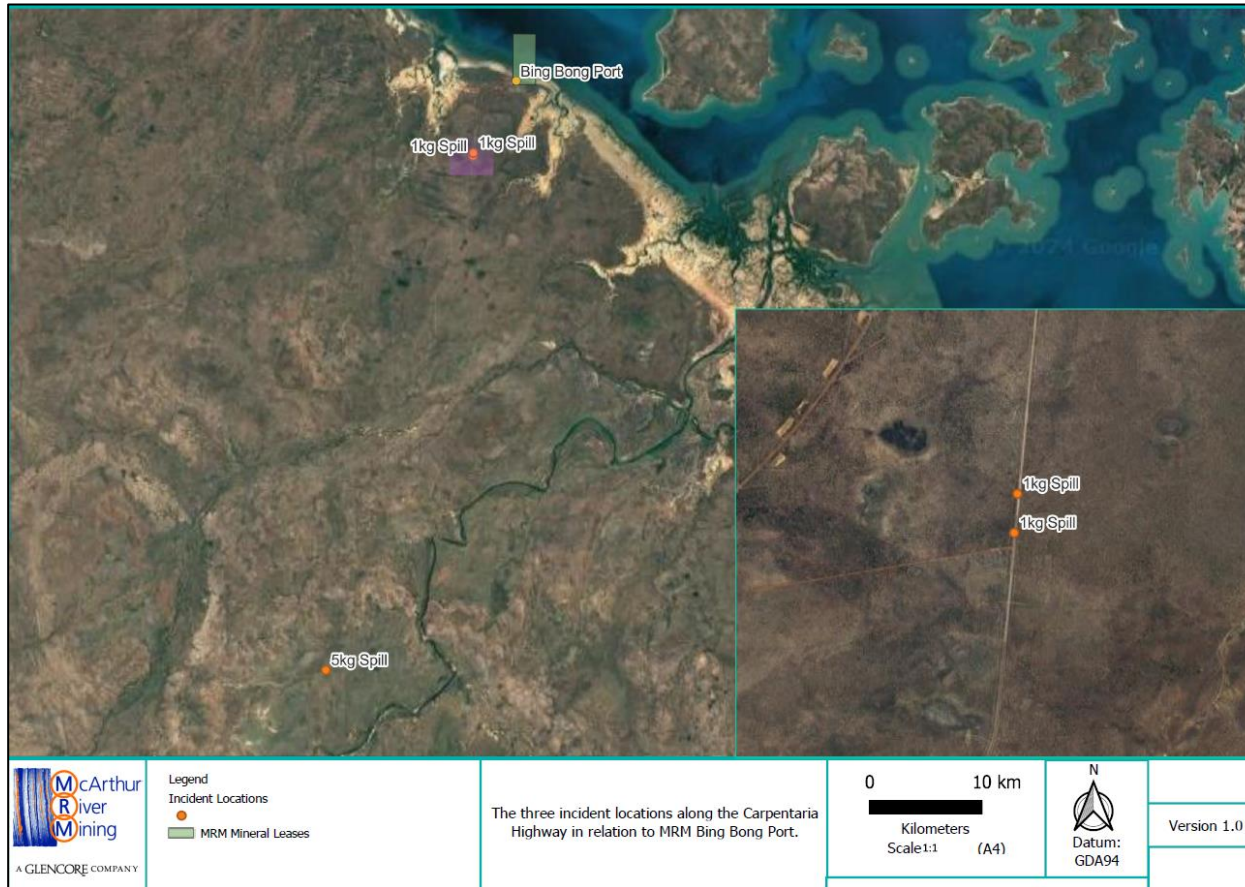
Figure 1: Incident Locations in relation to the BBLF

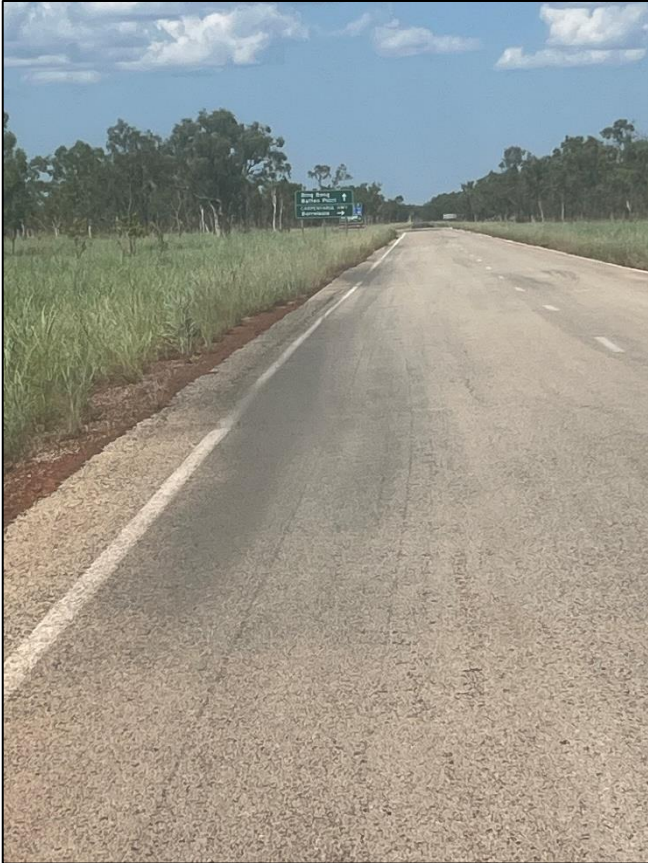
<p><b>d) how the pollution has occurred, is occurring or may occur</b></p>	<p>A road train transporting concentrate along the Carpentaria Highway from the Mine to the BBLF inadvertently released approximately 7 kg of bulk concentrate to the road and roadside, across three locations.</p> <p>An investigation is being undertaken to determine how the incident occurred.</p> <div data-bbox="608 584 1259 1444" data-label="Image">

</div> <p><i>Figure 2: Extent of the first spill heading North towards BBLF (5kg)</i></p>
--	---

A pressure hose and vacuum truck was used to collect the concentrate from the road and roadside at the incident locations. A grader will be used to collect all potentially contaminated material on the roadsides.

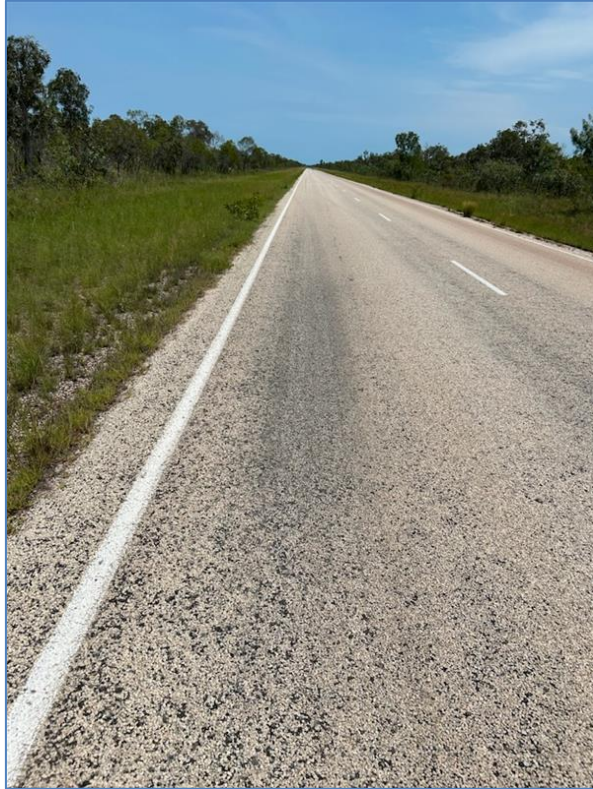
*Figure 3: Extent of the second spill heading North towards BBLF (1kg)*

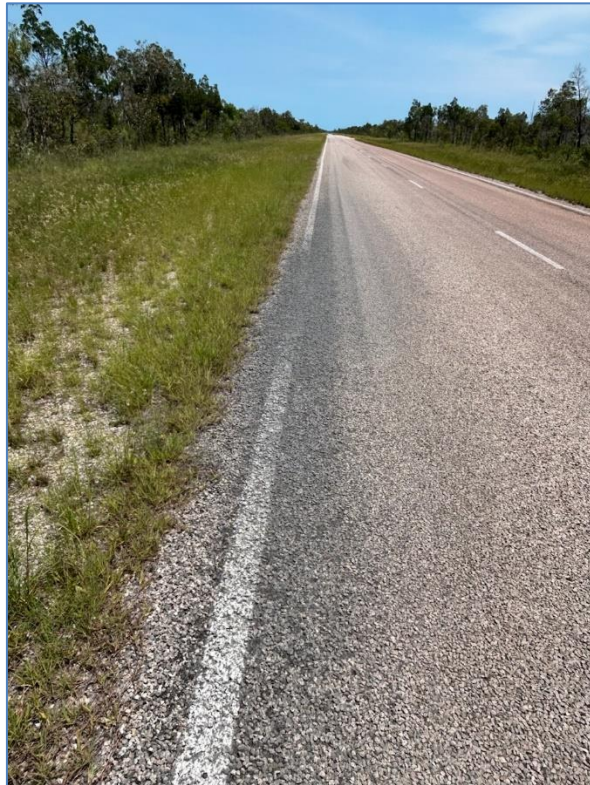
*Figure 4: Extent of the third spill heading North towards BBLF (1kg)*

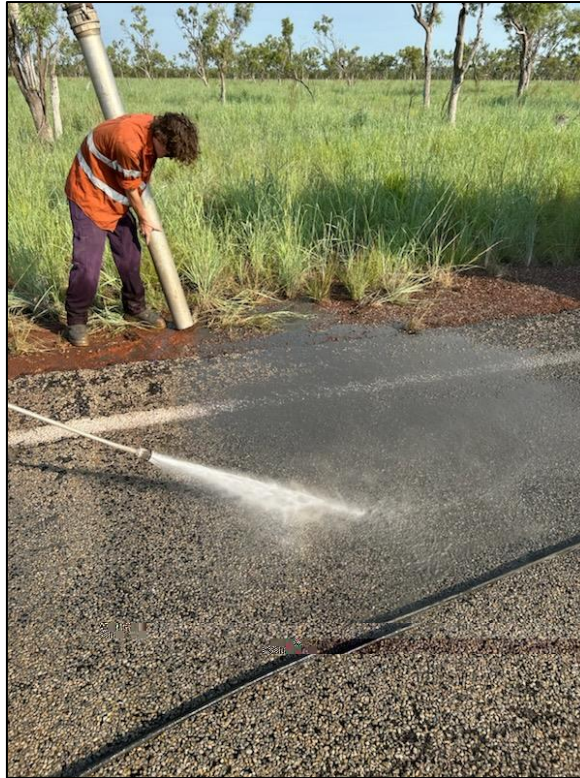
Figure 5: Removal of concentrate by a pressure hose and a vacuum truck.

All concentrate and removed material will be appropriately disposed of at the Tailings Storage Facility.

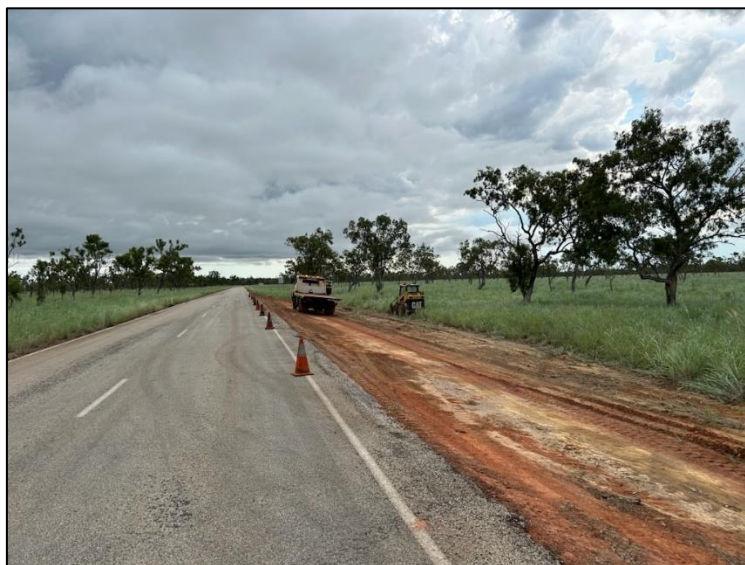
Figure 6: Grading of potentially contaminated material from the roadside.
