SOIL INVESTIGATION & STOCKPILE ASSESSMENT

CLIFT FREIGHT SERVICES

**ERLDUNDA DESERT OAKS RESORT
CORNER STUART & LASSETER HIGHWAYS
ERLDUNDA
NORTHERN TERRITORY**

Ref: EC0360

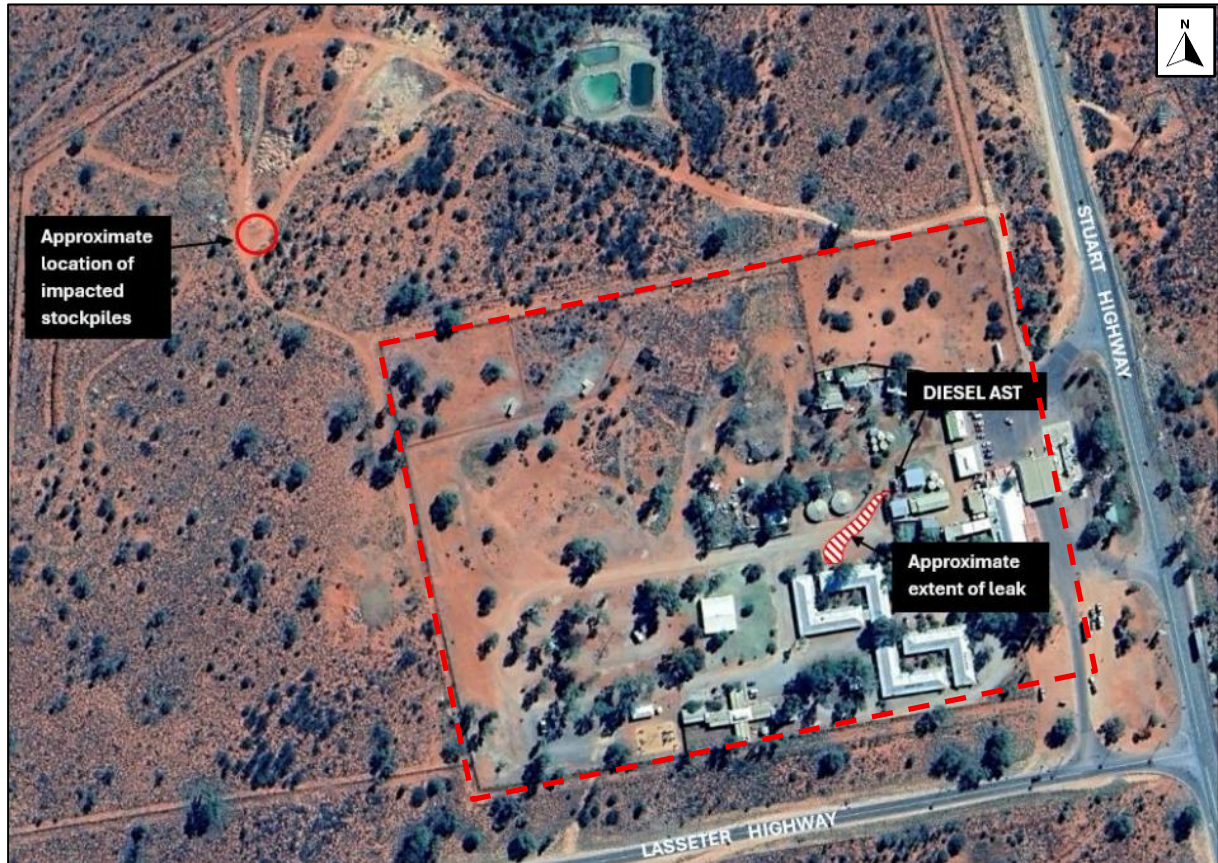
Figure 2: Diesel spill and stockpile location

A plan showing the approximate extent of the diesel spill and location of the stockpiled soil is presented as Figure 2. Photographs taken by Clift during remediation works follow.

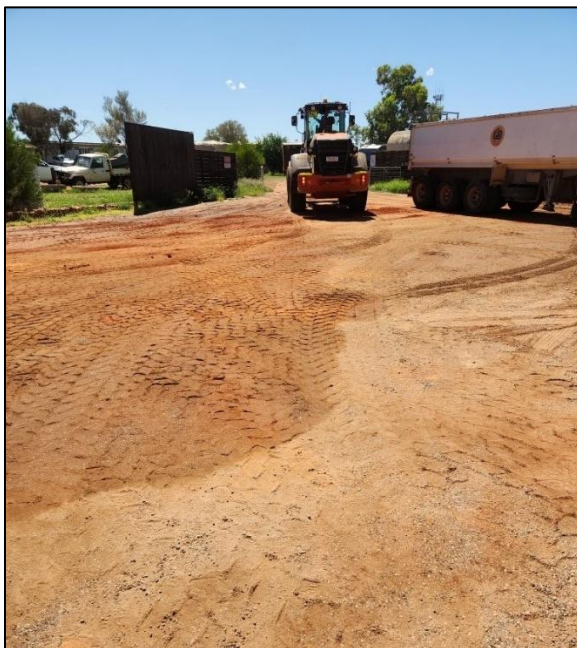
Photograph 1: View northeast across spill area during remediation works

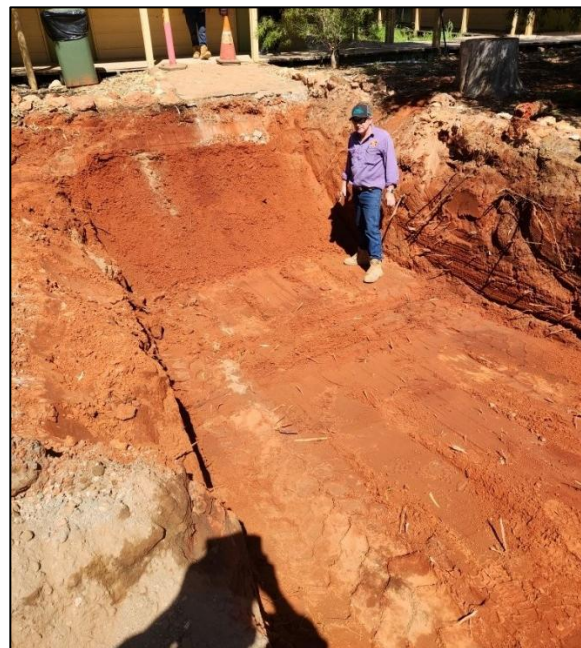
Photograph 2: Deeper excavation area where diesel had pooled

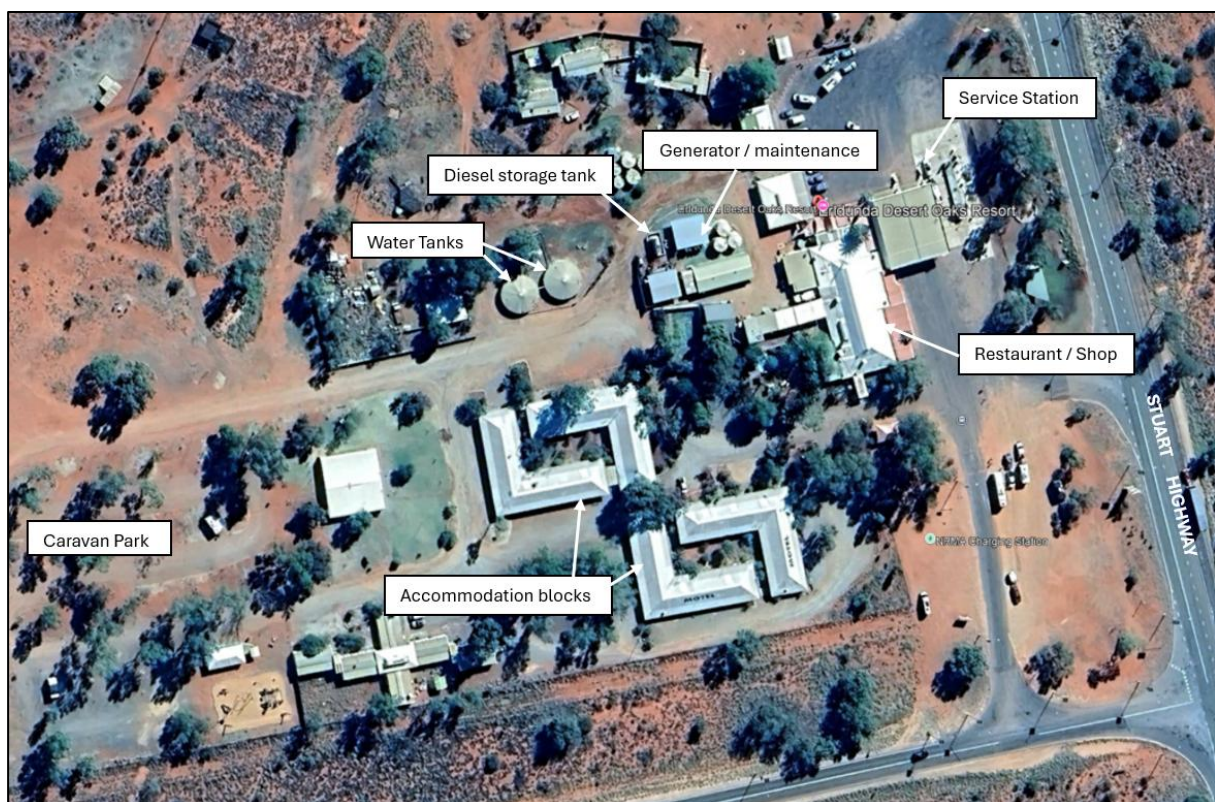
Figure 3: Site features

The Erlunda Desert Oaks Resort is located within an essentially rectangular shaped allotment of approximately 8.91 hectares. The site comprises a Shell service station fronting Stuart Highway and a tourist resort, including accommodation buildings, a caravan park area with ablution blocks, and a supermarket/ shop/ restaurant. The site is powered by diesel generators located in the eastern portion of the site. The approximate allotment boundary is shown on Figure 1 and Figure 2. A plan showing the location of the main site features of the Erlunda Desert Oaks Resort is presented as Figure 3.

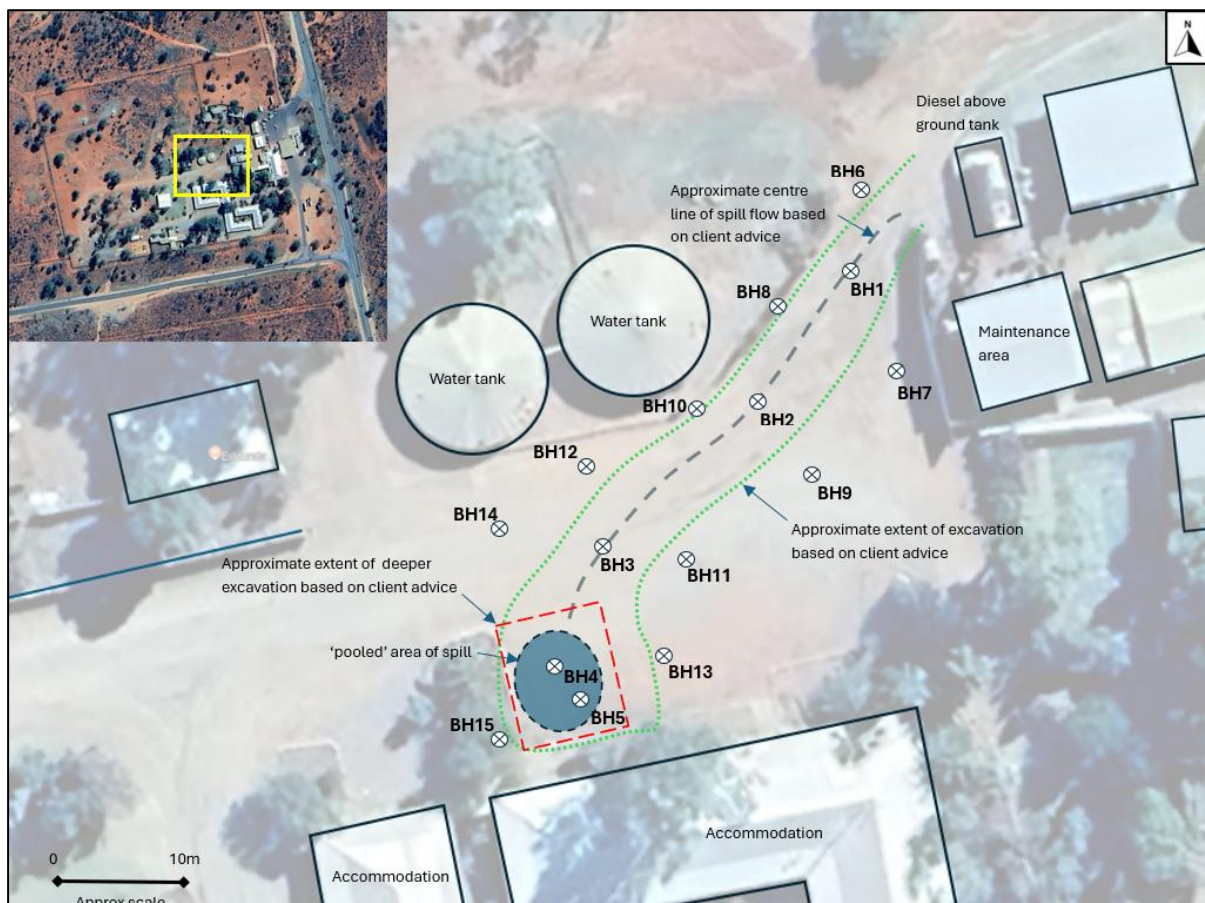
Figure 4: Soil Test Locations

Bore ID	Depths	Rationale
BH1, BH2, BH3	1.0m	Bores drilled along the approximate centre line of the spill (as advised by Clift and onsite personnel) where diesel travelled along a shallow drainage channel towards the area where the majority had pooled. These bores were drilled to ensure excavations had extended to sufficient depth.
BH4, BH5	2.2m	Bores drilled in the area where deeper excavations were completed to remove soils where the diesel spill had pooled to assess whether excavations had extended to sufficient depth.
BH6-BH15 inclusive	0.25 – 0.5m	Bores drilled outside of the line of the spill to assess whether the lateral extent of the excavation was sufficient.

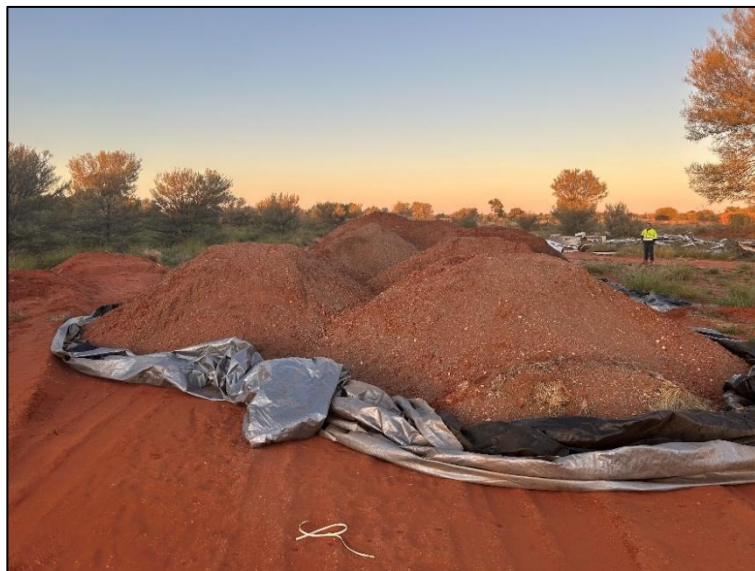
Photograph 3: View west towards stockpile

The stockpile was estimated to have a volume of 100-150m³ and comprised red brown silty sand material, which is consistent with advice from Clift that approximately 200 tonnes of soil was excavated from the spill area during remediation works.

The stockpile comprised red brown silty sand. No suspected asbestos containing material (ACM), or stained soils were identified during sampling. Hydrocarbon odours were noted from all samples collected from the stockpile.

Stockpiled soil generated from the excavation works contains elevated hydrocarbon concentrations and are not considered suitable for re-use at the site without further remediation works being undertaken. Echo understands the client is currently considering whether to undertake onsite remediation of the stockpiled soil or arrange for the soil to be disposed offsite to an appropriately licenced facility.

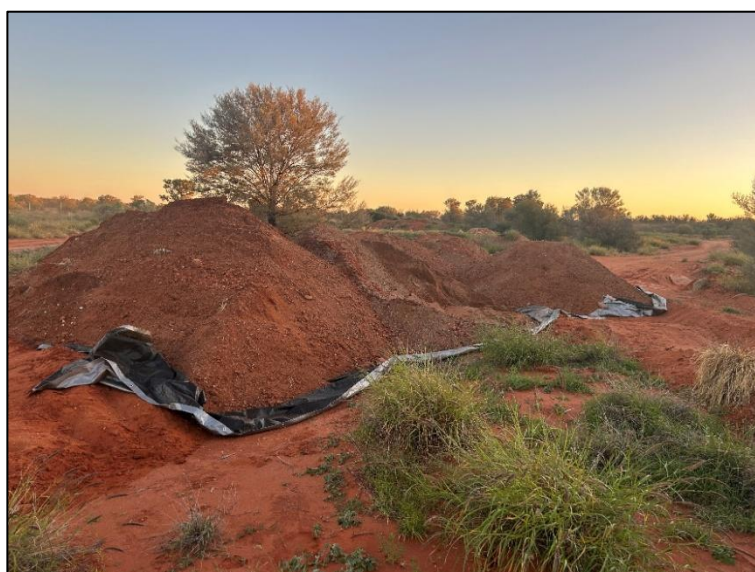
Photograph 4: view northeast towards stockpile
