# WDL 247 Environmental Monitoring Report Version 1

22 June 2021- 21 June 2022

Rustlers Roost Project Area

| MLN1083 | Waste Discharge Licence No. 247 |

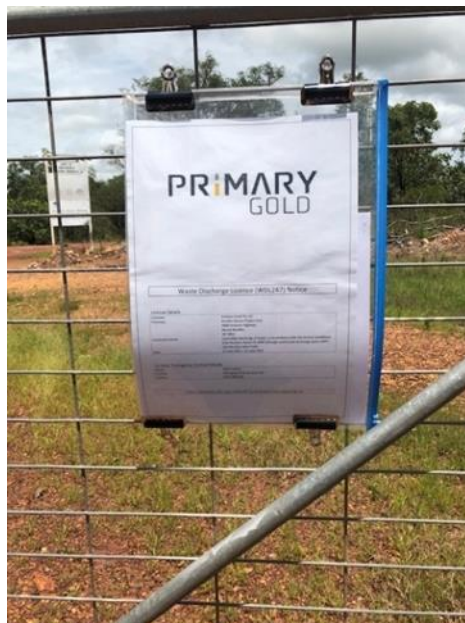
**Photo 1-1 PGL RRPA WDL247 Front Entrance Sign**

As per Licence Condition 4, a temporary sign was displayed at the entrance to the RRPA which included the license number as issued under the *Water Act* and a 24-hour emergency contact for public viewing (Photo 1-1).

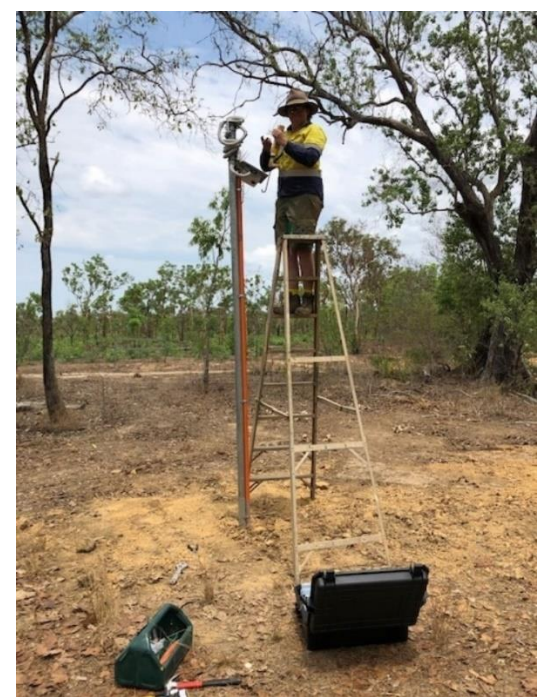
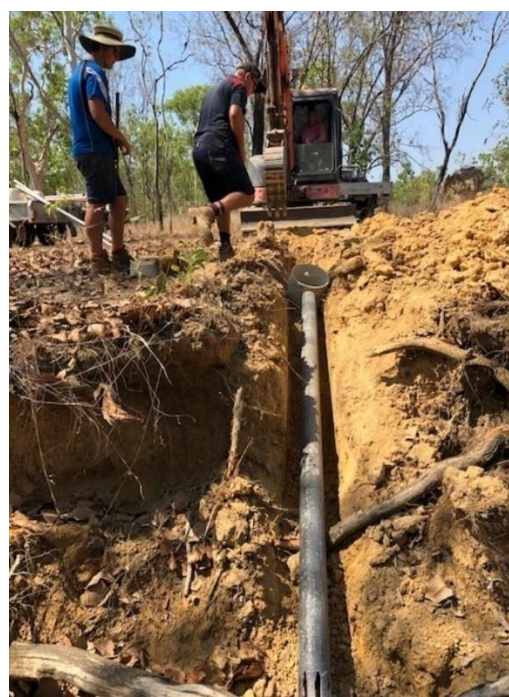
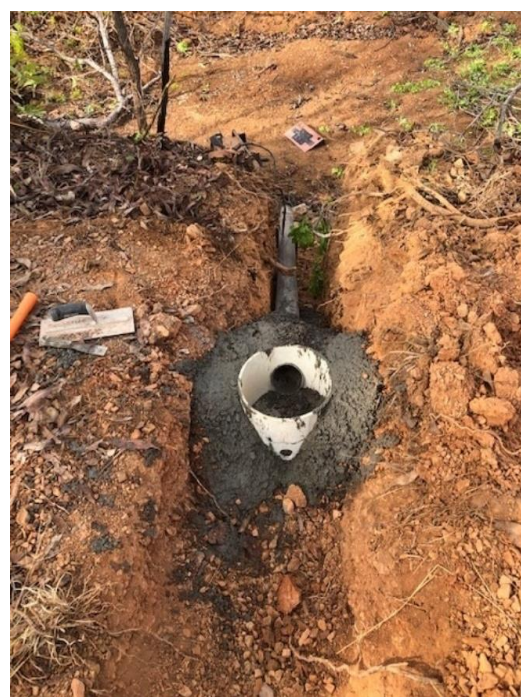
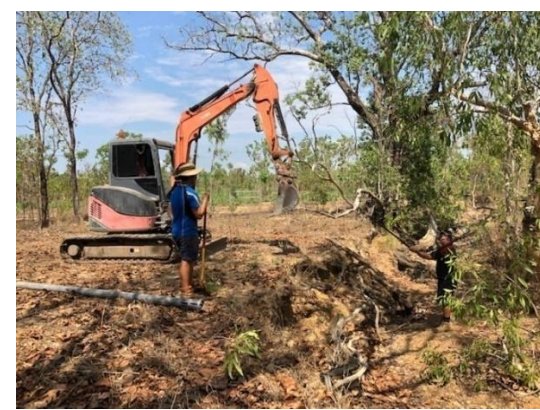
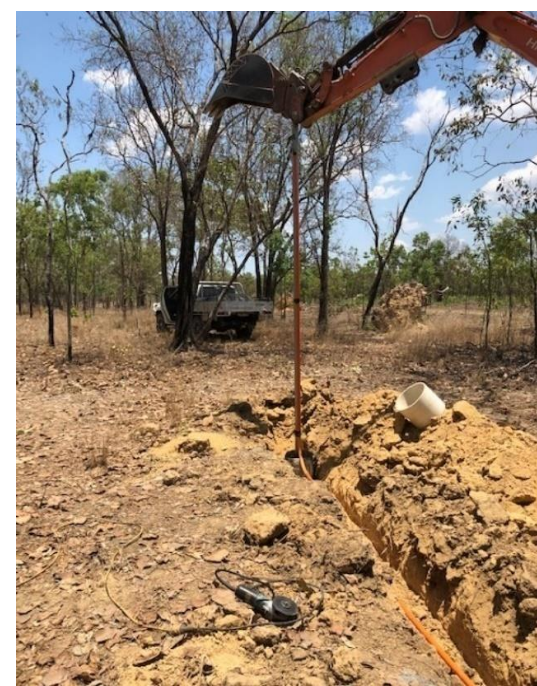
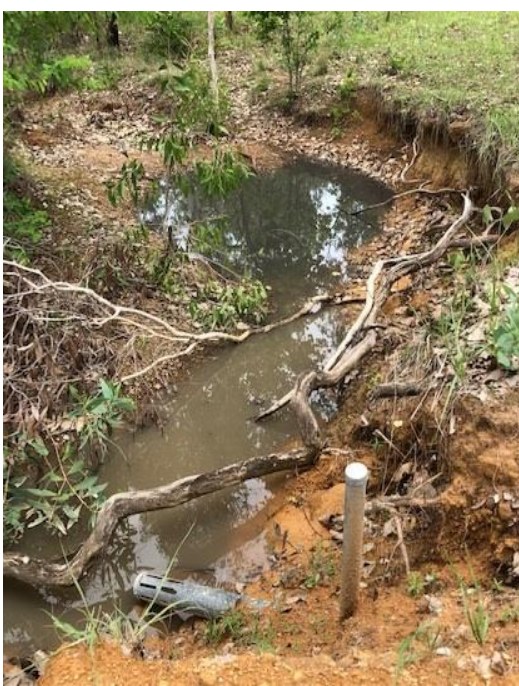
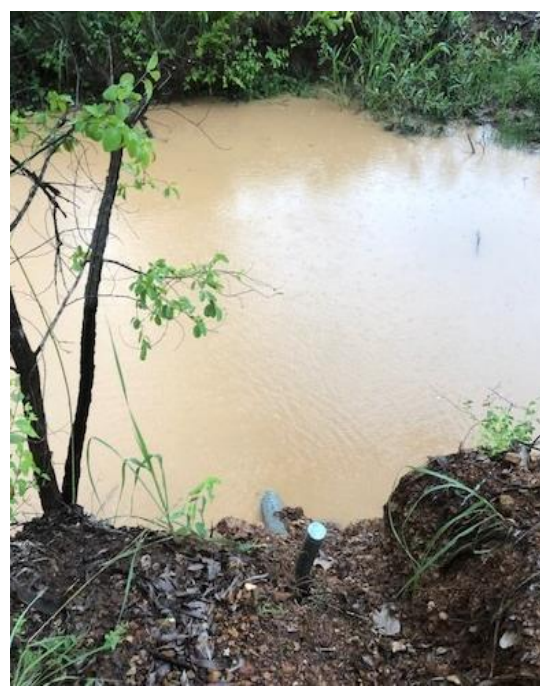
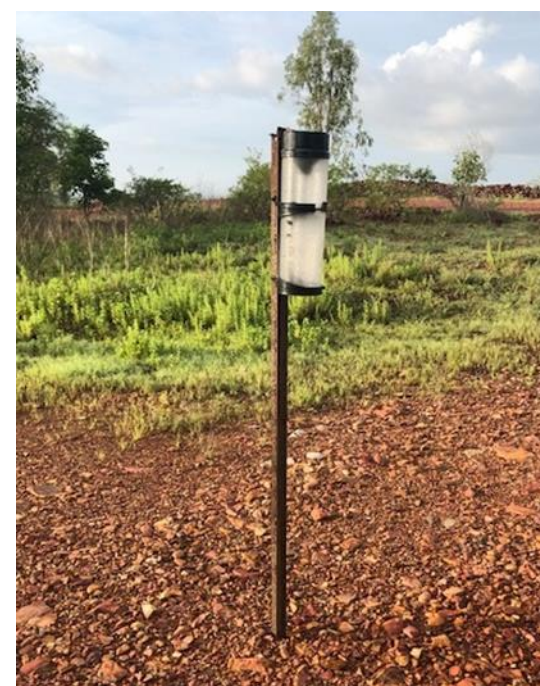
**Photo 1-2 Compliance Points Telemetry Stations (RRSW23 and RRSW24) Installation and Rain Gauge**

**RRSW24** telemetry station construction installing satellite and solar panel (Nov 2021) Rustlers Roost

**RRSW24** telemetry station construction installing steel housing to creek (Nov 2021) Rustlers Roost

**RRSW24** telemetry station construction installing access connection pit (Nov 2021) Rustlers Roost

**RRSW24** telemetry station construction digging conduit line (Nov 2021) Rustlers Roost

**RRSW24** telemetry station construction laying conduit (Nov 2021) Rustlers Roost

**RRSW24** telemtry station logger in creek (April 2022), Rustlers Roost

**RRSW23** telemetry station logger in creek (March 2022), Rustlers Roost

Rain gauge located at the top of the main WRD, Rustlers Roost

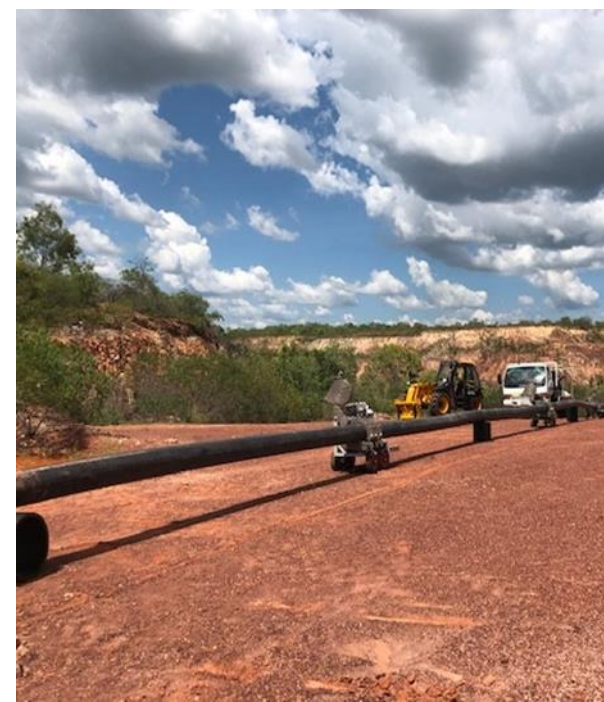
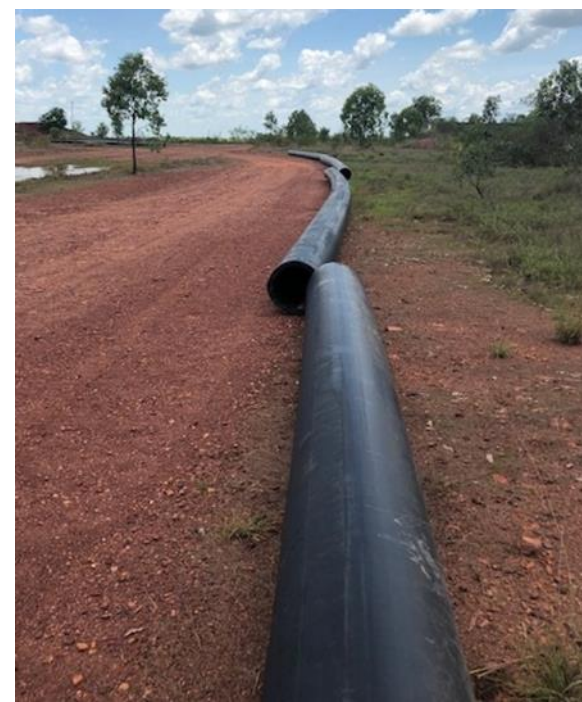
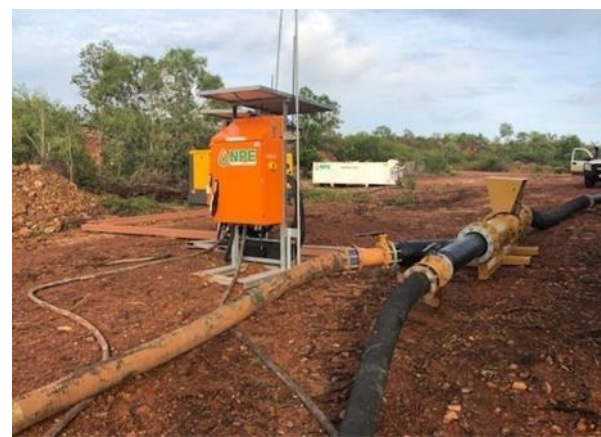
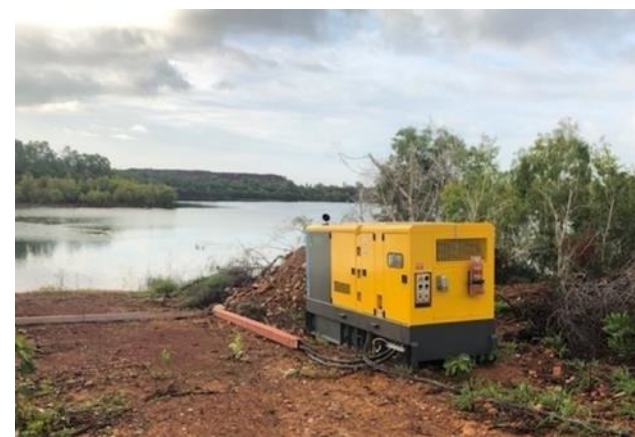
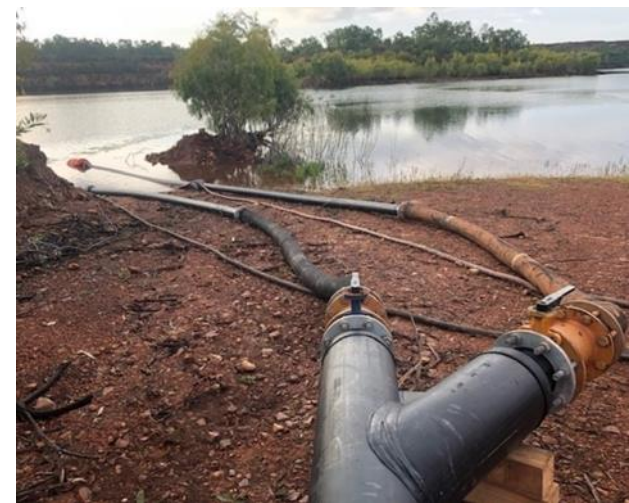
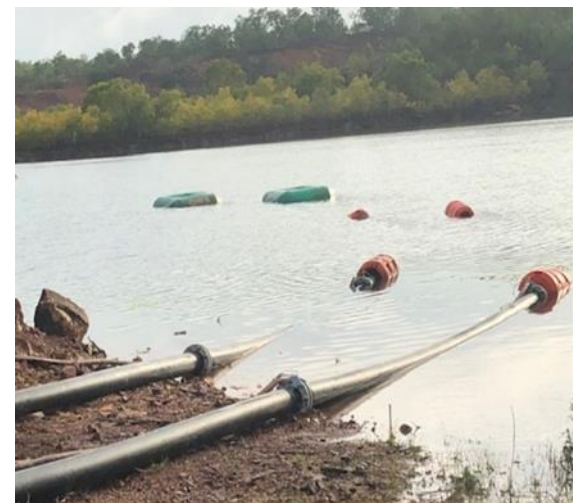
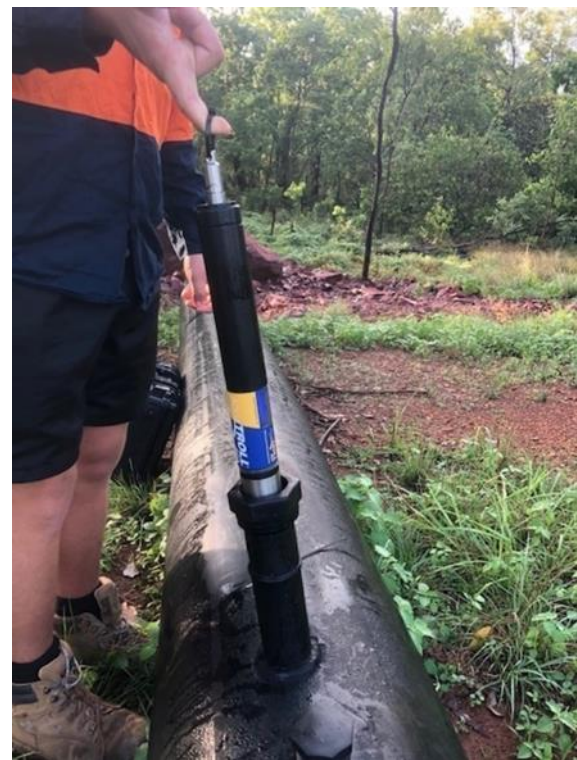
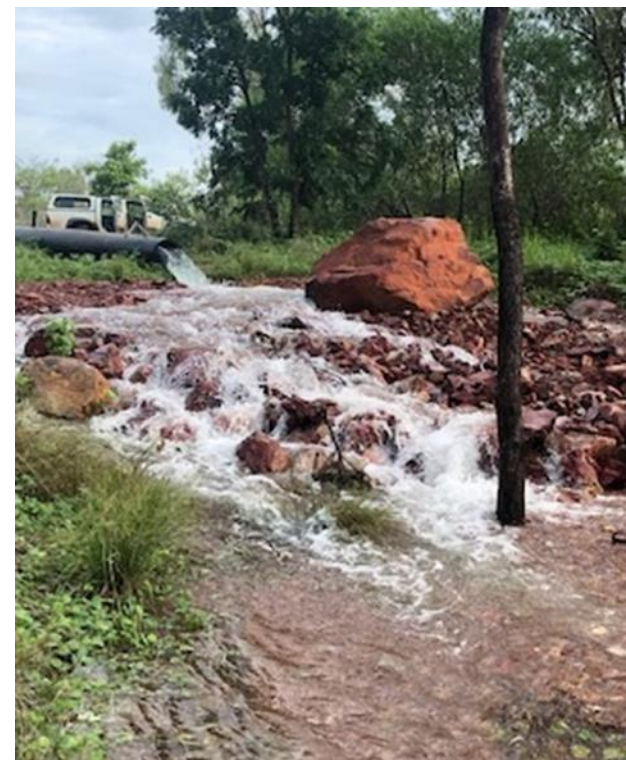
Photo 1-3 Installation of Discharge Pipeline for Authorised Discharge Point 2

Rustlers Roost Pit water discharge pipeline construction (Dec 2021) Rusters Roost

Rustlers Roost Pit water discharge instrumentation and 10,000 litre diesel tank (Dec 2021) Rusters Roost

Rustlers Roost Pit water discharge diesel generator (Dec 2021) Rusters Roost

Rustlers Roost Pit water discharge pipeline into pit (Dec 2021) Rusters Roost

Rustlers Roost Pit water discharge pipeline pipeline floats (Dec 2021) Rusters Roost

ADP2 (WDL 247 monitoring)-Aqua Troll logger placed in pipe, Rustlers Roost

Rustlers Roost pit water discharge (ADP2) – discharge point (Feb 2022)

Prior to the 2021- 22 wet season, a poly pipeline was installed to discharge water from the Rustlers Roost Pit to a tributary to the west of the Heap Leach Pad and ultimately to the headwaters of Mount Bunday Creek (Figure 1-3; Photo 1-3). An Aqua Troll data logger was installed at the end of pipe to record electrical conductivity ( $\mu\text{S}/\text{cm}$ ) and flow ( $\text{kL}/\text{sec}$ ) during discharge events to meet Licence requirements.

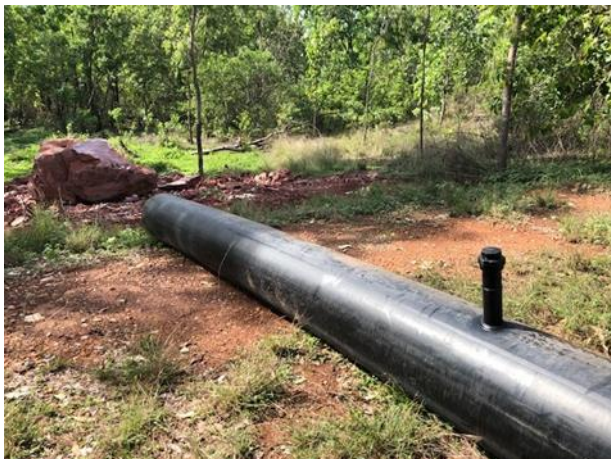
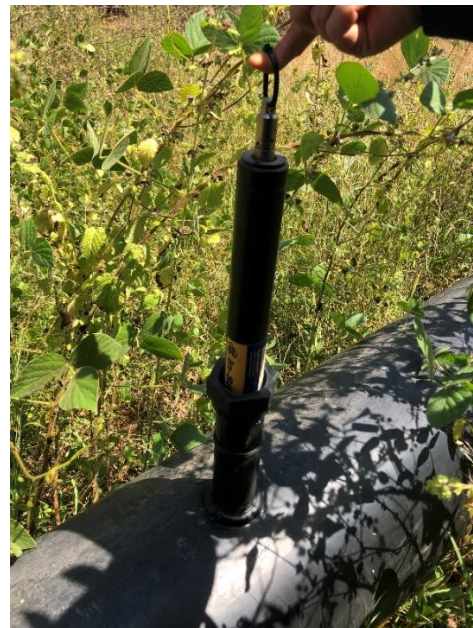
**Photo 2-1 Authorised Discharge Point 2 Continuous Data Logger**

In-situ Aqua Troll sonde housing vertical in end of pipe, water discharge from Rustlers Roost Pit, January 2022, Rustlers Roost PA

In-situ Aqua Troll sonde in housing end of pipe, water discharge from Rustlers Roost Pit, February 2022, Rustlers Roost PA

Data collection at ADP2 was performed using the In-Situ Aqua Troll 600 multiparameter sonde installed to continuously gather field data for flow (KL/ sec) and Electrical Conductivity ( $\mu\text{S}/\text{cm}$ ). The probe was installed in a purpose constructed slot in the pipe (situated vertically in the pipe) to ensure the sensors were continuously maintained in pipe flow. Data management involved logged data stored and downloaded weekly via the VuSitu Mobile App in a Universal Data File accessing via blue tooth to the field smart phone. Calibrations using a Quick Cal Solution was performed prior to installation.

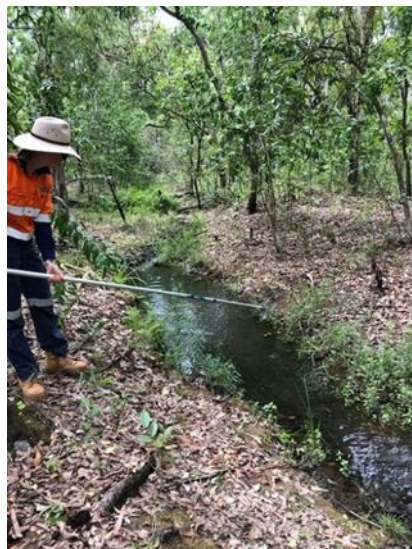
### Photo 2-2 Field Sampling Method

Field sampling using extension pole at Mine Management Plan  
Monitoring Site

All metals/metalloids, general chemistry and nutrients were field sampled as per the routine sampling method in pre labelled and acidified bottles provided by the analytical laboratory (Envirolab NATA accredited for the related analysis). Samples were stored in eskies and kept cool using ice or ice bricks. At the end of each day samples were either moved to a fridge/freezer for overnight holding if field sampling finished after 3pm or delivered to the Darwin Envirolab before 3 pm, repacked with new ice bricks and sent by air to Perth Envirolab laboratory for analysis. To ensure samples were delivered to the lab within the respective holding times and temperature, sampling was performed Monday to Wednesday each week and dispatched same day or next day at the latest. A fast turnaround of laboratory analysis was requested for Compliance Point RRSW23.

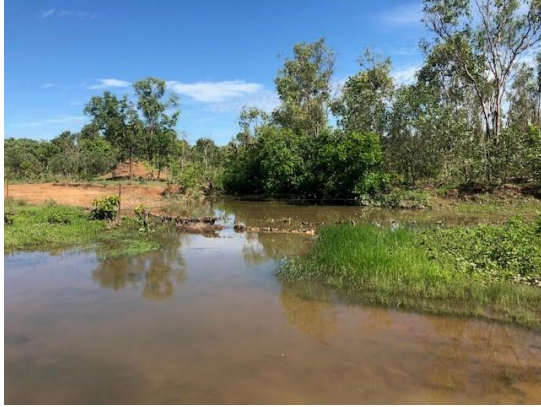
**Photo 6-1 Proposed WDL247 Control Site Q29SW9a**

Q29SW9a proposed control site upstream, photo taken January 2022.

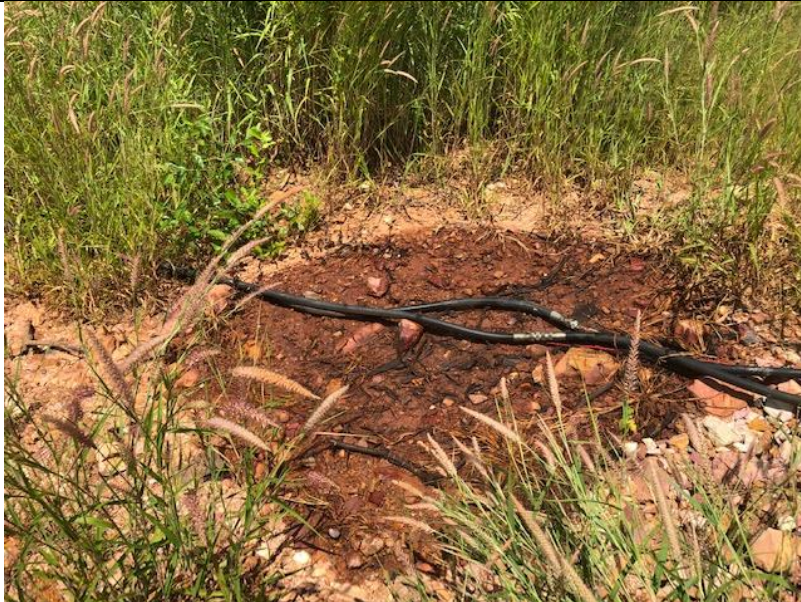
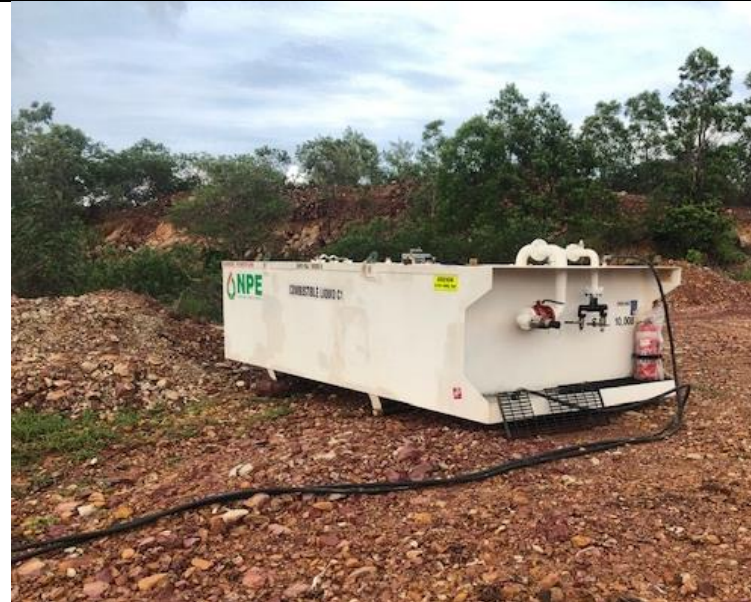
Diesel fuel leak -generator and diesel tank area near main pit, Rustlers Roost

10,000 litre diesel fuel tank and line to generator with leak, Rustlers Roost

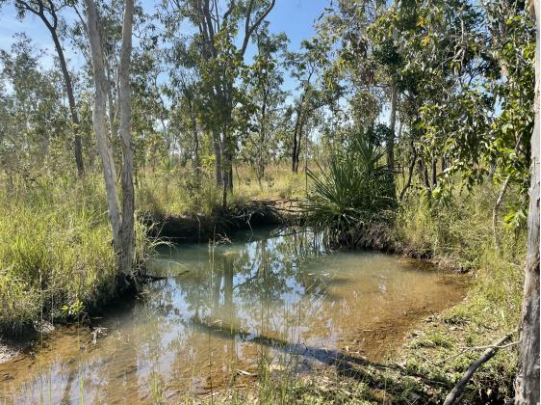
| Site description | Site photo |
|---|---|
| <p><b>RRMCUS – Upstream</b></p> <p>The site was located in a tributary of Marrakai Creek. The site is characterised by a narrow, meandering creek line through Paperbark and Pandanus which lined the banks. the creek was flowing at the time of sampling and contained several pools connected by shallow runs.</p> | |

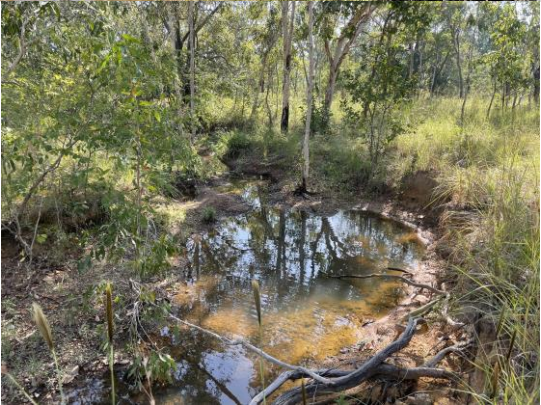
| Site description | Site photo |
|---|---|
| <p><b>RRMCDS – Downstream</b></p> <p>The site is located downstream of a large dam constructed across Marrakai Creek. The site is characterised by a narrow, meandering creek line through Paperbark trees and an understorey of grass. Habitat was very similar to the upstream site, containing pools and runs</p> | |

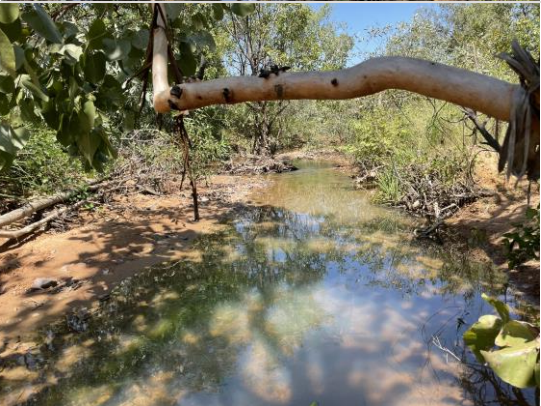
| Site description | Site photo |
|---|---|
| <p><b>MBCUS – Upstream</b></p> <p>The site is located upstream of influences from Rustlers Roost and Quest 29. The site was characterised by sandy substrate in pools connected by shallow runs. There was an indication of nutrient enrichment, as filamentous algae was present in the water column. Riparian vegetation provided moderate shade.</p> | |

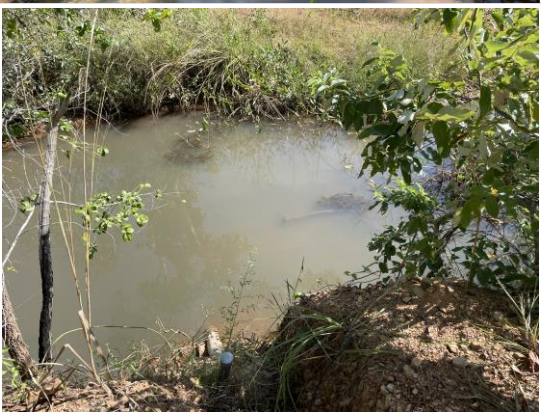
| Site description | Site photo |
|---|---|
| <p><b>RRSW23 -Downstream</b></p> <p>The site is located on a tributary of Mount Bunday Creek and consisted of a large, deep pool between riffles and runs. Substrate in shallow habitats was a mixture of sand and pebbles, and the pool contained sand with bedrock covered by detritus. Riparian vegetation was made up of shrubs, with some trailing into the water. There was very little shade at the site.</p> | |

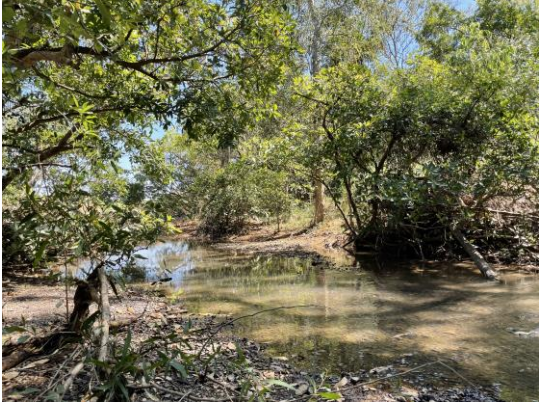
| Site description | Site photo |
|---|---|
| <p><b>Q29SW2 – Downstream</b></p> <p>The site is located on a tributary of Mount Bunday Creek and was relocated downstream of the road crossing due to safety concerns. A bridge had been constructed across Mount Bunday Creek prior to the 2021/2022 wet season. The site consisted of shallow pools between riffles and runs. Substrate in shallow habitats was a mixture of sand and pebbles with a layer of fine silt. Riparian vegetation was made up of shrubs and provided good and continuous shade.</p> | |

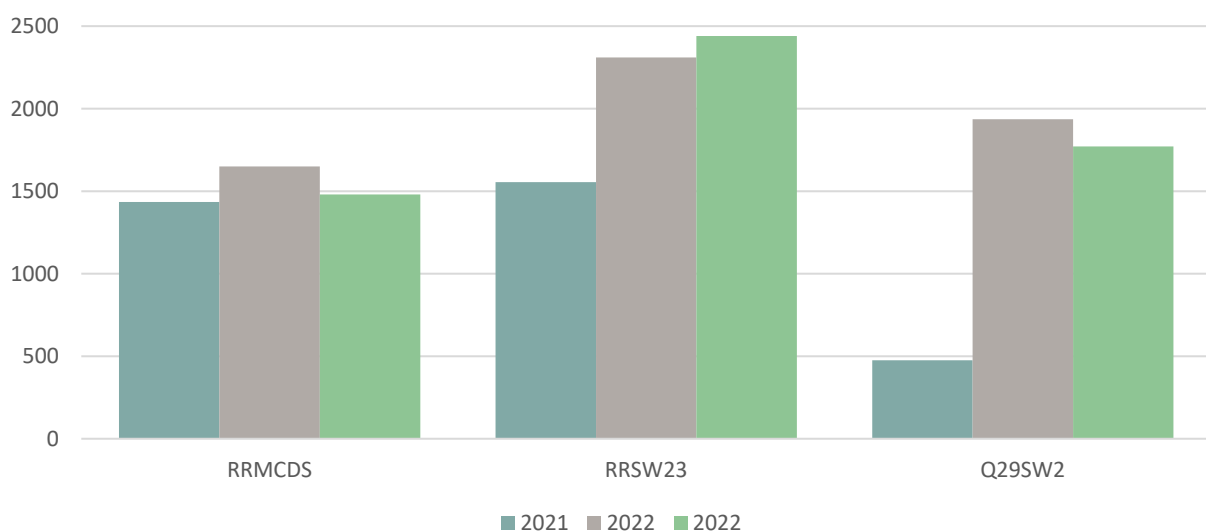
Figure 5 – Relative abundance of samples from 2021 and 2022

Relative abundance results from pre and post discharge are compared in Figure 5. Only sites for which there is data from 2021 are presented. Samples from downstream sites on Mount Bunday Creek contained a higher abundance of macroinvertebrates in 2022, compared with 2021, whereas samples from Marrakai creek were similar.

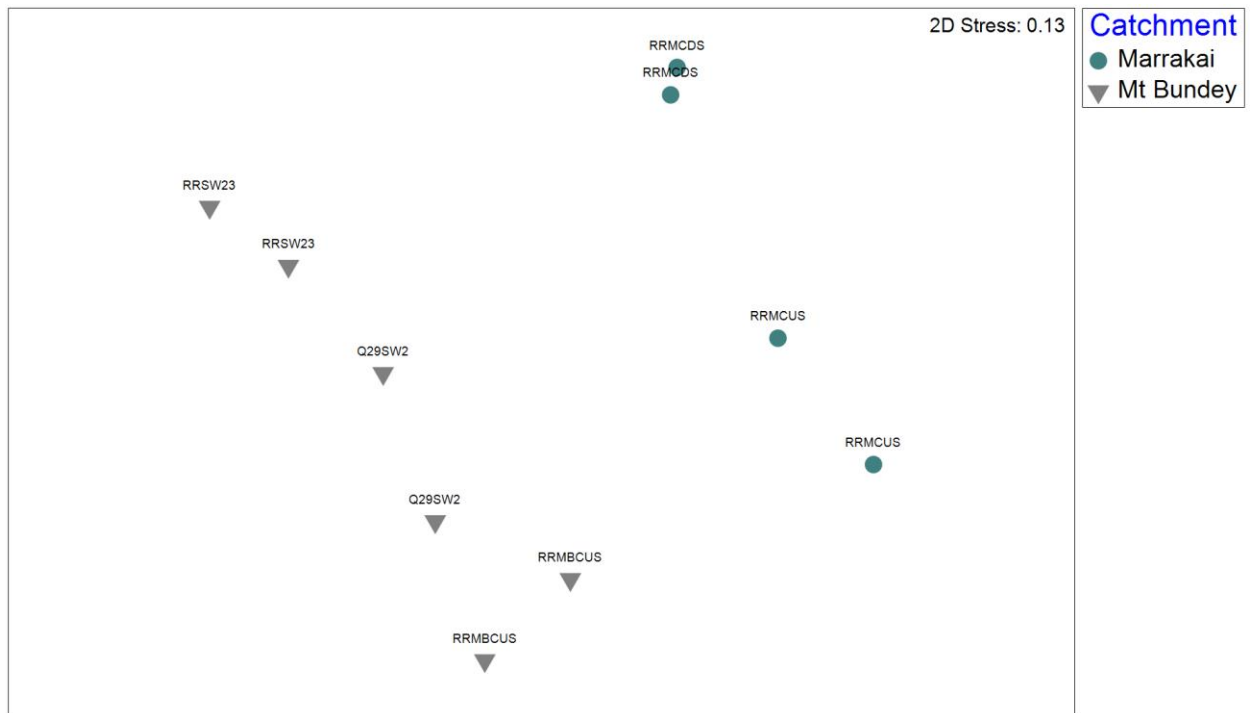
Figure 14 - NMDS demonstrating similarities and differences between samples collected in 2022

The nMDS ordination (Figure 14) demonstrates the difference in community composition between the two catchments, confirming that sampling of a site upstream on the Mount Bunday Creek catchment will allow for a more nuanced assessment of impact that relates directly to each catchment.
