# WDL 247-02 Environmental Monitoring Report

8 August 2023 to 1 April 2024

Rustlers Roost Project Area

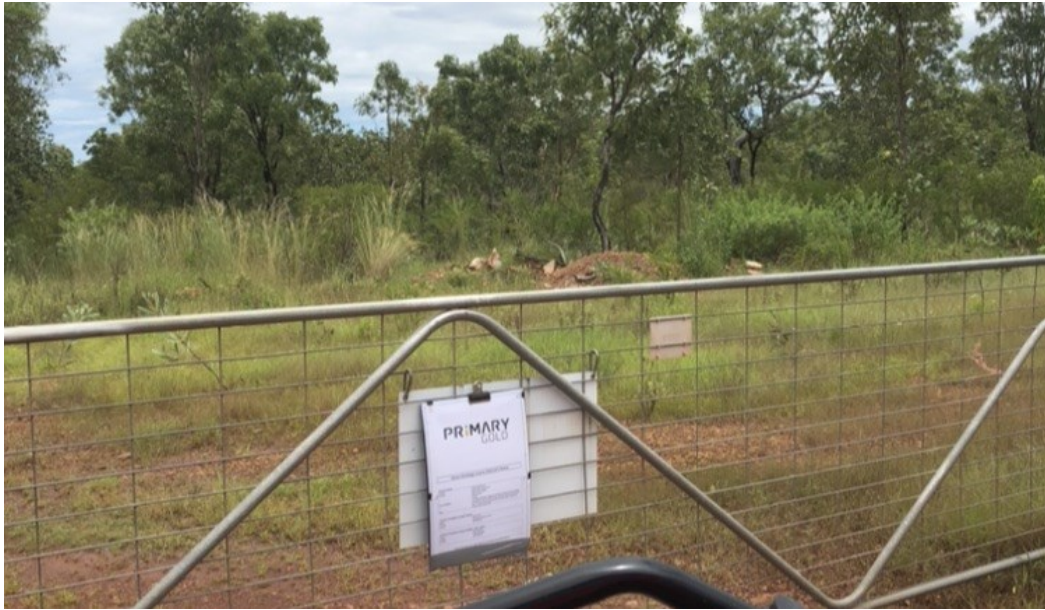
**Photo 1-1 PGO RRPA WDL247-02 Front Entrance Sign**

As per Licence Condition 4, a sign was displayed at the entrance to the RRPA which included the licence number as issued under the Water Act and a 24-hour emergency contact for public viewing (Photo 1-1).

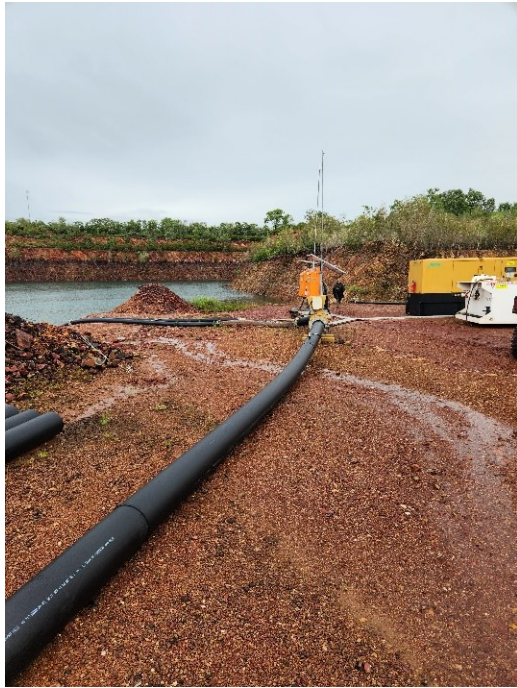
Rustlers Roost Pit Pump infrastructure- electric pumps, 10,000L diesel tank and generator (Jan 2023)

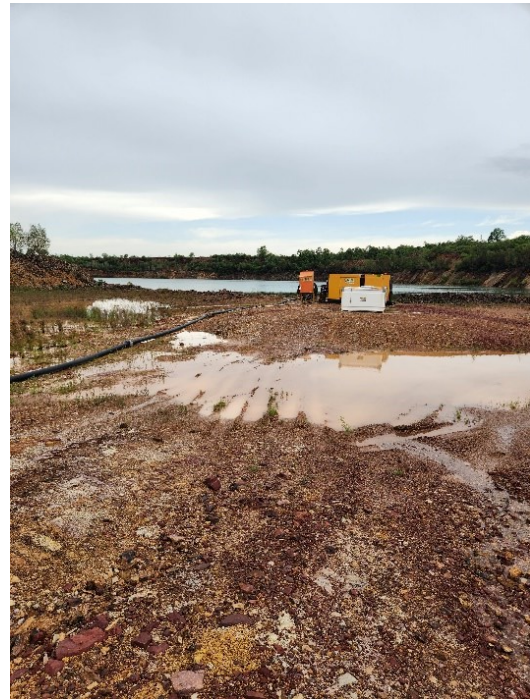
Staging water pump and generator located on wall between Backhoe Pit and Rustlers Roost Main Pit (Jan 2023)

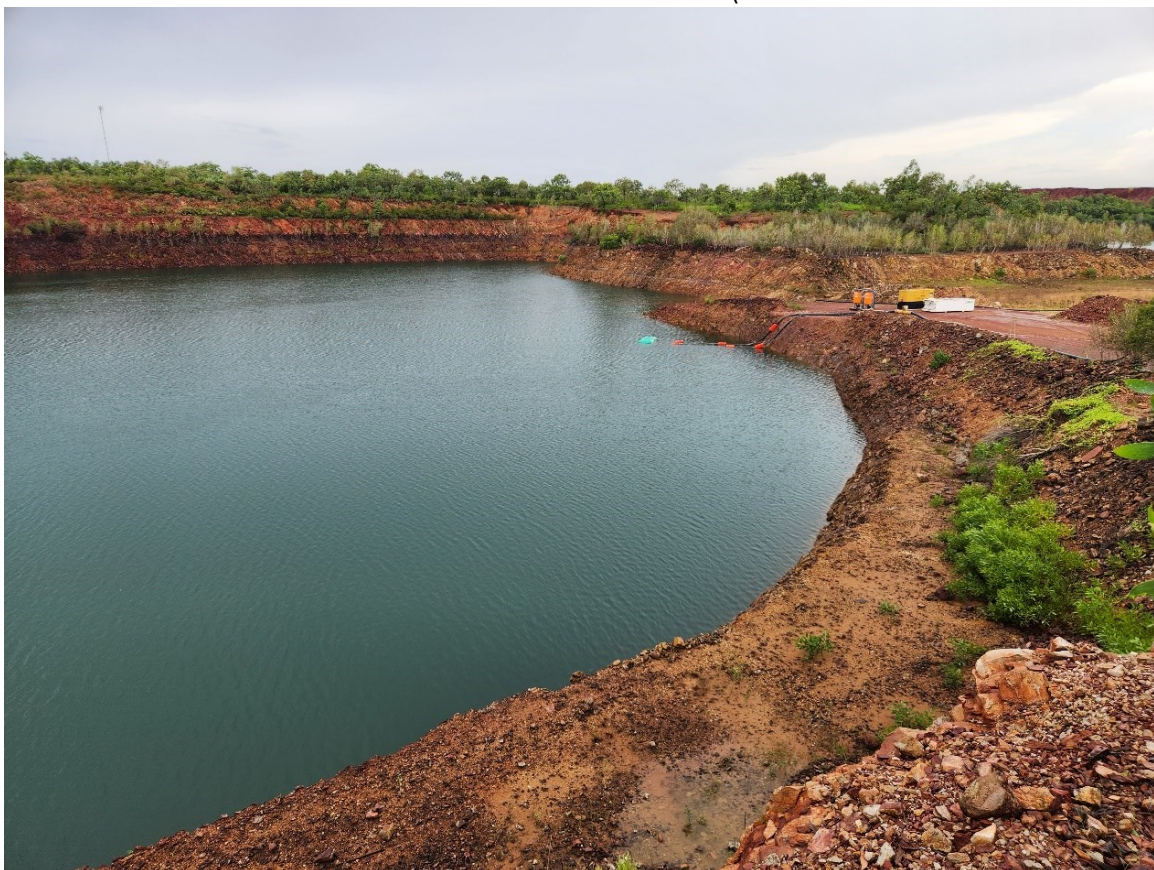
**Photo 1-2 Installation of Discharge Pipeline for Authorised Discharge Point 2**

Overlooking Pump set up in Rustlers Roost Main Pit

**Note: All pumps and generators removed, and pipes maintained during the 2023/24 season as no active discharge occurred**

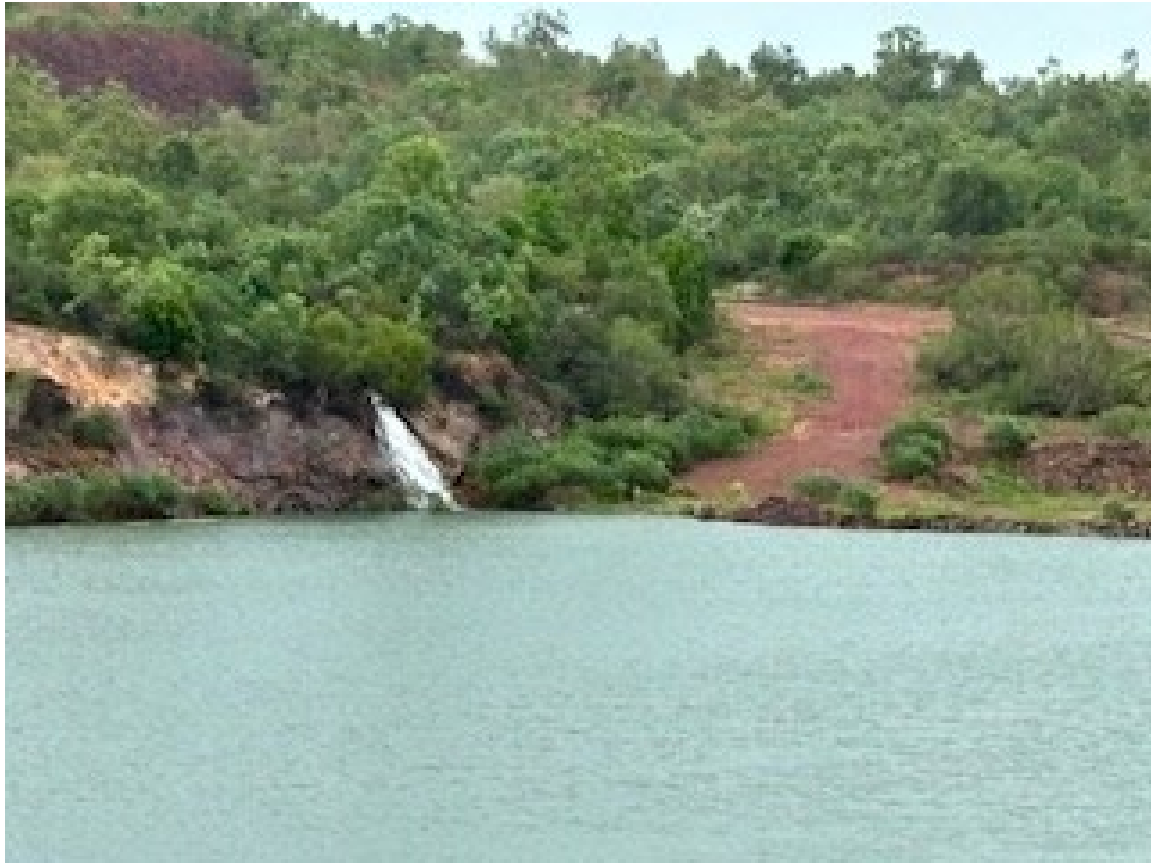
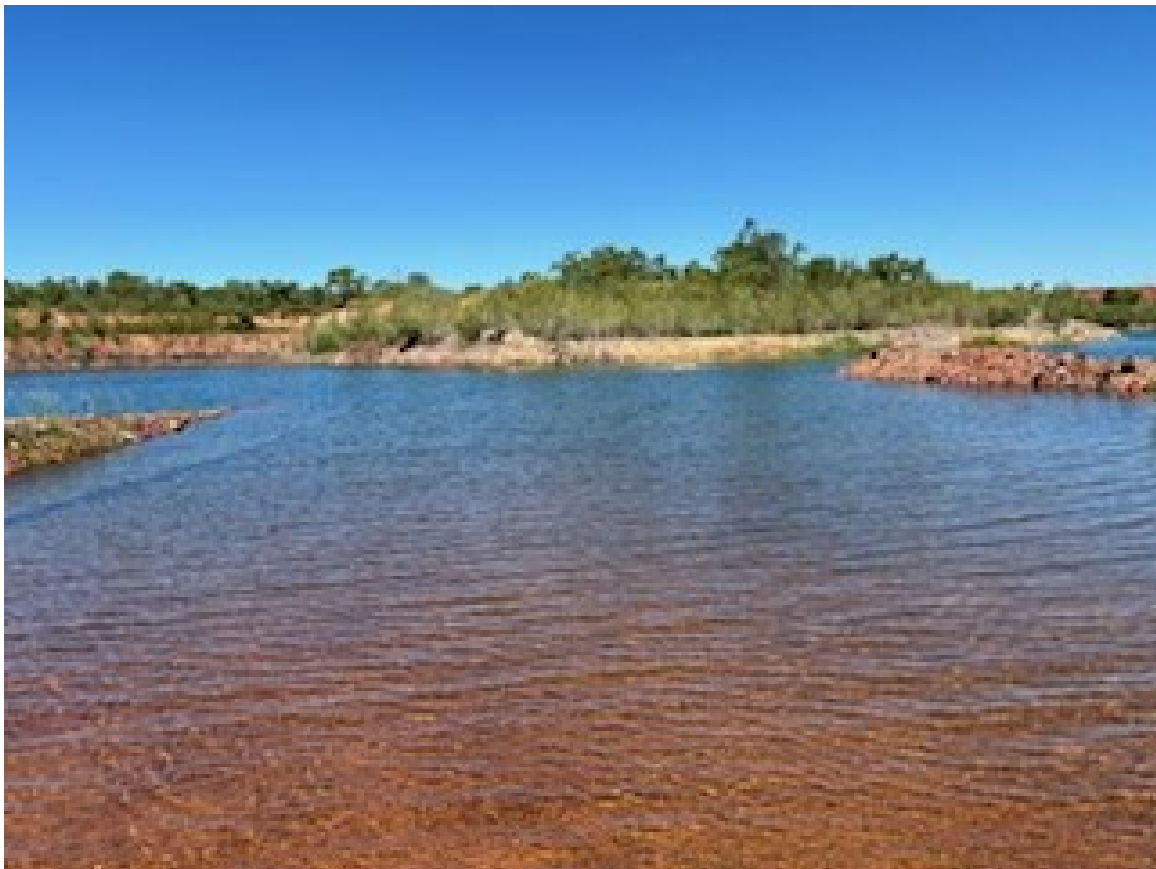
Photo 1-3 Surface Water Inflow to Backhoe Pit and current pit levels (April 2024)

The unforeseen natural surface inflow (150-180 L/sec) into the southern Pit (Backhoe Pit), observed by field officers in February 2023 continued during the 2023/24 wet season. These considerable inflows were not included in the pit dewatering programme model and has compounded the below forecast pit water volume reduction. It is likely these surface inflows have been occurring since mining ceased over 30 years ago which supports the reason why there was a lower than predicted overall pit water reduction during the previous dewatering activities in 2021/2022 and 2022/2023 wet seasons. A photo taken in April 2024 shows the inflows and Rustlers Roost pit water levels have increased to levels around the 55.39RL in (Photo 1-3).

For operational safety, PGO is currently preparing a plan as part of start-up for redirecting these inflows.

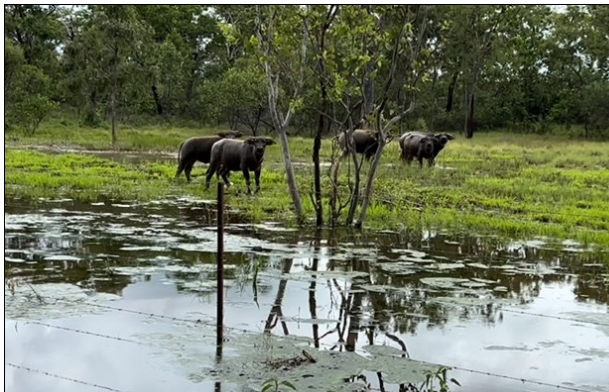
| Invasive species | Feral animals i.e. pigs, buffalo wallowing near at sample sites ( |

Photo 2-1 Presence of buffalo upstream of RRSW23, in the upper catchment of Mount Bunday Creek

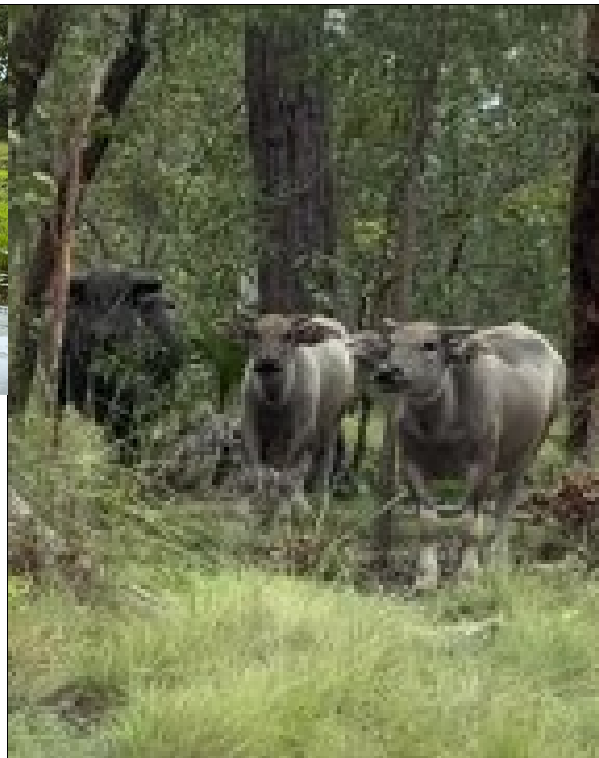
Photo 2-2 Presence of Buffalo at RRSW6 Spillway, January 2024

| Contributions | Rationale |
|---|---|
| Animal activity | Notable increase of buffalo number was recorded several times during routine monitoring at the RRPA when compared to previous years. Sightings and evidence of buffalo activity were recorded at RRSW23, RRSW6, Q29SW2 and Q29SW10 on several occasions. Buffalo are known to cause considerable disturbance to the environmental landscape through erosion of riverbanks and wading/ creating wallows. The presence of buffalo is considered to have contributed to nutrient loads during the reporting period. |
