# WDL 249 Environmental Monitoring Report

22 December 2022- 21 December 2023

Toms Gully Project Area

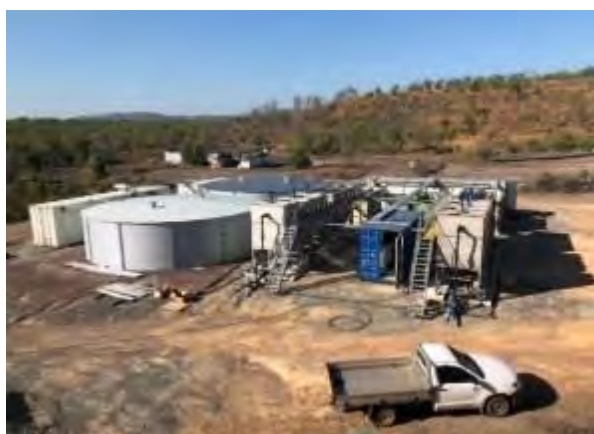
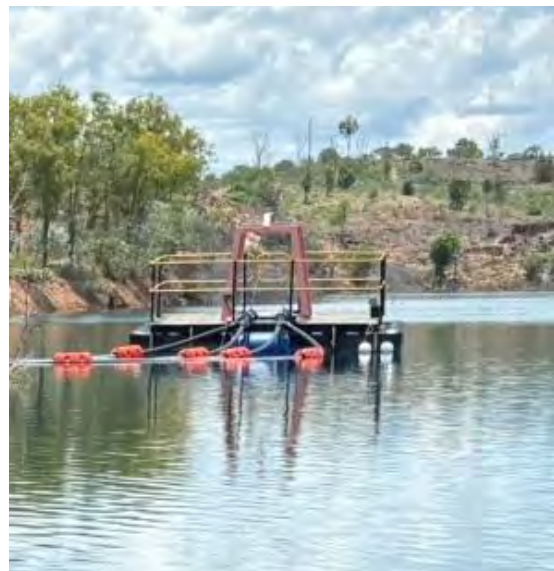
**Photo 1-1 TGPA Reverse Osmosis Plant and Pump Pontoon**

TGPA remained in care and maintenance during 2022-2023 reporting period and has been since PGO's purchase of tenements in 2013. No exploration activities occurred at TGPA during this reporting period. The EIS for TGPA was formally approved in 2020 under the *NT Environmental Protection Act 2019*. The Reverse Osmosis (RO) water Treatment Plant received approval from the Department of Infrastructure, Tourism and Trade (DITT) in December 2022 under the *Mining Management Act 2001*. Construction of the plant and auxiliary infrastructure (including reconnection of mains power) occurred during 2023 with commissioning of the RO Plant in October 2023 (Photo 1-1).

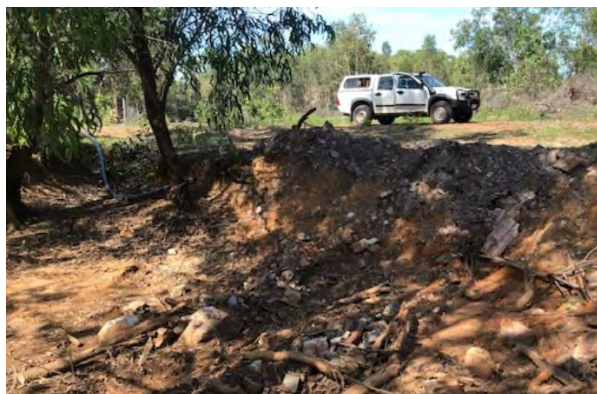
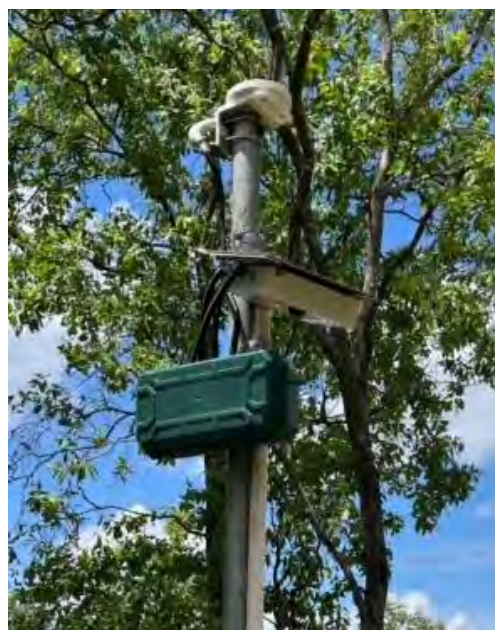
**Photo 1-2 Authorised Discharge Point 1 and Compliance Point Telemetry Station**

Photos include ADP1 and the telemetry station setup at the Compliance Site, SWTG2 (Photo 1-2).

Though there was no active discharge of treated water to ADP1 during this reporting period, under typical conditions during discharge, flow data including total discharge volumes to ADP1 is captured and recorded continuously. Continuous logger flow meters are installed at the RO plant and data retrieved as required. Height levels are taken weekly at Toms Gully Pit. The RO Plant and pumps are connected to mains power.

A solar powered telemetry station was installed at the Compliance Point (SWTG2) in November 2022 to monitor compliance against discharged water during creek flow. The telemetry station provide data in real time with continuous hourly recordings of electro- conductivity, pH, turbidity, dissolved oxygen, temperature and water levels. Data is captured via the Xylem Eagle internet portal. Weekly water quality sampling is done as per License conditions.

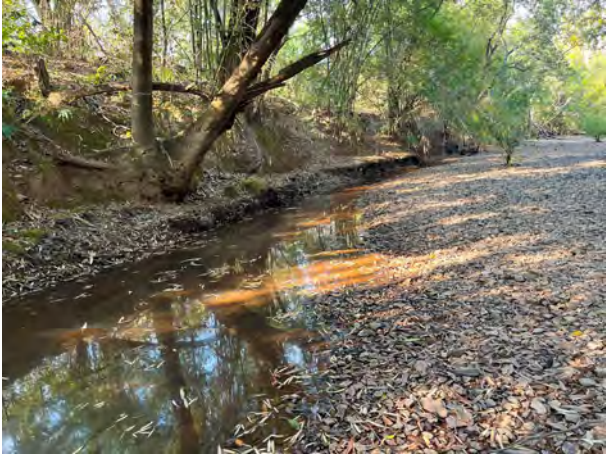
| Site description | Site photo |
|---|---|
| <p><b>SWG1A - Upstream</b></p> <p>The site was made up of two large pools connected by a shallow run. The creek was lined by a closed canopy of riparian vegetation and shading was high. The left bank was steep, and a mixture of consolidated clay and gravel with sections of bedrock, while the right bank was a gentle slope and consisted of cobbles and pebbles. Bed material was majority pebbles and sand.</p> | |

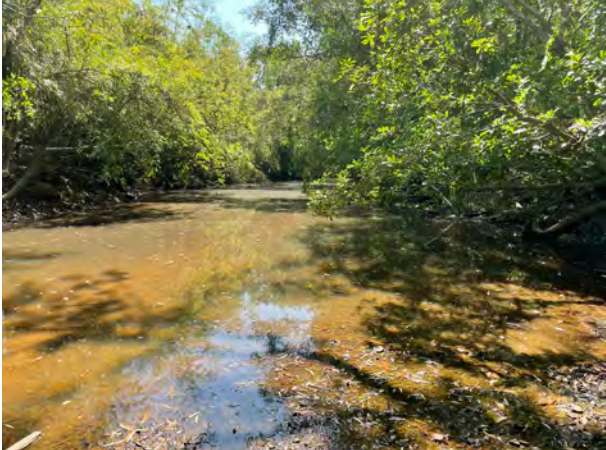
| Site description | Site photo |
|---|---|
| <p><b>SWG1 – Upstream</b></p> <p>The site is made up of two large, deep pools, connected by a run. The substrate of both pools was made up of sand and gravel, and the connecting run has substrate made up of pebbles, cobbles and sand. Both banks of the pool are lined by continuous riparian vegetation providing shade and exposed roots. Undercut banks were prevalent, along with leaf packs and small log jams.</p> | |

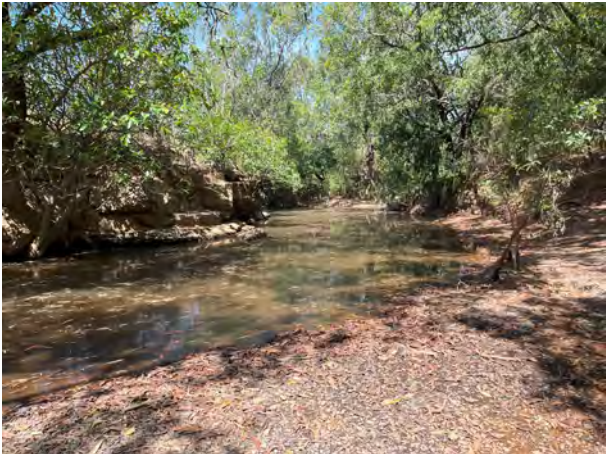
| Site description | Site photo |
|---|---|
| <p><b>MBC0 – Adjacent</b></p> <p>The site is located approximately 100m upstream of the confluence between a small, unnamed tributary that drains passive discharge from mining infrastructure. The site was well shaded due to a continuous riparian zone, and presence of trees along banks allowed for exposed roots, large woody debris and leaf packs to be common through the site. The majority of substrate at the site was made up of sand and pebbles. Long gliding pools were connected by shallow runs. And riffles</p> | |

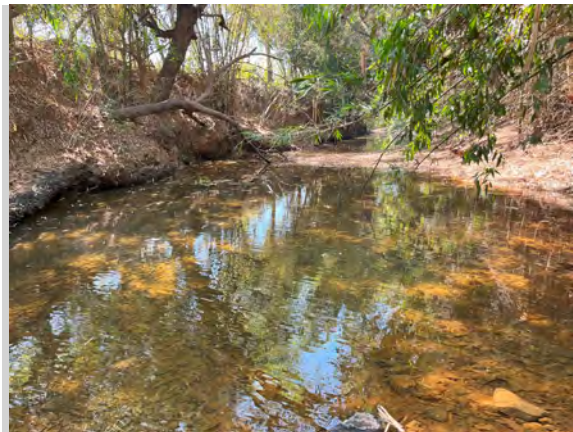
| Site description | Site photo |
|---|---|
| <p><b>SWG2 - Downstream</b></p> <p>The site is made up two gliding pools connected by runs, and is intersected by a stock crossing. The stock crossing has undergone significant upgrades, which have resulted in erosion and a change in flow through the site from previous years. Downstream of the crossing, the site was a wide, shallow pool. Substrate along the entire reach was a mixture of cobbles, pebbles and sand, with clay banks covered by a film of iron-producing bacteria.</p> | |

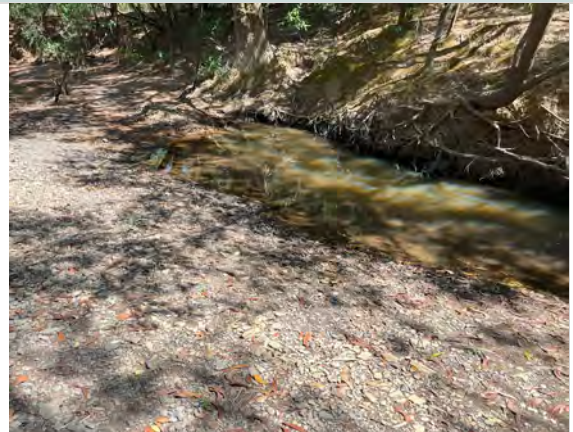
| Site description | Site photo |
|---|---|
| <p><b>CC02 - Reference</b></p> <p>The site is intersected by a ford made of, cobbles and clay. Upstream of the ford was a large, deep pool. Downstream of the ford was a series of pools connected by shallow runs. The creek was shaded by a dense, 5 m wide, native riparian strip on both banks. Beyond the riparian zone was cleared and the land used for grazing and horticulture (mango plantation).</p> | |
