# WDL 249 Environmental Monitoring Report

22 December 2023- 21 December 2024

Toms Gully Mine Project Area

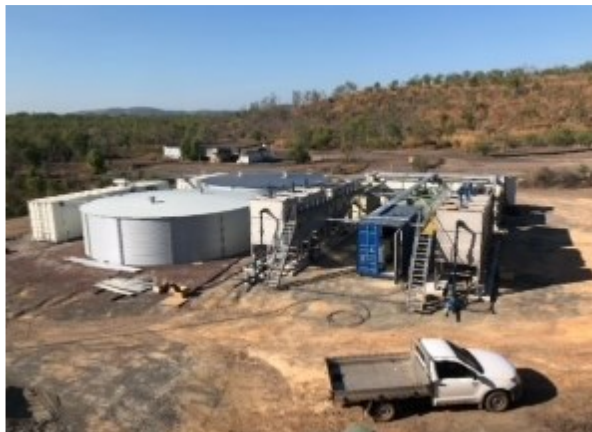
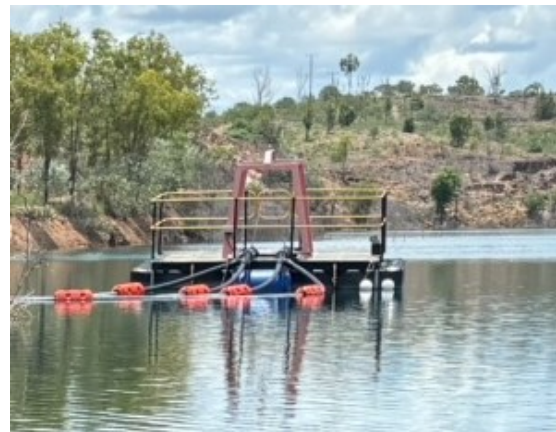
**Photo 1-1 TGPA Reverse Osmosis Plant and Pump Pontoon**

TGPA RO Plant (September 2023)

RO Pontoon in TGM Pit (September 2023)

TGPA remained in care and maintenance during 2023-2024 reporting period and has been since PGO's purchase of tenements in 2013. No exploration activities occurred at TGPA during this reporting period. The Environmental Impact Statement (EIS) for TGPA was formally approved in 2020 under the *NT Environmental Protection Act* 2019. The RO water Treatment Plant received approval from the then Department of Infrastructure, Tourism and Trade (now Department of Lands Planning and Environment [DLPE]) in December 2022 under the *Mining Management Act* 2001. Construction of the plant and auxiliary infrastructure (including reconnection of mains power) occurred during 2023 with commissioning of the RO Plant in October 2023 (Photo 1-1).

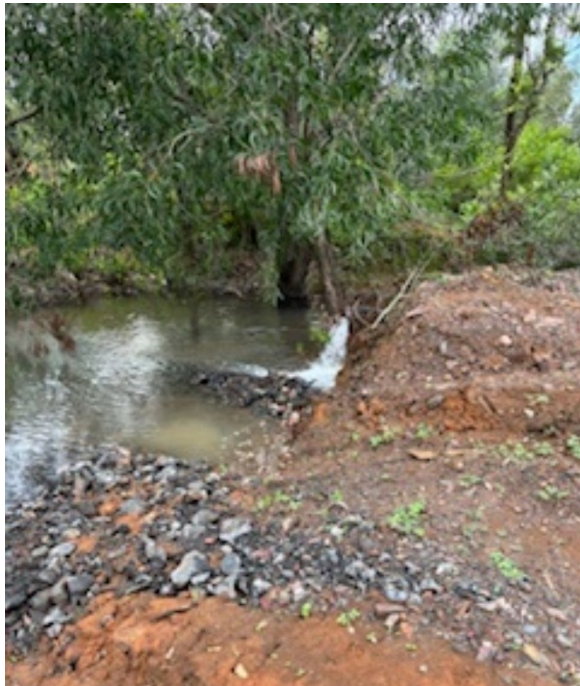
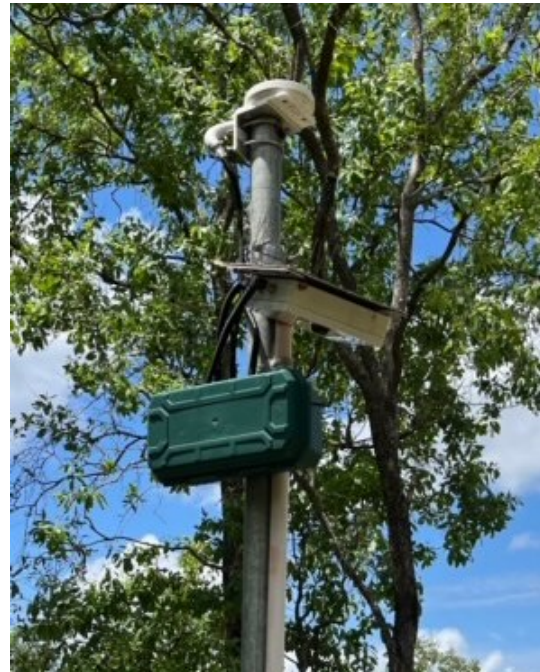
### Photo 1-2 Authorised Discharge Point 1 and Compliance Point Telemetry Station

TGPA ADP1 (January 2024)

SWTG2 WDL 249 Compliance Point, telemetry station

A solar powered telemetry station is situated at the Compliance Point (SWTG2) to continuously monitor physical water quality during creek flow and wastewater discharge as per License conditions. Information provided by the logger is invaluable during controlled/no controlled site discharge events to gain a clearer understanding of creek flows and water quality fluctuations particularly when site access was limited.

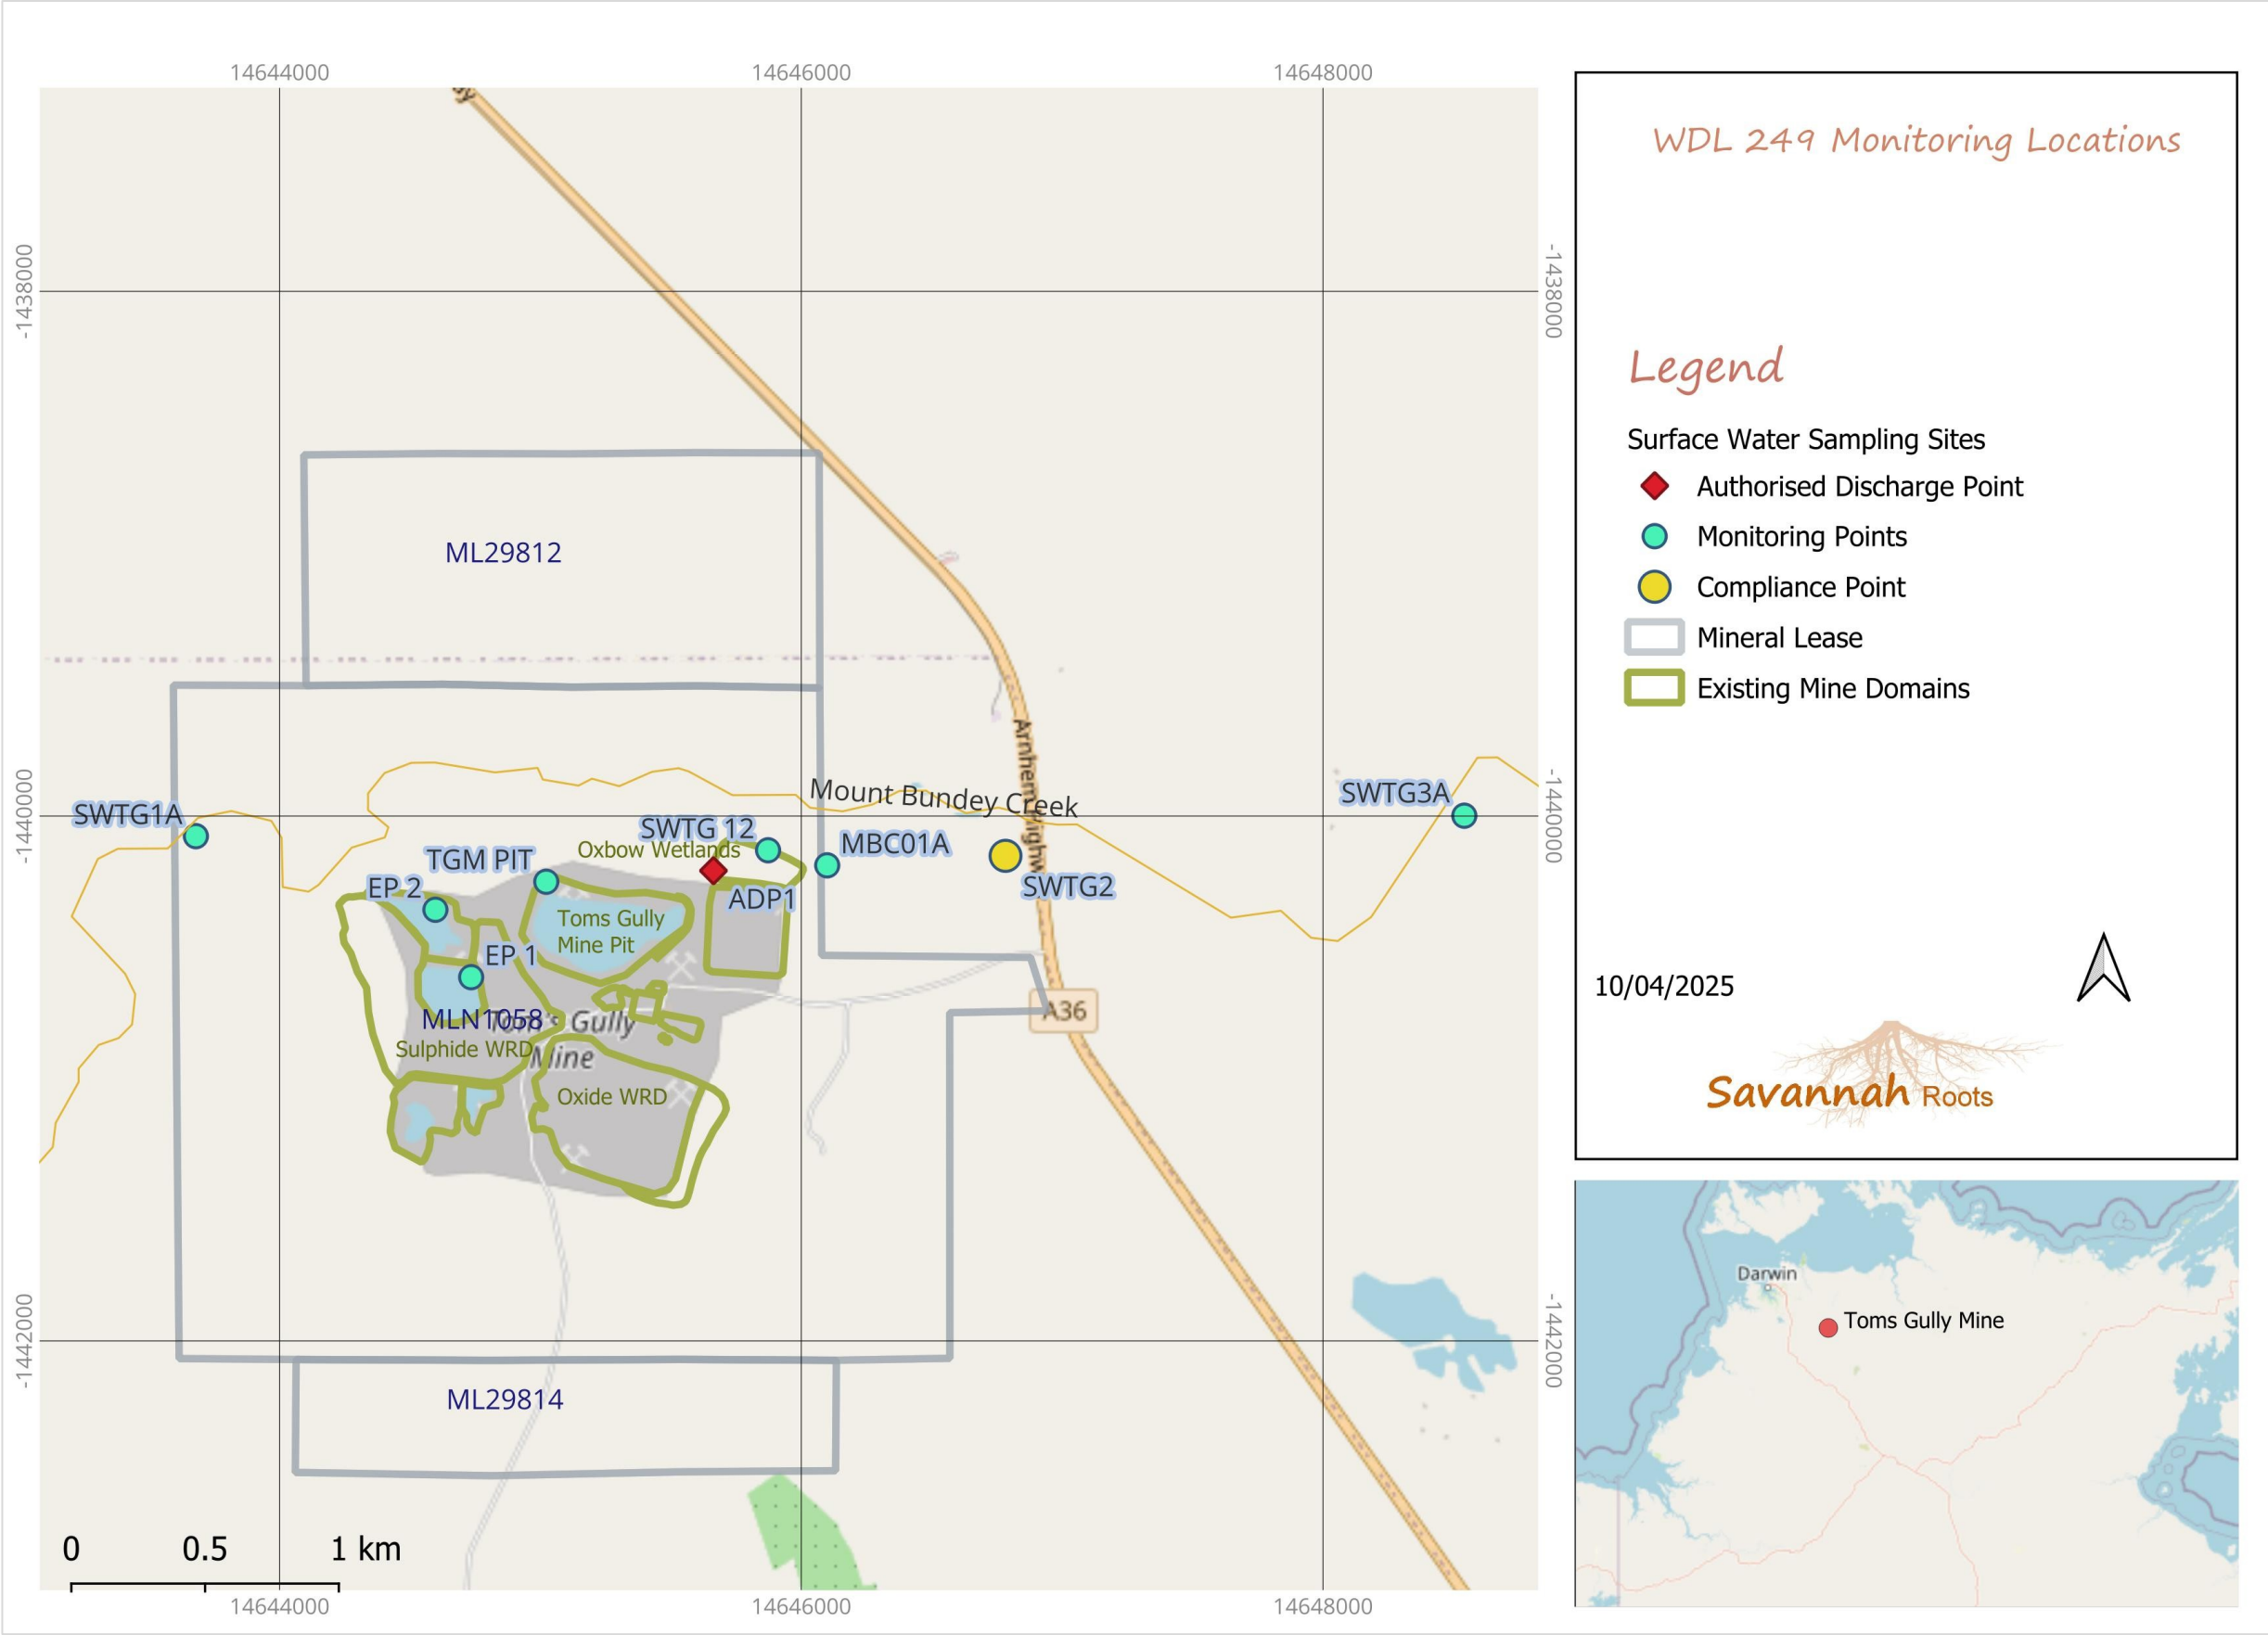
Figure 2-5 WDL 249 monitoring locations

Surface water sampling locations are presented in Figure 2-5 which include seven sampling locations, one Authorised Discharge Point (ADP1) and compliance point (SWTG2). The monitoring program sample locations are in Table 2-1 and water quality parameters and monitoring frequencies in Table 2-2 and Table 2-3. Appendix E presents a photo record of each site.

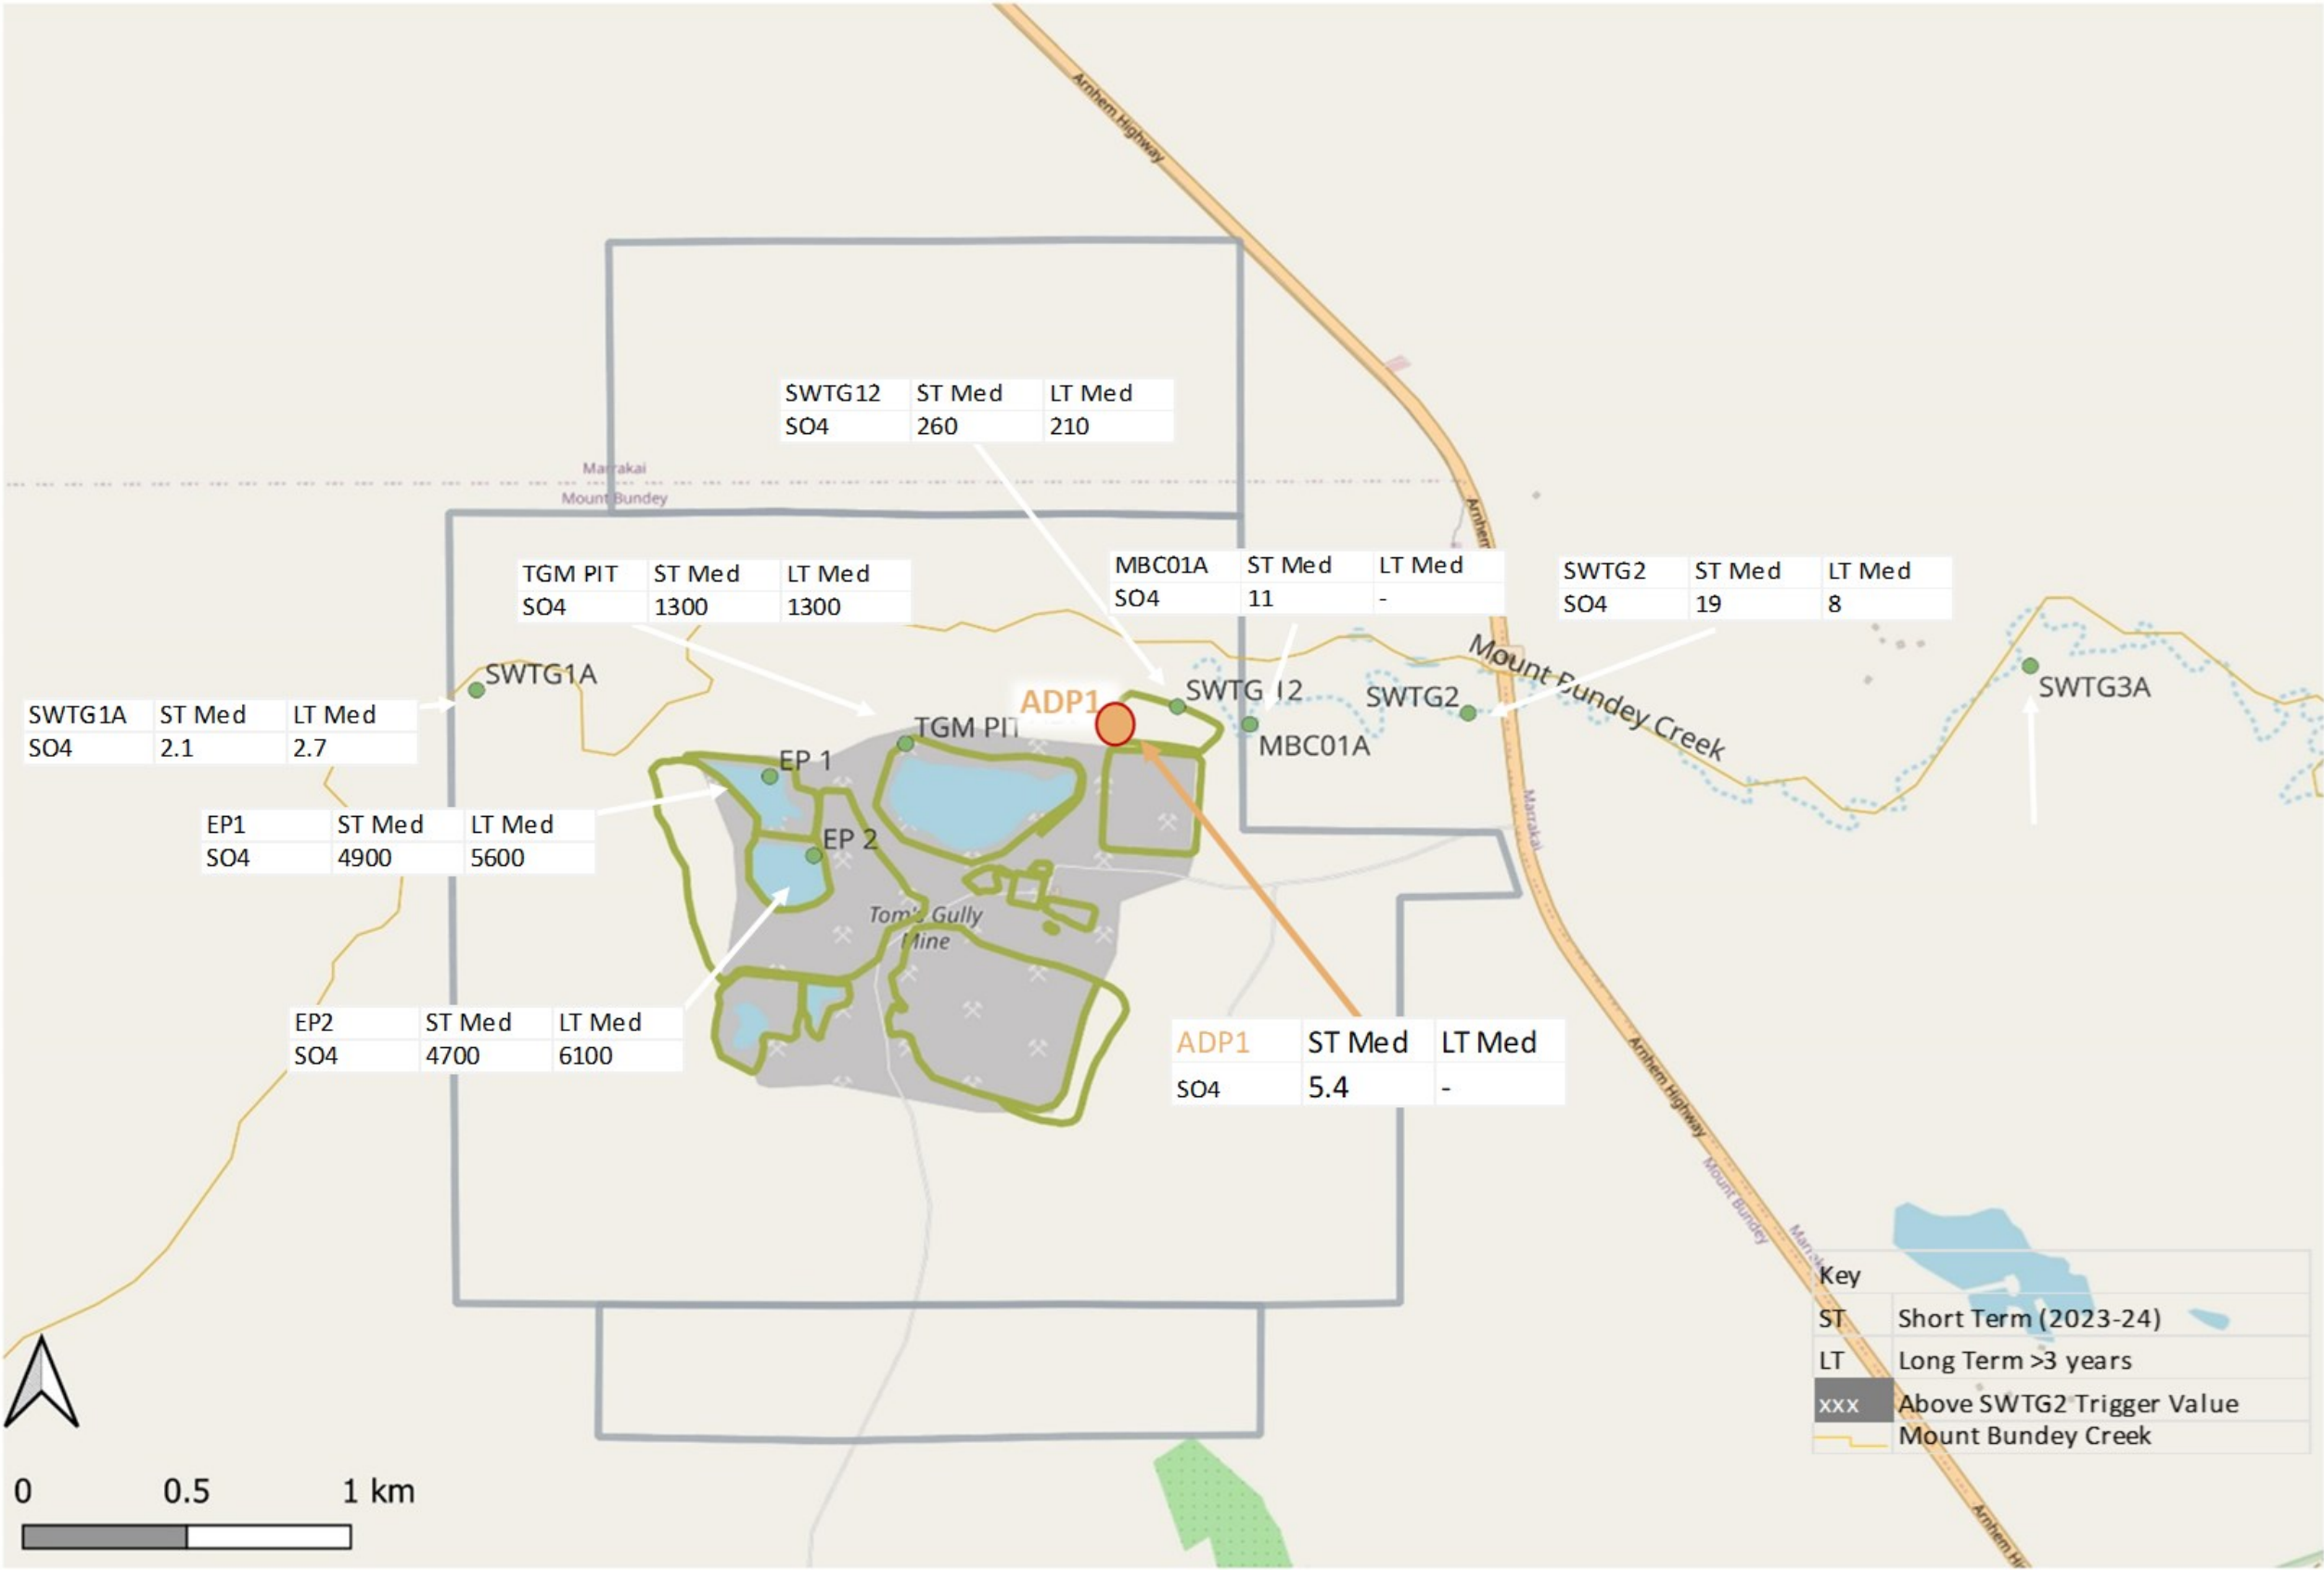
Figure 4-3 Spatial Trend for General Chemistry

- General chemistry concentrations exceeded WDL249 TV for total suspended solids on several occasions though not for sulphate which remained below TV The highest recording for TSS was 130 mg/L on 30/01/2024.

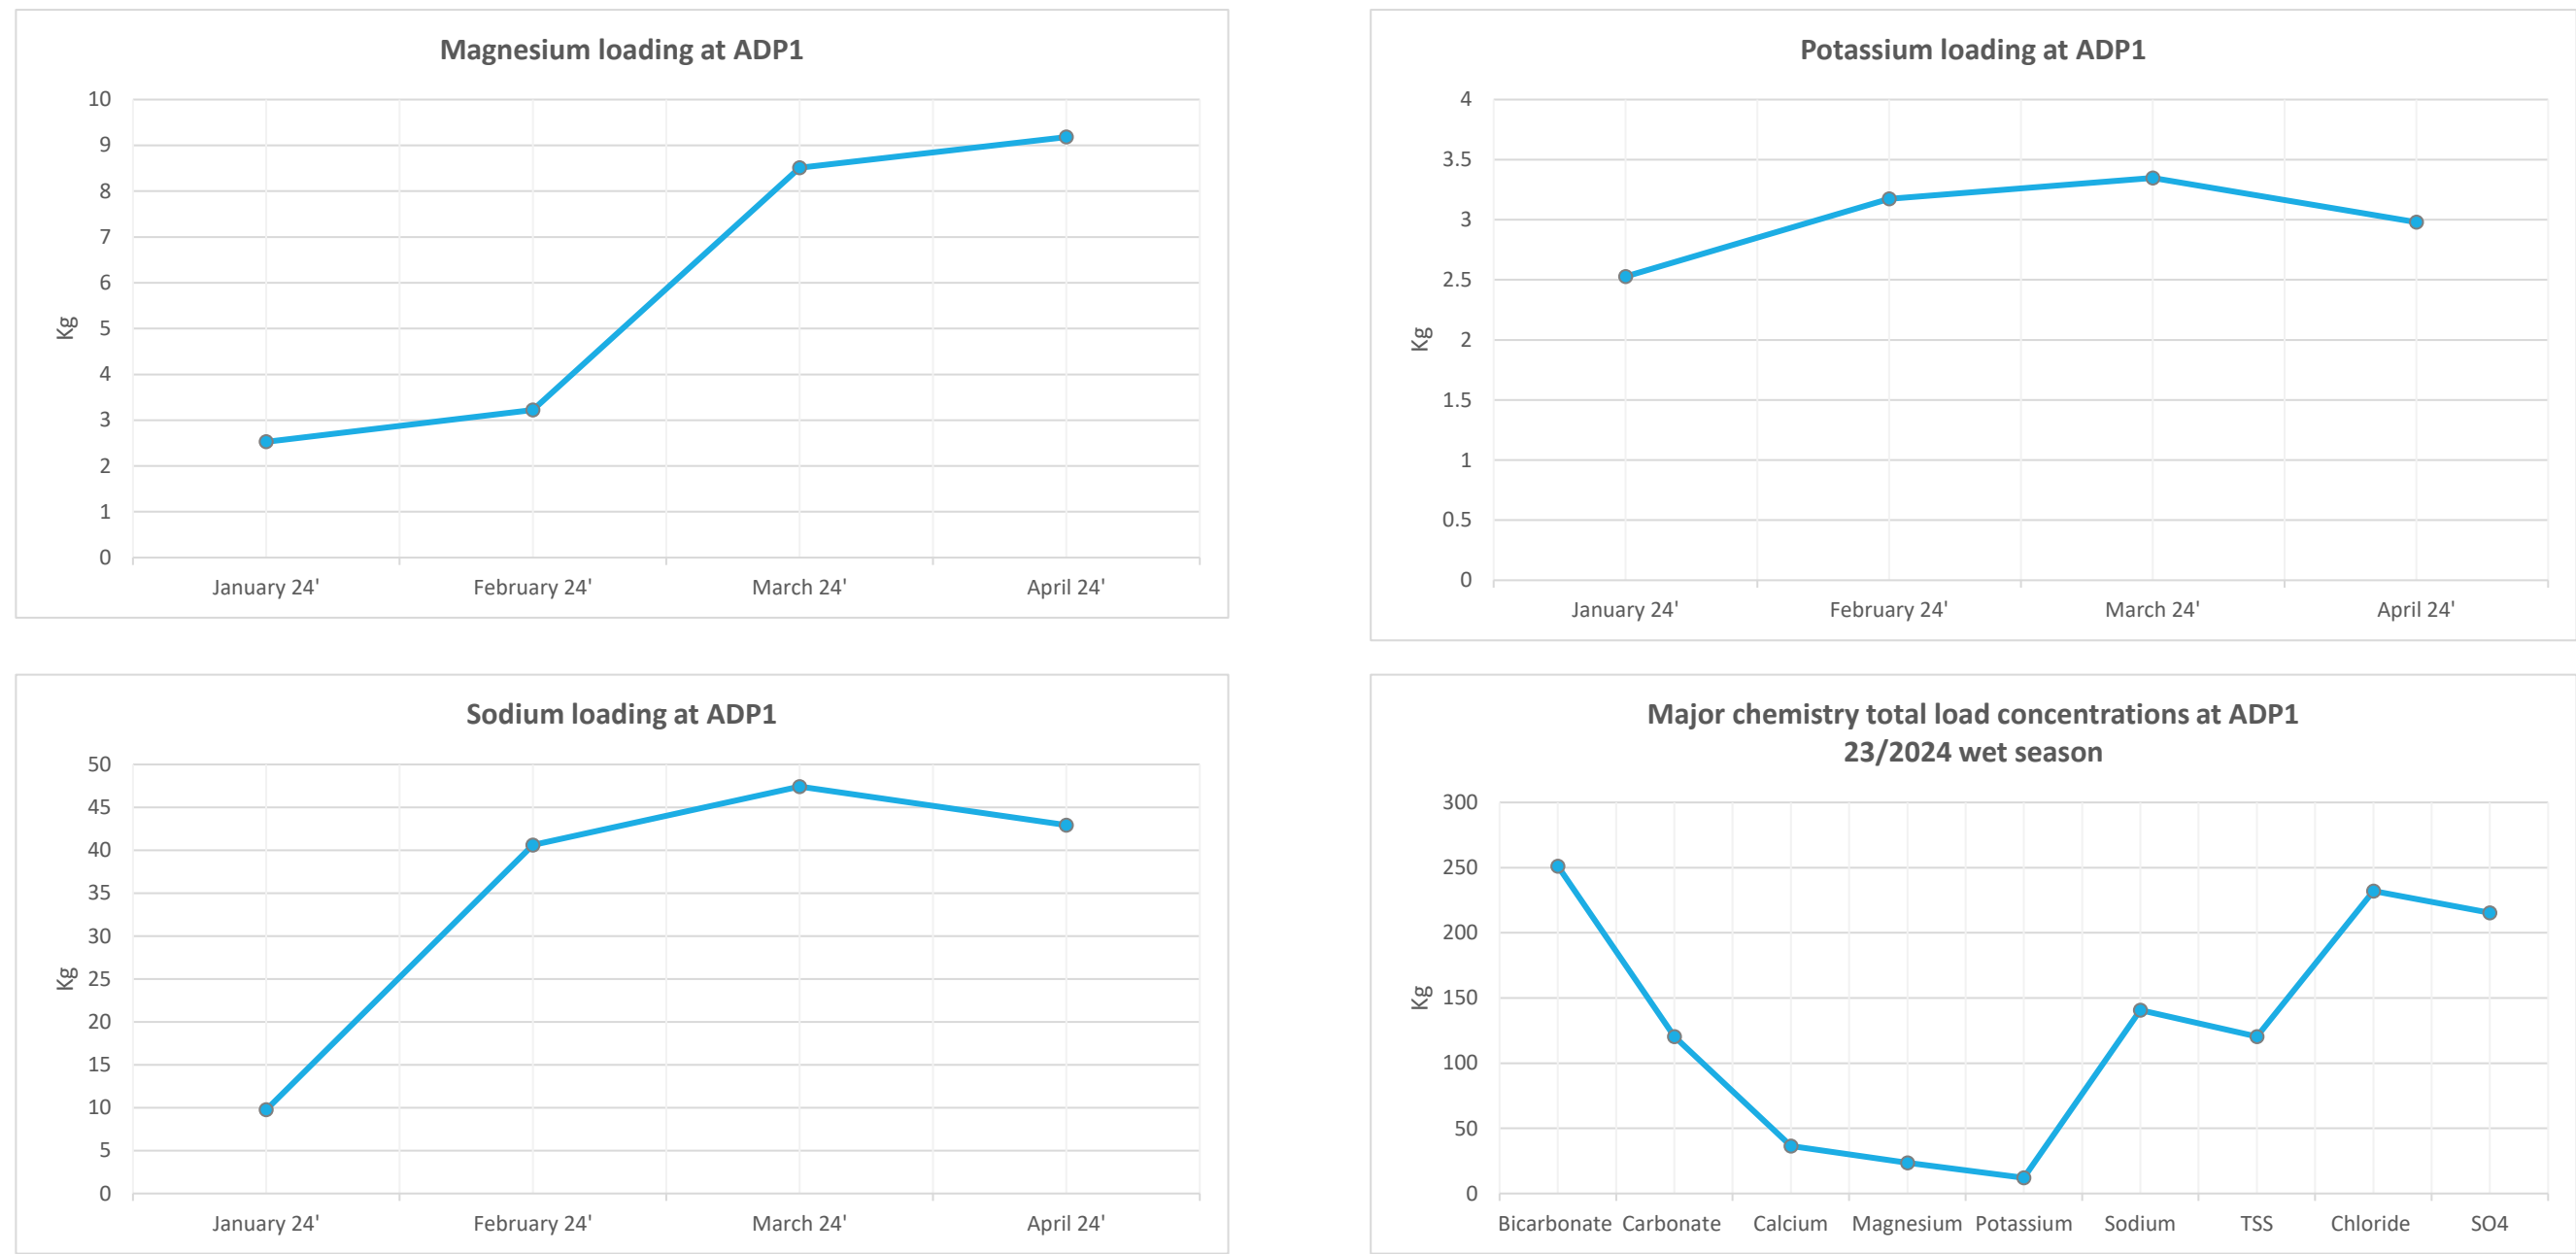
Figure 4-7 ADP1 General Chemistry Loadings

ADP1 total loadings for general chemistry are provided in Figure 4-7. Total loadings for metals/metalloids from ADP1 are provided in Figure 4-8. ADP1 discharge water was used to calculate total loading. The NSW EPA 'Load Calculation Protocol' (2008) was applied to measure the mass load of a specified analyte from controlled discharge activities. Continuous flow allowed for an accurate load calculation. A total of 60,480 KL of treated water was discharged from ADP1 during the 2023- 24 wet season. Total load calculations were assessed, and the following analysis has been made:

- Total loads concentrations at ADP1 with the highest concentration of bicarbonates (250kg), with cation loads dominated by sodium (150kg) followed by calcium (36kg);
- Chloride (232kg) load was slightly higher load compared to sulphates (215kg); and
- Total load concentrations at ADP1 with the highest concentration (kg) included Manganese (1.2kg), followed by Zinc (0.7kg), Aluminium (0.5kg) and Iron (0.2kg).
