Environmental Monitoring Report

MCARTHUR RIVER MINE

Environmental Monitoring Report 2019-2020

1 May 2019 to 30 April 2020

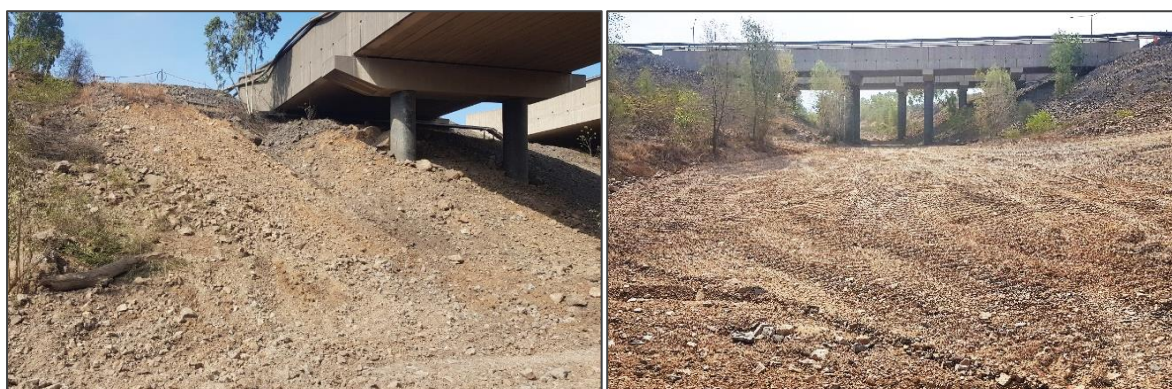
Plate ES4: Sediment Removal from Barney Creek

Identified Contaminant Source	Measures to be Undertaken in next Reporting Period	Timing
Dust impacts associated with haulage across Barney Creek Bridge	<ul style="list-style-type: none"> • Trial of dust suppression binders / additives for watering of haul roads. • Investigate the viability of extending the sediment removal program to include the lower reach of Barney Creek in the vicinity of FS20 and FS06. This will be dependent on safe machinery access, AAPA and water licensing approvals. • Annual assessment and management of sediments along the Barney Creek batters, sump and creek bed near the Barney Creel Bridge. • Further planned use of the newly commissioned water trucks to reduce wheel-sourced dust from vehicle movements. 	2020-21 reporting period.
Dust impacts associated with the Mill operations	<ul style="list-style-type: none"> • Trial of dust suppression binders / additives in the Mill area. • Investigate options for providing a clean water source to the Primary Crusher/ ROM hopper, to allow for improved operation of the recently installed dust suppression system. • Further planned use of the newly commissioned water trucks to reduce wheel-sourced dust from vehicle movements. 	2020-21 reporting period.

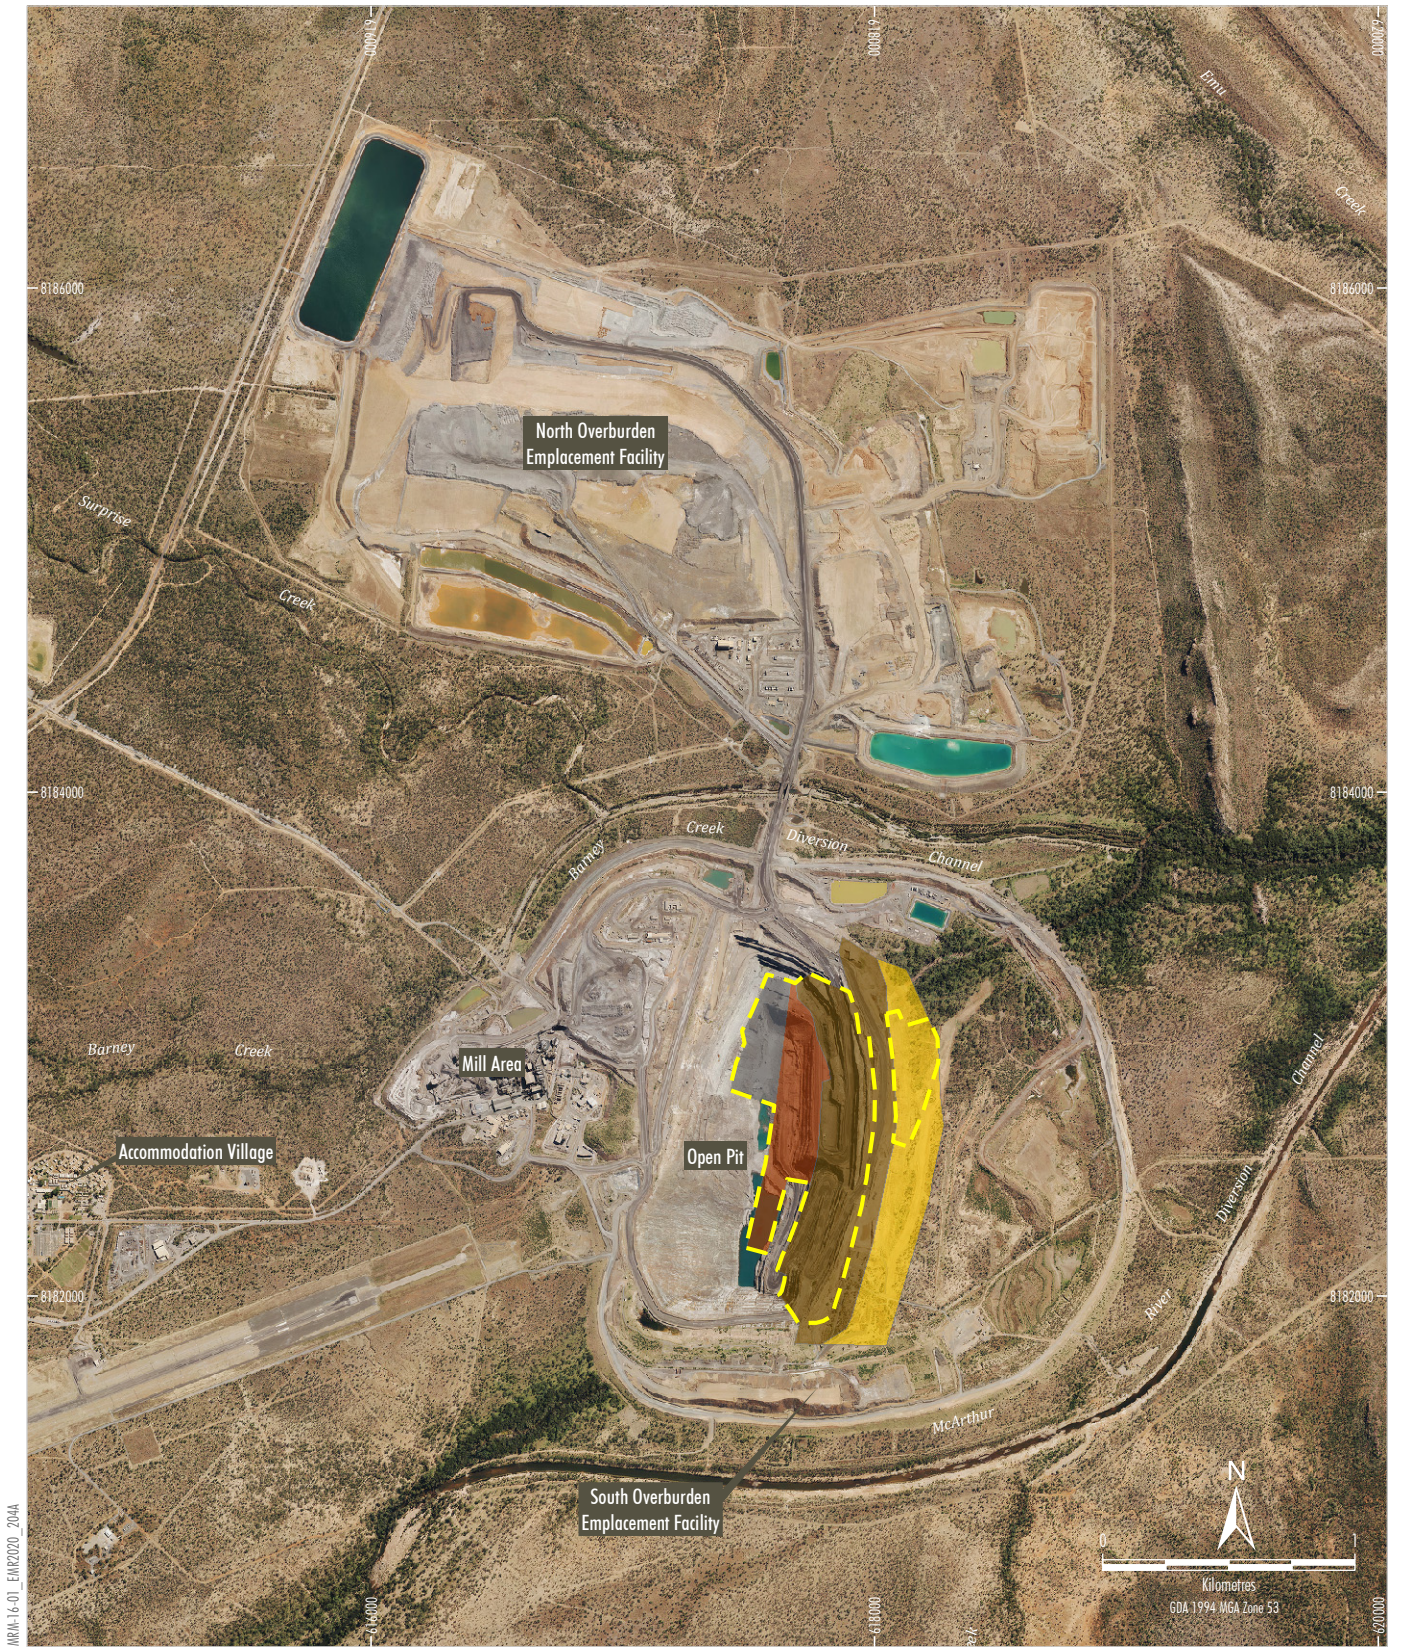
MRM-16-01_EMR2020_204A

Stage I, FWQ, J and K progressed as planned during the reporting period. The FWQ and Stage I reached their extents, while waste pre-strip in Stage J progressed down to the 9,904 reference line (RL). During the reporting period, a small portion of the upper bench of Stage K (10,016 RL) was mined to provide alluvium for use in development of the NOEF. The northern portion of Stage K around the old McArthur River and Fairy Wren habitat was not disturbed during the reporting period.

- LEGEND**
- Active Mining Area (2019-2020 Reporting Period)
 - Footwall Quarry
 - Stage I
 - Stage J
 - Stage K

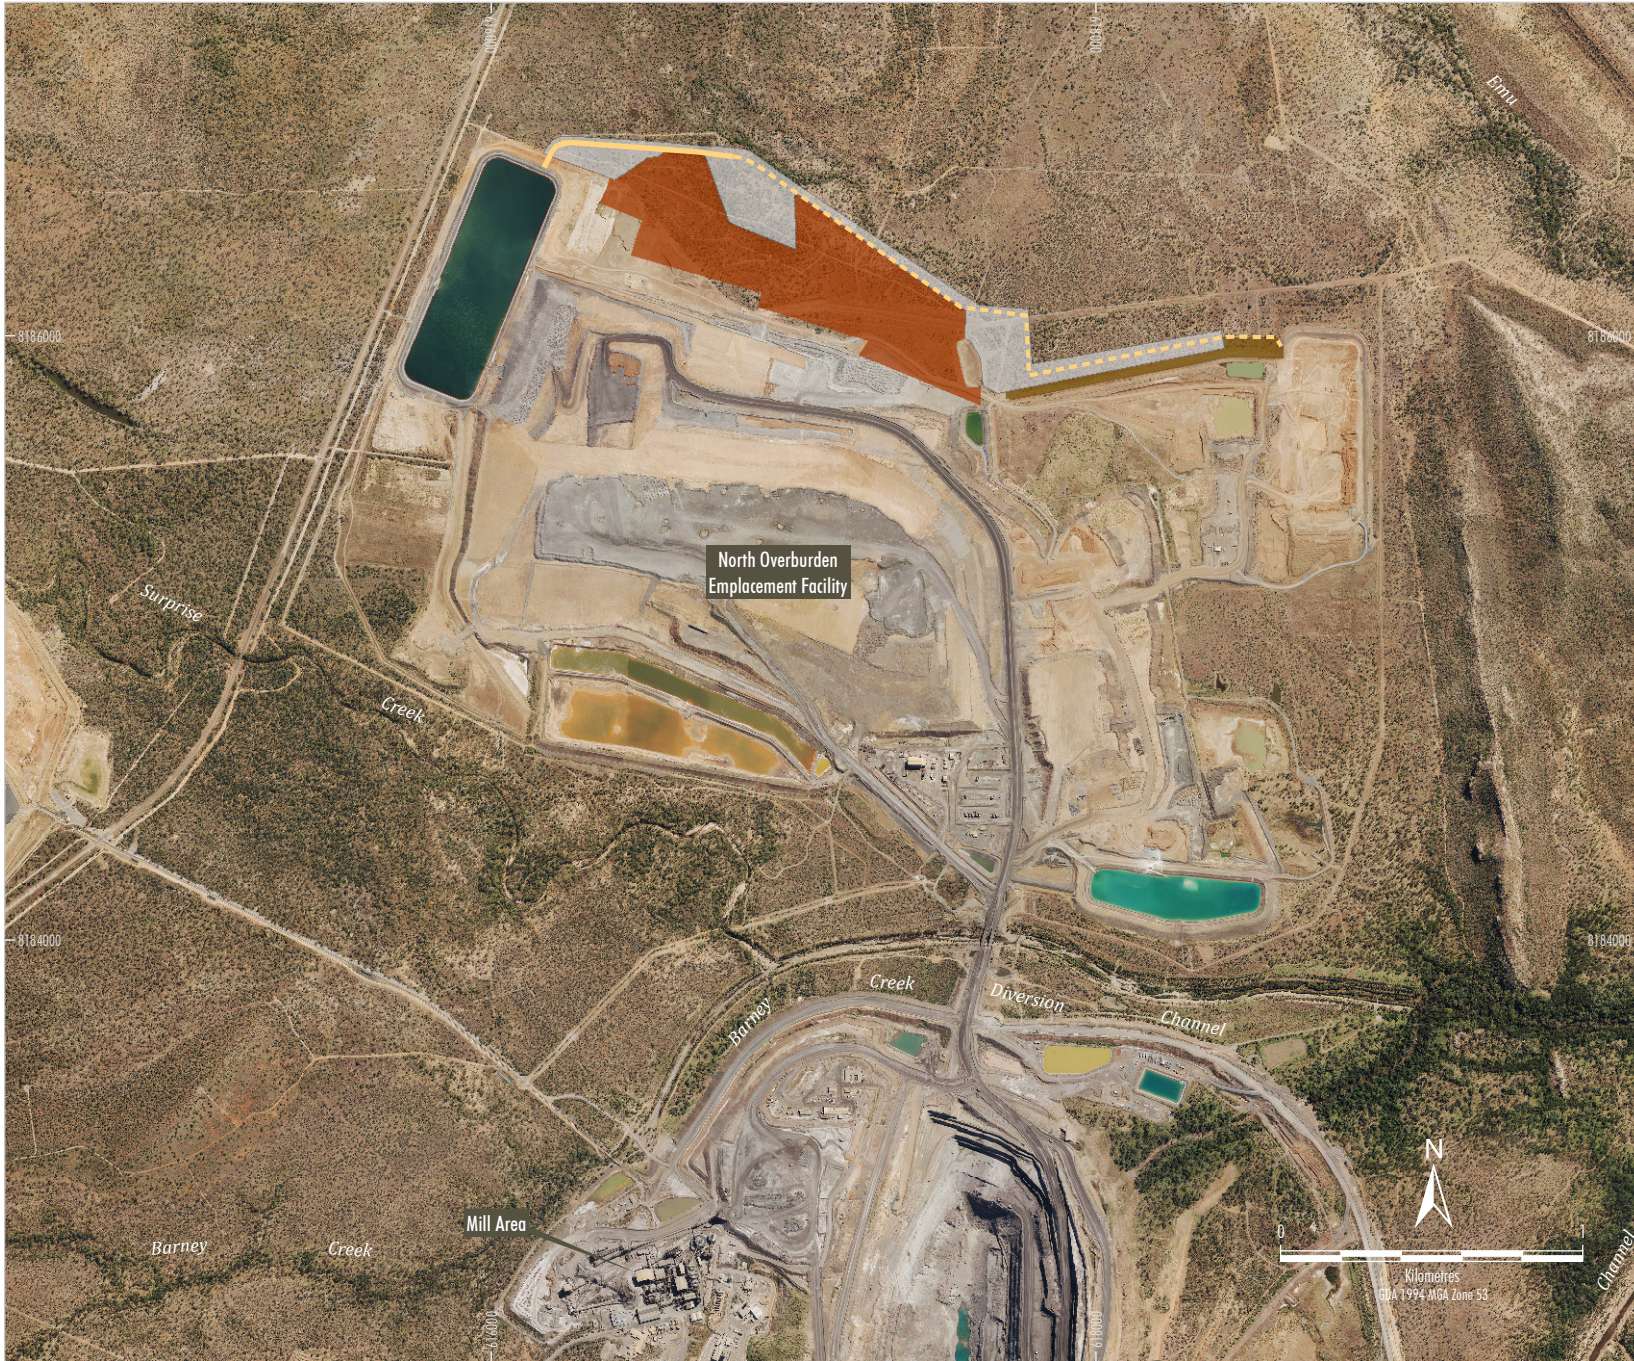
Plate 1 shows the cleared area and completed CCL in the CW Charlie and Central East Levee areas. The Plate also indicates the extent of the flood protection levee between WPROD and EPROD, with the solid line on the western end towards WPROD forming the permanent outer extent of the NOEF, and the dashed line representing the temporary internal section of flood barrier, to be covered by subsequent NOEF stages in the future. The temporary section of the levee had a flood protection CCL constructed during the reporting period, while the permanent section had a temporary clay barrier applied to a portion of it prior to the 2019/20 wet season, with the full geosynthetic liner based cover system which will form the permanent flood protection barrier to be installed in the next reporting period.

- LEGEND**
- Central East Levee Permanent
 - Central East Levee Temporary
 - Central East Levee - CCL Completed
 - Central West Charlie - CCL Completed
 - Cleared Areas

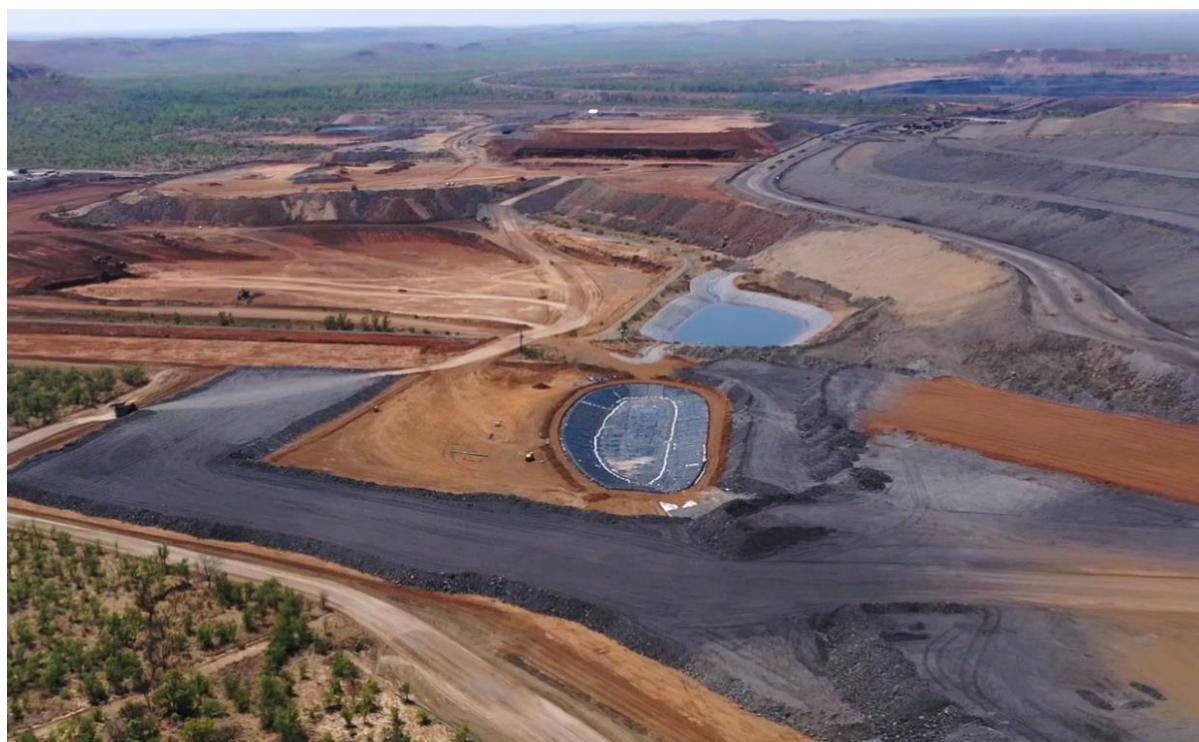
Plate 2: Central West Charlie Sump (Looking South)

Central West Charlie Sump was lined with HDPE during the reporting period, as indicated on Plate 2.

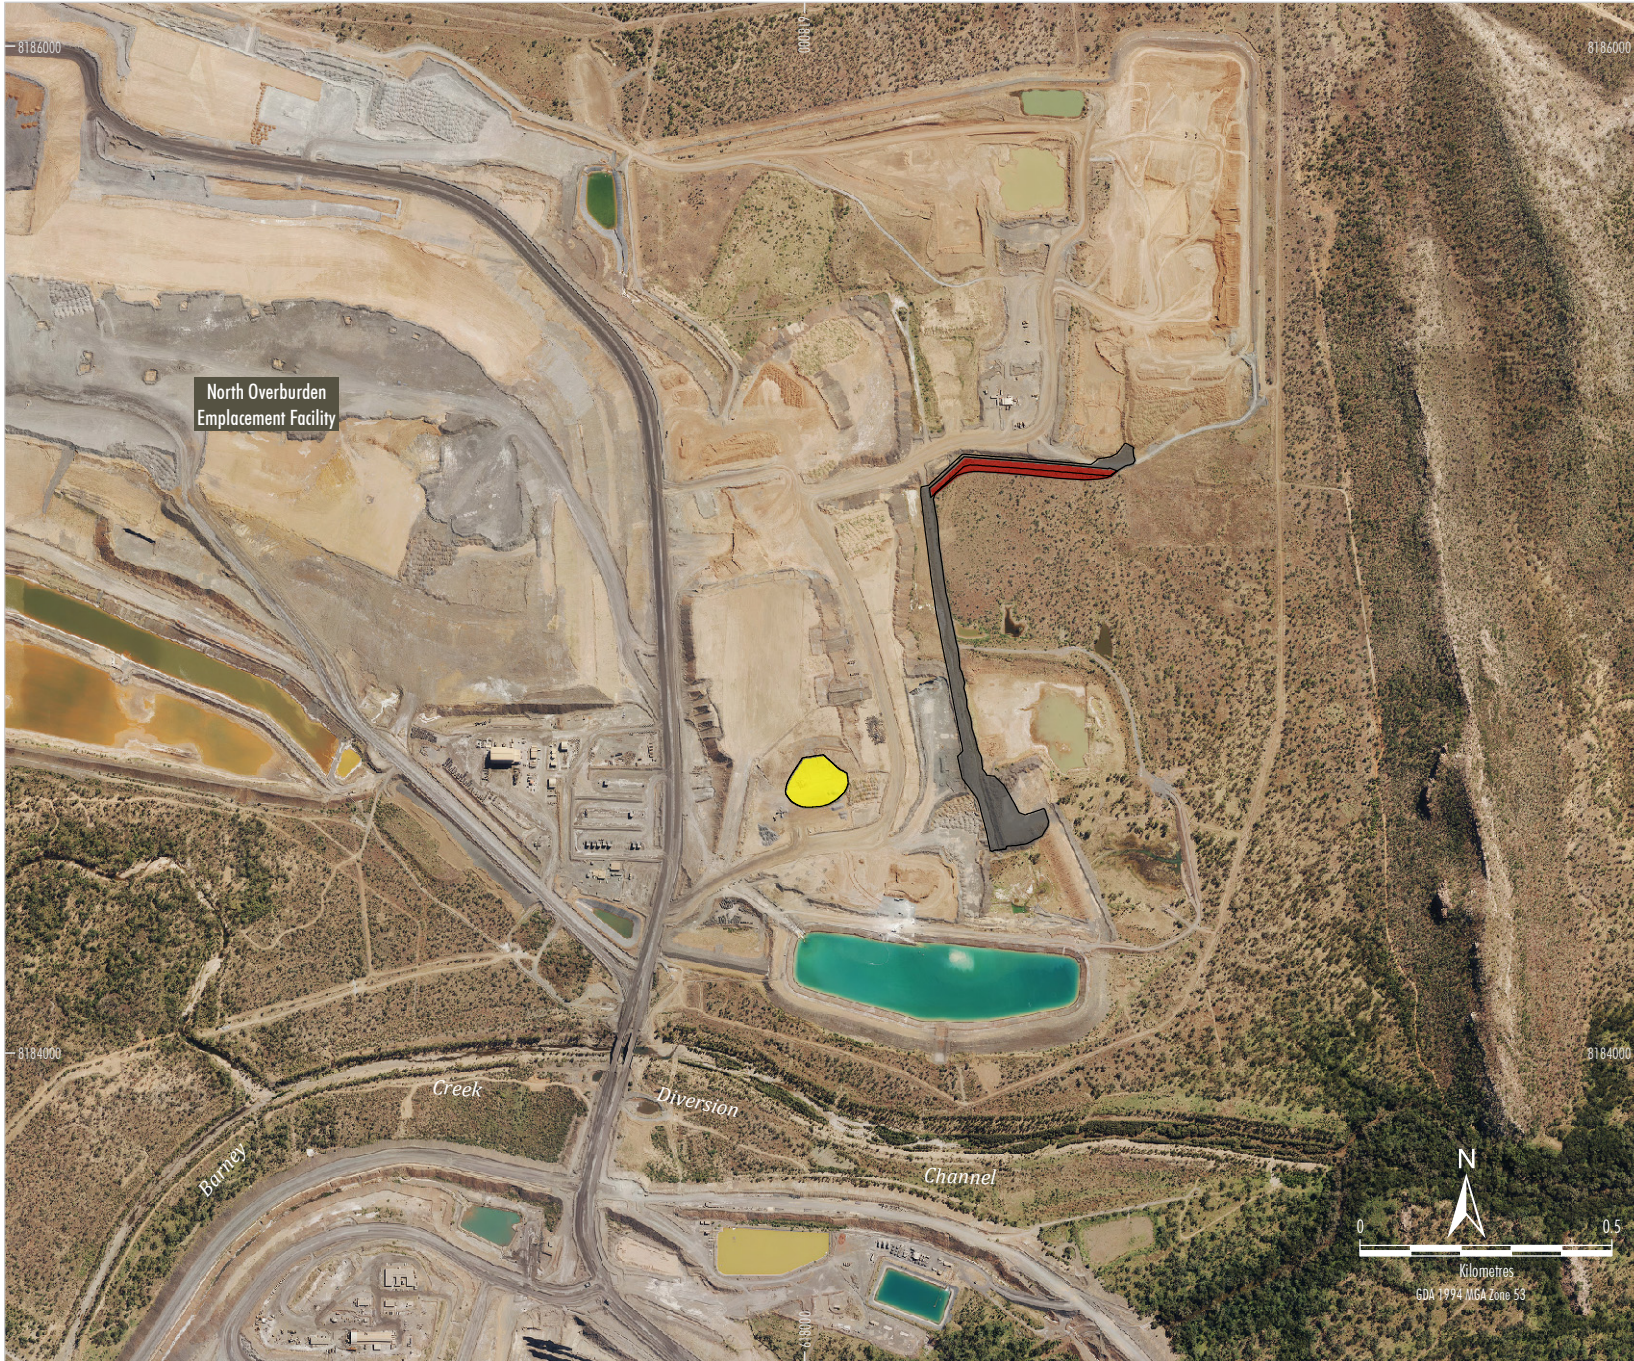
Construction of the South East 20-year ARI flood protection levee and Phase 1 of the PAF(RE) Trial Pad were undertaken as described in the January 2019 Amendment. Approximately 0.9 ha of clearing was required for the northern portion of the flood protection levee (Plate 3).

- LEGEND**
- PAF (RE) Trial Cell
 - South East Levee - Clay Composite
 - South East Levee - Cleared Area

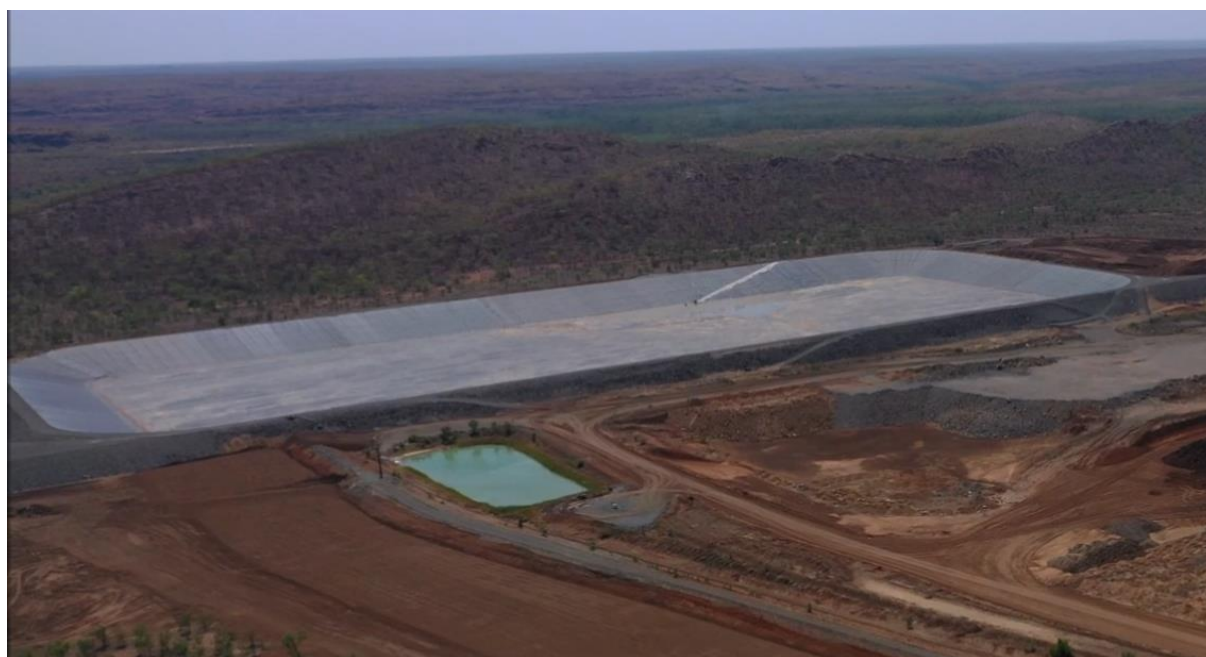
Plate 4 HDPE-Lined EPROD

- Installation of the HDPE liner in EPROD (Plate 4). The commissioning process is underway and is expected to be complete during the next reporting period.
- HDPE lining of the previously clay lined South Perimeter Runoff Dam (SPROD) (Plate 5).

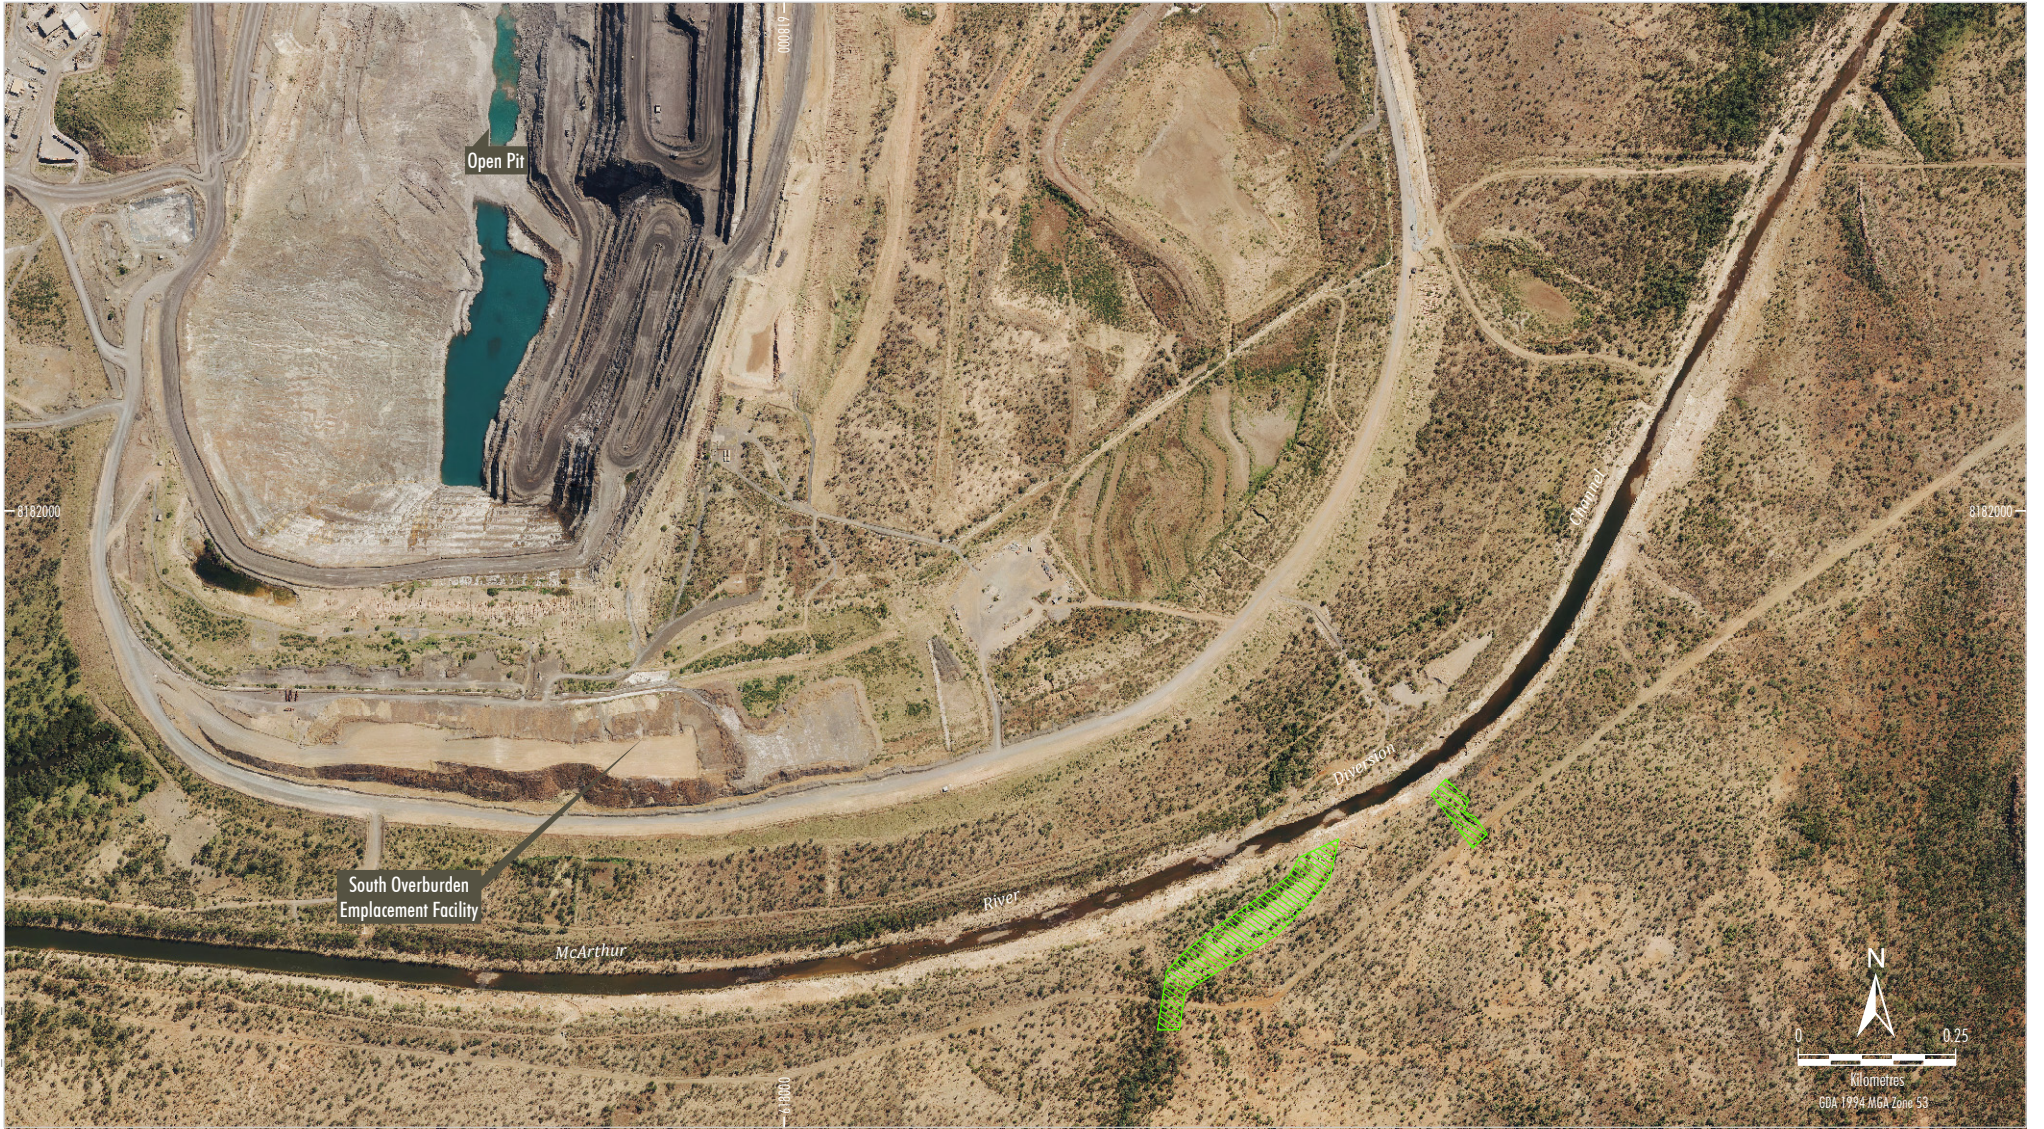
MRM-16-01 - ENR2020 - 277A

The work involved channel re-contouring and the placement of large boulders, LS-NAF riprap sized rock and sediment traps to help reduce flow velocities and subsequent erosion. Observations during the 2019-2020 wet season indicated that the mitigation works were successful at reducing erosion and improving channel stability.

In the next reporting period, MRM will continue to implement erosion mitigation activities at key locations to prevent long-term stability issues at the Mine and BBLF.

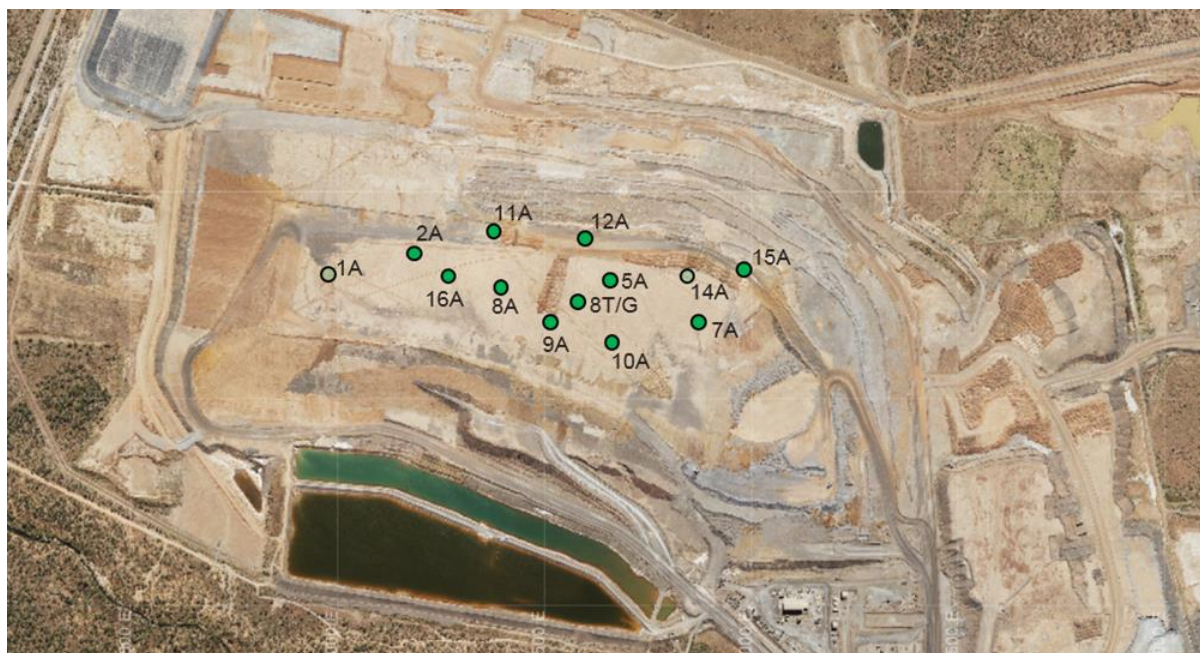
Note: 1A and 14A were not instrumented.

In order to gain information as to internal temperatures and to monitor the conditions within the NOEF, drilling campaigns were undertaken in 2016 and 2017 as part of the Overburden Management Project EIS (OMP EIS), concentrating on the existing NOEF PAF cell. A total of 22 temperature and gas monitoring wells were drilled with locations selected based on our understanding of the NOEF internal architecture and the special distribution of PAF material within the facility. The locations of the bores are shown in Plates 7 and 8 on the 2017 NOEF.

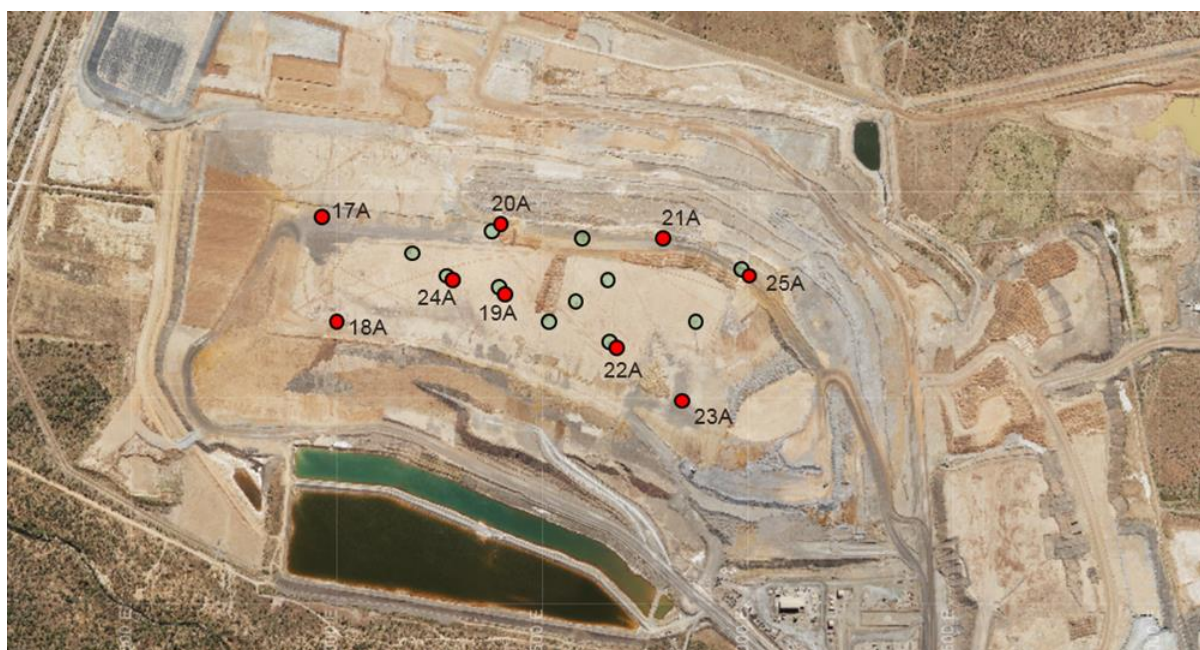
Plate 8: Location of the 2017 NOEF Temperature Monitoring Bore Network

Note: 2017 network shown in red.

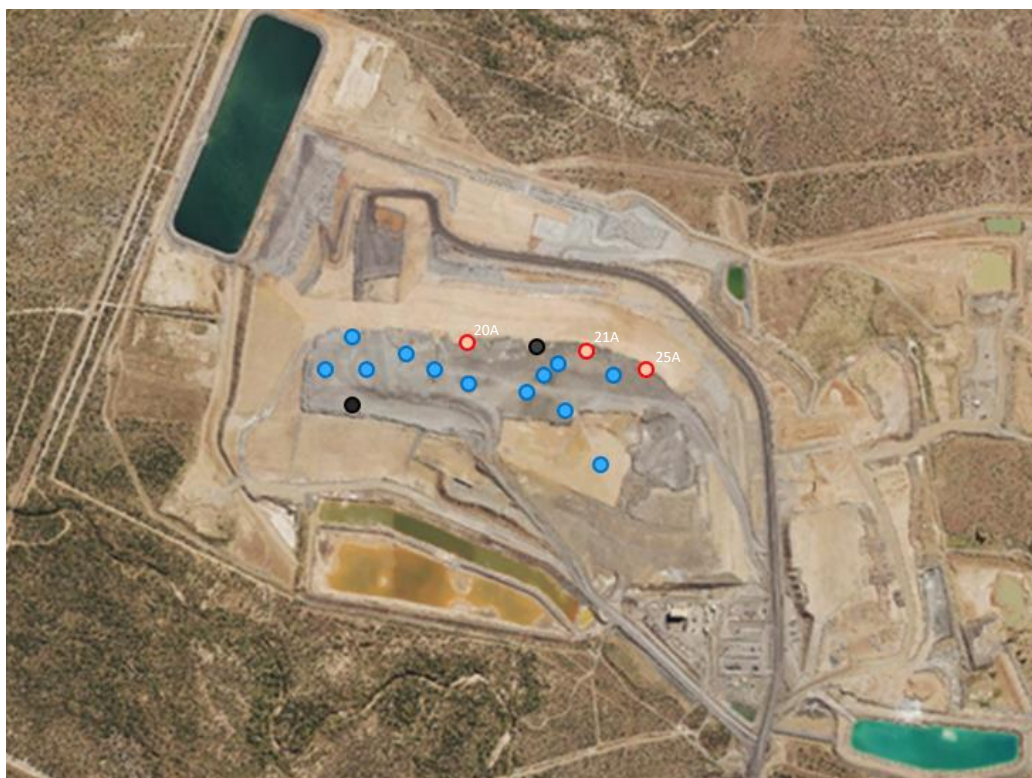
Plate 10: Spatial Distribution of Background and Elevated Temperatures on the NOEF in June 2019

The June 2019 spatial distribution of background temperatures, elevated temperatures, and out of service temperature locations are presented in Plate 10.

Shown: Background temperatures (blue), elevated temperatures (red), and out of service temperature (black) locations

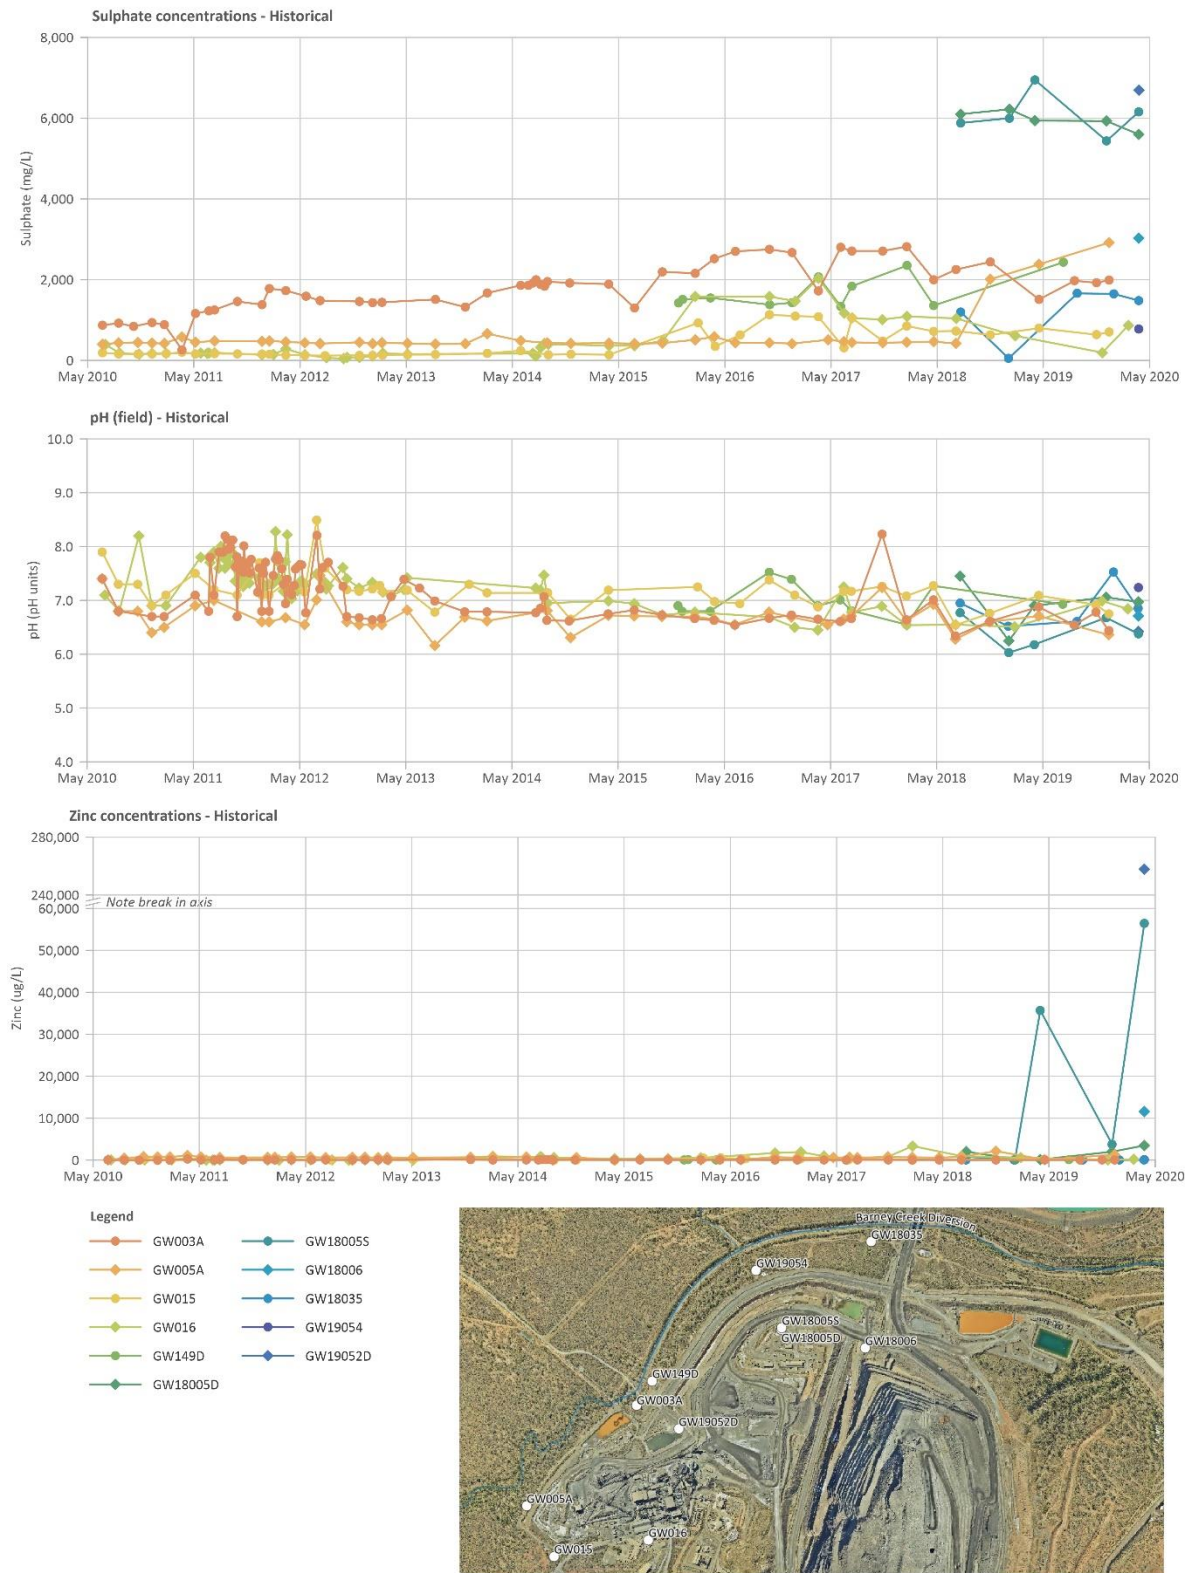
Plate 15: Historical Sulphate, pH and Zinc Concentration – Mill Area

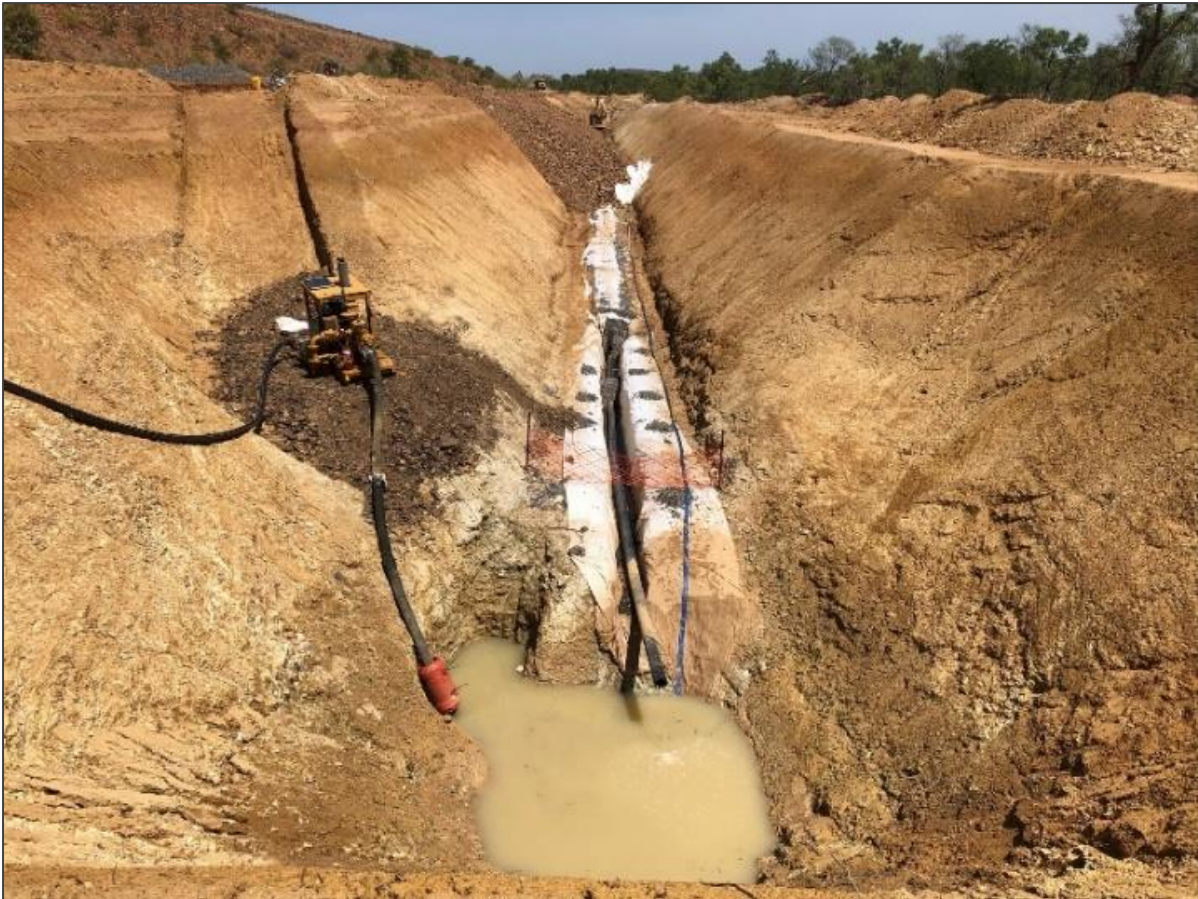
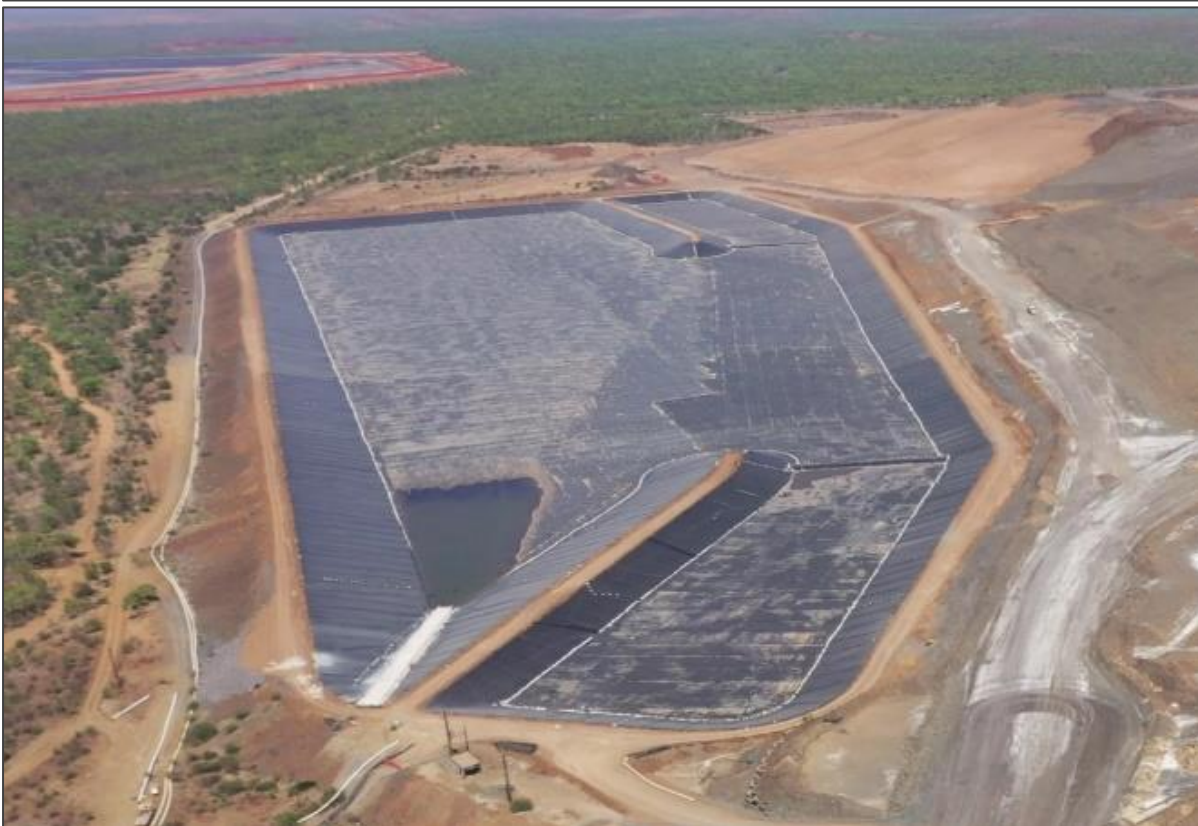
Plate 21: Construction of the TSF Interception Trench (top) and HDPE Lining of SPREAD (bottom)

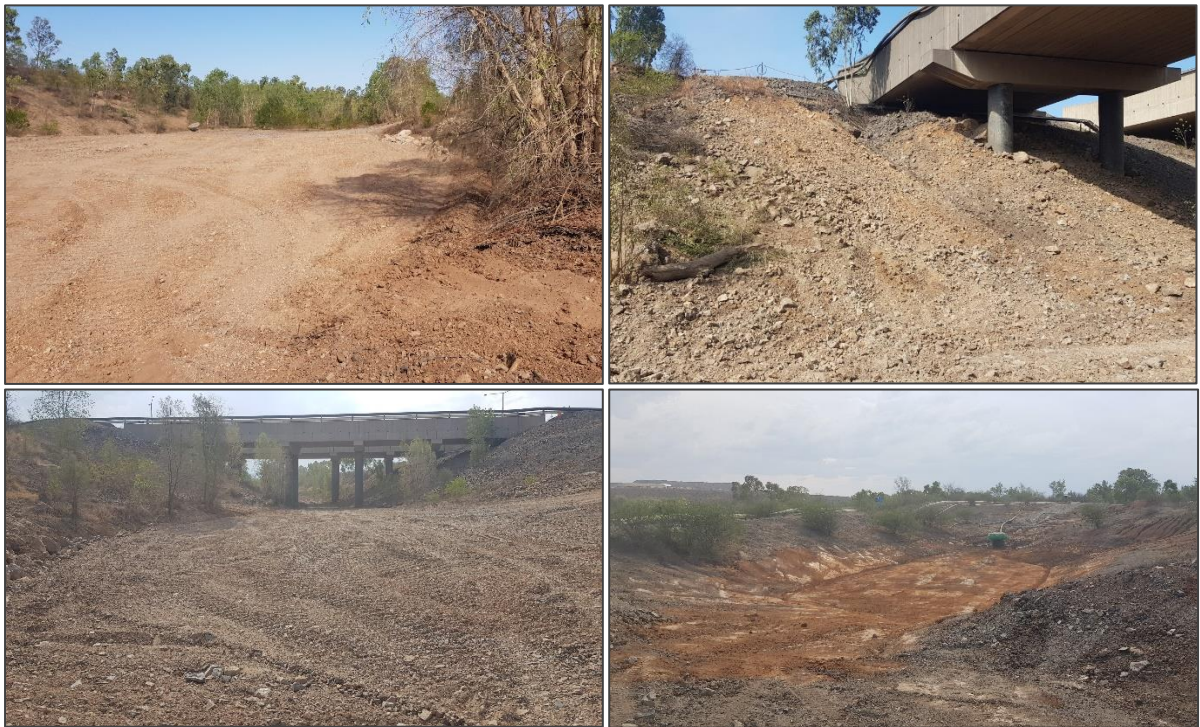
Plate 22: Sediment Removal from Barney Creek and Barney Creek Bridge Sump
