Environmental Monitoring Report

MCARTHUR RIVER MINE

McArthur River Mining Pty Ltd

August 2022

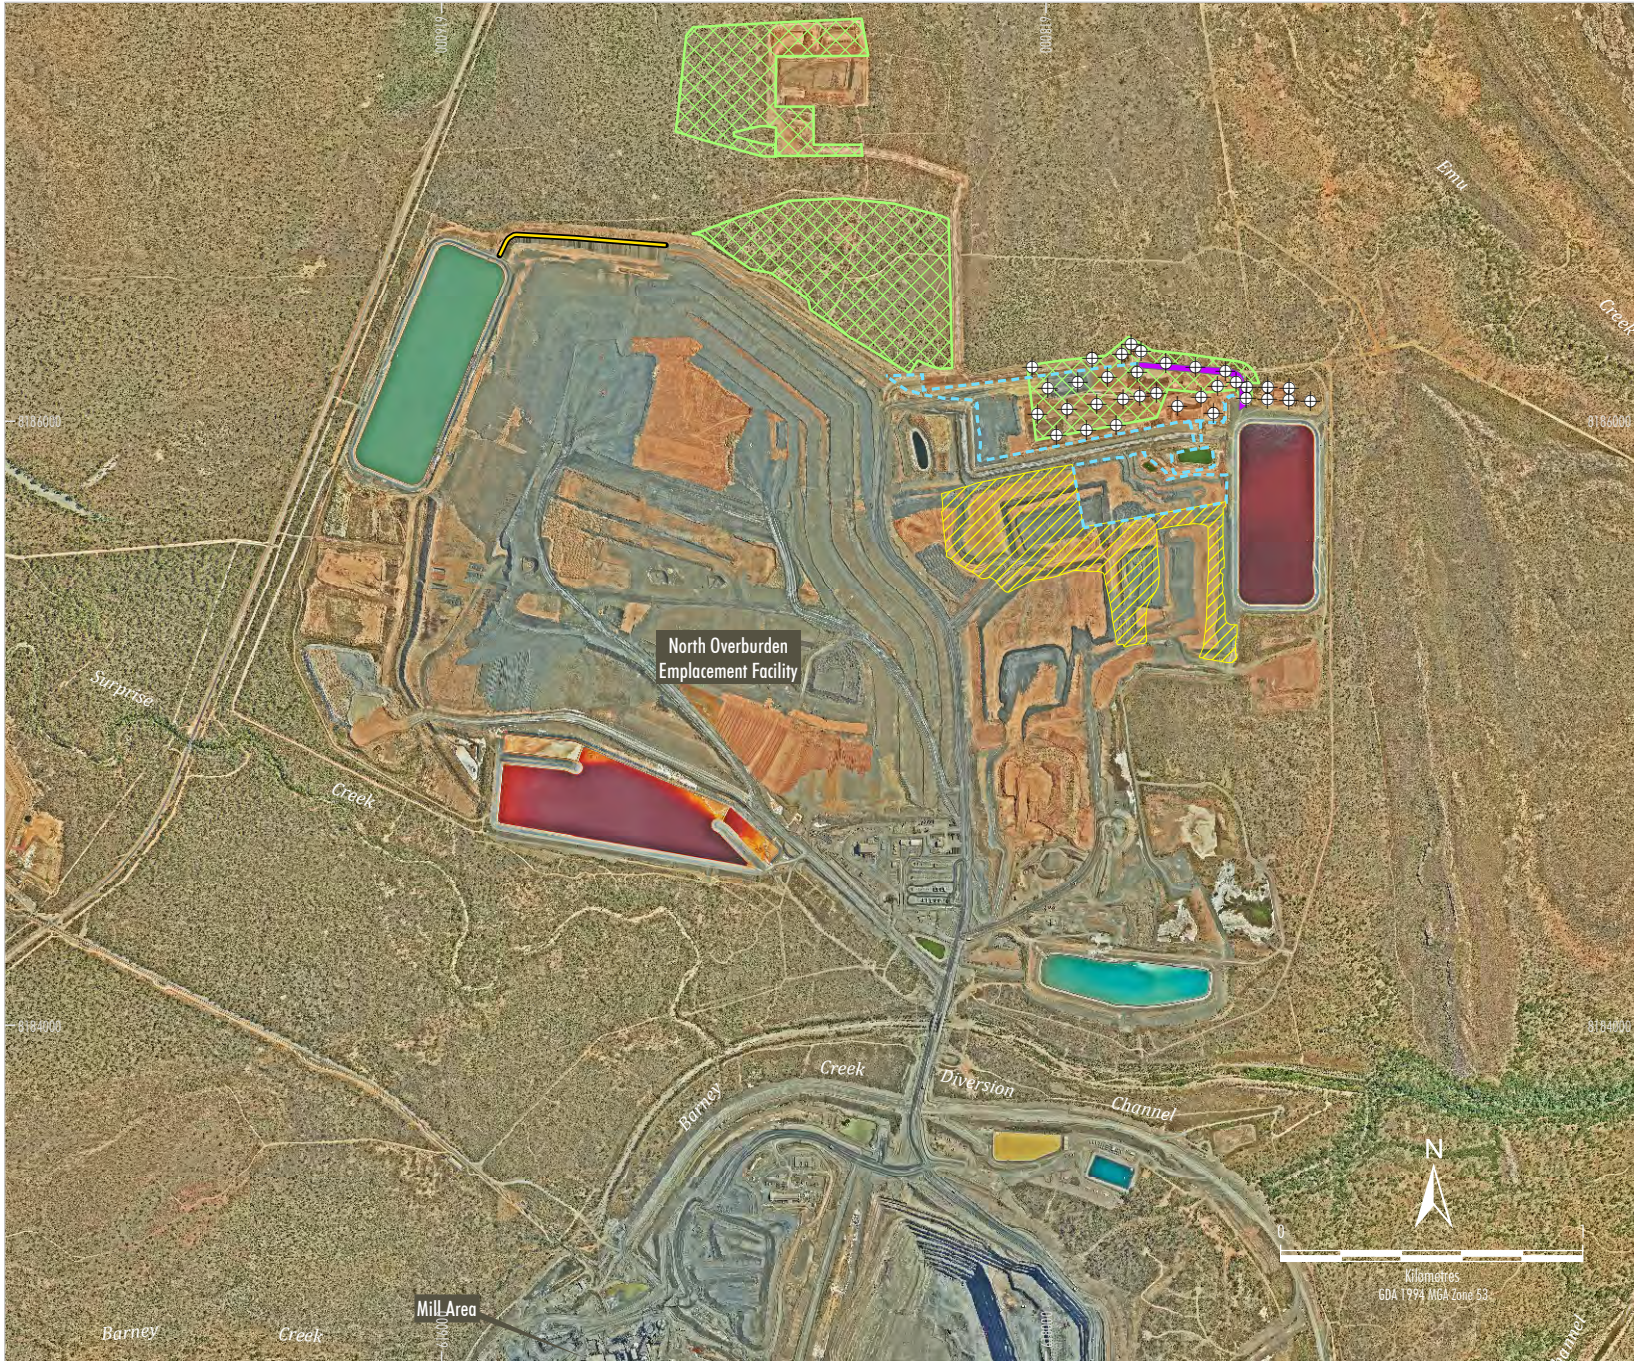
The CE stage was constructed as per the OMP EIS methodology and consistent with the approved 2020 MMP, including the development of:

- a minimum 0.5 m thick low permeability liner with a maximum saturated hydraulic conductivity of 1×10^{-9} metres per second (m/s), shaped such that water reaching the liner will flow towards dedicated seepage extraction locations;
- an approximate 5 m MS-NAF Base on top of the Basal CCL;
- 'Wedge' geometry on top of the Base zone, constructed from non-benign material in up to 7.5 m lifts, with alluvium advection barriers between each lift, and sloped to assist surface water runoff to NOEF East Perimeter Runoff Dam (EPROD);
- the Core and Halo zones constructed from non-benign waste in up to 7.5 m lifts, with alluvium advection barriers between each lift to limit oxidation of the PAF material; and
- the PAF(RE) Cell, constructed in up to 2 m lifts, with alluvium advection barriers between each lift to limit oxidation of the PAF(RE) waste.

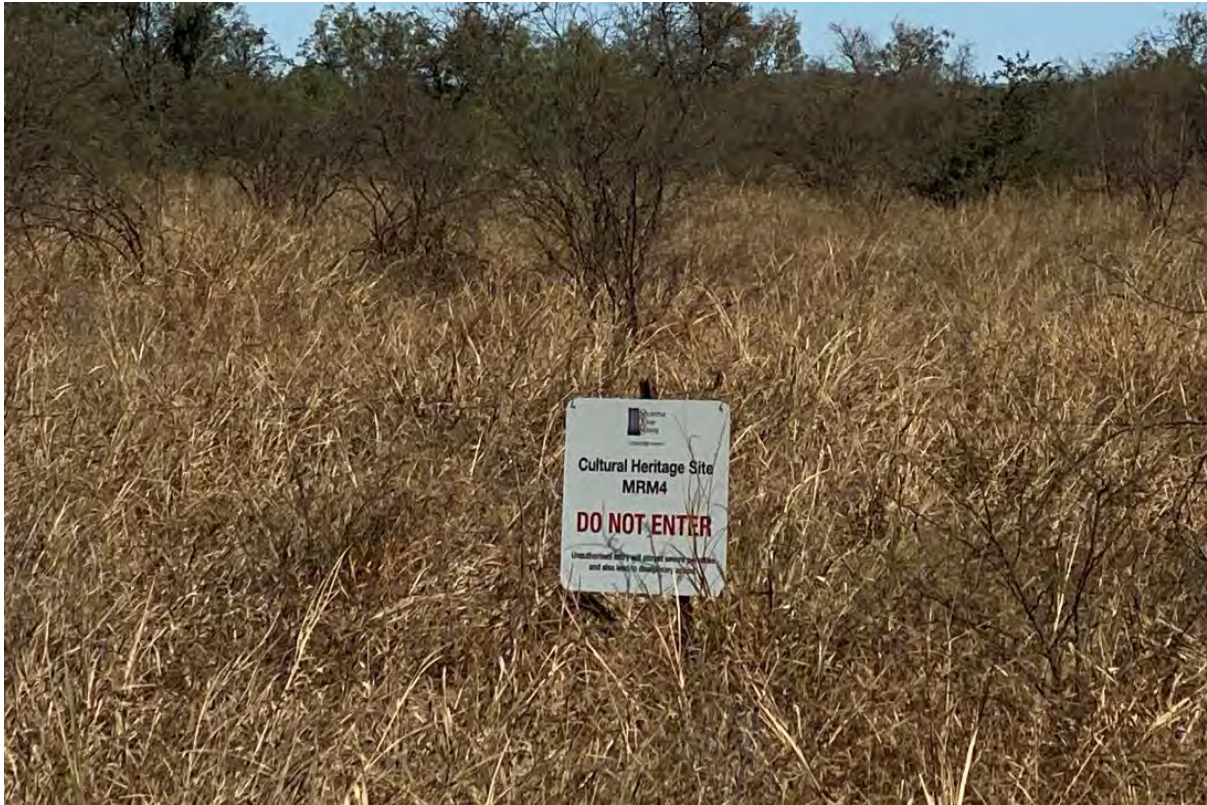
Plate 2: MRM4 Area Fence and Signage

No disturbance has occurred in the area of the MRM4 Cultural Site. The MRM4 Cultural Site has an exclusion fence constructed around it, ranging from approximately 5 - 85m offset from the actual site, with appropriate signage as per Plate 2.

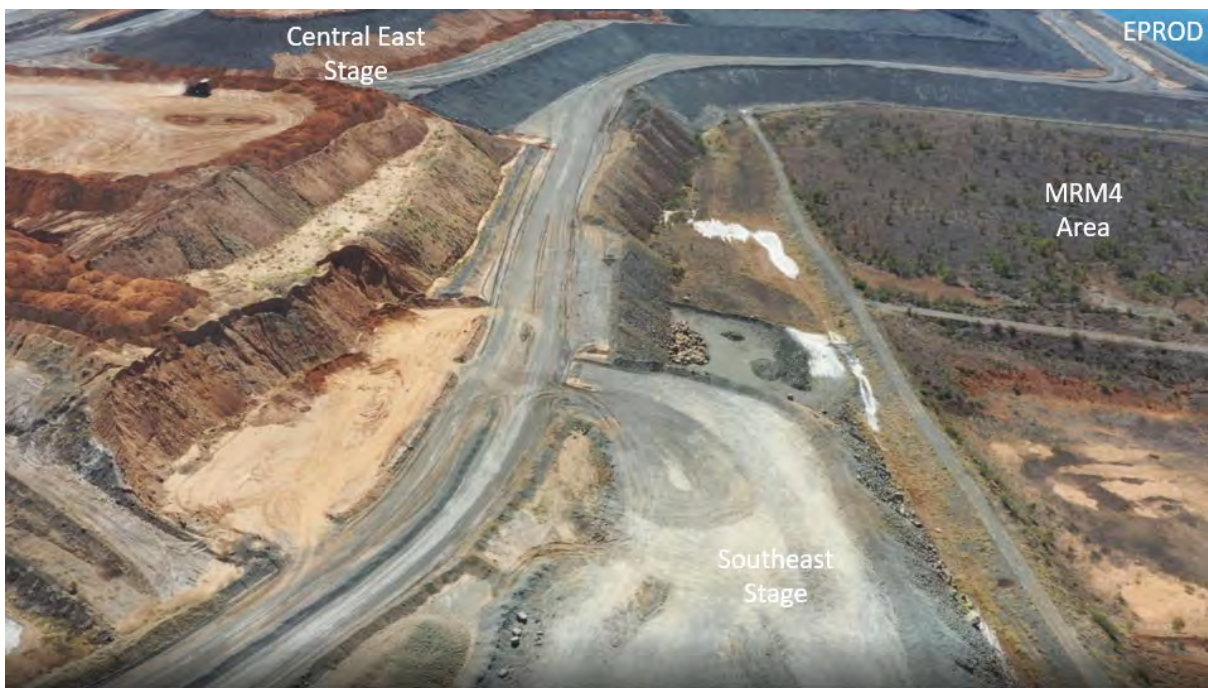
Plate 4: MRM4 Area Drone Photo – 24 July 2022

Plates 3 and 4 show recent photos of the undisturbed MRM4 Cultural Site area.

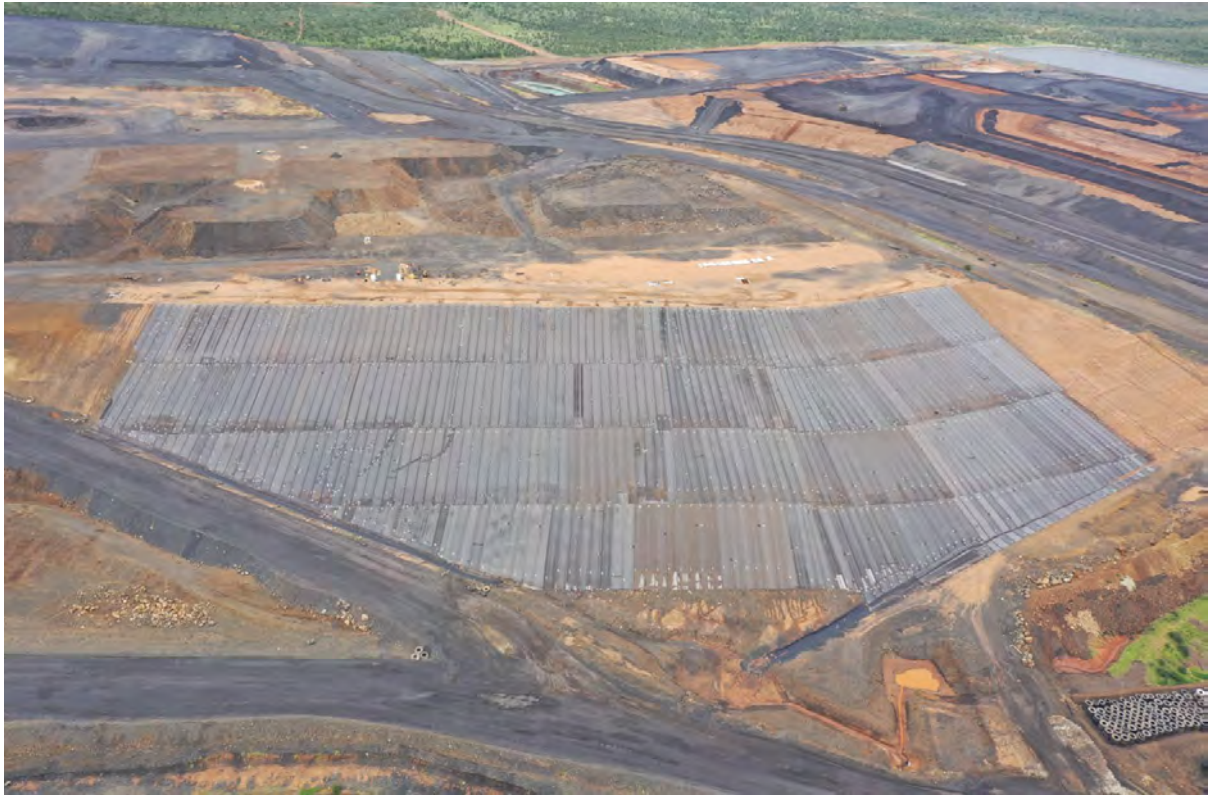
Plate 7: NOEF Rehabilitation Trial Area – Drone Shot

The over-liner, growth medium and topsoil layers will be constructed during the 2022 dry season, after which monitoring data will also start to become available.

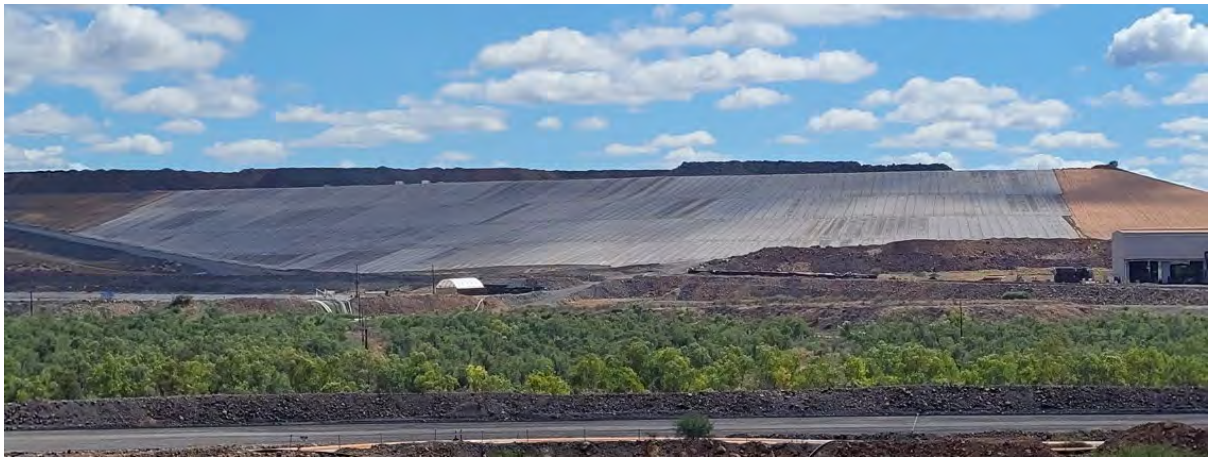
Plate 8: NOEF Rehabilitation Trial Area

Ten hectares of BGM were installed during 2021 on the West AB southern face, as indicated in Plate 7 and Plate 8. Delays in the delivery of the BGM in 2021 meant that no over-liner, growth medium or topsoil was constructed during the reporting period. Two separate monitoring systems are being trialled under/over the BGM, including a wireless system and a fibre optic system, however no monitoring data is available as yet.

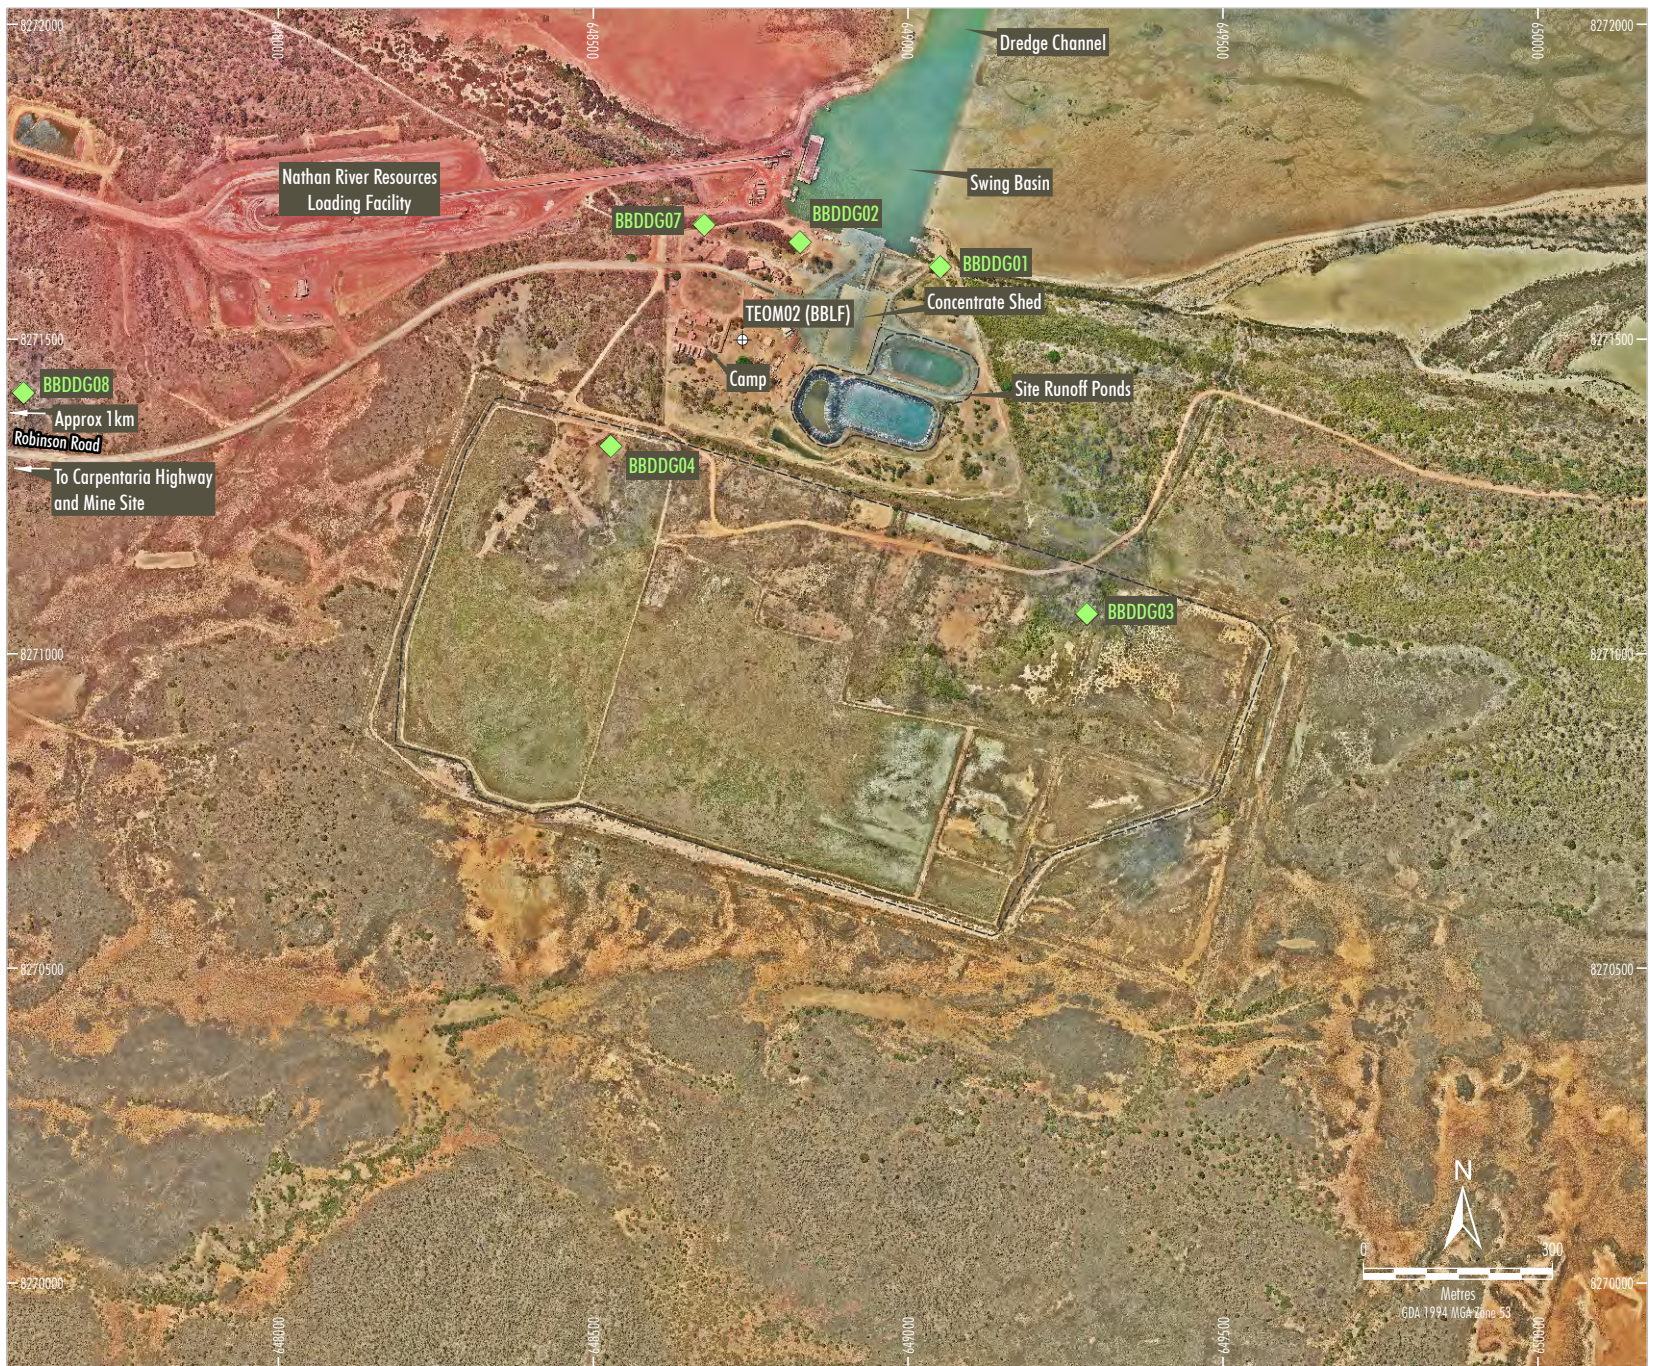
Figure 7

The air quality monitoring network at the Mine and the BBLF during the reporting period consisted of multiple methods (locations presented in Figures 7 and 8), including:

McARTHUR RIVER MINE
Mine Ambient Air Quality
Monitoring Sites

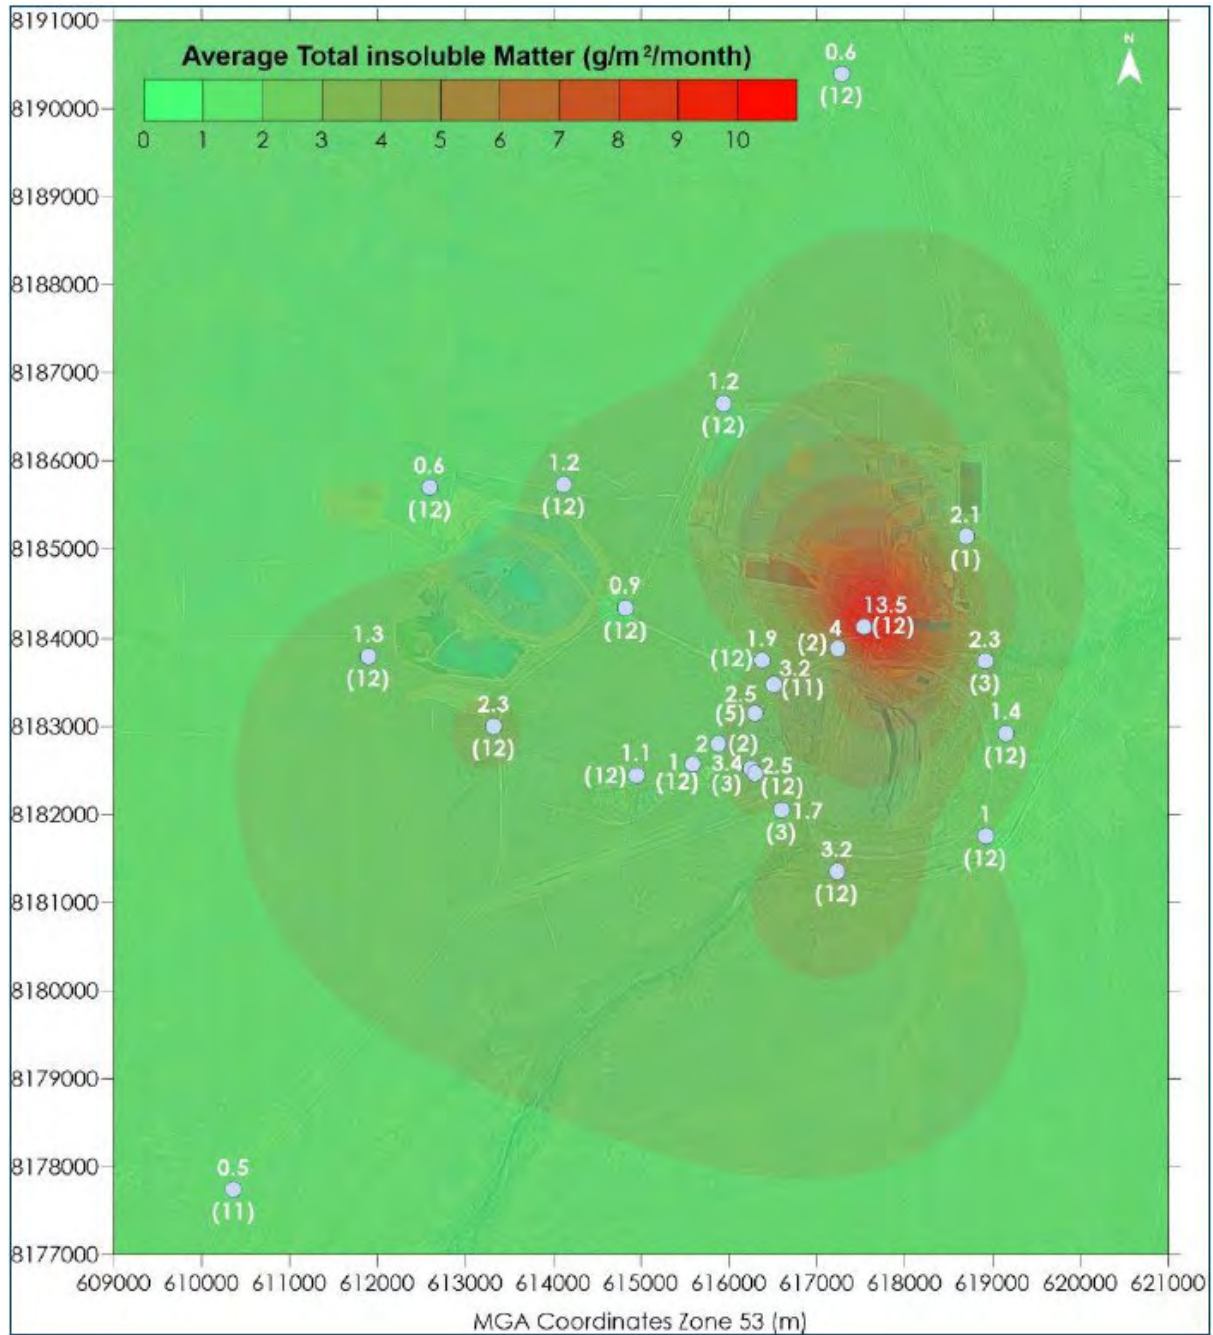
Figure 9: Interpolation of May 2021 to April 2022 Mine Annual Average Total Insoluble Matter Results

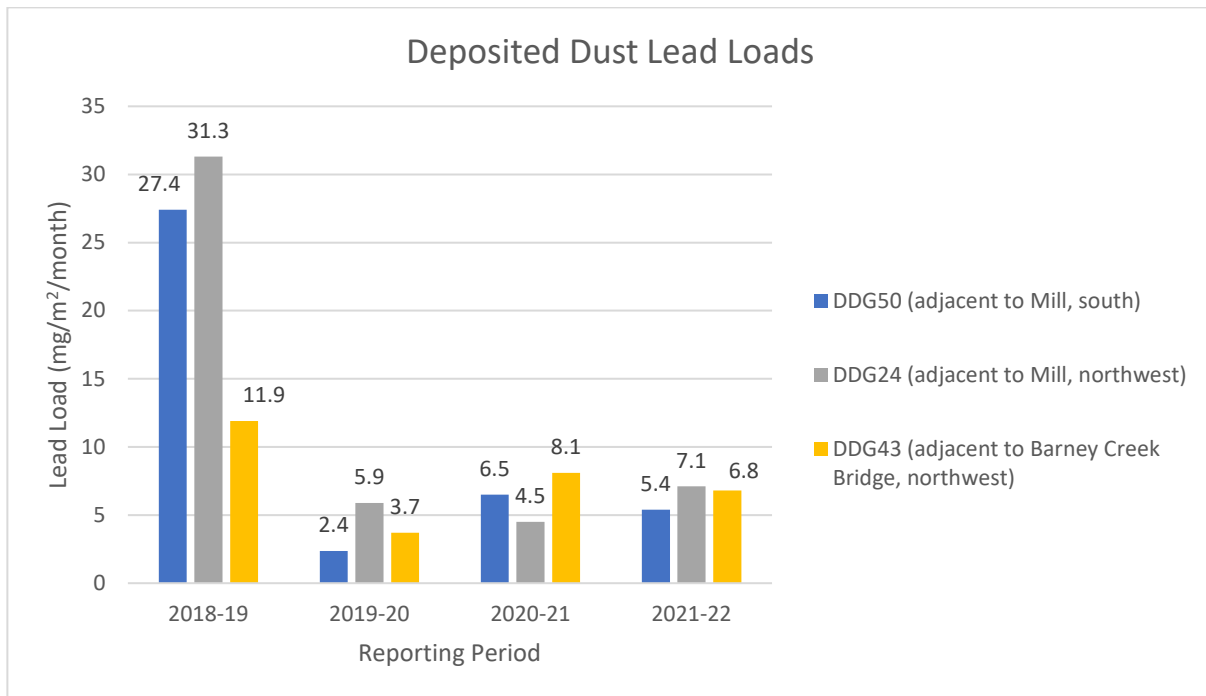
Chart 2 gives a comparison of the annual average lead loads at the same sites for the same reporting periods.

Chart 2: Average Deposited Lead Loads at Key Depositional Dust Monitoring Sites

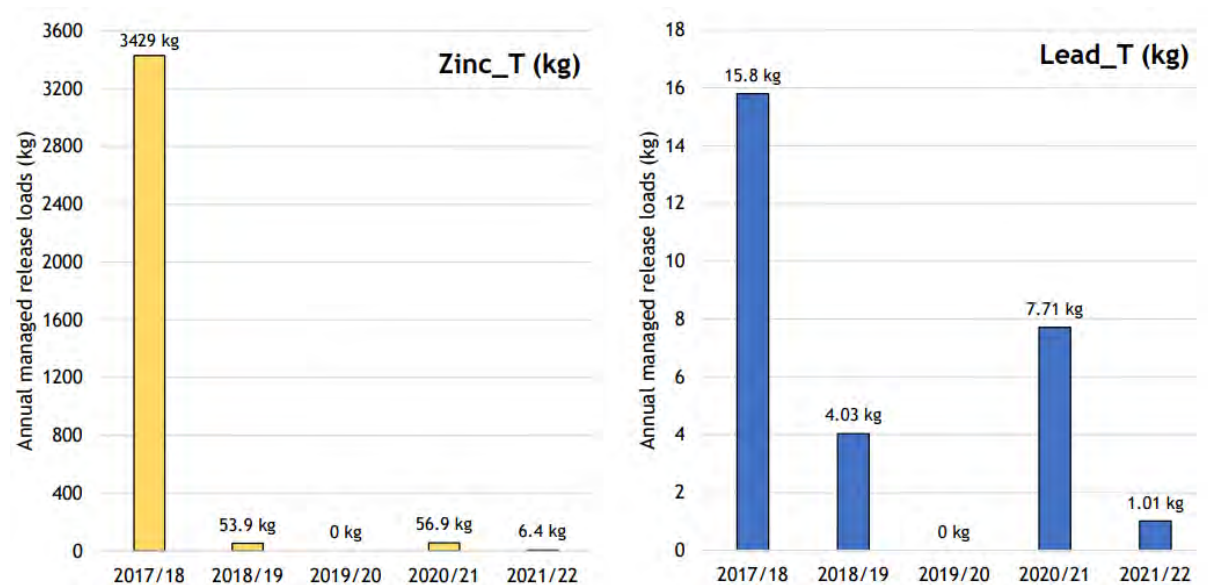
The 2021-22 reporting period managed release loads for total zinc and total lead were 6.4 kg and 1.01 kg respectively. The loads were considerably less than those released over the baseline period of 2017-18 (Chart 11).

Chart 11: Managed Release Loads of total Zinc and Lead for the Reporting Period

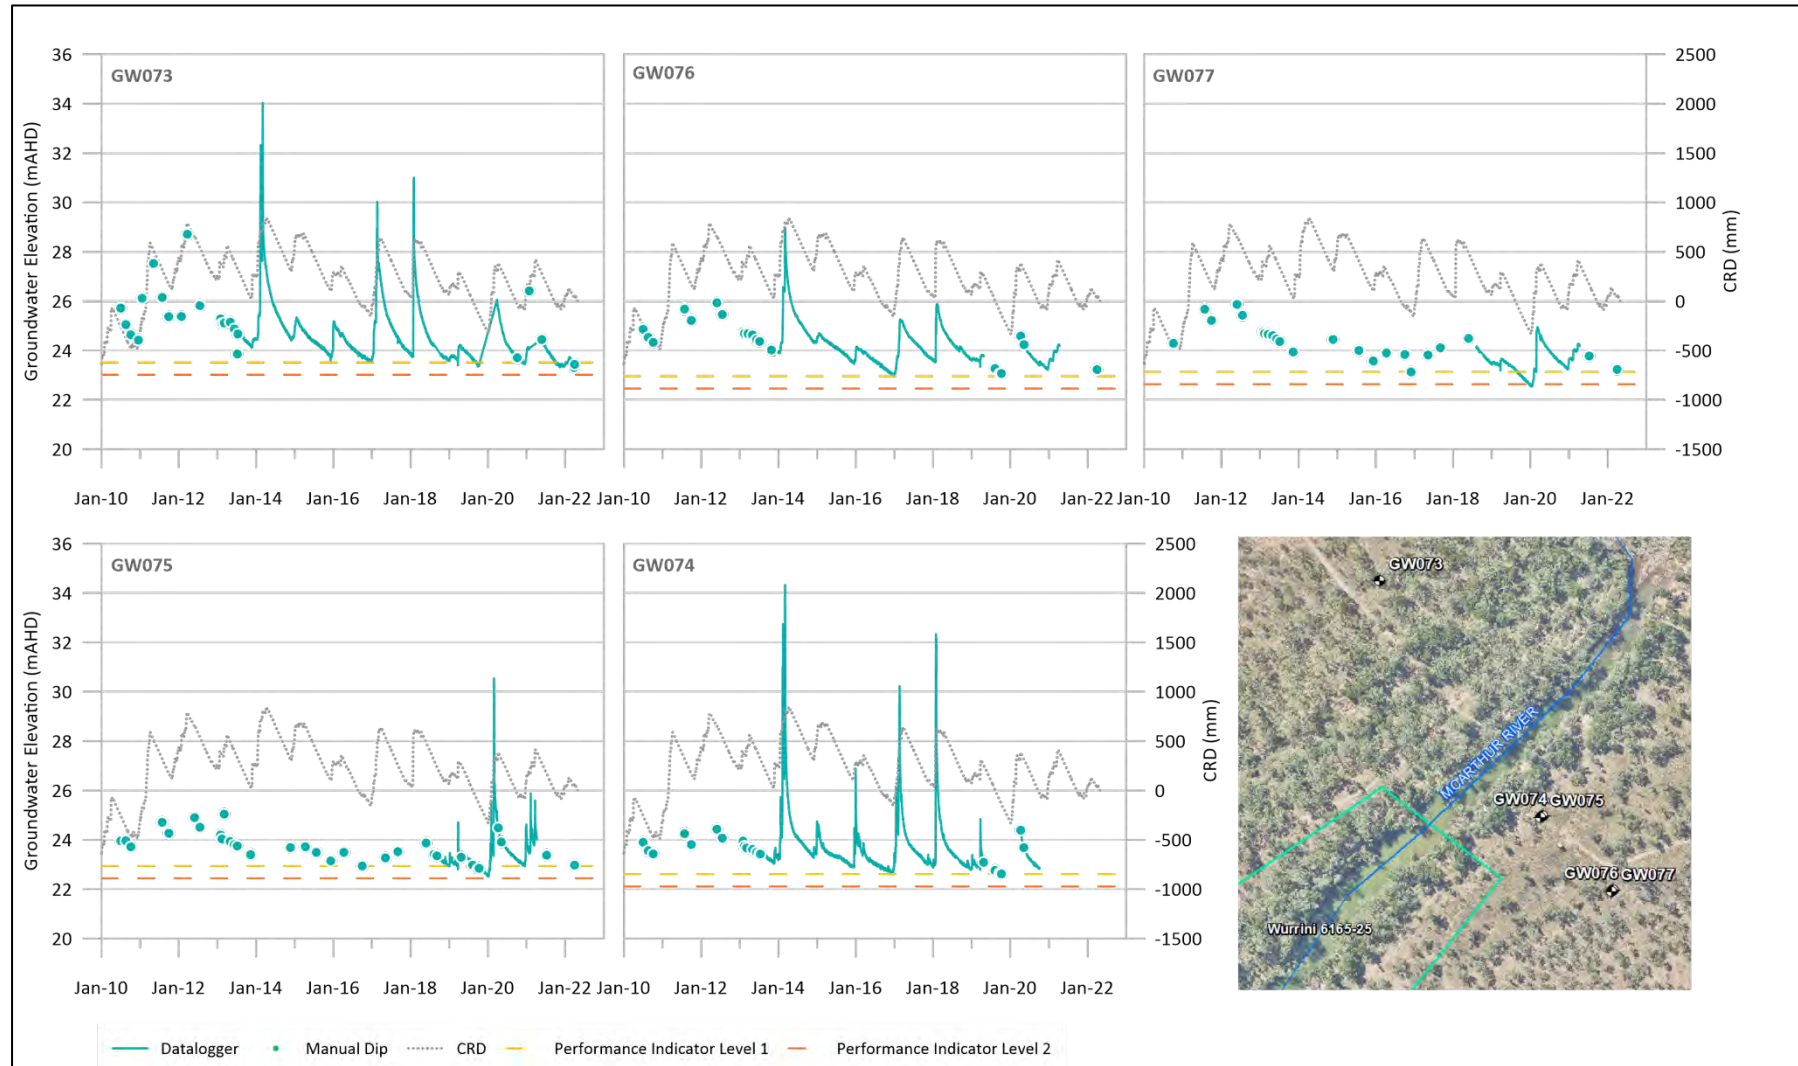
Plate 10: Groundwater Level Data from Performance Indicator Bores Surrounding the Djirrinmini-Wurrini Waterhole (after KCB, 2022a)

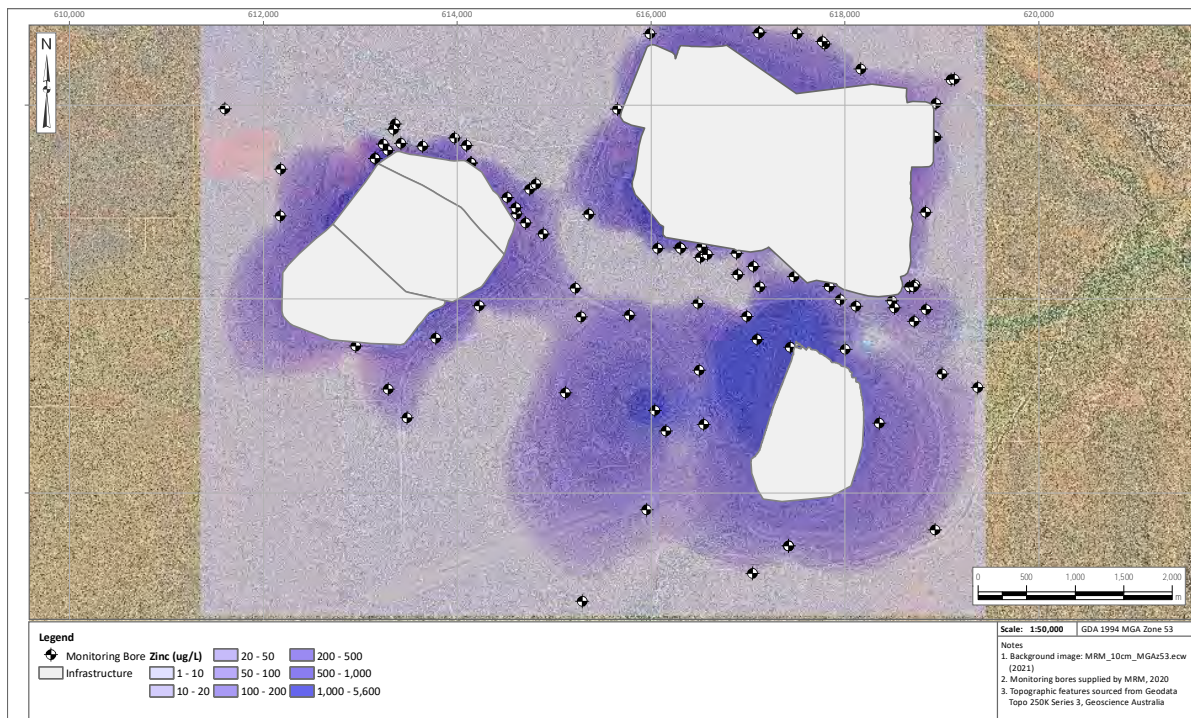
Plate 12: Zinc Concentration Contours in the Weathered Bedrock and Alluvial Aquifers for October – December 2021

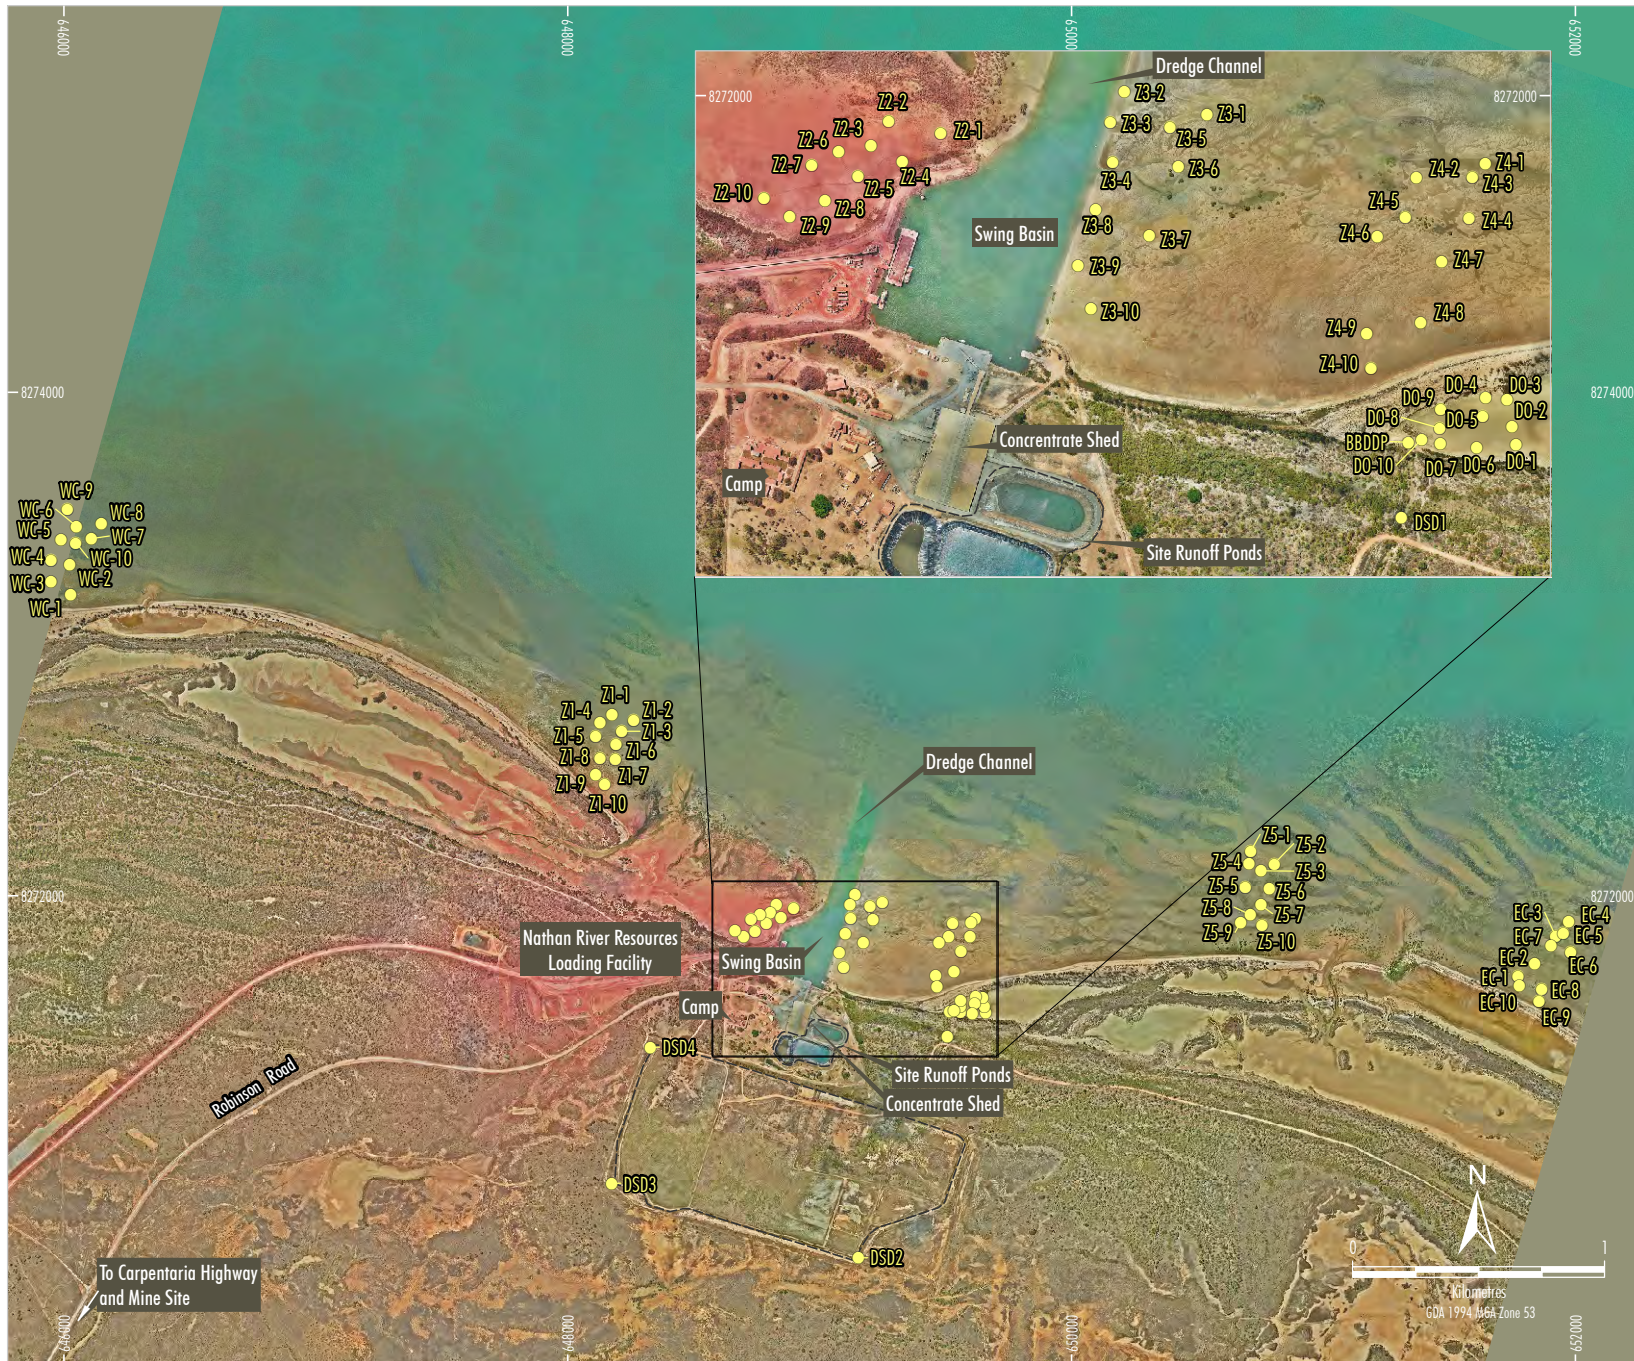
Regarding the BBDDP, DSD and Drain Outlet (DO) sites, the survey found no exceedance of any applicable SQVG, aside from one sample collected at DSD-4 which recorded a Pb concentration of 53 milligrams per kilogram (mg/kg). Due to the location of DSD-4 and its level of Zn (180 mg/kg), it is likely that shipping concentrate rich dust has accumulated within the site. Overall, the concentrations of analytes associated with the shipping product at BBDDP, DSD and DO sites were found to be comparable to the wider survey area, or at least no greater than those recorded within Zone 3, particularly if concentration data from DSD-4 is removed from the analysis. Continued monitoring of these zones will provide an 'early warning system' should changes to coastal morphology or environmental processes occur.

LEGEND
 ● Near Shore Sediment Monitoring Site

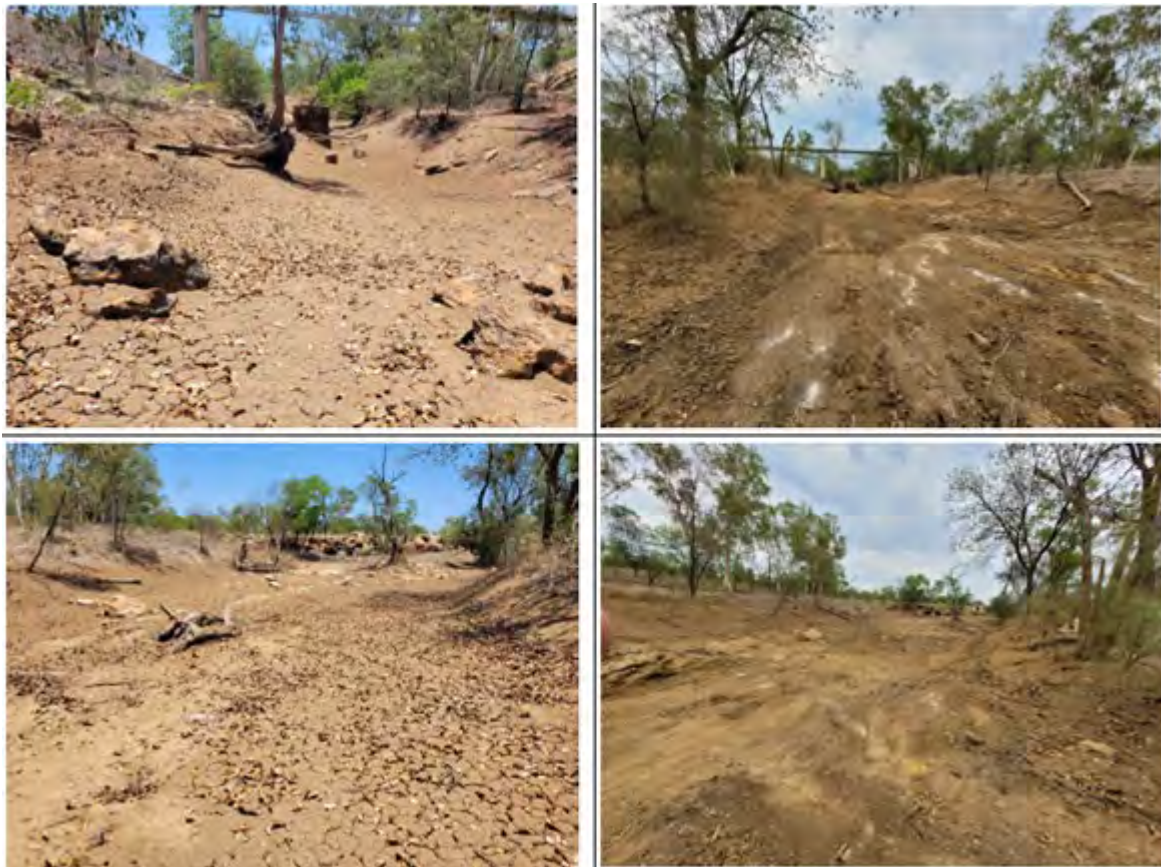
Plate 14: Sediment Removal from Barney Creek and Barney Creek Haul Road Bridge Sump

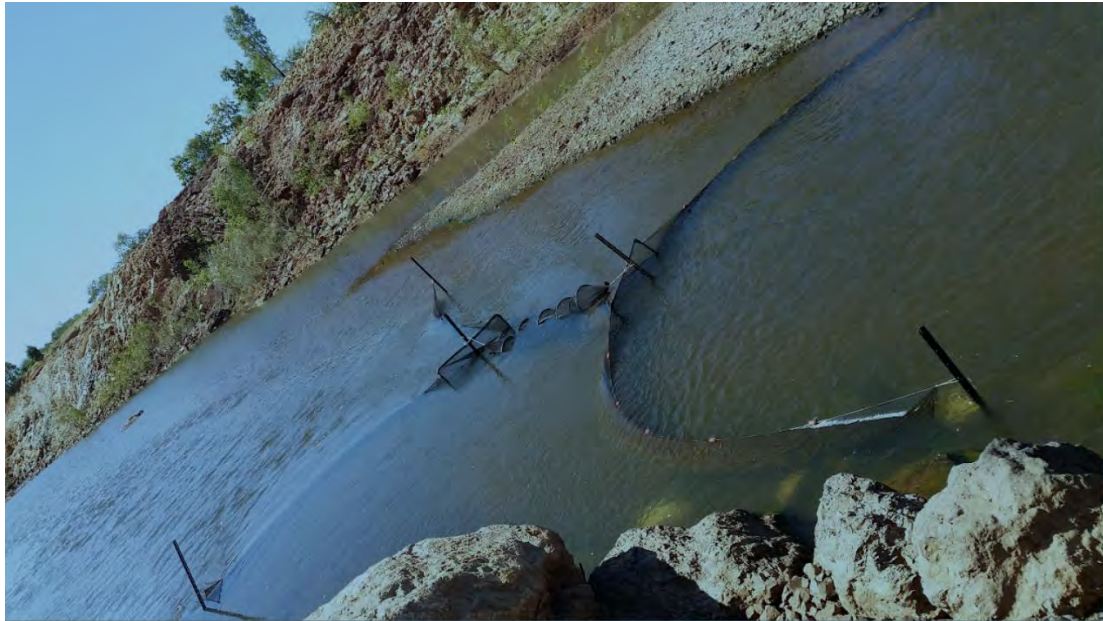
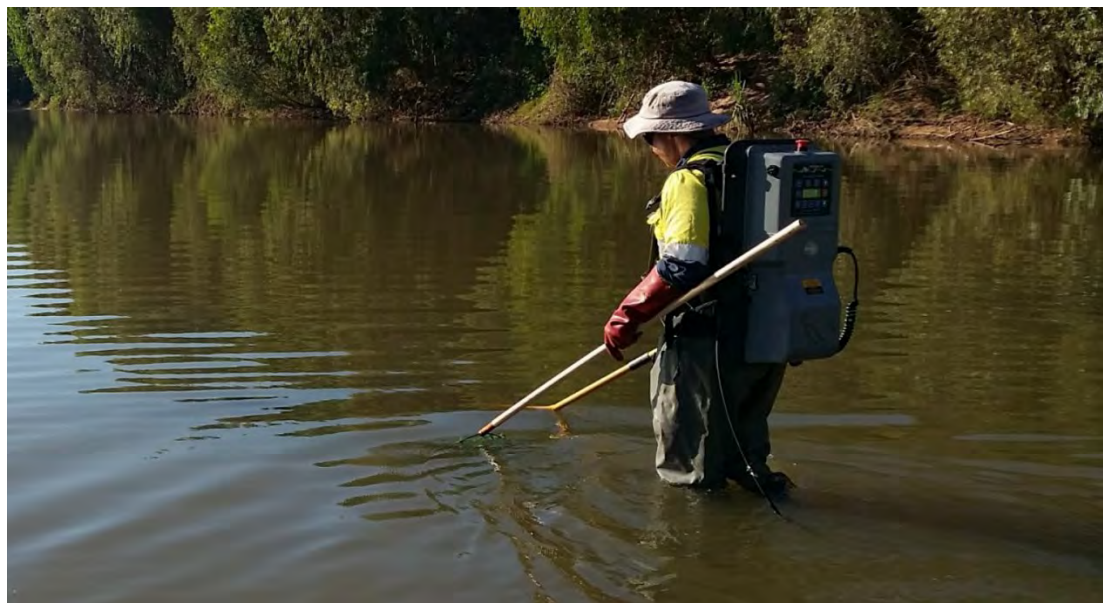
Plate 15: Two Sampling Methods Utilised to Capture Aquatic Fauna during the Reporting Period

In addition, the current data continues to support past conclusions that there has been no observable decline in species diversity or abundances in waters upstream and downstream of the mineral lease, outside of that which would be considered to be natural variation as a result of variable seasonal flows or changes in river bed morphology (Plate 15).
