# Environmental Risk Assessment

Barunga Waste Stabilisation Ponds 2023

| Document Title: Environmental Risk Assessment 2023 - Remote Community Waste Discharge Licences – Barunga Waste Discharge Licence 214-02 | | | |

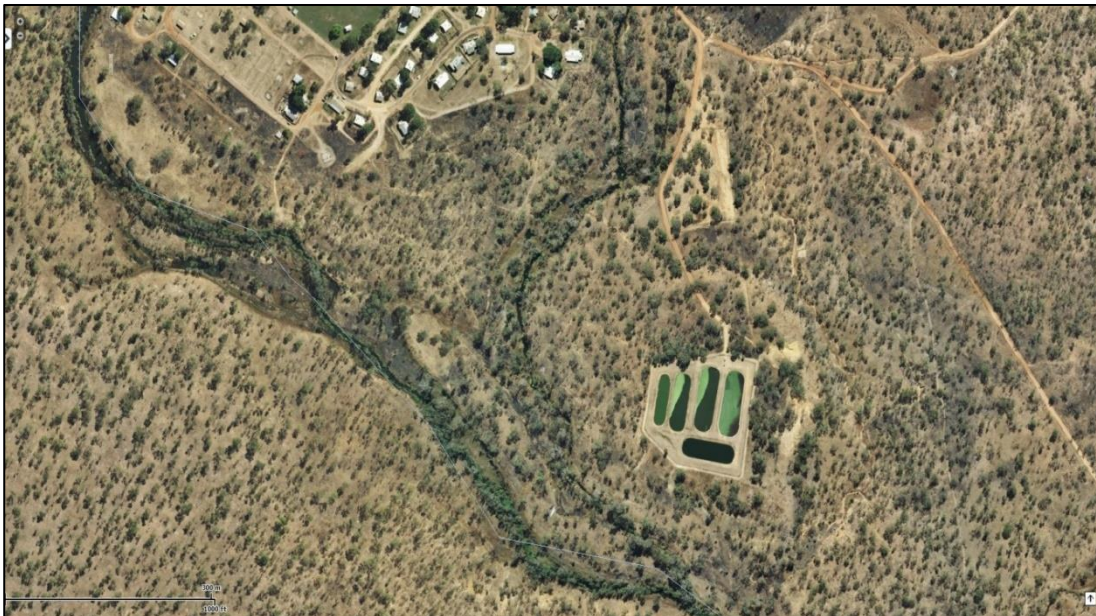
Figure 2: Barunga site layout including WwTP and outfall location (NT ILIS 2017)

Barunga is located in the Katherine region in the Northern Territory, 82 km east of Katherine, approximately 396 km south-east of Darwin (Figure 1). Barunga has an estimated population of 396 in 2023 (BushTel 2023). The Wastewater Treatment Plant (WwTP) is located approximately 510m south-east of the Barunga Township (Figure 2).

Discharge from the facility occurs from a gravity fed discharge pipe located in the final tertiary maturation pond (Pond 5) (Figure 4). Discharge is thought to be continuous or on an as-required basis (discharge is all year round) and occurs into a permanent freshwater creek (and also possibly a spring) approximately 195m north-west of the final pond outlet (Figure 2).

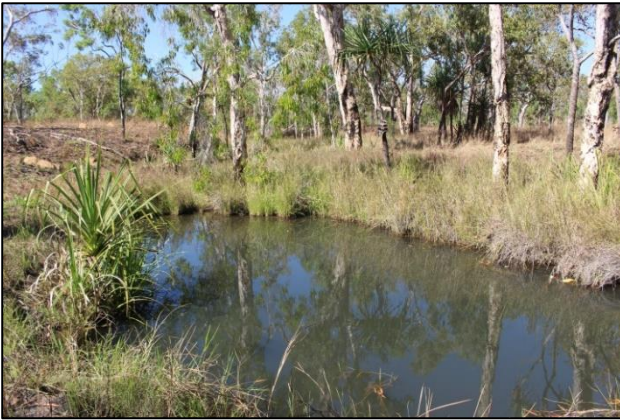
Figure 5: Small freshwater stream receiving outputs of Barunga (PWC 2017)

The receiving environment consists of a small, shallow, unnamed freshwater creek, extending from the larger Beswick Creek, both which flows all year round (Figure 5). The unnamed creek runs along the eastern side of the Barunga Township, discharge from the ponds is downstream from the town (south). The main section of town is approximately 400m from the discharge point (PWC 2017). In some sections during the dry season, the creek can be shallow with segregated sections of pooling. The water quality within the receiving environment during the 2017 dry season was observed to be clear and free of contaminants, odours, and algal blooms (Figure 7). The immediate discharge point was providing a healthy habitat for aquatic insects and small guppies (PWC 2017). In April 2021 *Lemna aequinoctialis* (duckweed) was observed within the pond system and receiving environment. The creek was flowing and water was clear (Figure 6) (PWC 2021b).

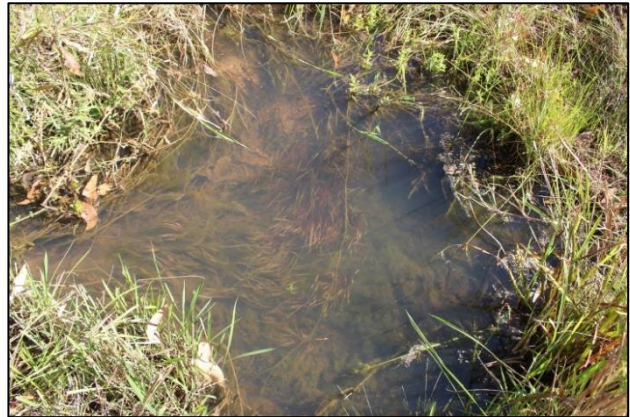
Figure 7: Clean water immediately downstream of discharge point (PWC 2017)

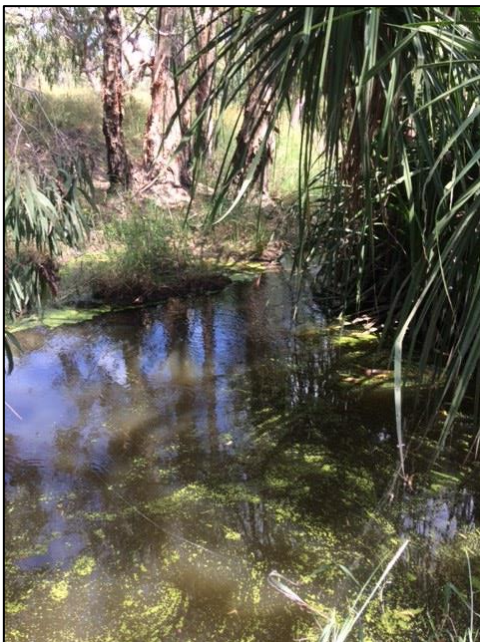
Figure 6: Receiving environment during 2020-21 wet season (PWC 2021)

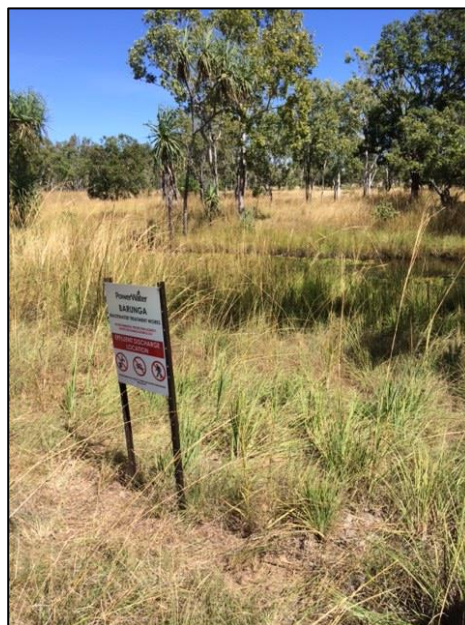
Figure 8: Effluent discharge warning signage at Barunga (PWC 2020)

discharge point to inform the public regarding the presence and location of the wastewater discharge (Figure 8).

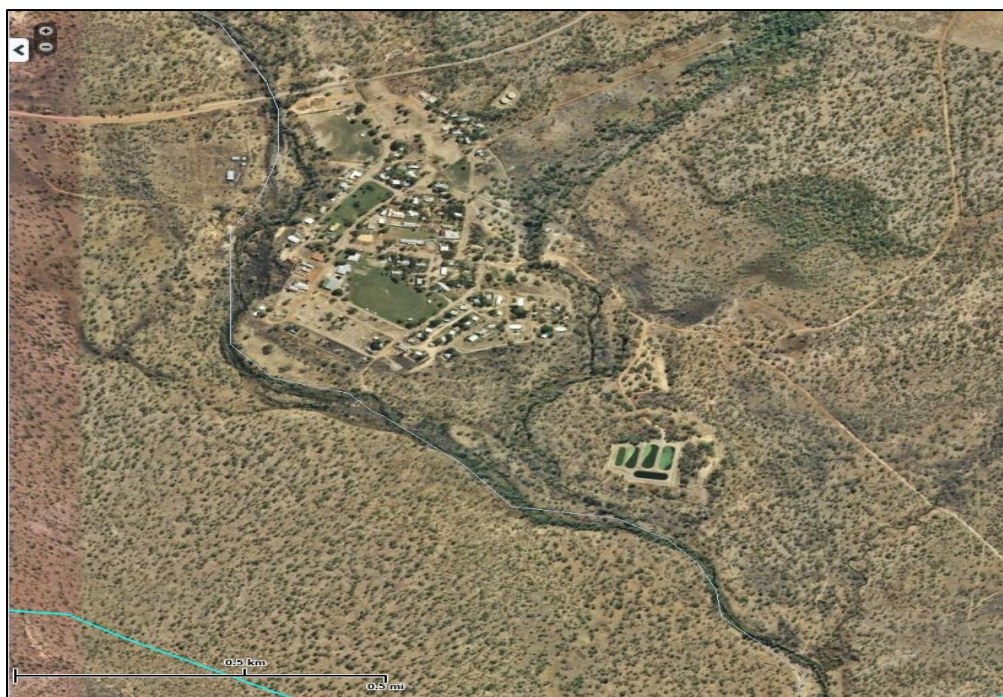
Figure 11: Catchment for Barunga WwTP (NT ILIS 2017)

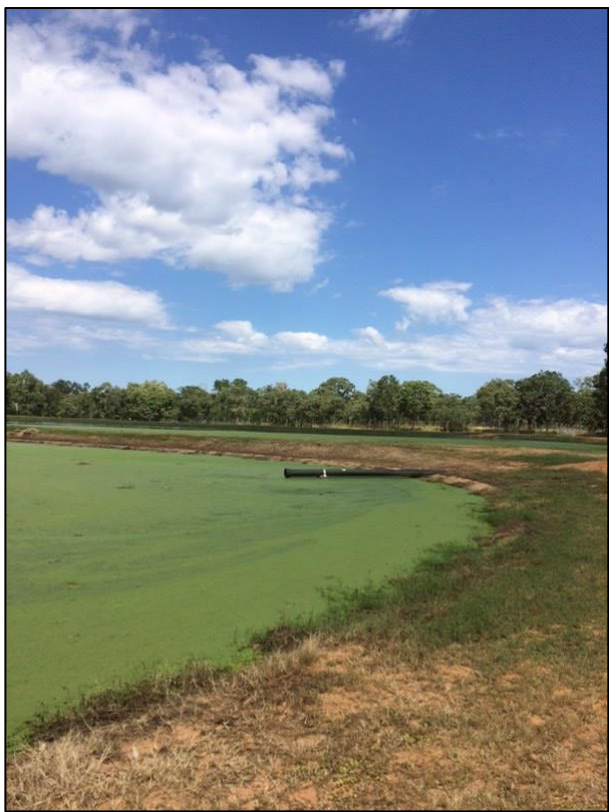
Figure 12: Barunga Pond 2 (PWC 2021)

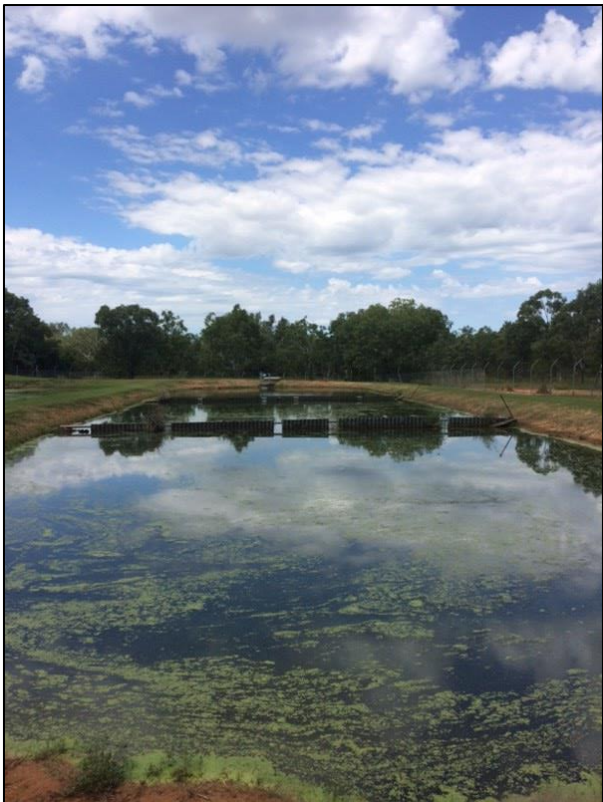
Figure 13: Barunga Pond 5 (PWC 2021)

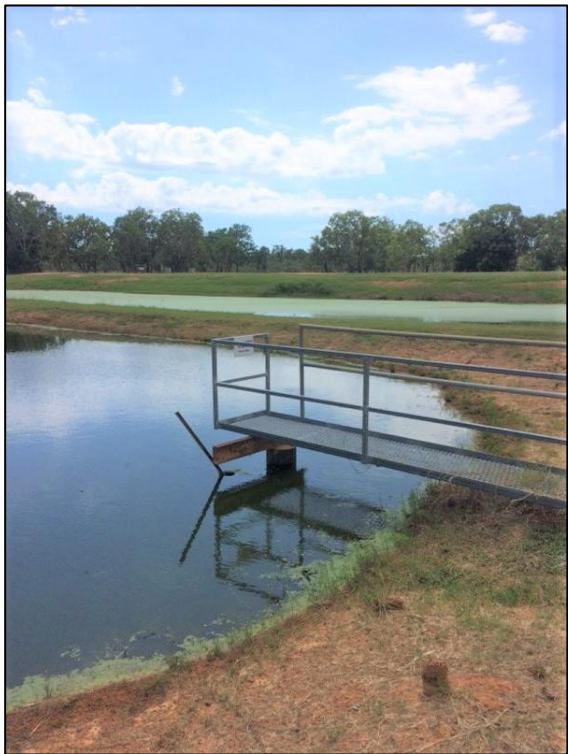
Figure 15: Barunga Pond 5, Final outfall (PWC 2021)

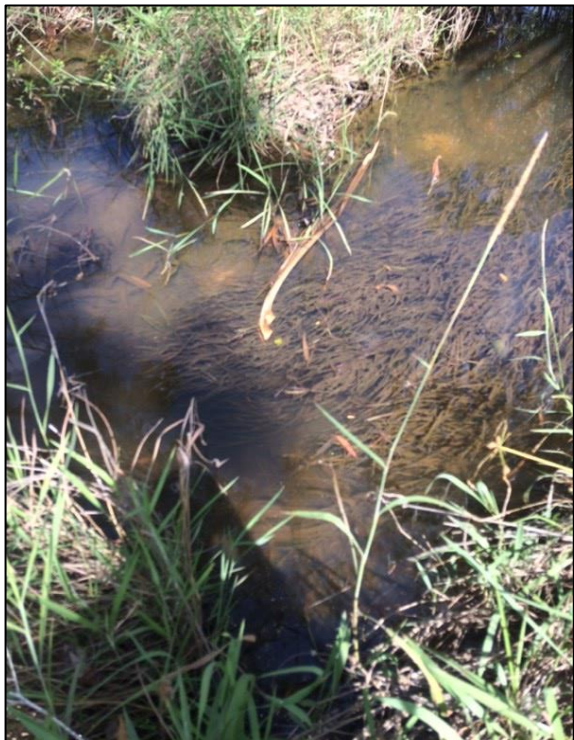
Figure 14: Water clarity within creek (PWC 2021)
