# Environmental Risk Assessment

Milikapiti Waste Stabilisation Ponds 2023

| <b>Document Title:</b> | Environmental Risk Assessment 2023 - Remote Community Waste Discharge Licences – Milikapiti Waste Discharge Licence 217-02 | | |

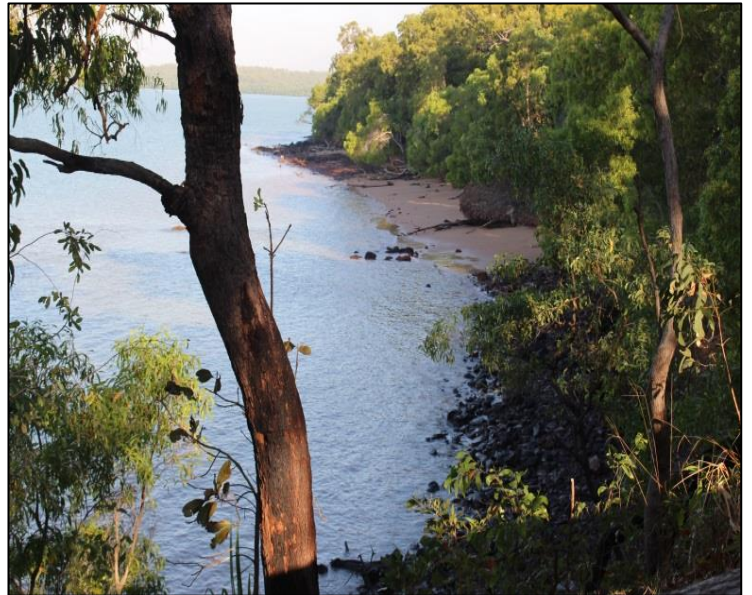
Figure 6. Coastal vegetation along beach south of discharge point, river in background (PWC 2017)

The receiving environment consists of a beach with rocky outcrops, with a steep 5 m drop off from the ground level of the ponds. The vegetation along the beach at the receiving environment is open Eucalypt forest along the higher side with more riparian species along the beach front side (Figure 6). No mangrove vegetation was observed in this area during inspections.
