# Remote Community Waste Discharge Licences Waste Stabilisation Ponds

## ENVIRONMENTAL RISK ASSESSMENT 2021

### Nganmarriyanga (Palumpa) Waste Discharge Licence 219-01

**Water Services**  
Remote Water Planning  
April 2021

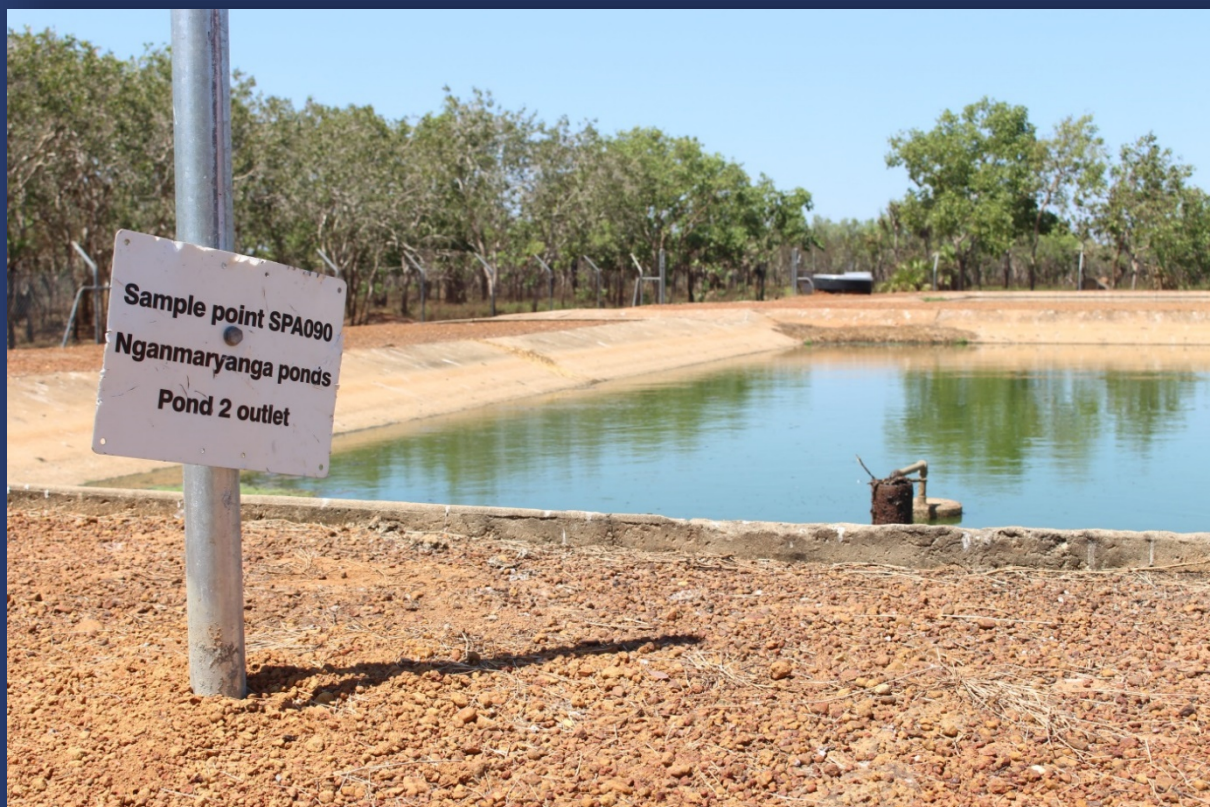
Cover Image: Nganmarriyanga Wastewater discharge sampling point 2017 – Power and Water Corporation

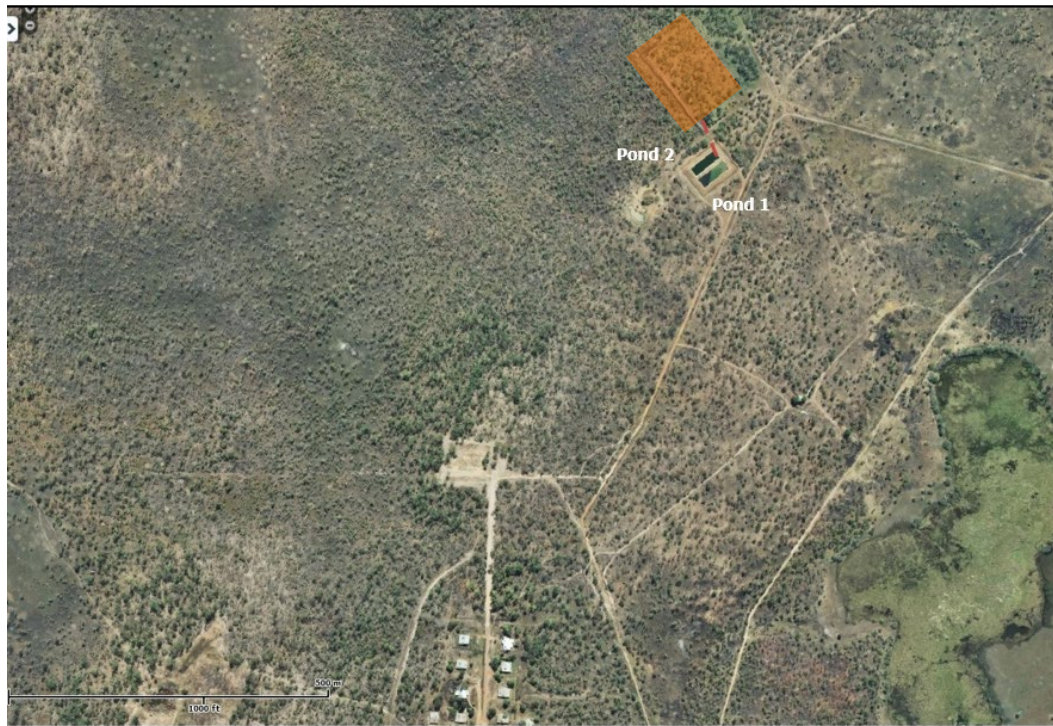
**Figure 2.** Nganmarriyanga site layout including WwTP and outfall irrigation location (NT ILIS 2017)

Nganmarriyanga is located inland along the western coast of the Northern Territory, approximately 362km south-west of Darwin (Figure 1). Nganmarriyanga has an estimated population of 494 in 2021 (DHCD 2017). The Wastewater Treatment Plant (WwTP) is located approximately 800m north of the Nganmarriyanga Township (Figure 2).

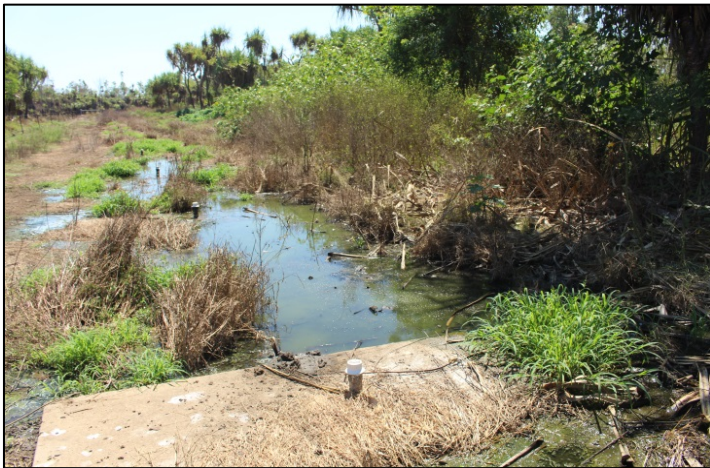
Treated effluent from the Nganmarriyanga WwTP is discharged into the environment within a fenced disposal area via a gravity fed, ground level irrigation system (Figure 5). The discharge area is approximately 15,388 m<sup>2</sup>. The sprinkler system forms a line approximately 150m in length to the north-west of the final pond.

**Figure 5.** Sprinkler irrigation system (PWC 2017)

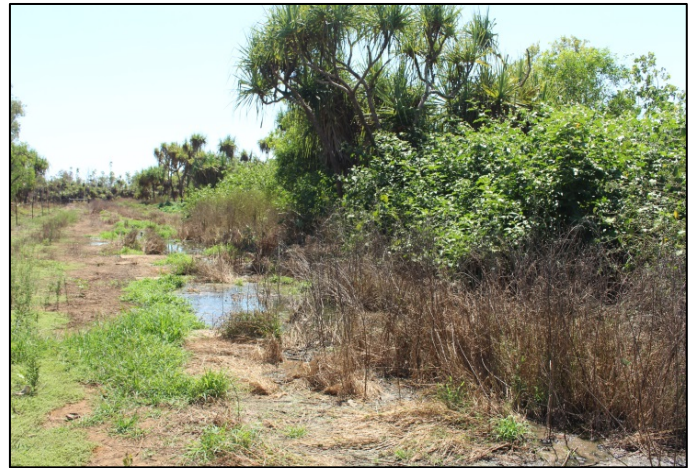
A small swamp area is evident within the immediate discharge area; this is thought to be due to the WwTP discharge (Figure 6, Figure 7). During the dry season the treated effluent is contained within the irrigation area (PWC 2017); during the wet season it is unknown if the treated effluent flows past the fence line (further investigation is required). When the ponds fill during the wet season, treated effluent is designed to discharge via a concrete spillway located on Pond 2 (PWC 2017). It is unknown how often this occurs; however, any effluent discharged would receive significant dilution from freshwater stormwater infiltration and rainfall.

**Figure 6.** Receiving environment of Nganmarriyanga WSPs (PWC 2017)

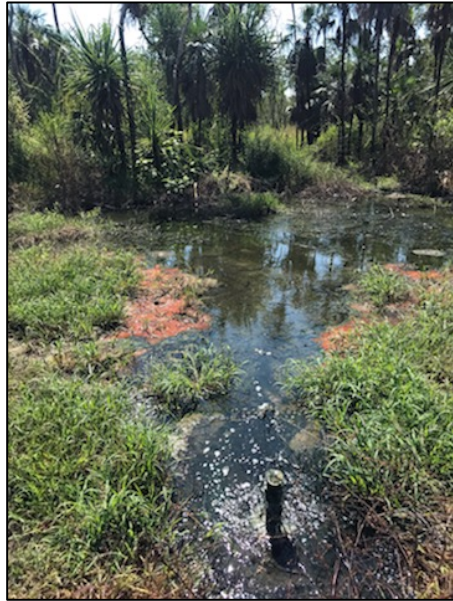
**Figure 7.** Disposal of effluent occurring to land during 2020-21 wet season (PWC 2021)

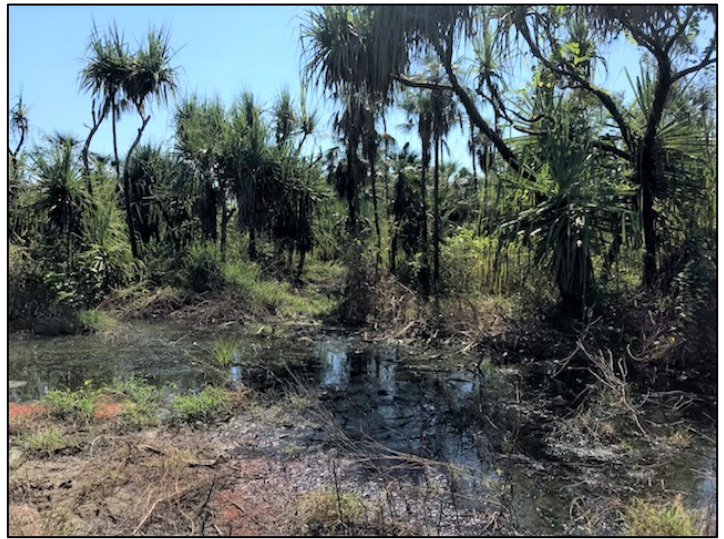
The surrounding vegetation within the receiving environment is Eucalypt woodlands, dominated by *Eucalyptus tetrodonta*, *Eucalyptus miniata*, and *Corymbia dichromophloia* or *Corymbia Capricornia* (Figure 8). *Pandanus spiralis* (Pandanus), shrubs and grasses are also dominant in the receiving area. The receiving environment is considered to be of a pristine conservation value, due to the lack of

**Figure 8.** Vegetation within receiving environment (PWC 2021)

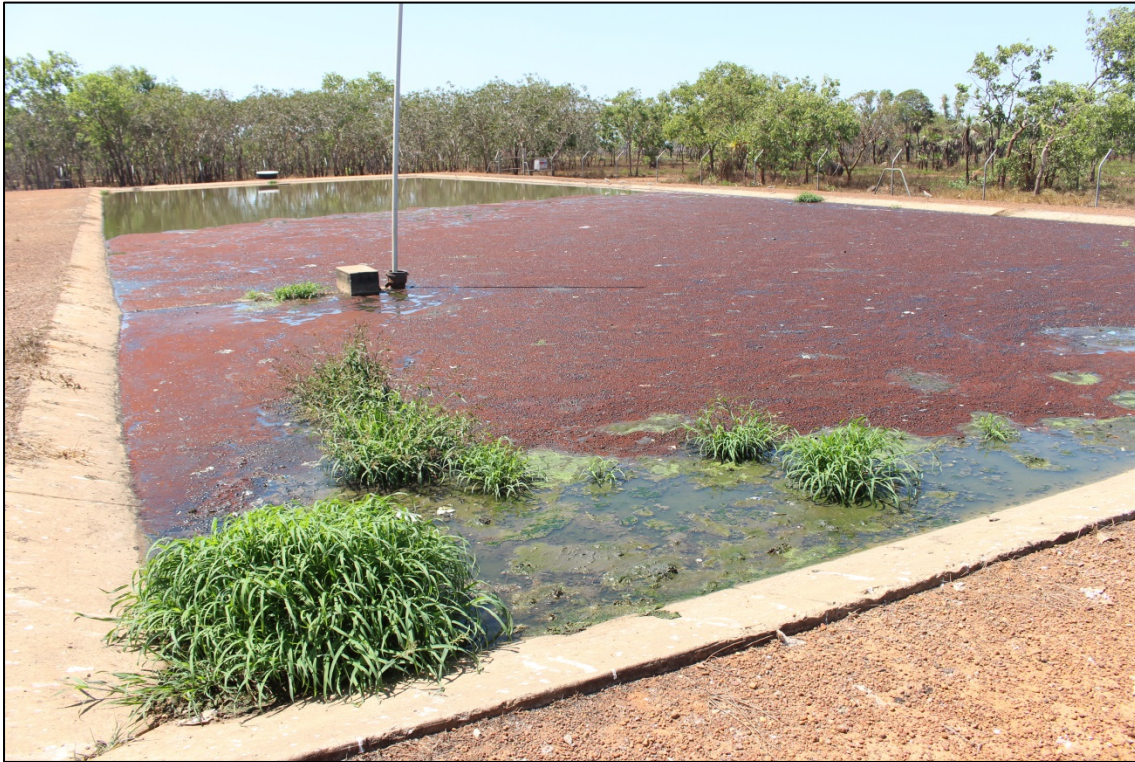
**Figure 13.** Nganmarriyanga WwTP Pond 1 (PWC 2017)

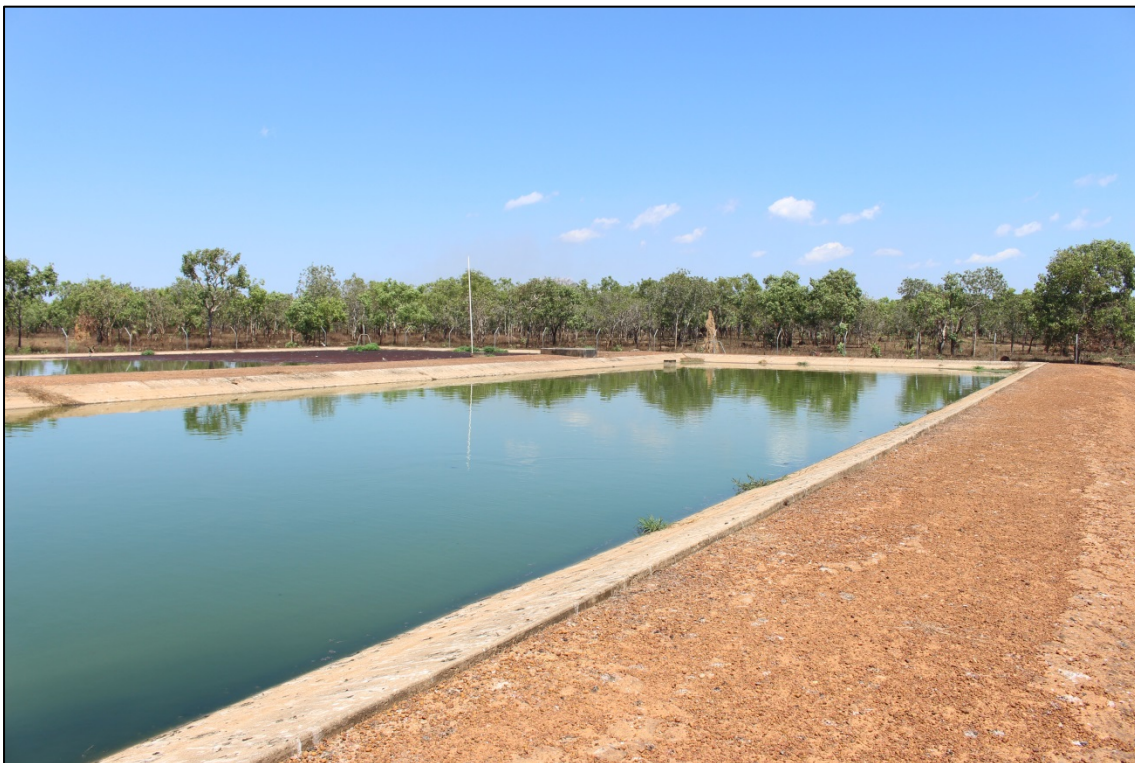
**Figure 14.** Nganmarriyanga WwTP Pond 2 (PWC 2017)

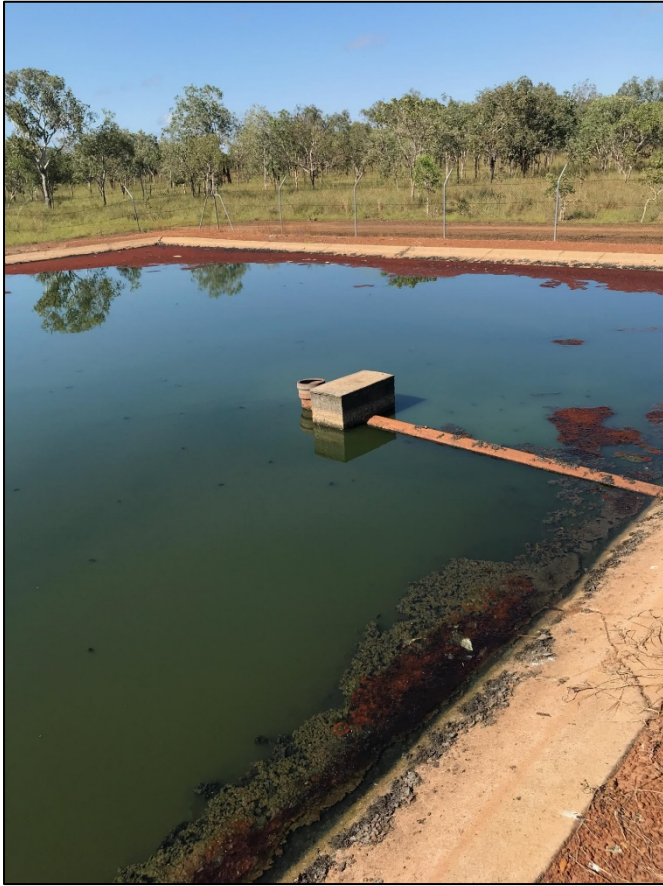
**Figure 15.** Pond 1 (PWC 2021)

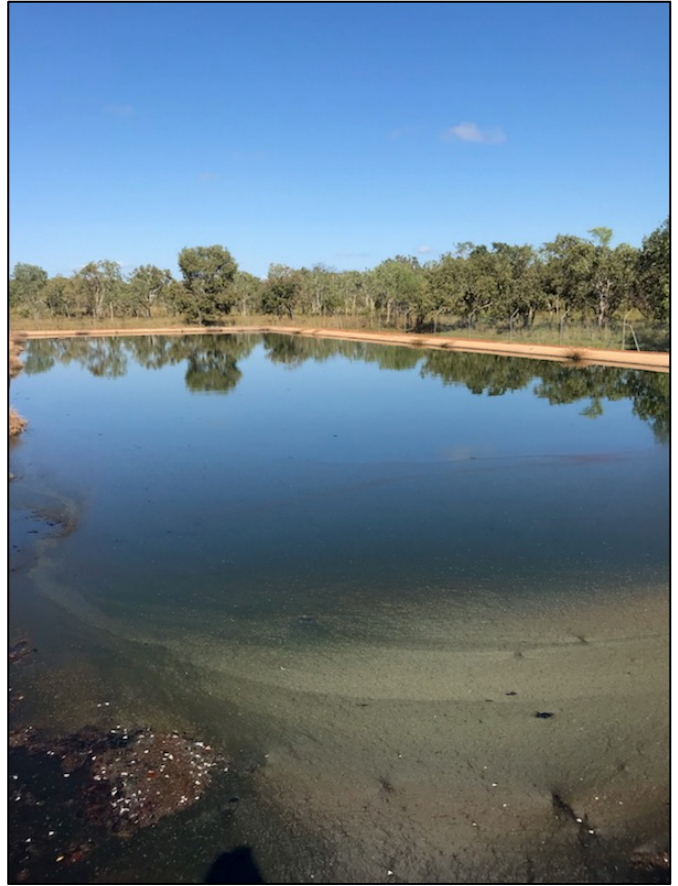
**Figure 16.** Pond 2 (PWC 2021)
