# Environmental Risk Assessment

Numbulwar Waste Stabilisation Ponds 2023

| <b>Document Title:</b> | Environmental Risk Assessment 2023 - Remote Community Waste Discharge Licences – Numbulwar Waste Discharge Licence 218-02 | | |

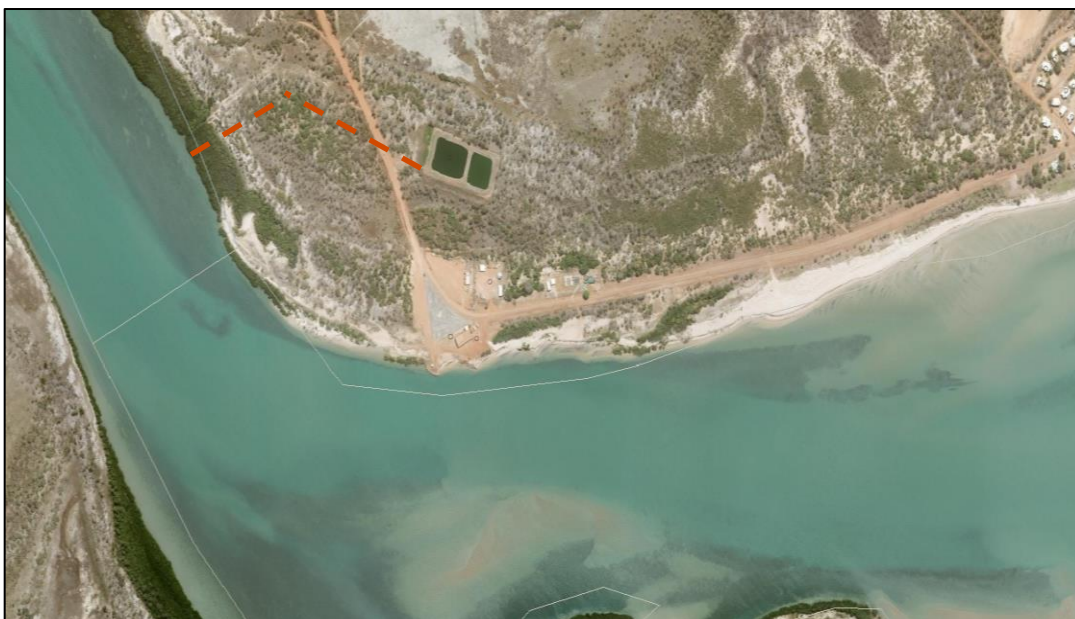
Figure 2. Numbulwar site layout including WwTP and outfall location (NT ILIS 2017)

Numbulwar is located along the eastern coast of the Northern Territory, south-west of Groote Island, approximately 783 km south-east of Darwin (Figure 1). Numbulwar has an estimated population of 884 in 2021 (DHCD 2017). The Wastewater Treatment Plant (WwTP) is located approximately 1.3 km south-west of the Numbulwar Township (Figure 2).

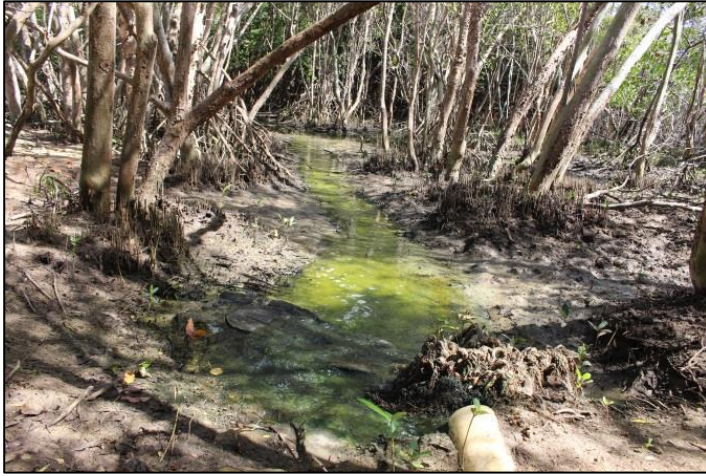
*Figure 5: Final discharge point (PWC 2017)*

The receiving environment consists of a tidal mangrove forest community that covers most sections of the Rose River banks (Figure 5); the receiving area drains into a tidal estuary channel about 50 m from the discharge pipe (Figure 6) (PWC 2017). The outer section of the estuary is approximately 2 km downstream from the discharge point area in the river. Mangrove vegetation is dominated by *Sonneratia alba* (Mangrove apple) and *Rhizophora stylosa* (Stilt rooted mangrove) species. Shellfish were observed within the discharge waters during an inspection (PWC 2017).

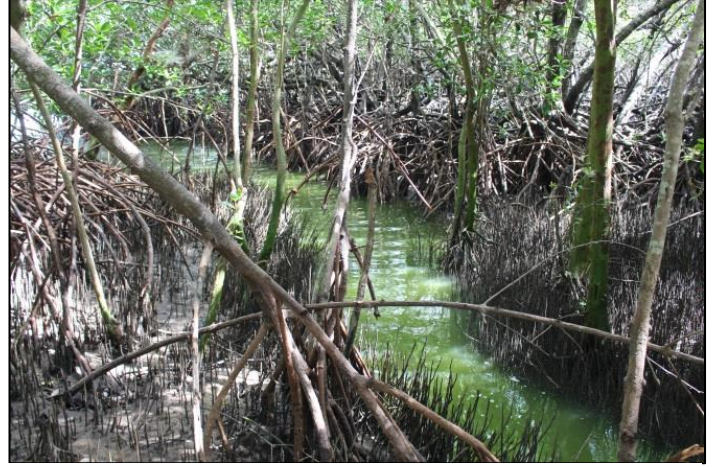
*Figure 6: Tidal estuary channel into Rose River (PWC 2017)*

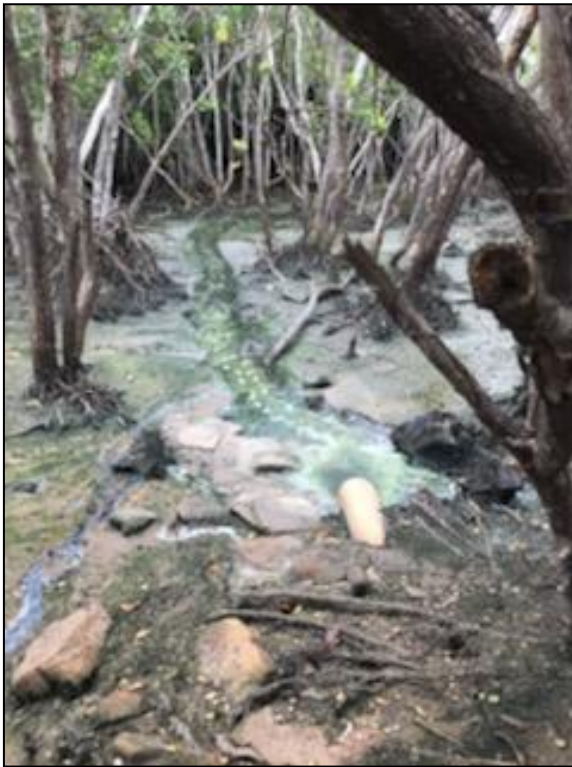
Figure 7: Final discharge point (PWC 2021)

Visual observations during a recent site visit in 2021 at the Numbulwar WwTP discharge point indicate no significant changes to mangrove vegetation over time (PWC 2021b) Figure 7, Figure 8). Water clarity within the discharge area was green consistent with pond water, however recent tidal flushing was apparent, with aquatic macroinvertebrates and fish species observed within the deeper sections near the outlet.

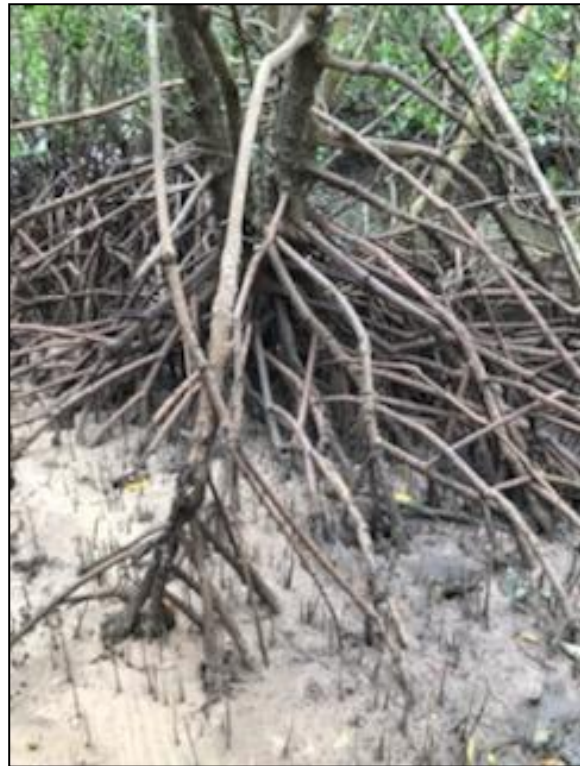
Figure 8: Healthy mangroves observed at immediate discharge point (PWC 2021)

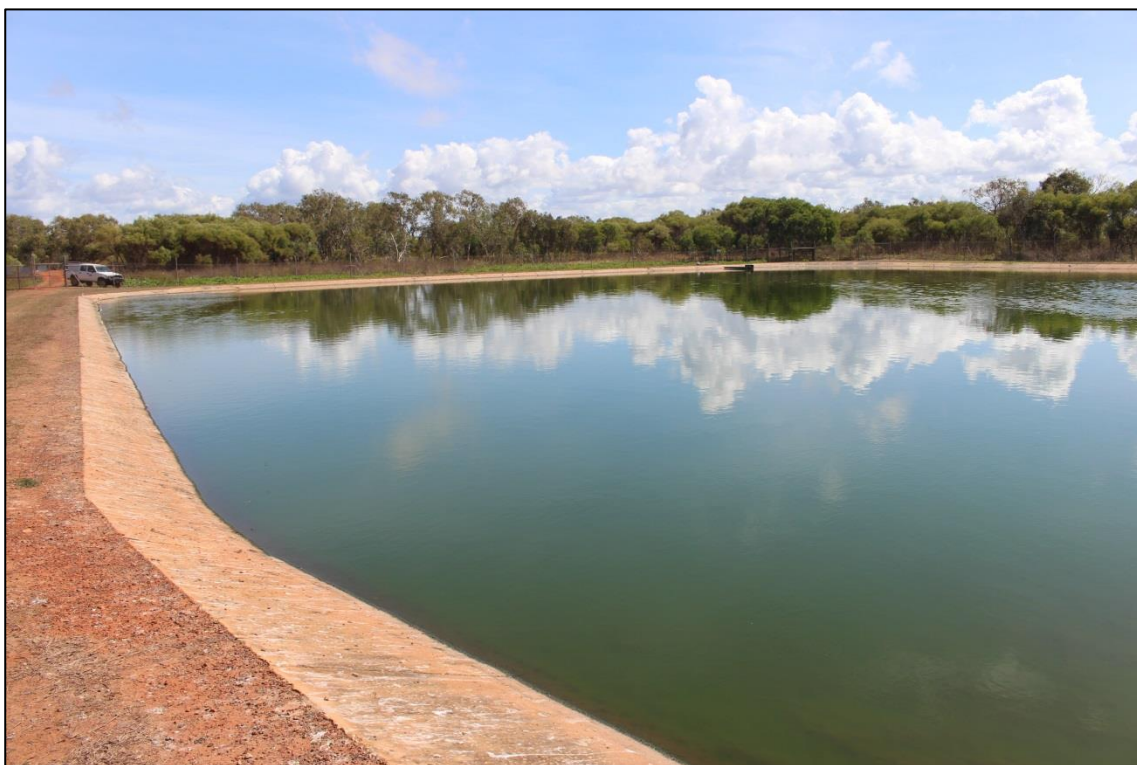
*Figure 11: Numbulwar WwTP (PWC 2017)*

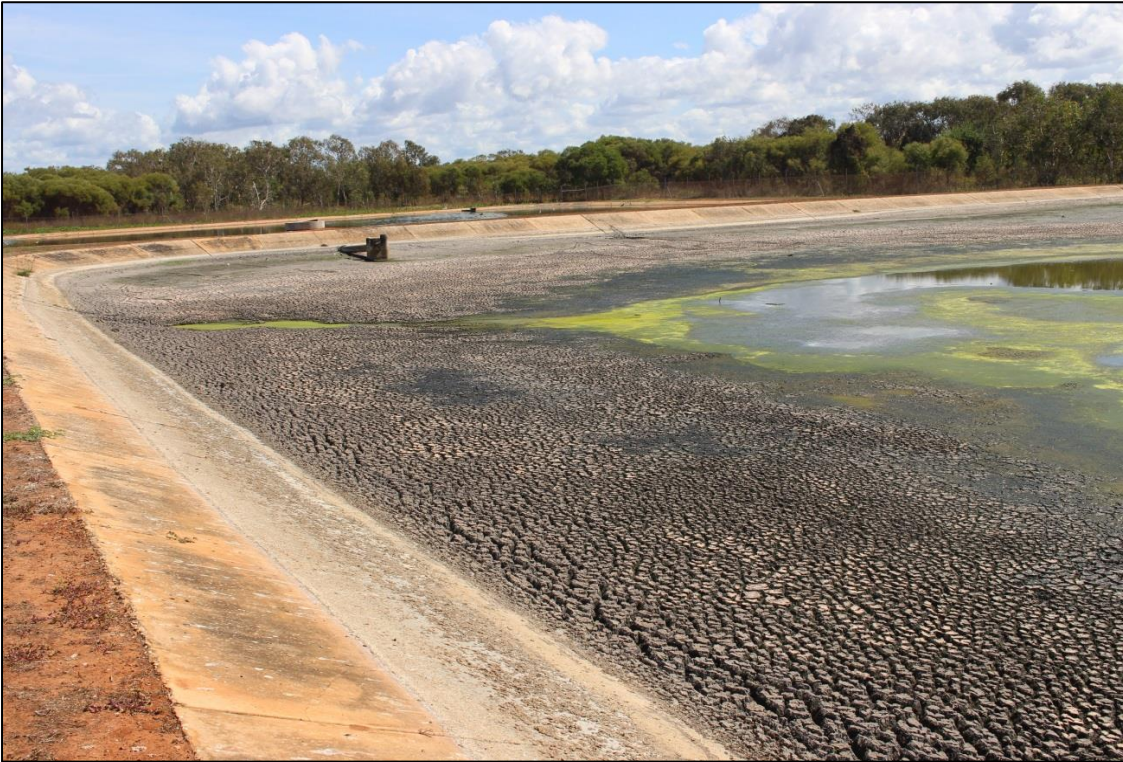
*Figure 12: Pond drained to be desludged (PWC 2017)*

There is no gross pollutant screening, grit removal, maceration or storm flow separation located on the inlet to the pond system. The majority of the removal process for gross pollutants and other entrained materials is via sedimentation to sludge layers or entrapment in concentrated surface scums that can be physically removed. Desludging of the WSPs is conducted where required to remove accumulated solids and increase hydraulic performance, which may result in improved treatment performance. Desludging was most recently completed at Numbulwar in 2017.

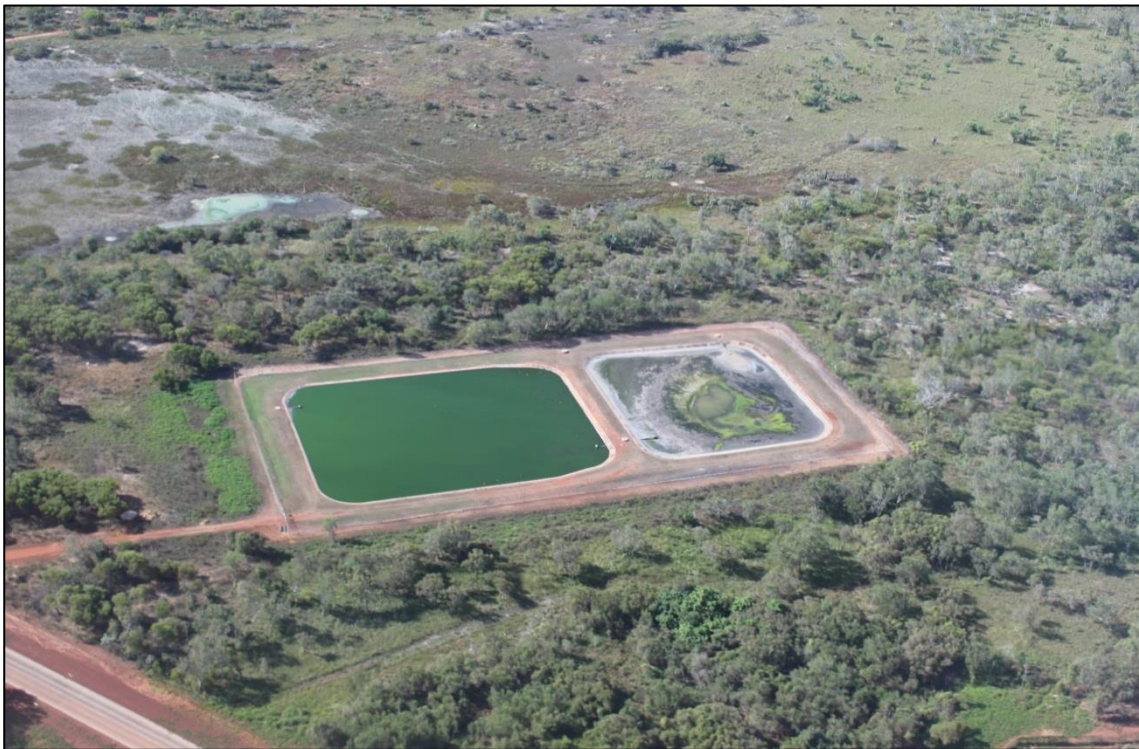
*Figure 13: Aerial photo of Numbulwar Ponds (PWC 2017)*

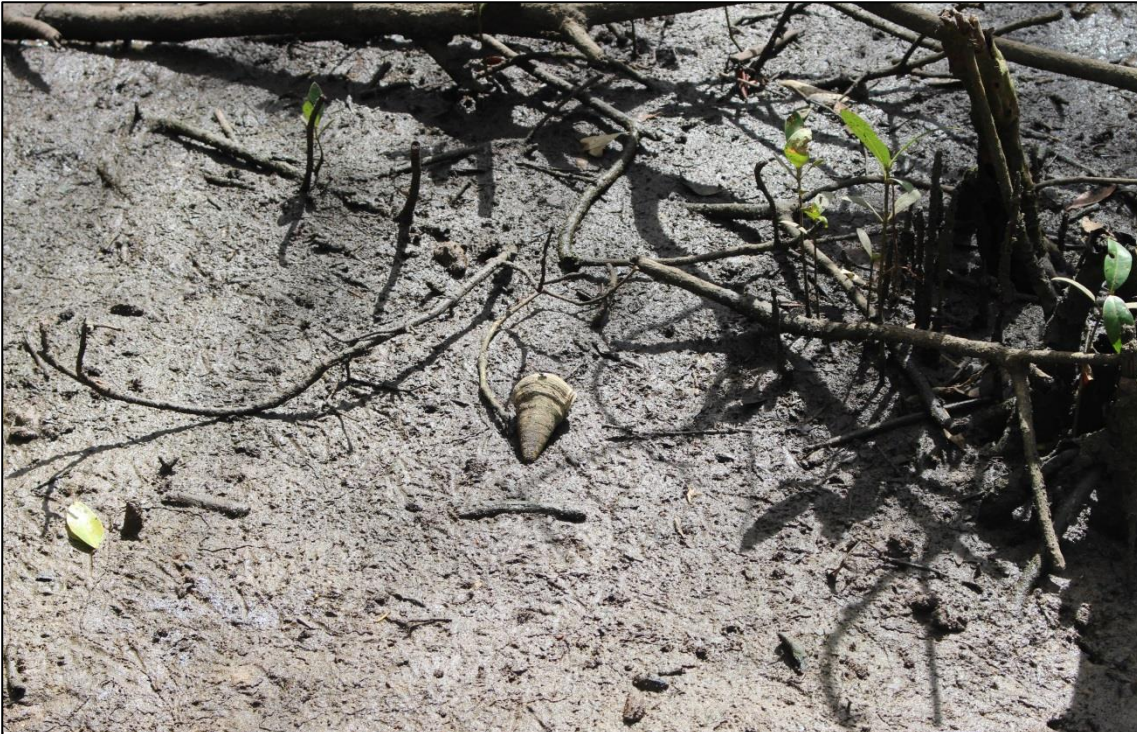
*Figure 14: Shellfish (Longbums) observed at Numbulwar discharge outfall during inspection – June 2017 (PWC 2017)*

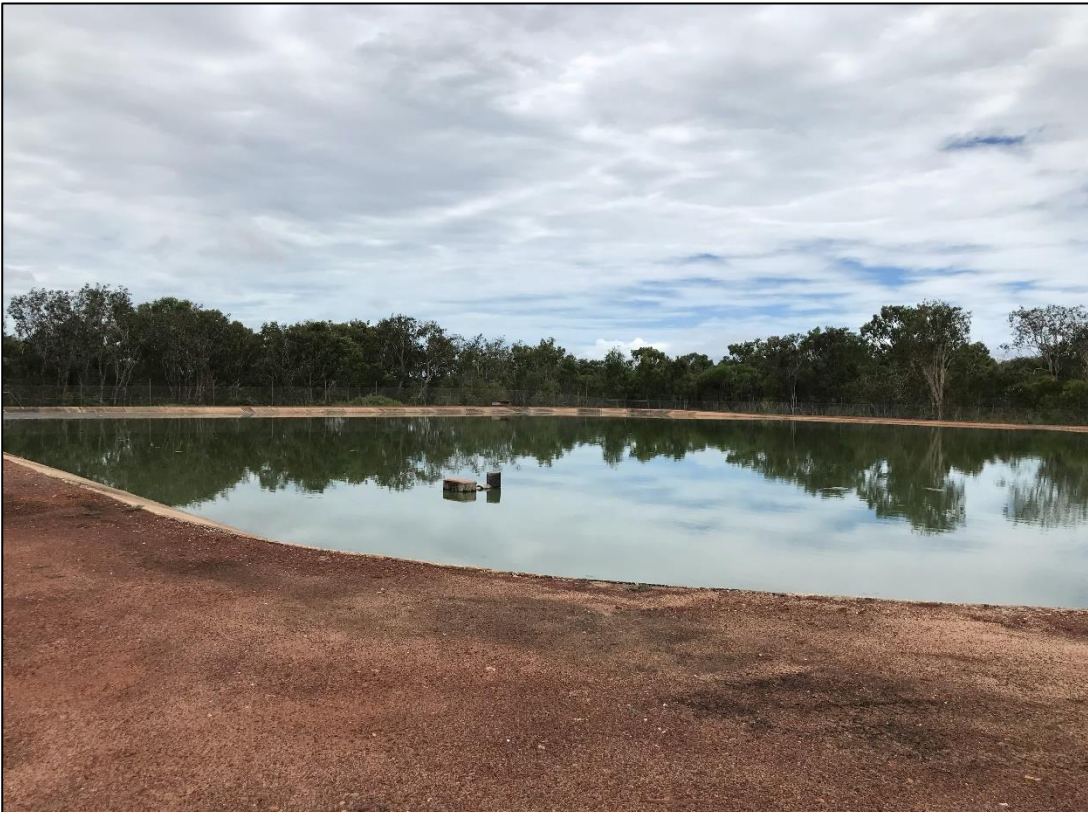
*Figure 15: Numbulwar pond 1 - Wet Season 2021*

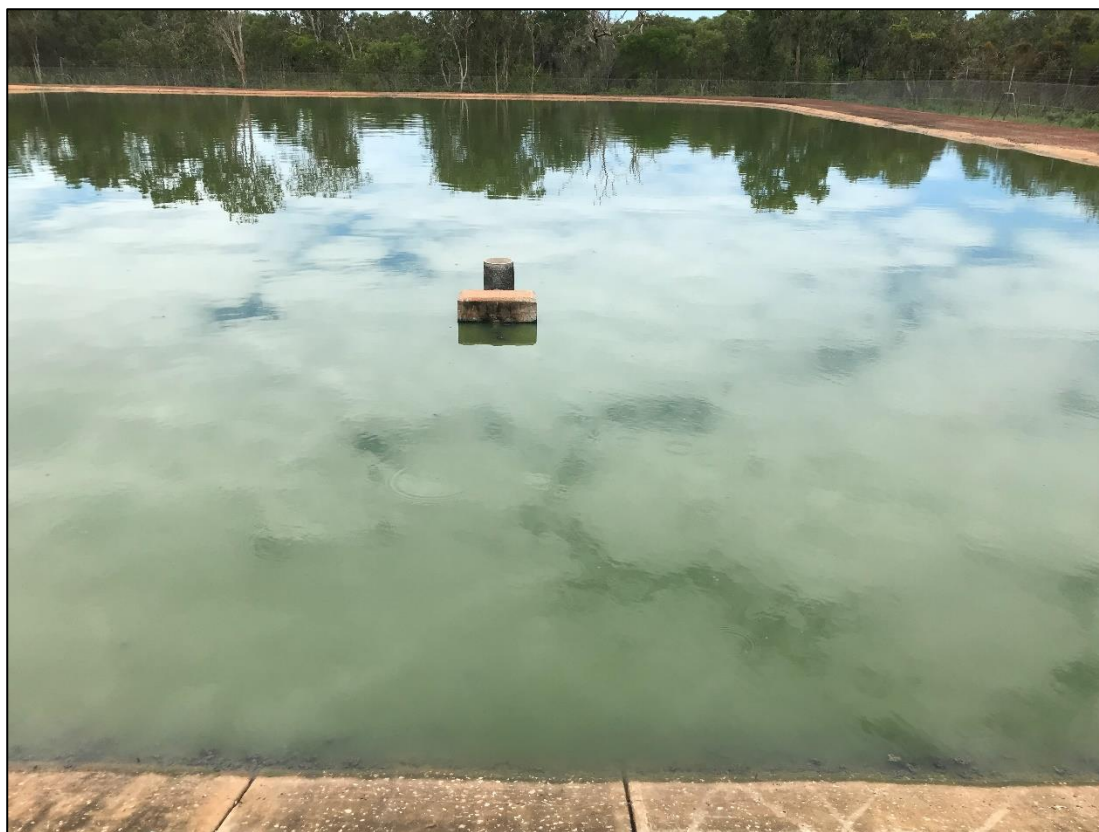
*Figure 16: Numbulwar pond 1 water quality - Wet Season 2021 (PWC 2021)*
