# Environmental Risk Assessment

Wurrumiyanga Waste Stabilisation Ponds  
2023

| <b>Document Title:</b> | Environmental Risk Assessment 2023 - Remote Community Waste Discharge Licences – Wurrumiyanga Waste Discharge Licence 223-02 | | |

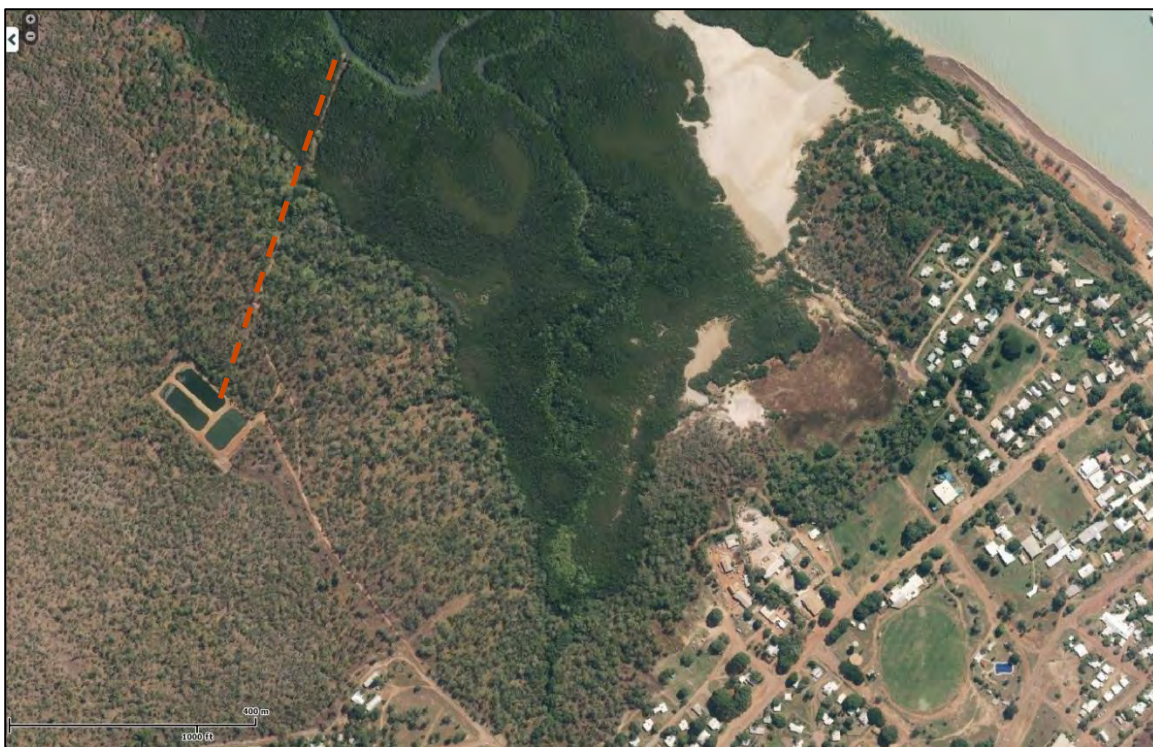
Figure 2. Wurrumiyanga site layout including WwTP and outfall location (NT ILIS 2017)

Wurrumiyanga is located on Bathurst Island, forming part of the Tiwi Islands located approximately 80 km north of Darwin across the Beagle Gulf (*Figure 1*). Wurrumiyanga has an estimated population of 1,668 in 2021 (BushTel 2023). The Wastewater Treatment Plant (WwTP) is located approximately 900m northwest of the Wurrumiyanga township (*Figure 2*).

Discharge from the facility occurs from a gravity fed discharge pipe located in the final tertiary pond (Figure 4). Discharge is continuous on an as-required basis (discharge is all year round) and occurs daily into a tidal creek. The discharge outfall from the tertiary maturation pond is approximately 580m in length, and is located to the north-east of the ponds (Figure 2).

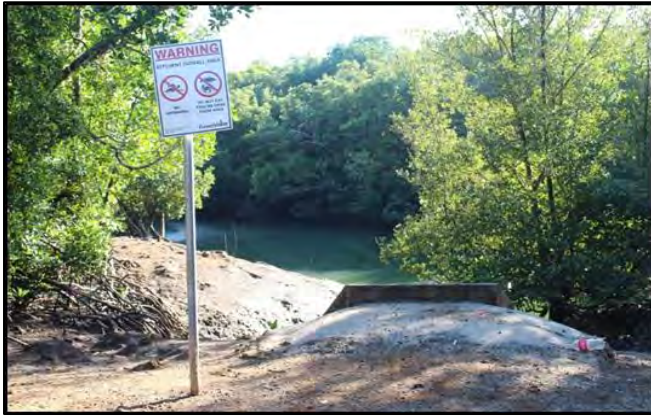
Figure 5. Wurrumiyanga WwTP discharge outlet (PWC 2017)

The unnamed creek that receives the Wurrumiyanga effluent discharge consists of tidal brackish water and extends approximately 1.25km north-west (Figure 5, Figure 6). Flow is directed towards the estuary separating Bathurst Island from Melville Island, which eventually flows into the Timor Sea via the Beagle Gulf.

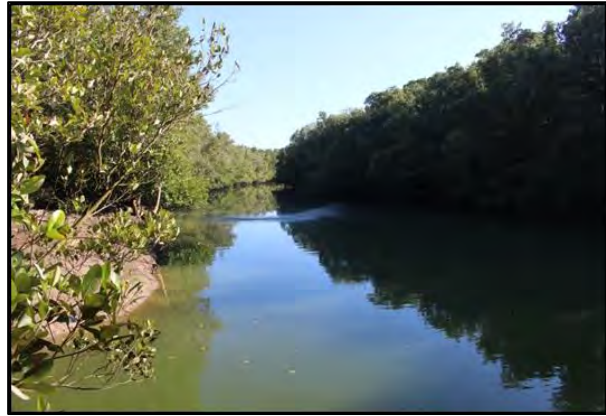
Figure 6. Receiving tidal creek (PWC 2017)

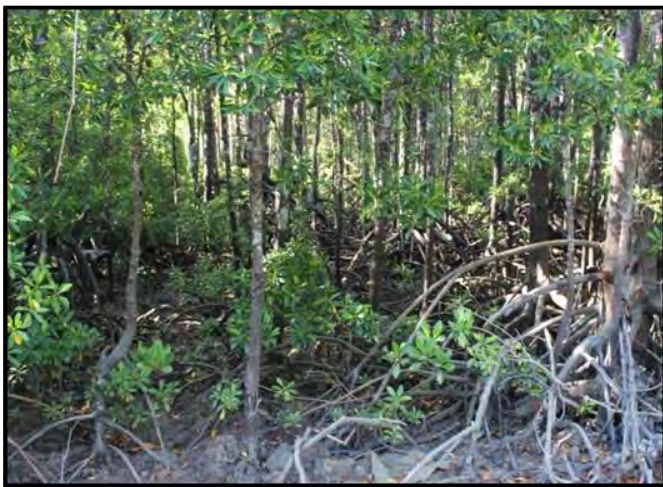
The receiving environment is considered to have experienced minor disturbance due to easy access to the site with established vehicle tracks, and observed recreational use of both the creek and estuary areas (PWC 2017). The area consists of riparian vegetation, dominated by mangrove forest, particularly *Excoecaria ovalis* (Blind Your Eye mangrove) and *Rhizophora stylosa* (Stilt rooted mangrove) individuals that were identified at the discharge point, and healthy fish were also observed (Figure 7, Figure 8), (PWC 2017).

Figure 7. Mangrove habitat at outfall (PWC 2017)

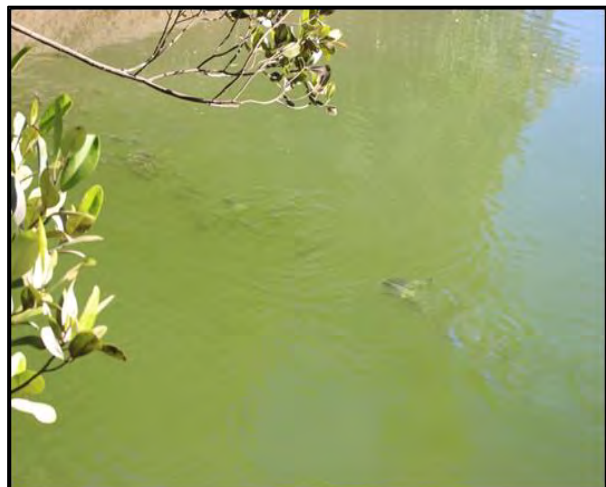
Figure 8. Fish observed at discharge point during ERA site inspection, 19 June 2017 (PWC 2017)

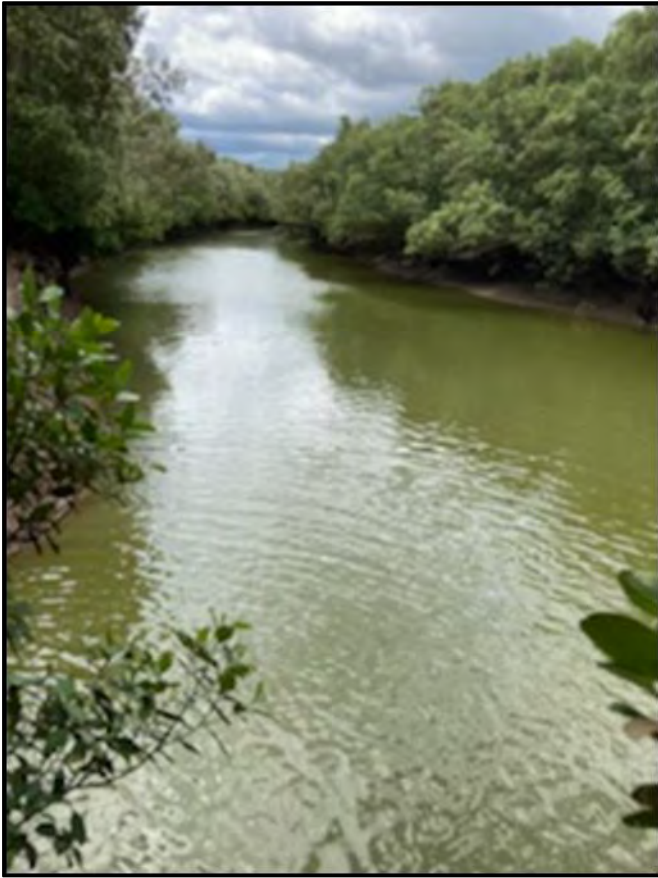
Visual observations during a recent site visit in 2021 at the Wurrumiyanga WwTP discharge point indicate no significant changes to riparian vegetation (PWC 2021b) (Figure 9). Water clarity within the brackish creek was clear, with aquatic macroinvertebrates and fish species observed near the outlet (Figure 10).

Figure 9. Receiving tidal brackish creek – wet season 2021 (PWC 2021)

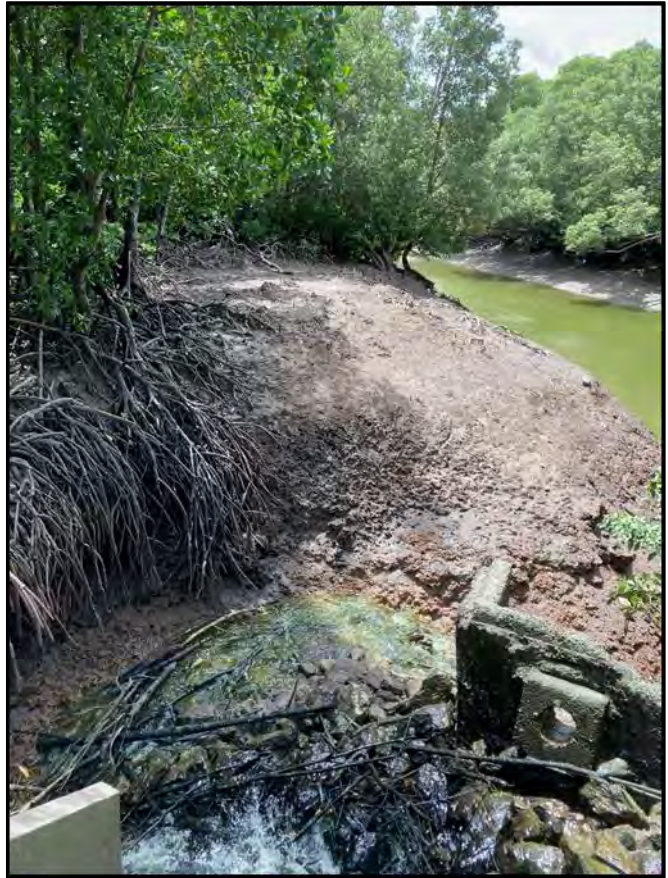
Figure 10. Mangroves at discharge point – wet season 2021 (PWC 2021)

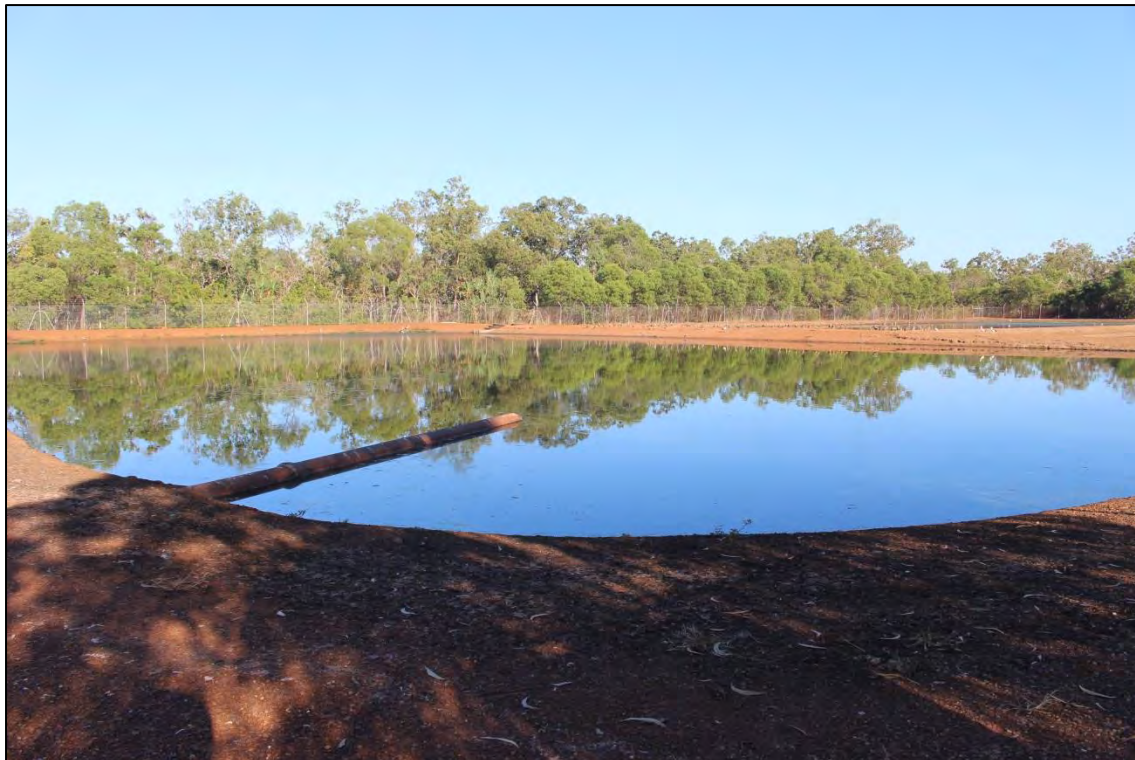
*Figure 15. Wurrumiyanga WwTP Pond 1 (PWC 2017)*

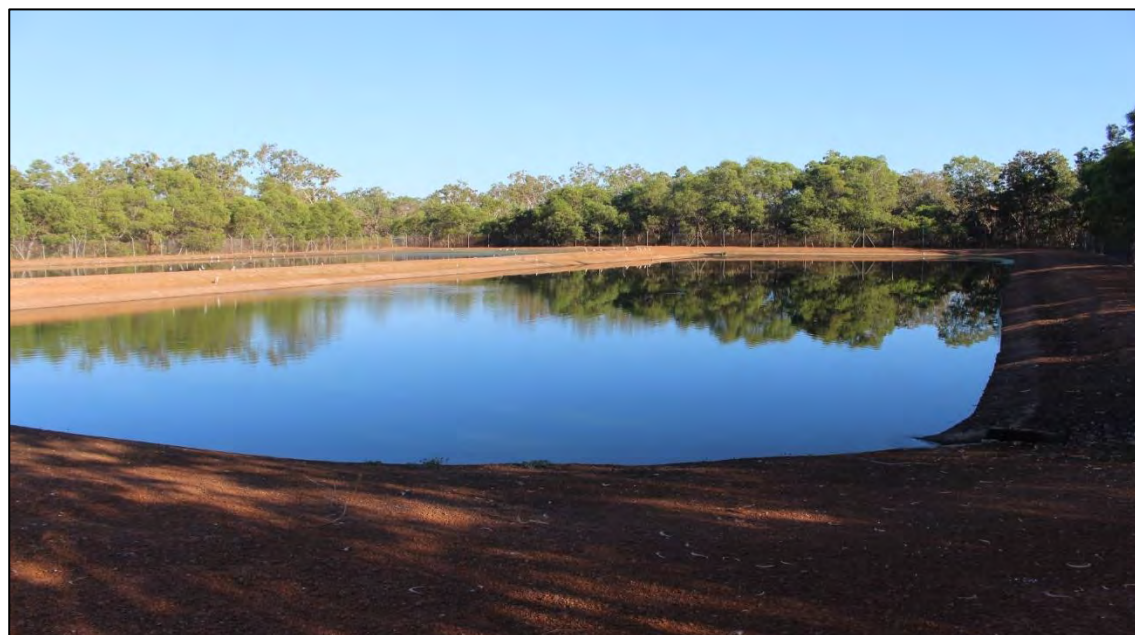
*Figure 16. Wurrumiyanga WwTP Pond 2 and Pond 3 (foreground) (PWC 2017)*

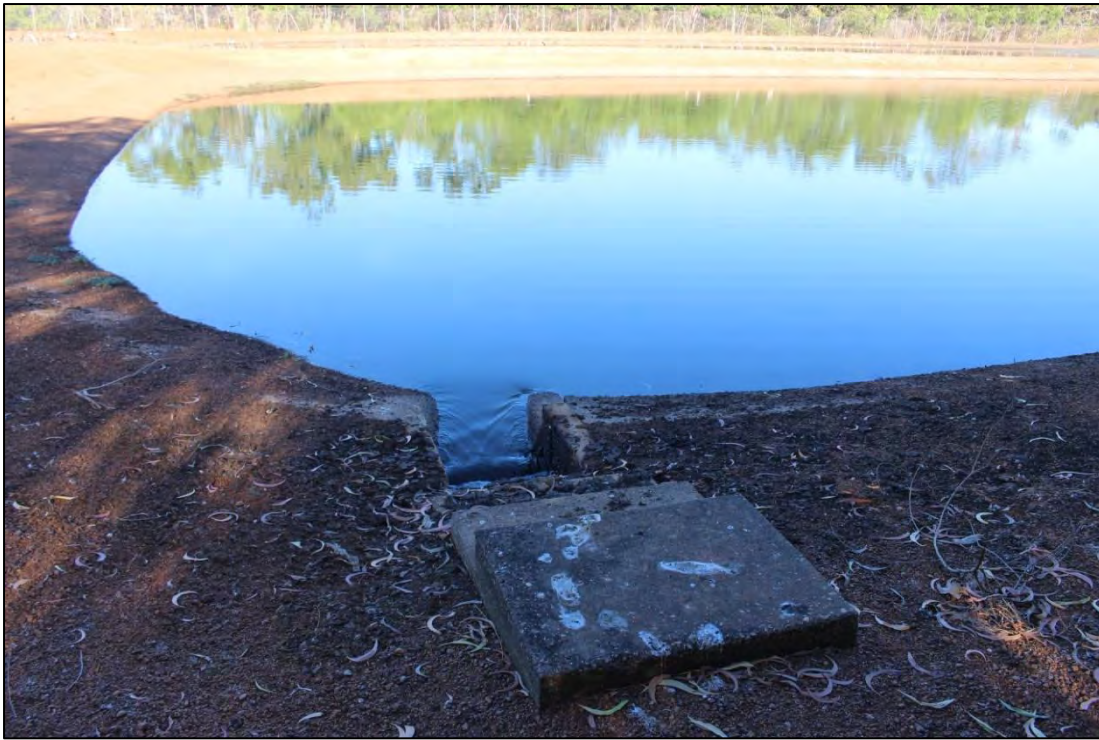
Figure 17. Wurrumiyanga Pond 3 Outfall (PWC 2017)

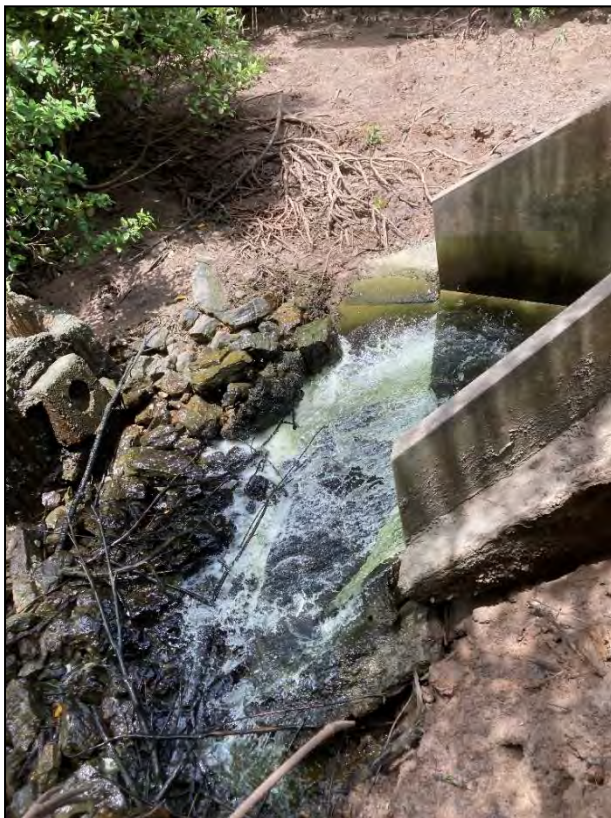
Figure 18: Effluent discharge to the receiving environment (PWC 2021)
