# Soils Investigation Report

**Tellus Holdings Ltd**

**Chandler Salt Mine Project – Stage 1**

**EL29018 (Maryvale)**

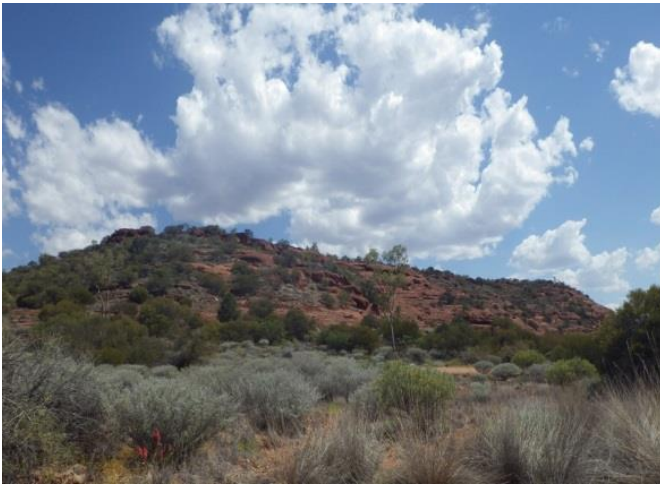
**Plate 1: S04 Sand dune**

Soils sampled from S04 were collected from an inter-dunal area with 10 m dunes on either side of the site (Plate 1). Scattered low shrubs (*Senna*, *Eremophila*), tall shrub (*Acacia kempeana*, *A. aneura*) and low trees (*Hakea divaricata*, *Corimbia opaca*) were present across the ground cover. The site consisted of very deep sands that extended beyond 1 m depth. There was no presence of an A horizon. The profile was fairly uniform with the exception of an increase in the intensity of red soil colour with depth.

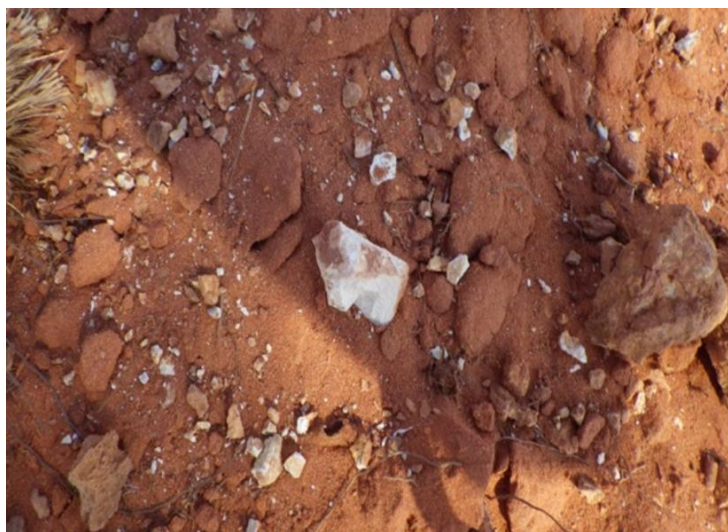
**Plate 4: S08 Evidence of calcium carbonate**

All soils were found to be slight to moderately alkaline with the pH ranging from 7.78 to 8.12 (Figure 3). This finding is also supported by the calcium carbonate that was found at S08.

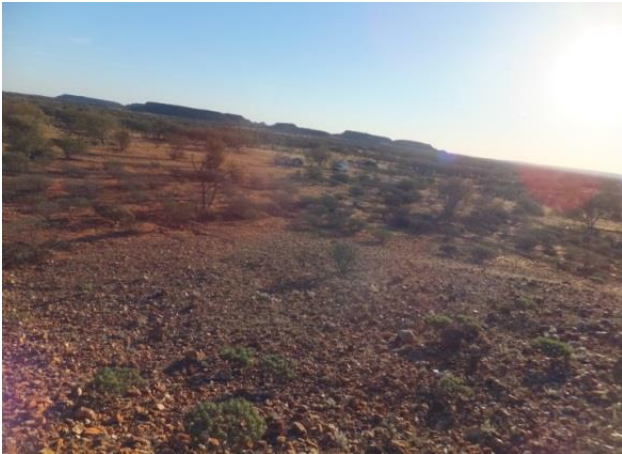
**Plate 9: S11 Looking onto grassland from the base of the rocky hill slope**

Open grassland extended within this site to the base of a very rocky hill (Plate 9). Six soil samples were taken in total, three within the grassland and three up the side of the rocky hillside. A surface soil assessment was conducted for both the grassland and hillside portion of the landscape. There is minimal soil development within the grassland area and there is shallow soil depth along the rocky hillside. An isolated case of rill erosion was present next to sample site S-11-3-0 that was roughly 1 m deep and 2 m wide (Plate 12).

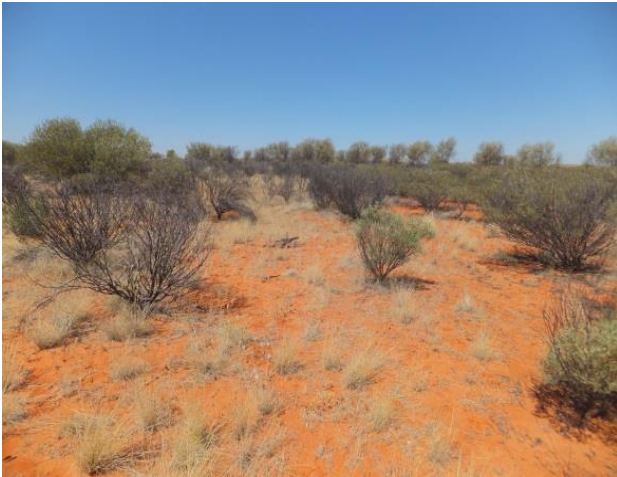
**Plate 13: CNP01 General view**

Sand hummocks present (Plate 13). No presence of bedrock within 50 cm of sample CNPO1-1 or within 40 cm of sample CNPO1-2.

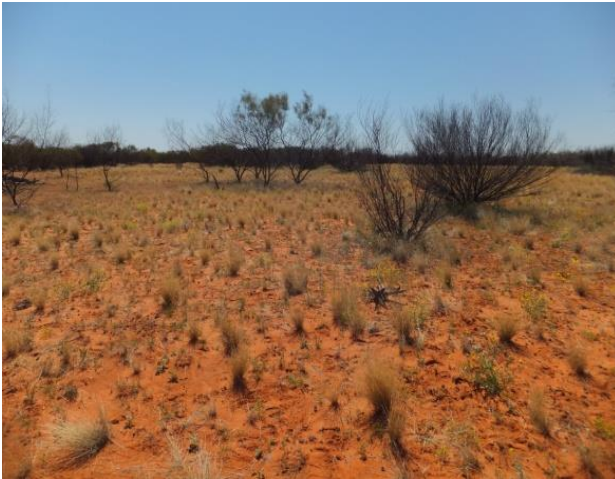
**Plate 16: CNP02 General view**

Sand mounds with 1 m relief are located across site landscape (Plate 16).

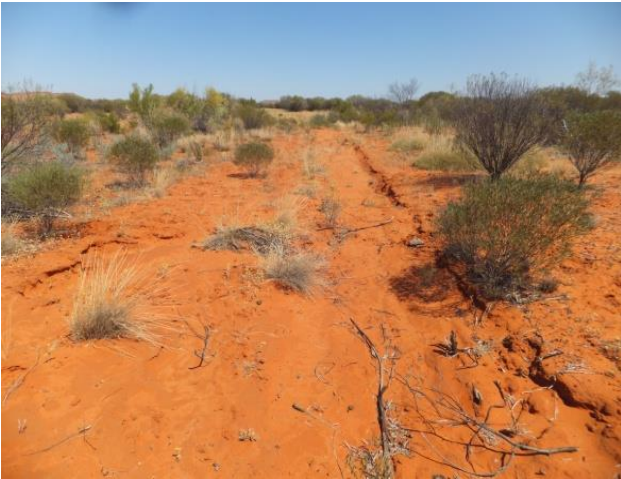
**Plate 18: CNP03 Erosion rill**

The landscape has previously been burned. An erosion rill was located at 24° 47' 49.1", 133° 56' 27.7" (Plate 18).

Sand dunes and hill slopes are present across EL29018. Linear structures within the dune will have the potential to cause erosion. The drill site soils (CNP01, CNP02 and CNP03) have high rain splash protection due to generally high soil cover (30-50%) with moderate below ground contributions (10-20%) from basal and canopy cover. The ground is also covered with more than 10% to 50% litter. However, as the drill sites will be cleared this rain splash protection will be reduced. The soils have relatively low crust, easily penetrated surfaces and high infiltration rates significantly reducing their erosion potential. Care will need to be taken to ensure there is no impedance to overland sheet flow. S04, S08, S10, and S11 have less ground protection and would be more susceptible to erosional forces.

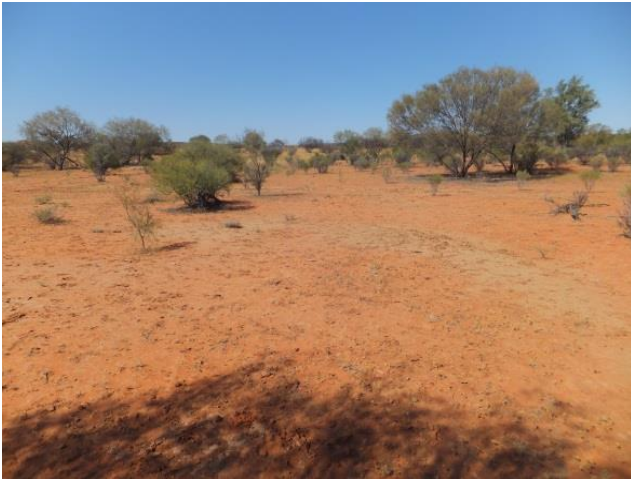
**Plate 19: CMP Potential camp site 1 in drainage depression**

Sample CMP1-1 is located in a floodplain/drainage depression (Plate 19). Sample CMP1-2 (Plate 20) is located on a lower sand ridge that contains an adjacent mulga swale.
