Darwin Ship Lift Project Preliminary Site Investigation

Client: Northern Territory Government

08-Sep-2021

Job No.: 60633505

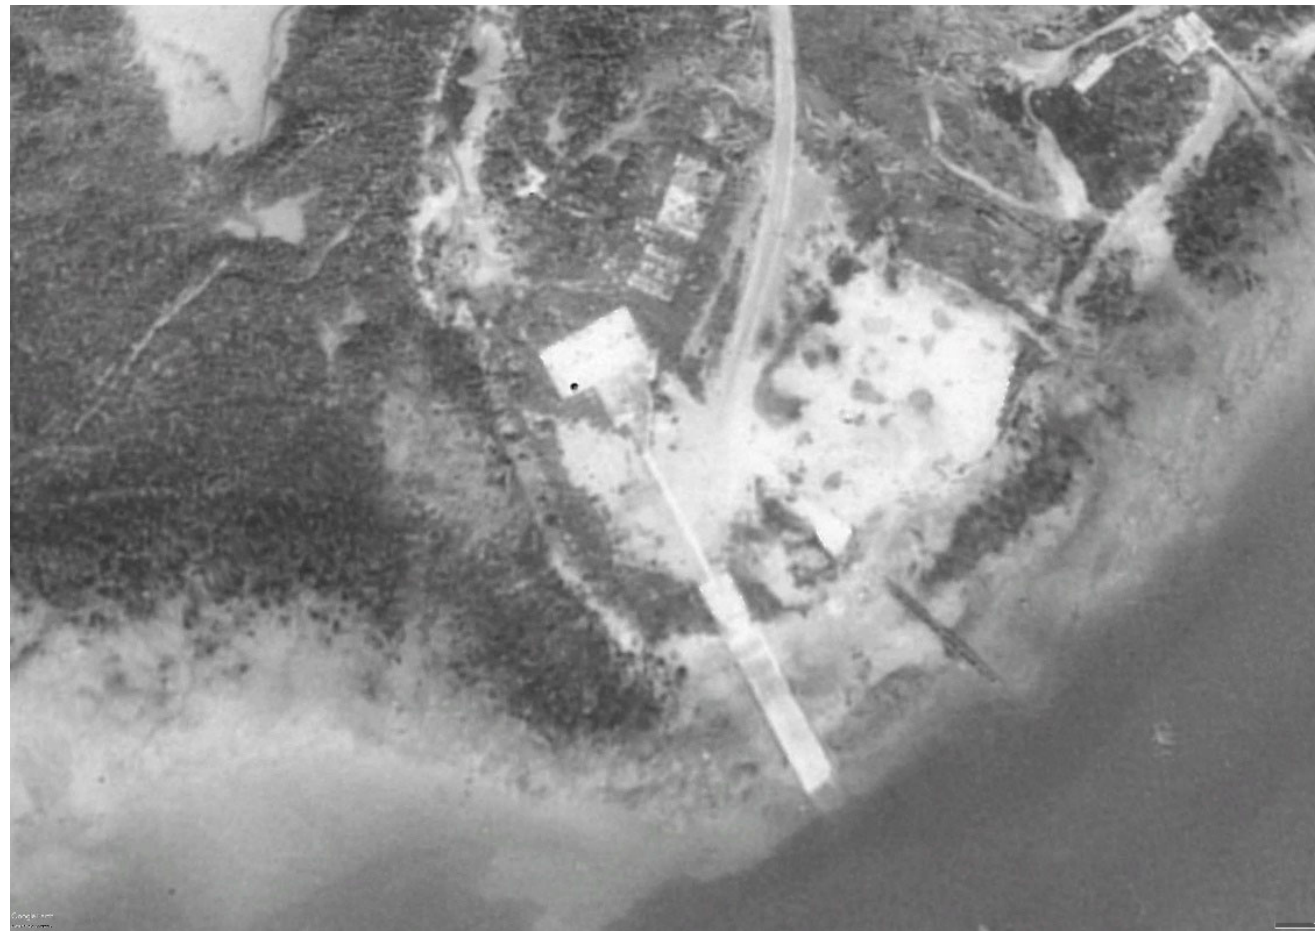
Plate 1 Historical aerial photograph of site - 1975

A concrete boat ramp (eastern portion) and an historical crash boat slipway (southern portion) exist at the site, serviced by Berrimah Road which appears unsealed at this point in time. Clearings/lots exist west of Berrimah Road, however no structures appear to exist at the site.

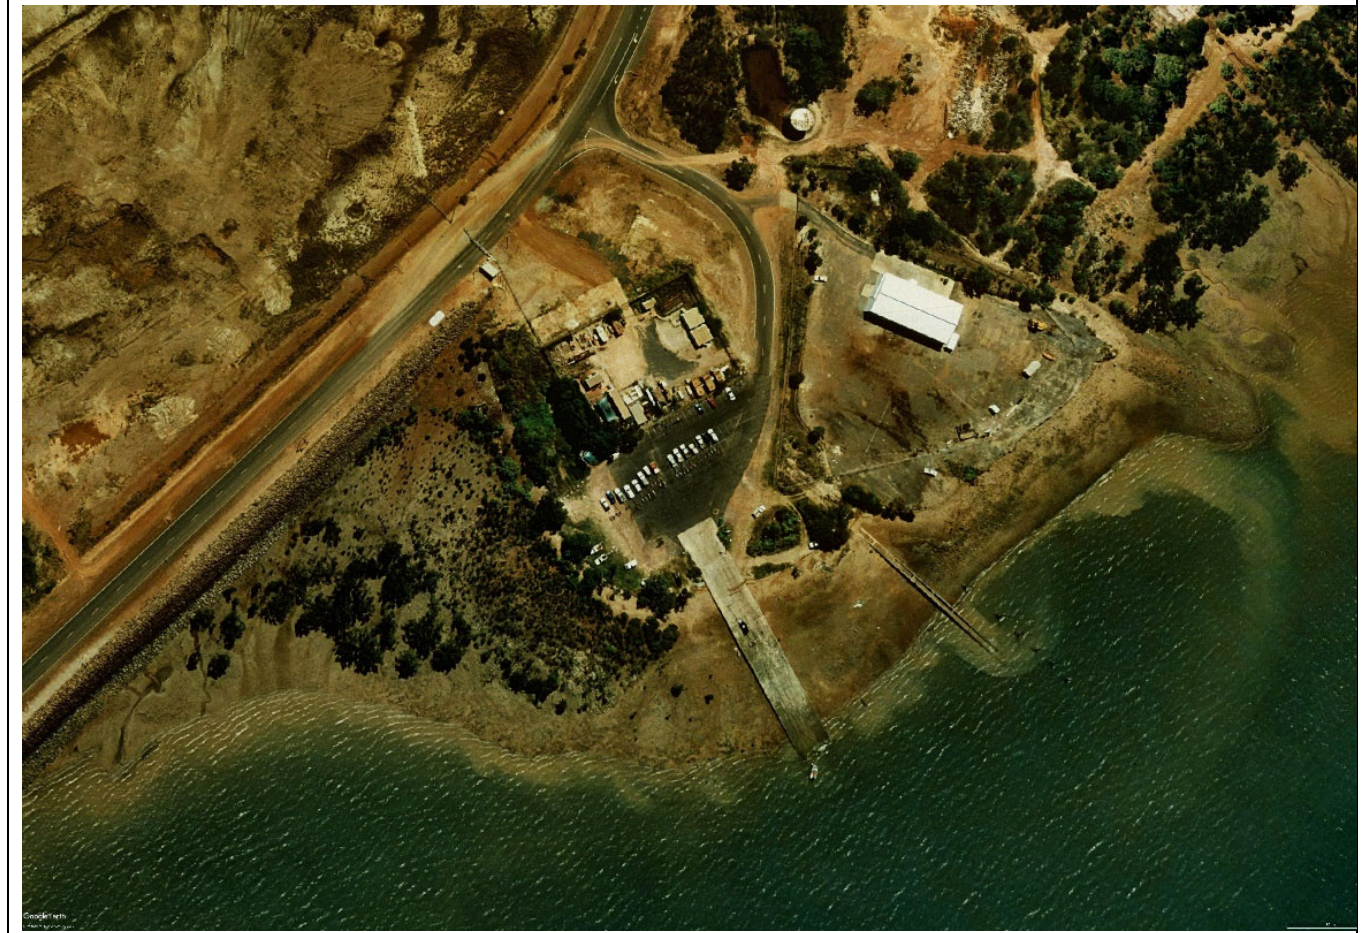
Plate 2 Historical aerial photograph of site - 2000

The boat ramp and slipway persist at the site; however Berrimah Road has been redirected past the site and the access road and portions of the site have been sealed. A sealed carpark has been installed servicing the concrete jetty, with a laydown/yard enclosure housing sea containers in an area north of the carpark. A warehouse has been constructed to the north east of the eastern boat ramp, and this area appears sealed with what appears to be blue metal gravel. Off site development to the northwest is in progress.

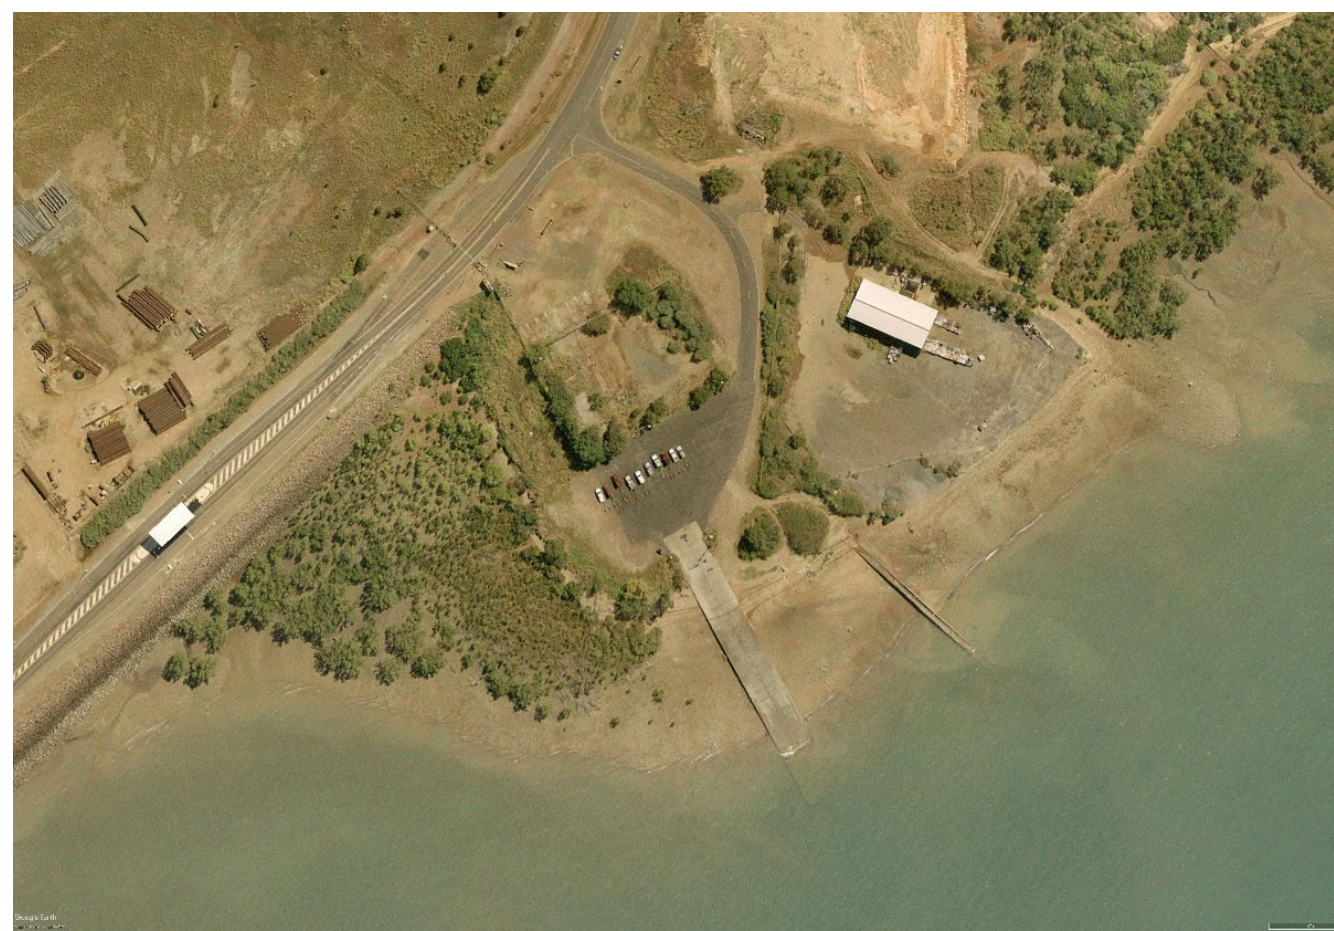
Plate 3 Historical aerial photograph of site - 2006

The boat ramp and slipway persist at the site. Contents of laydown/storage yard to north of concrete jetty has been removed and shrubs have grown considerably. Warehouse in the east of the site remains, with items stored at this portion of the site appearing more organised around the warehouse. Development appears to have been completed to the northwest of the site, with the portion pictured used as a laydown area.

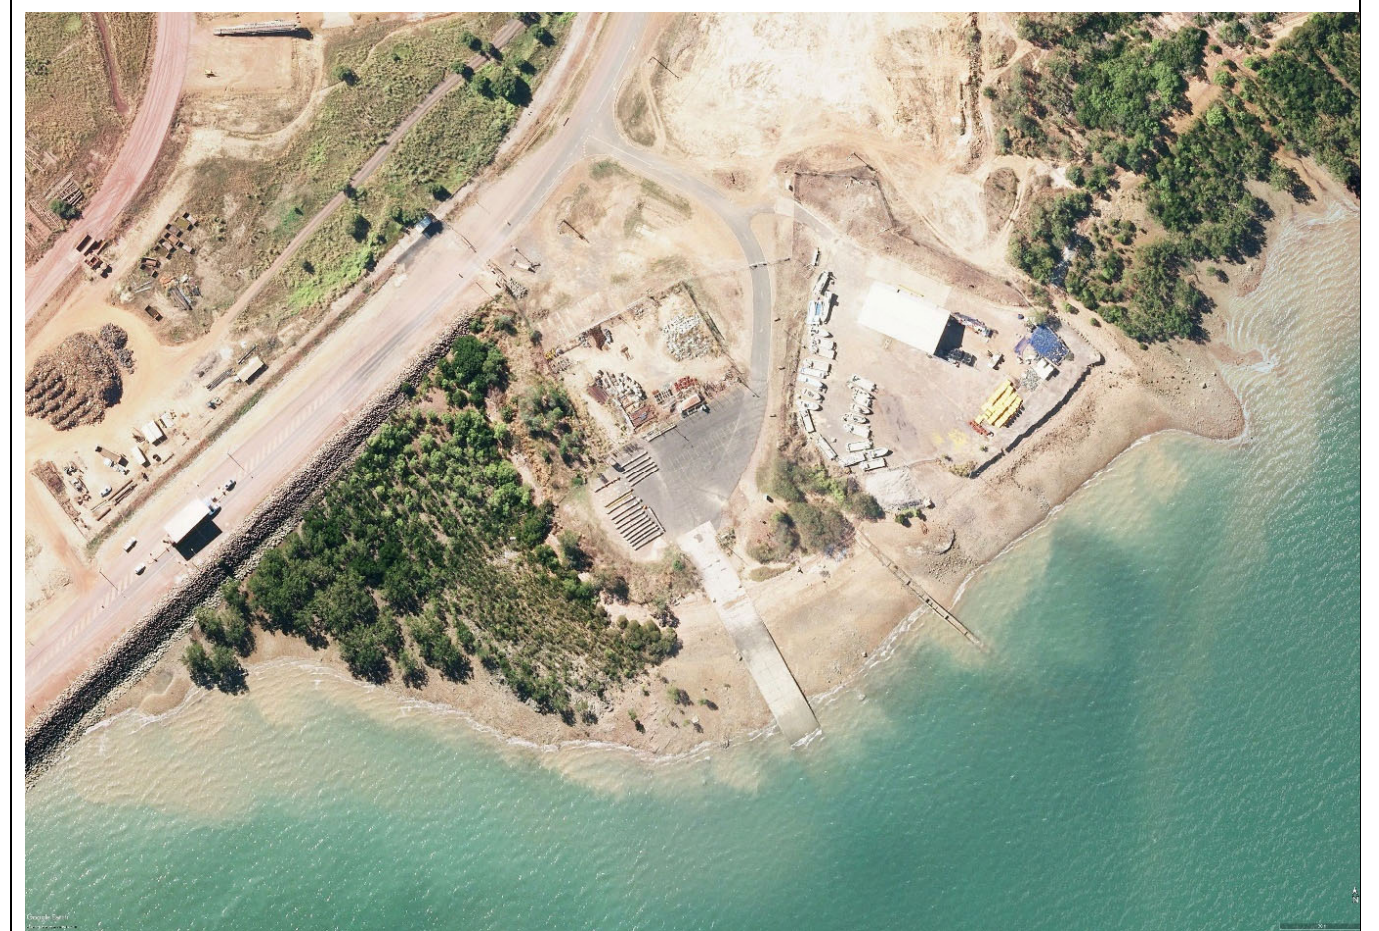
Plate 4 Historical aerial photograph of site - 2010

The boat ramp and slipway persist at the site. Clearing of the site and the area to the north has occurred and a fence around the site has been installed. The area previously used as a car park is now being used as a laydown, and the previous laydown area to the north (left to overgrow in the previous Plate) is being utilised again. Boats are being stored onshore in the eastern portion of the site, which is also being used as a laydown.

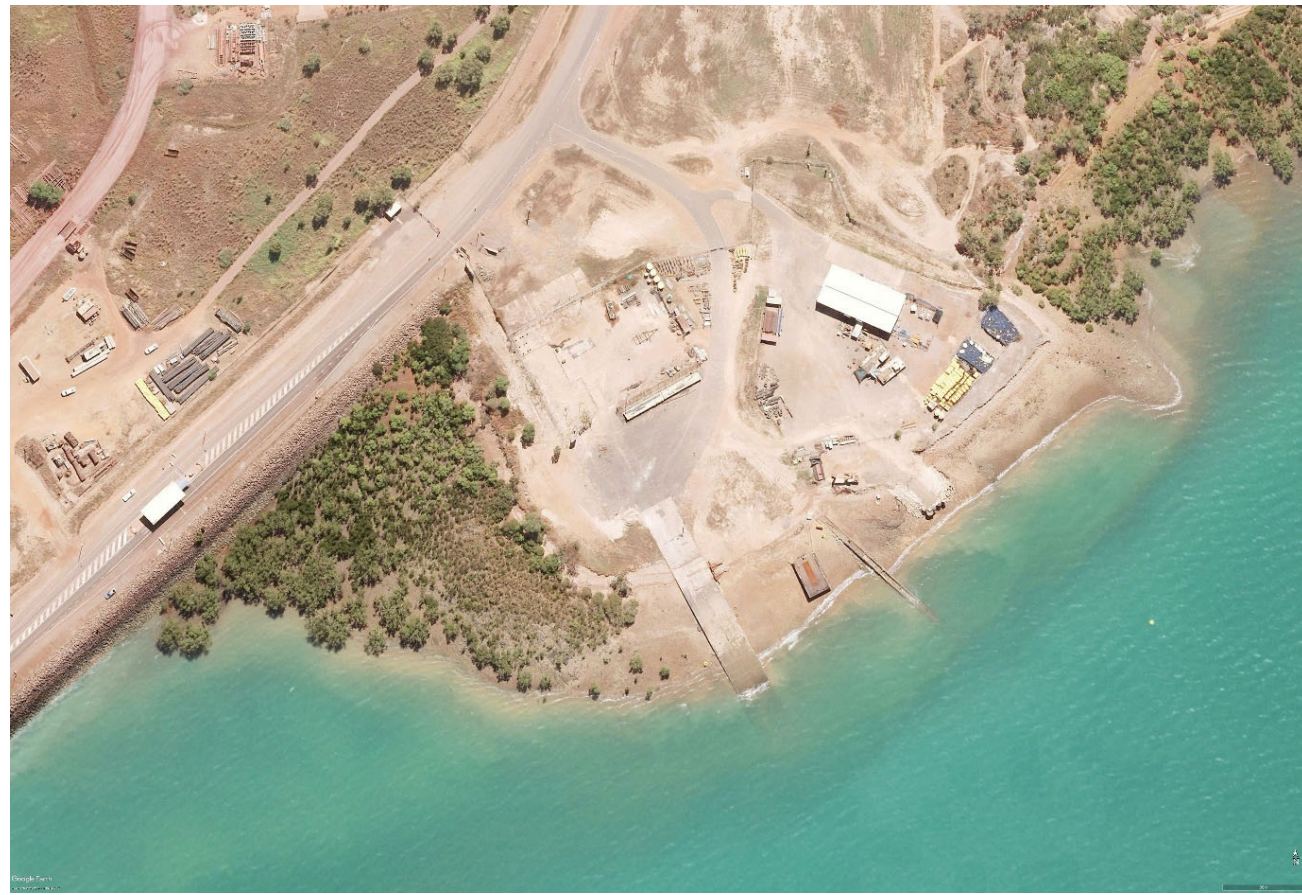
Plate 5 Historical aerial photograph of site - 2012

Boats have been removed from the eastern portion of the site and the former carpark area is no longer being used as a laydown.

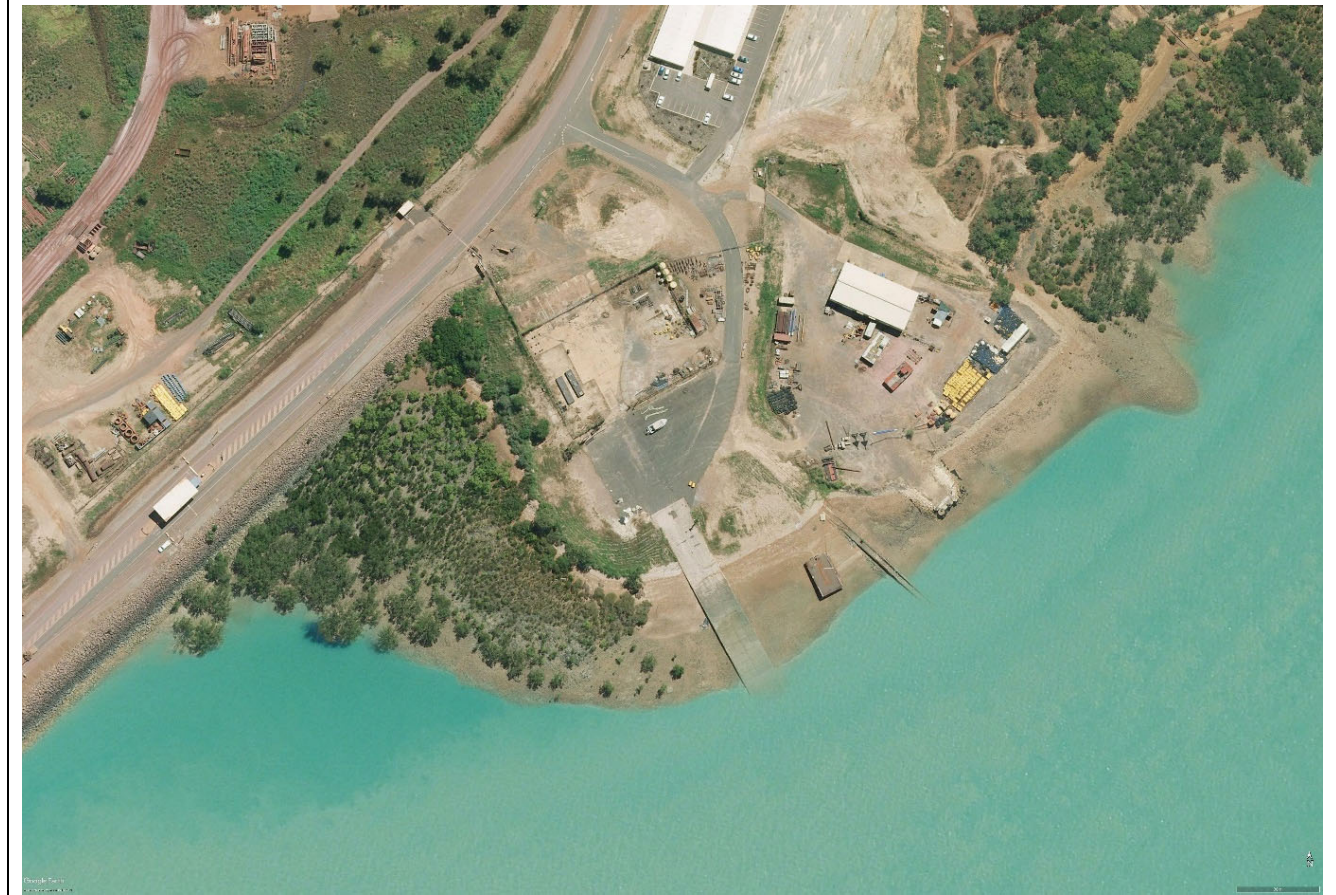
Plate 6 Historical aerial photograph of site - 2013

The area north of the site which was previously cleared has been developed and a warehouse has been built on it. Land to the northwest previously used as a laydown is no longer used in this manner. A new wharf/wet berth has been constructed to the north east of the concrete boat ramp.

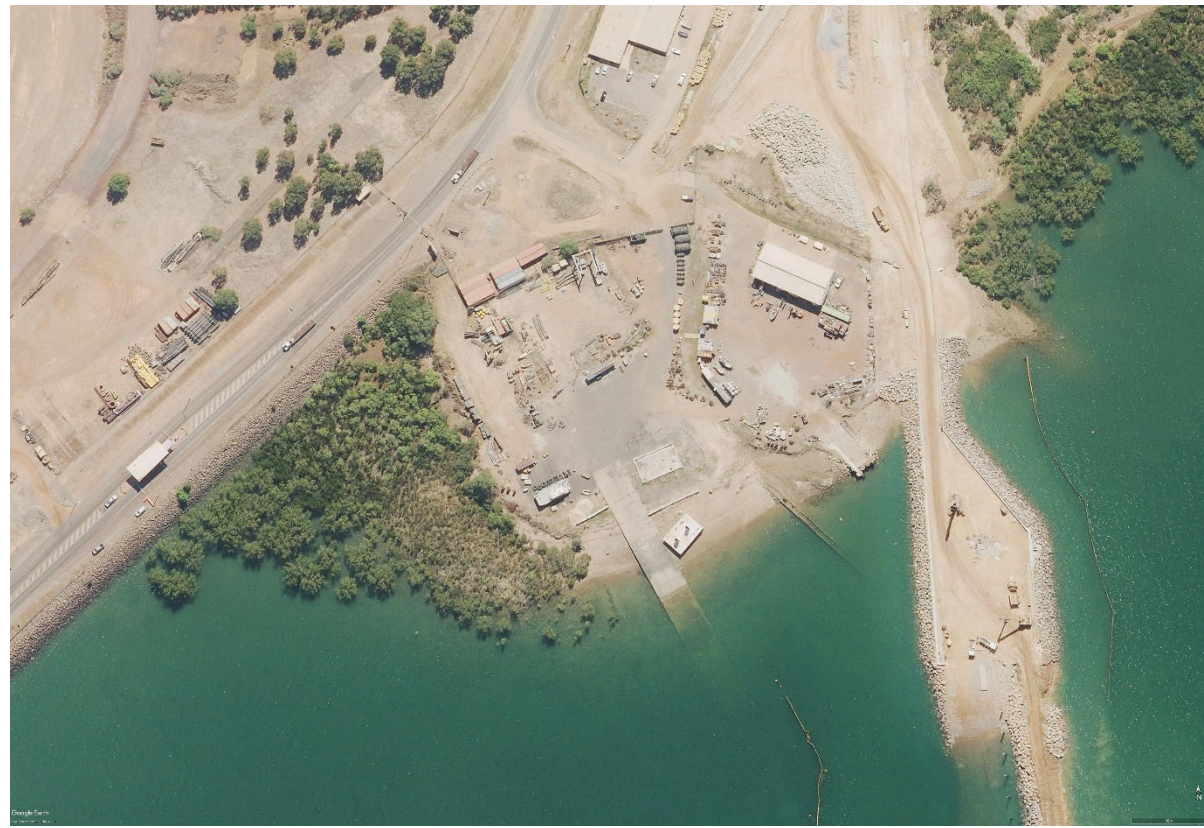
Plate 7 Historical aerial photograph of site - 2016

Installation of the MUBRF is under construction to the east of the site. Additional sea containers are being stored at the area in the western portion of the site and the former carpark area has additional items, such as tyres and intermediate bulk containers (IBCs), stored on it. This area has also been expanded with a concrete pad installed on the shoreline which is understood to be used for the burning of seized fishing boats.

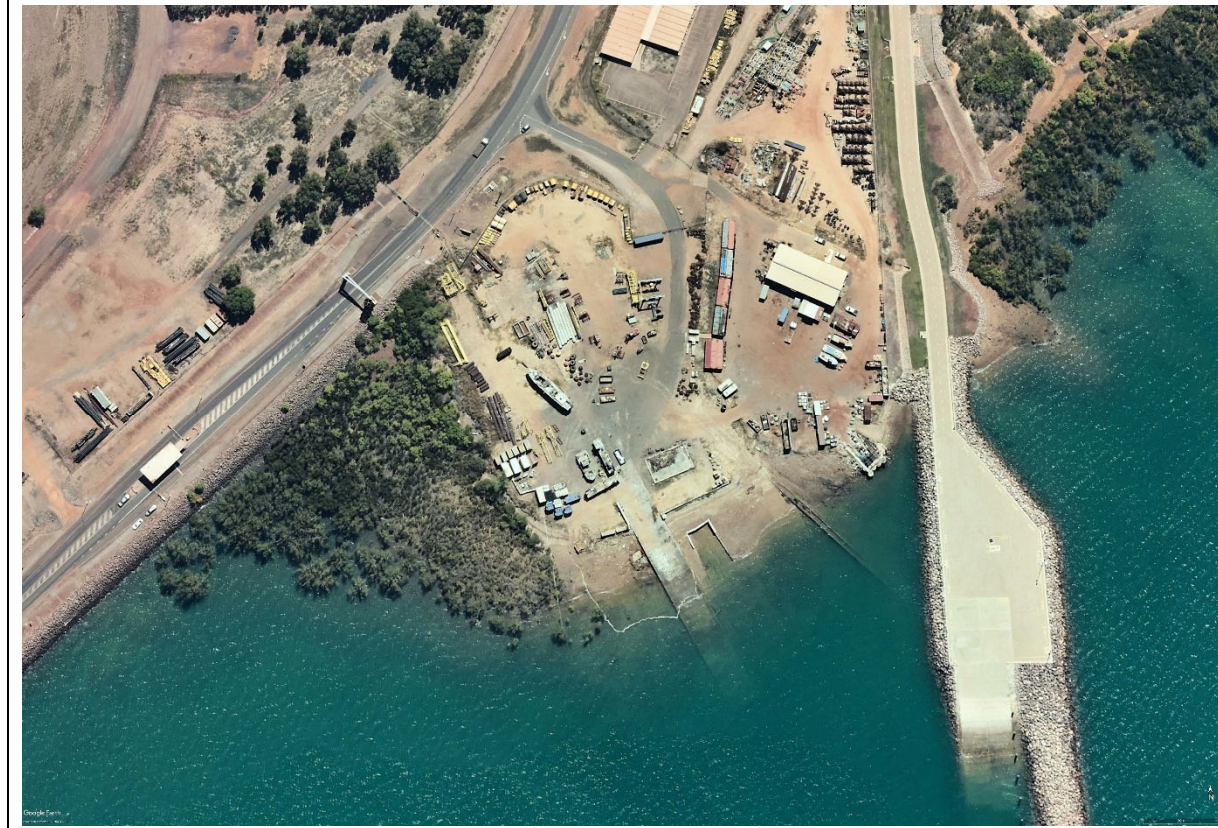
Plate 8 Historical aerial photograph of site - 2019

The western portion of the site has been expanded to include additional land to the north which is being used to store what appears to be tanks. The area to the north of the site has been developed and is now also being used for the storage in a laydown capacity.

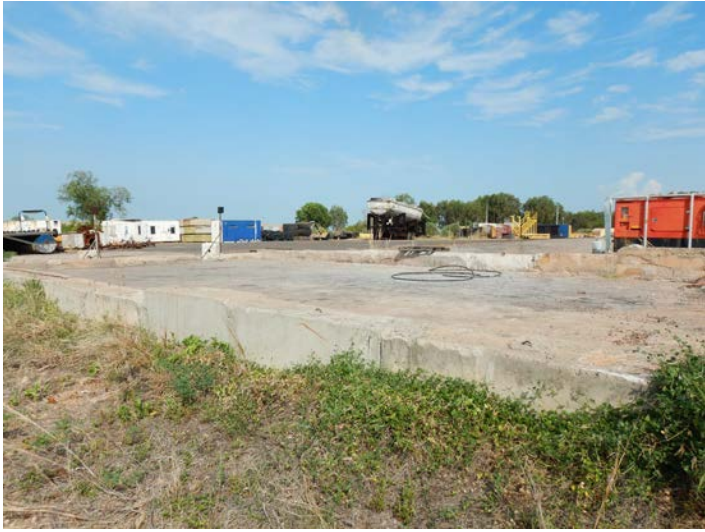
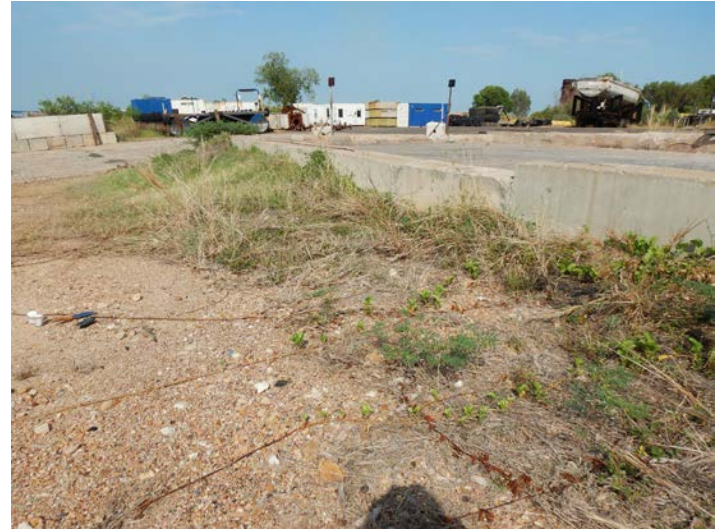
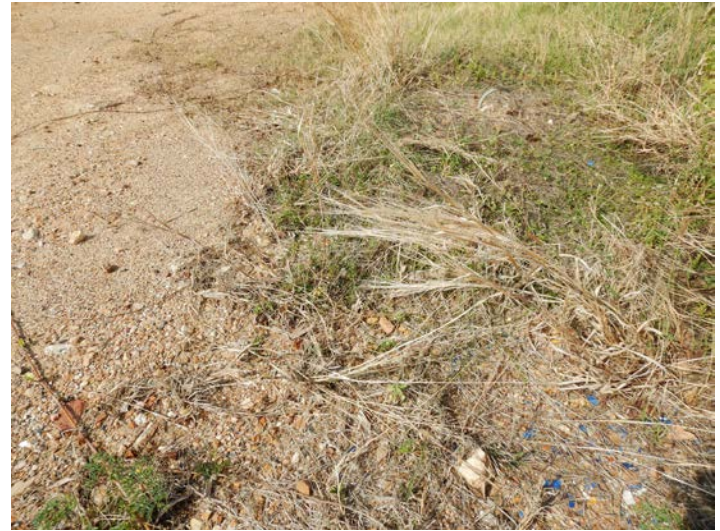
SS001 (1)

All samples were analysed for hydrocarbon compounds, with detectable concentrations reported at two locations only; one reported at the laboratory limit of reporting (LOR) at SS001, the location of the boat burning site, and a second location marginally above LOR noted at the SS006, a location used for the storage of IBCs and barrels. No screening criteria were exceeded.

All samples were analysed for BTEXN compounds, with detections of xylenes at the LOR noted at SS001, the location of the boat burning site. No screening criteria were exceeded and BTEXN were not detected in any other sample.

Selected heavy metals were analysed for in each of the eight samples collected from areas of interest at the site. Higher concentrations of zinc were observed in SS006 (laydown) and SS001 (boat burning pad) compared to levels in other samples collected. Higher concentrations of copper were also observed in SS01. No adopted screening levels were exceeded.

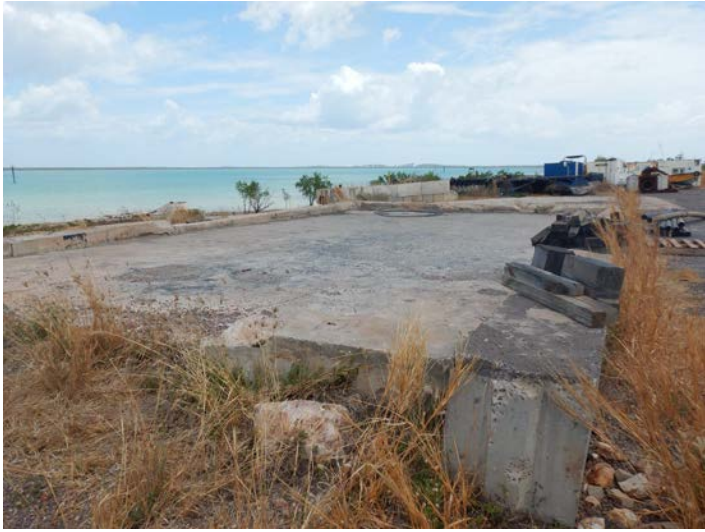
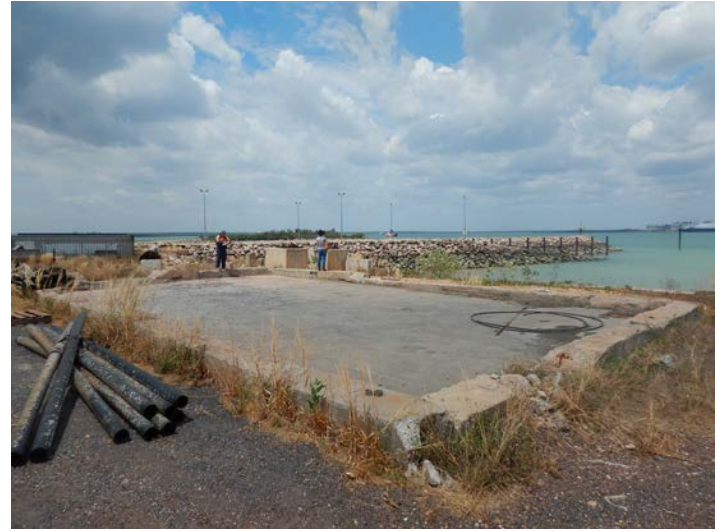
Waypoint 117 (1)

Waypoint	Location Description/Use	Observations	Contaminants of Potential Concern
117	Boat burning location	Elevated concrete pad with grasses growing around it	Antifouling substances, TRH, BTEXN, heavy metals
118	Historical Storage	Concrete waste stored, rusted drums and scrap metal dumped within edge of mangroves	TRH, BTEXN, heavy metals
119	Storage and laydown	Sea containers and miscellaneous items stored	TRH, BTEXN, heavy metals
120	Historical site	Containers and miscellaneous items stored as laydown area. Historical USTs at this location.	TRH, BTEXN, metals
121	Disused generator	Generator stored at site	TRH & BTEXN
122	Historical AST storage area	Crane storage and other miscellaneous items	TRH & BTEXN
123	Historical crane lift	Crane storage and other miscellaneous items	TRH & BTEXN
124	Disused generator	Generator stored at site	TRH & BTEXN
125	Combustible liquid sea container	Faint hydrocarbon odour adjacent to chemical storage	TRH, BTEXN, oils, lubricants

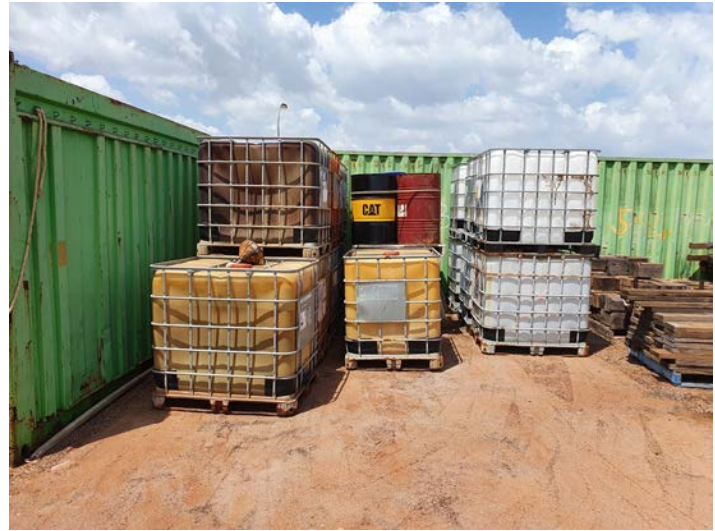
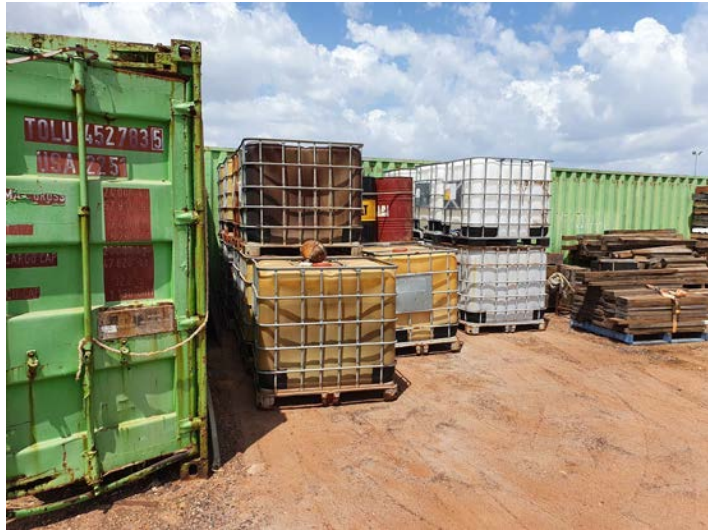
Waypoint 126 (2)

126	IBC laydown area	IBCs stored unbanded on pallets	TRH, BTEXN, oils, lubricants, antifouling substances
127	IBC laydown area	Stained ground around sea container	TRH, BTEXN
128	IBCs of oil and other fluids	IBCs stored unbanded on pallets	TRH, BTEXN, oils, lubricants, antifouling substances
129	Underground septic	Gravel surface, unbanded sewage tanks stored in vicinity	Nutrients and pathogens
130	Storage container	Warning sign saying no smoking or ignition sources within 3 m, possible storage area for volatile substances	TRH & BTEXN
131	Tyre storage	Used as storage for waste tyres, possibly received other waste from vehicles	TRH & BTEXN
132	Storage area	Hydrocarbon odour	TRH & BTEXN
