# **Proposed Marine Industry Park Modelling Report**

## **Sediment transport and bed material testing to support the Darwin Harbour sediment transport model**

**Ruth Patterson and David K Williams**

Australian Institute of Marine Science

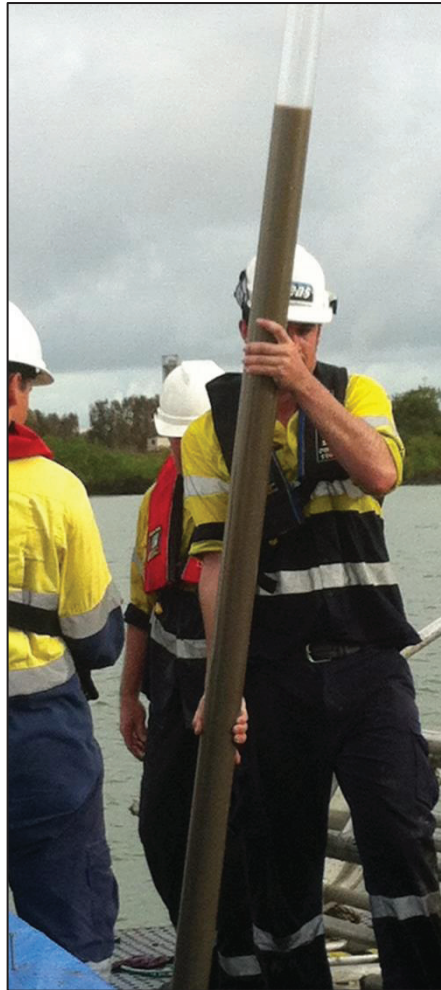
**Figure 2: A core taken showing no distinction between the turbid water and the mud sample.**

Vibrocores were carried out at the locations specified above in conjunction with the sediment testing team at URS. The vibrocore penetrates until hard clay material causes refusal. It was observed that this usually occurred when the drill touched on hard, red and ochre coloured clay. The water was drained from the head of the first core using a sponge to hold back the sediment. However, it was observed that the water being drained was very turbid (see Figure 2) and may be important to the hydrodynamics and sediment transport if the local lutocline were better understood. After this instance, both the material and the water was retained in the tubes and allowed to settle.

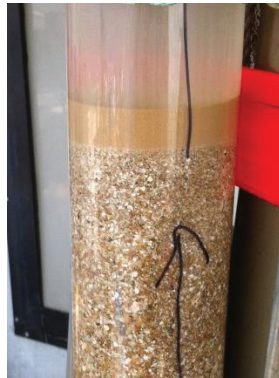
**Figure 3: Settling of fine material from the water column on top of bed sediment**

The vibrocores were left to sit for the duration of the field work. Settling of fine material from the water column occurred, leaving visible sediment layers in some cores (Figure 3). Slight movements such as bumping or knocking the core caused the fine sediment layer to mix with the water column.

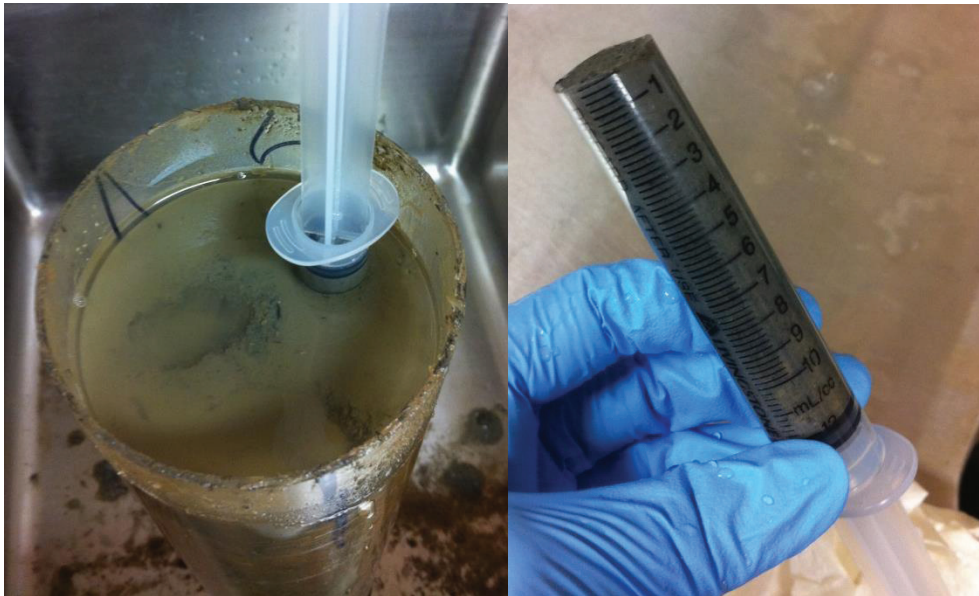
**Figure 4: Taking core samples of known volume for bulk density testing**

The only method of separating the different layers of sediment and collect the measurements required for bulk density analysis was to freeze the cores and manually separate the layers. This was carried out using a pipe saw and hot blade. Where visible, the fine sediment layer was also separated. The core was recapped to be airtight and allowed to thaw standing upright. Three different syringe sizes of known volume were used to carefully collect vertical core sediment samples. Each sample was placed in a beaker of known weight. They were weighed and left to dry in an oven for 55 hours at 105°C before being re-weighed.

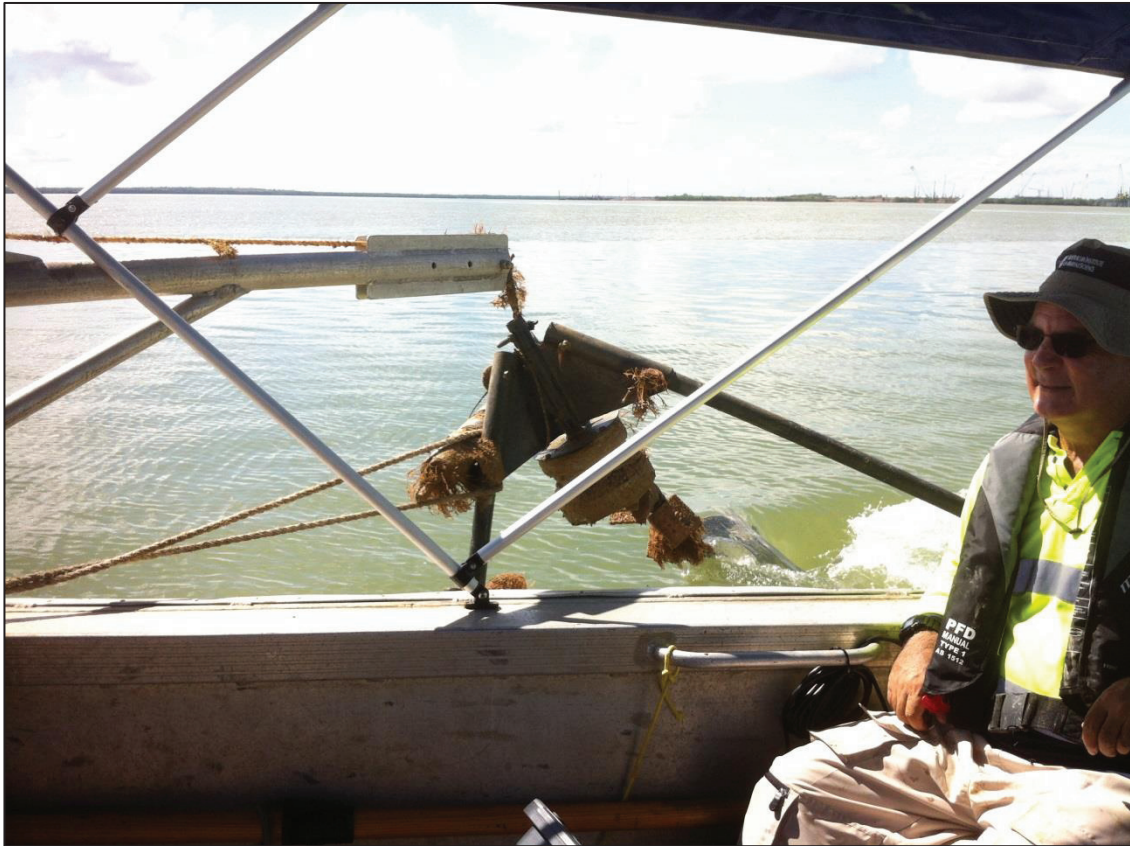
The frame was retrieved successfully after 32 days of deployment. There were no signs of disturbance and little fouling was observed on the instruments. Figure 6 shows the retrieval of the large and heavy frame using the AIMS research vessel. A davit on the left holds the frame in place on the side of the slowly moving boat.

**Figure 6: Frame retrieval on the AIMS research vessel**

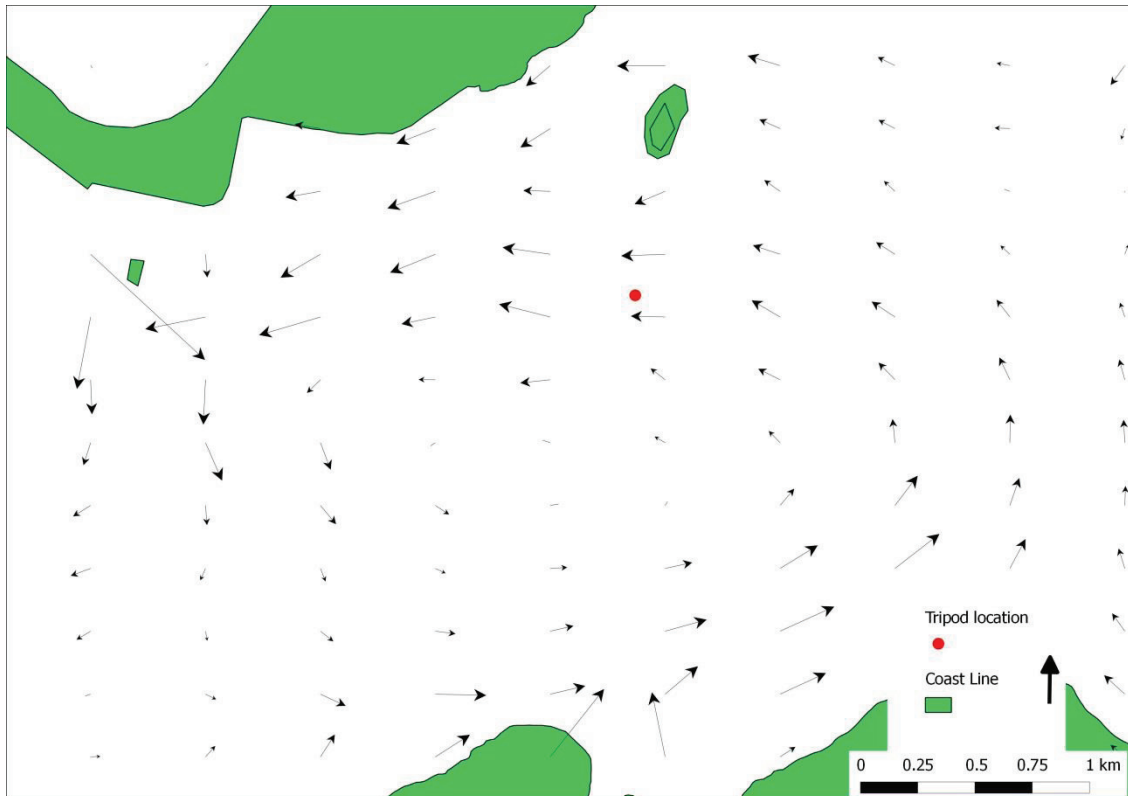
The model from task 1 of the proposed LDC shoreline development was re-run using the data collected above. The hydrodynamic model was first run using the existing geometry. Plotting the modelled residual currents shows a large scale eddy consistent with the velocity results in section 5.2.

**Figure 25: Residual currents at East Arm Wharf**
