Holtze Subdivision: Land Suitability Assessment

Prepared for: Department of Lands, Planning
and the Environment

Prepared by: EcOz Environmental Consultants

2015

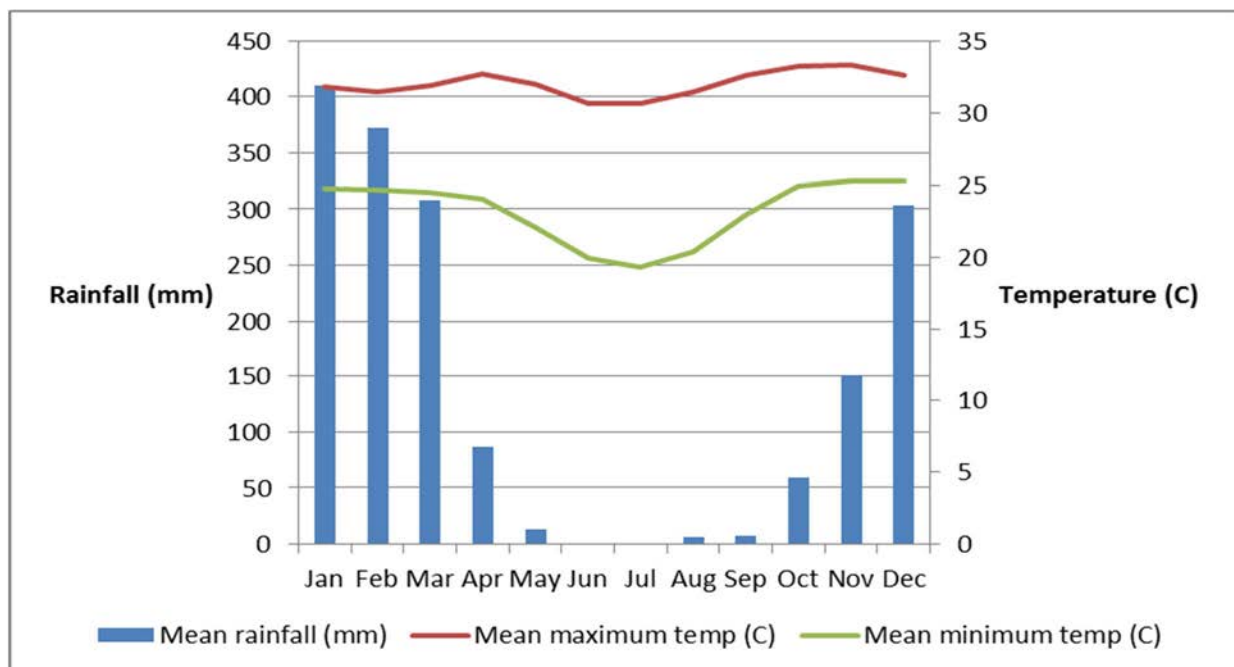
Figure 2-1. Graph of mean monthly rainfall and temperature range for Yarrowonga weather station (BOM 2014)

Climate data was sourced from the Bureau of Meteorology's Yarrowonga weather station (station number 014210), located approximately 1 km from the project area. The climate of the project area is characterised by a wet season (October to April) with high humidity and rainfall, and a dry season (May to September) with lower humidity and very little to no rainfall. During the monsoon period in January and February, the project area would experience frequent heavy rainfall and flooding in lower lying areas. The area typically receives around 1664 mm of rain each year (median) with more than 95 % occurring during the wet season. January is the wettest month of the year, with an average of 410 mm of rainfall.

Mean maximum temperatures range from 30.6 °C in June to 33.3 °C in November. July is the coolest month of the year, with an average minimum temperature of 19.3 °C.

Mean monthly rainfall and mean minimum and maximum monthly temperatures are displayed below in Figure 2-1.

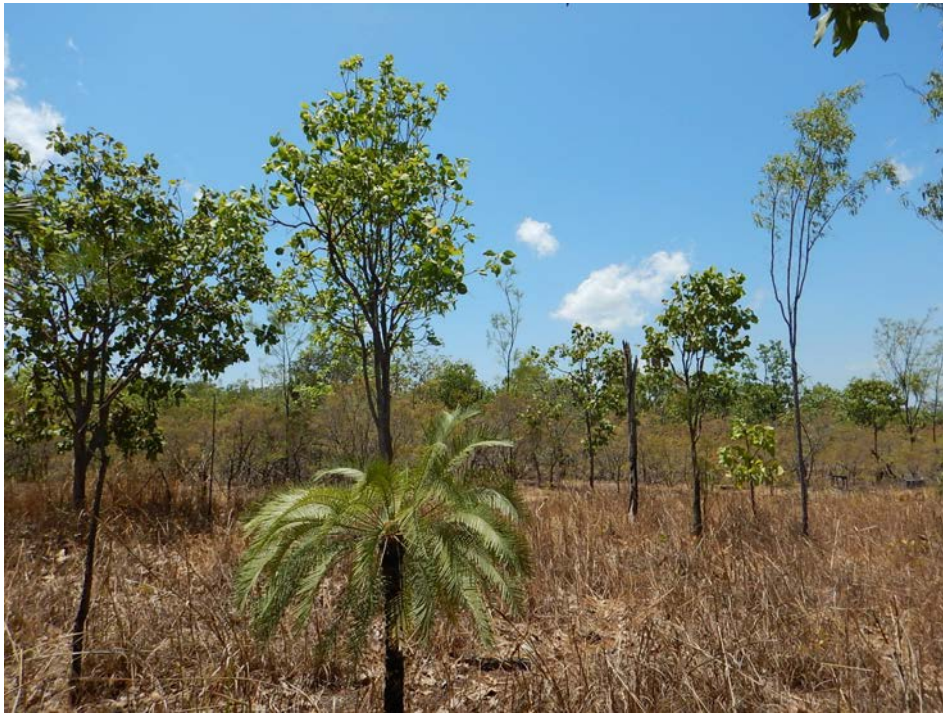
Figure 2-5. *Cycas armstrongii* in the project area

One threatened species was recorded during the site inspection. *Cycas armstrongii* was observed throughout the project area, with highest densities in the upland areas (Figure 2-5). The species occurs mainly in open grassy woodland on yellow and red earths, in well-drained areas. It is locally abundant in woodlands within the Darwin Coastal bioregion. *Cycas armstrongii* has been listed as Vulnerable under the TPWC Act due to an anticipated reduction in population size, with one of the main threatening processes being land clearing due to the expansion of Darwin and surrounding rural areas (Kerrigan et al. 2006).

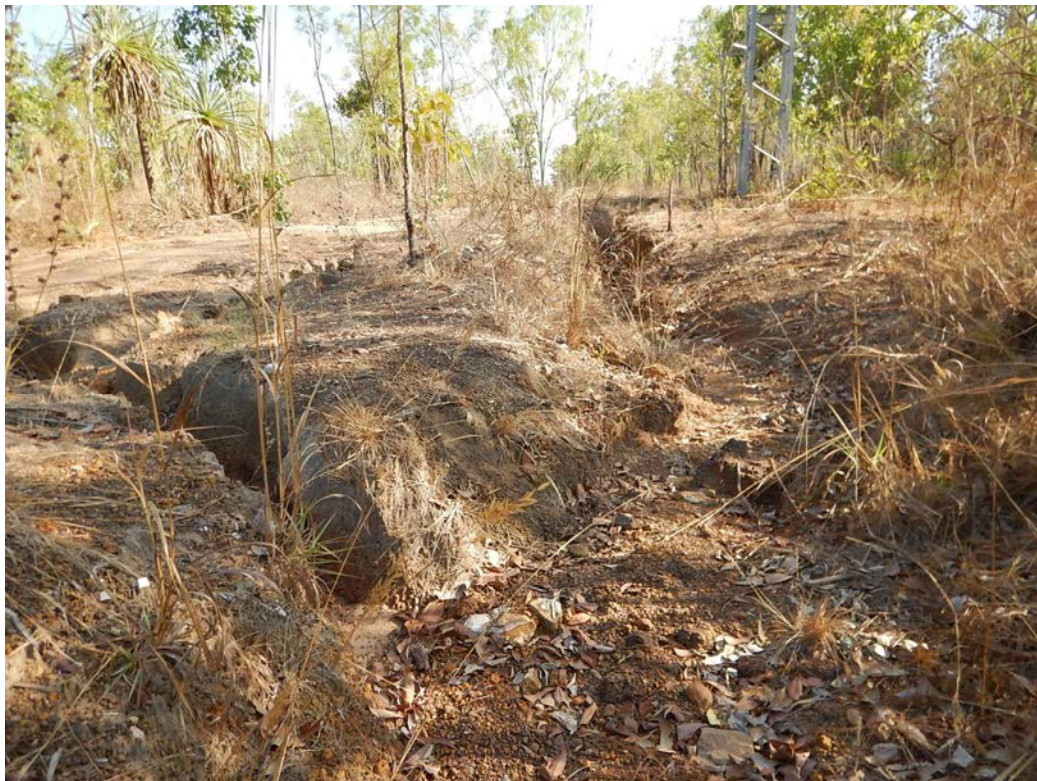
Figure 2-6. Image showing gully erosion next to dirt road

Instances of rill and gully erosion were observed in several locations within the project area (Figure 2-6). Erosion was most common adjacent to dirt tracks in the south-east section of the project area, where slopes of 2-4 % occur. Slopes of greater than 5 % in some sections increase the erosion potential of the area.

Clearing of vegetation and ground disturbance associated with subdivision of the project area has potential to cause erosion. Erosion potential along property boundaries can be minimised through the establishment of adequate drainage and erosion/sediment controls during the initial land development and construction activities. The design and implementation of erosion controls should be in accordance with NT Government guidelines, such as:

- Erosion and Sediment Control Guidelines – Built Environment
- Erosion and Sediment Control Guidelines – Fact Sheet – Rural Development.

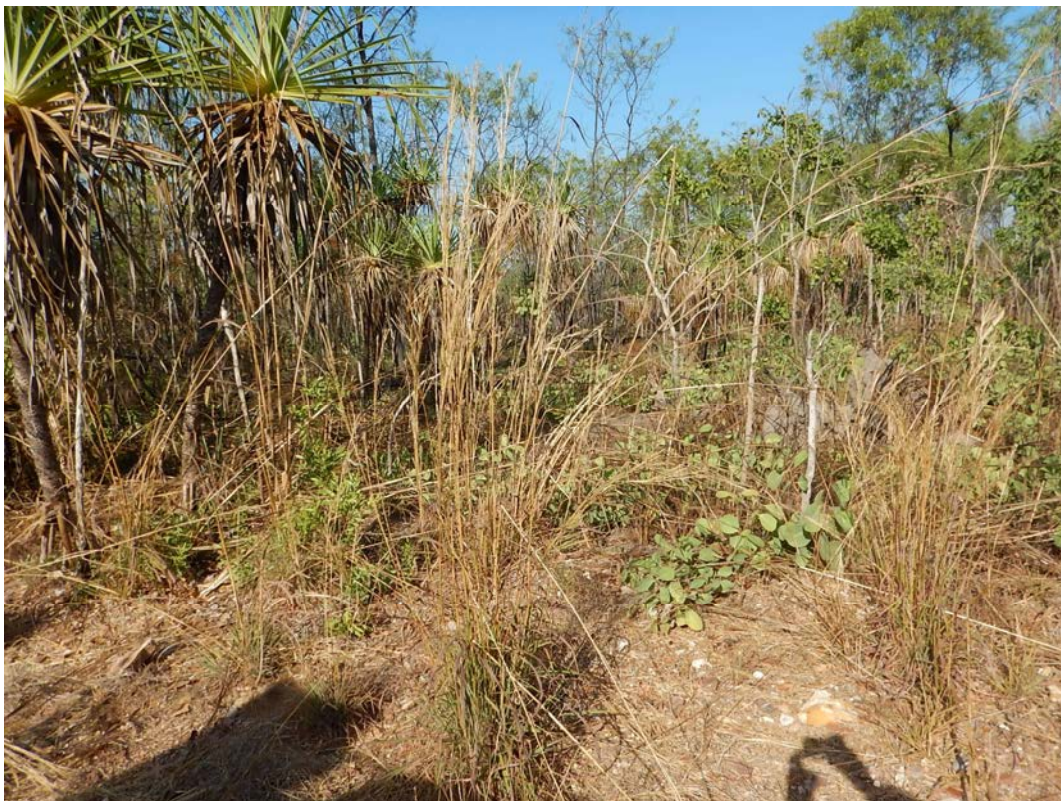
Figure 2-7. Gamba Grass (*Andropogon gayanus*) observed in the project area

- Gamba Grass (*Andropogon gayanus*) (see Figure 2-7)
- Mission Grass (*Cenchrus polystachios*)

Both weeds are listed as Class B (spread to be controlled) and Class C (not to be introduced) under the NT *Weeds Management Act*. These weeds were observed in relatively low densities in some disturbed areas adjacent to tracks within the project area.

- Maintain good vehicle/equipment hygiene to avoid the spread of existing weed infestations during establishment of lot boundaries, access tracks, fences and firebreaks (including vehicle wash-downs, and avoiding driving through weed-infested areas).
- Any borrow material required should be sourced from weed free areas.
- Weed management regimes, such as spraying, should be implemented on all properties following subdivision.

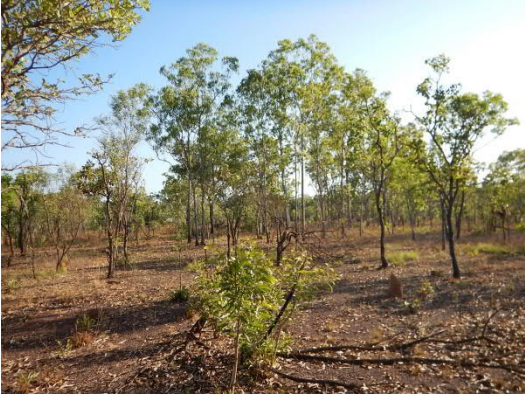
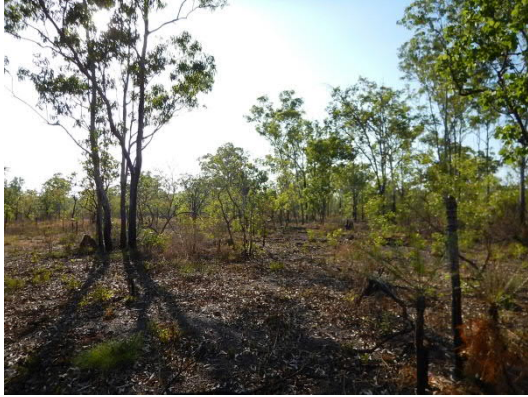
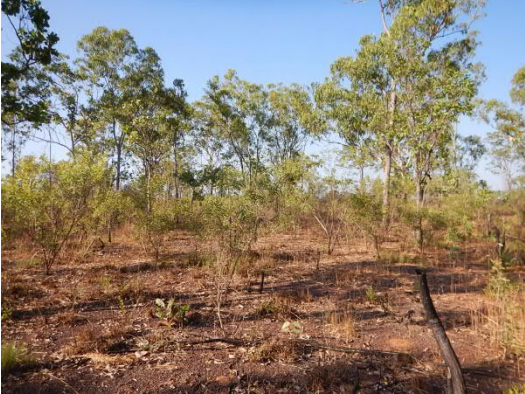
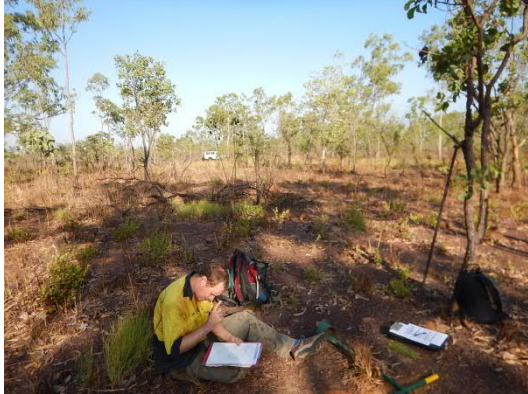
Reference Site		VS1			
Vegetation Type	Open Eucalypt woodland	Vegetation Description	<i>Eucalyptus tetradonta</i> , <i>E. miniata</i> +/- <i>C. bleeseri</i> Open Woodland, over <i>S. intrans</i> and <i>H. triticeus</i> .		
Ground cover	Gravel 80% Vegetation 10% Litter 10%	Land Unit	3b

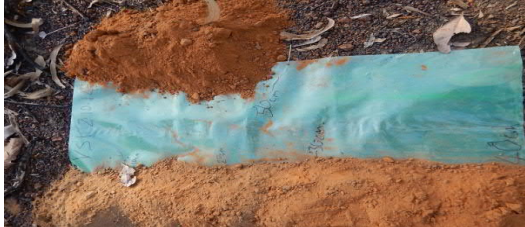
Soil					
Slope	1-2%

Aspect	North-west				
Drainage	Moderately well drained				
Horizon	Depth	Colour	Texture	Coarse aggregates (%)	Soil type
A1	0-15 cm	Dark brown	Sandy loam	30	Kandosol
A3	15-30 cm	Dark yellowish brown	Sandy loam	20	
B1	30-50 cm	Strong brown	Sandy loam	30

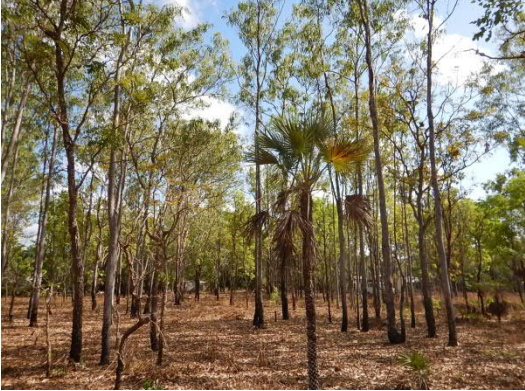
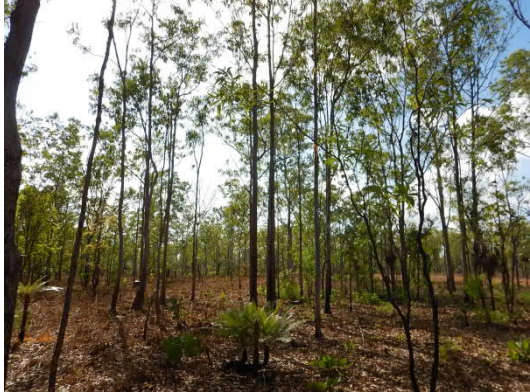
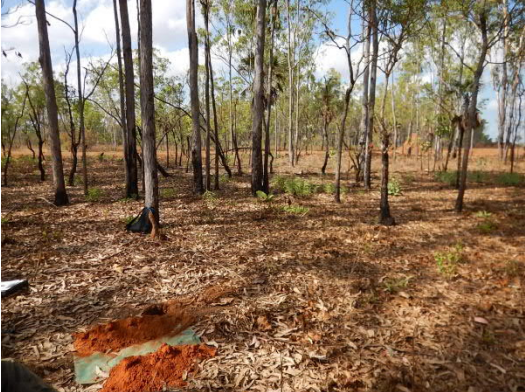
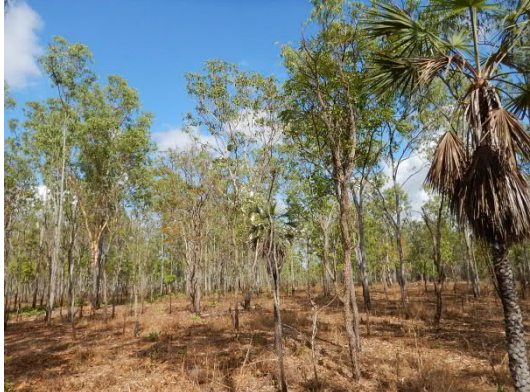
Reference Site		VS2			
Vegetation Type	Open Eucalypt Forest	Vegetation Description	<i>Eucalyptus tetradonta</i> , <i>E. miniata</i> +/- <i>Erythrophleum chlorostachys</i> Open Forest, over <i>S. intrans</i> and <i>H. triticeus</i> .		
Ground cover	Litter 70% Vegetation 5% Bare soil 10%	Land Unit	3a

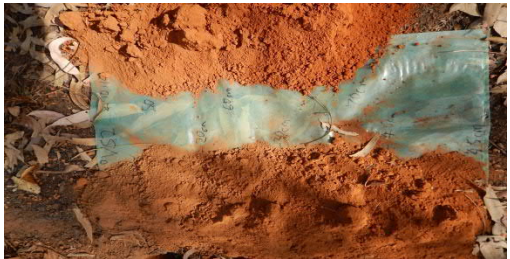
Soil					
Slope	Flat (0%)

Aspect	North				
Drainage	Moderately well drained				
Horizon	Depth	Colour	Texture	Coarse aggregates (%)	Soil type
A1	0-10 cm	Strong brown	Sandy loam	30	Kandosol
A3	10-35 cm	Reddish brown	Loam	20	
B1	35-70 cm	Yellowish red	Loam	15

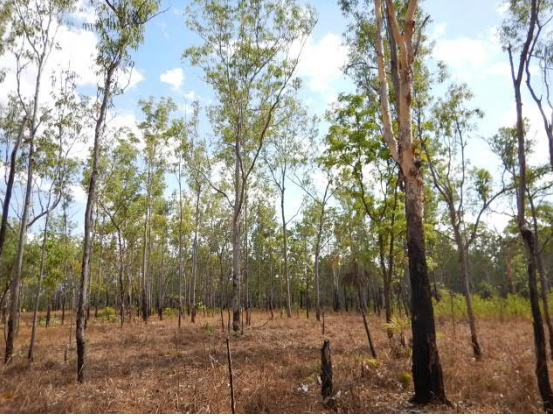
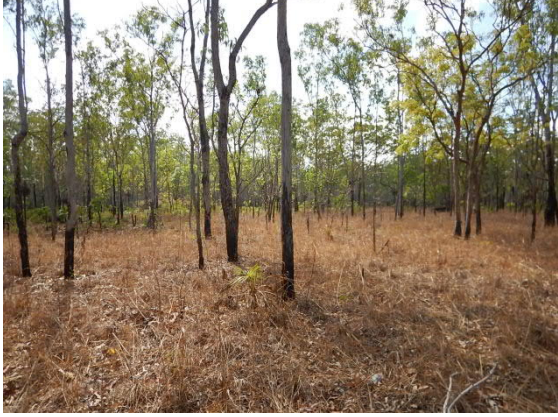
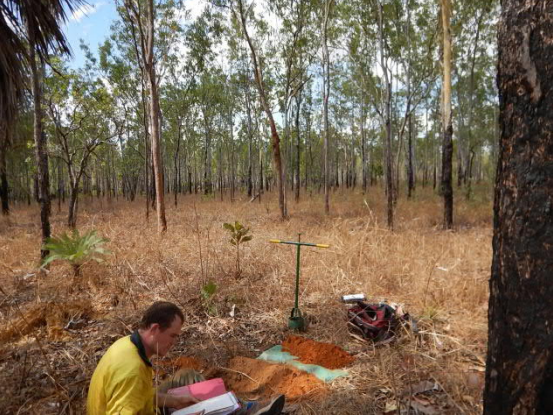
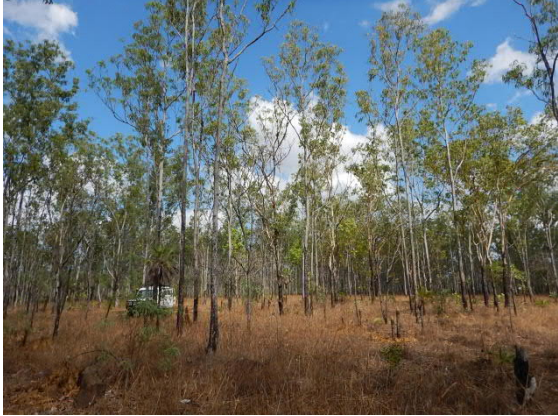
Reference Site		VS3			
Vegetation Type	Open Eucalypt Forest	Vegetation Description	<i>Eucalyptus tetradonta</i> , <i>E. miniata</i> +/- <i>Erythrophleum chlorostachys</i> Open Forest, over <i>S. intrans</i> and <i>H. triticeus</i> .		
Ground cover	Vegetation 80% Litter 20%	Land Unit	3a

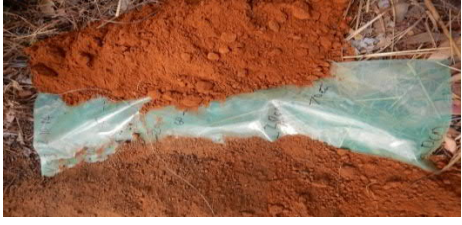
Soil					
Slope	Flat (0%)

Aspect	East				
Drainage	Moderately well drained				
Horizon	Depth	Colour	Texture	Coarse aggregates (%)	Soil type
A1	0-15 cm	Dark brown	Sandy loam	40	
A3	15-30 cm	Brown	Sandy loam	30	
B1	30-70 cm	Strong brown	Loam	20	
					Kandosol

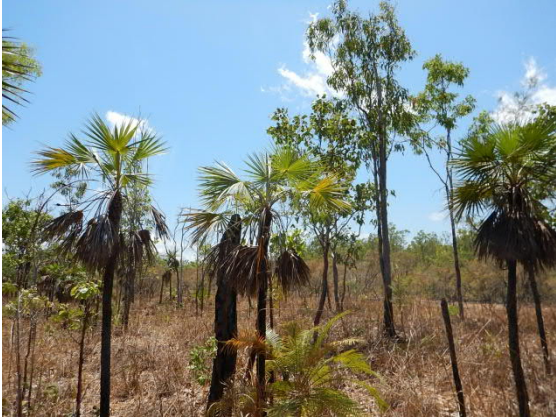
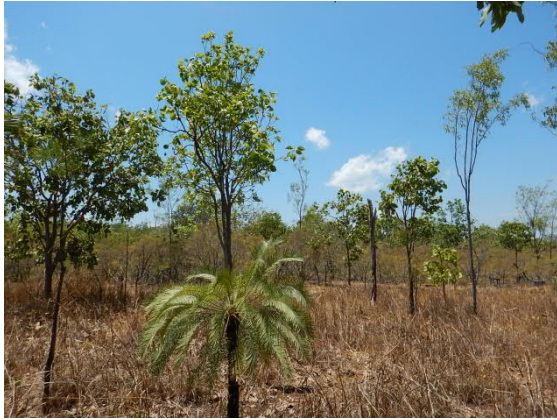
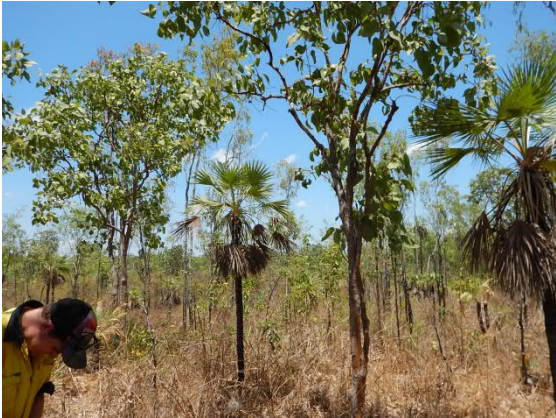
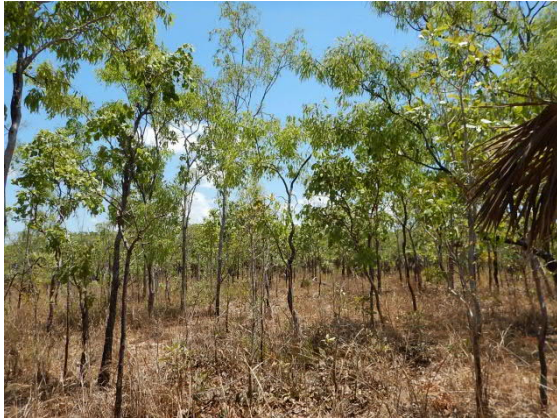
Reference Site		VS5			
Vegetation Type	Low Eucalypt Woodland	Vegetation Description	<i>Corymbia latifolia</i> , <i>E. tectifica</i> Low Woodland, over <i>S. intrans</i> and <i>H. triticeus</i> .		
Ground cover	Vegetation 50% Litter 20% Gravel 30%	Land Unit	2b2

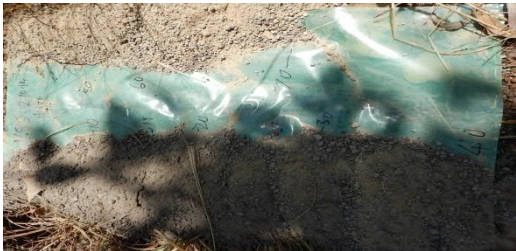
Aspect	East				
Drainage	Poorly drained				
Horizon	Depth	Colour	Texture	Coarse aggregates (%)	Soil type
A1	0-15 cm	Dark grey	Loamy sand	70	Hydrosol
A2	15-70 cm	Light olive brown	Sand	70

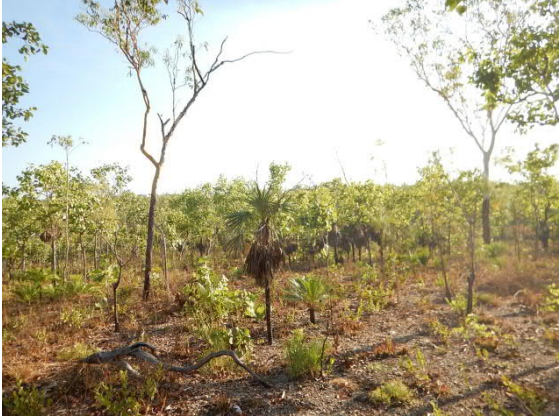
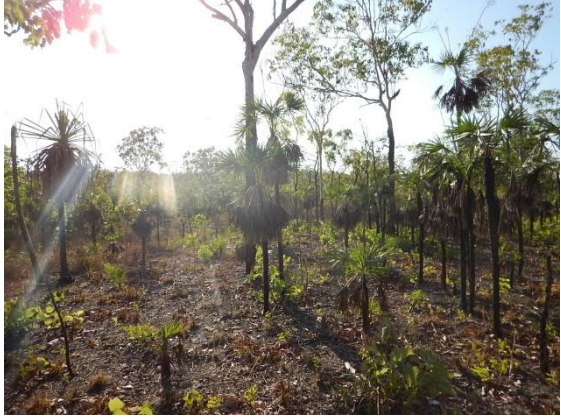
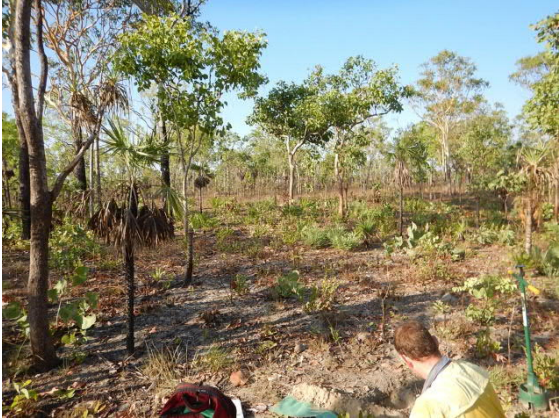
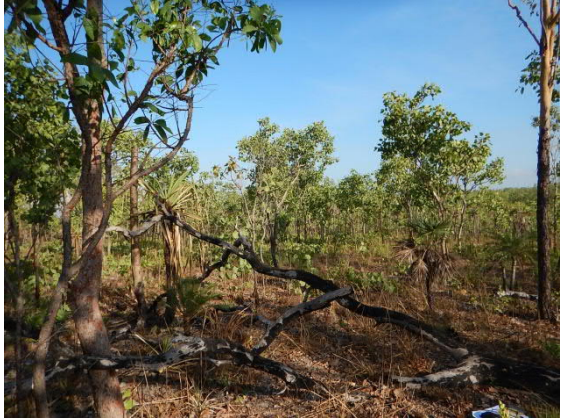
Reference Site		VS6			
Vegetation Type	Low Eucalypt Woodland	Vegetation Description	<i>Corymbia latifolia</i> , <i>E. tectificia</i> Low Woodland, over <i>H. triticeus</i>		
Ground cover	Vegetation 10% Litter 10% Gravel 80%	Land Unit	2b2

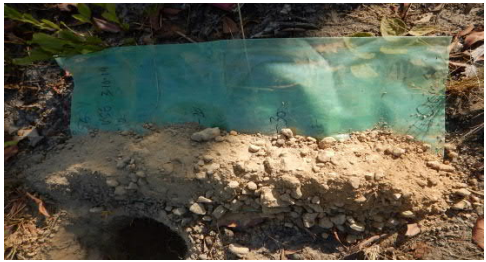
Aspect	North				
Drainage	Poorly drained				
Horizon	Depth	Colour	Texture	Coarse aggregates (%)	Soil type
A1	0-20 cm	Dark grey	Loamy sand	50	Hydrosol
A2	20-40 cm	Brown	Loamy sand	70

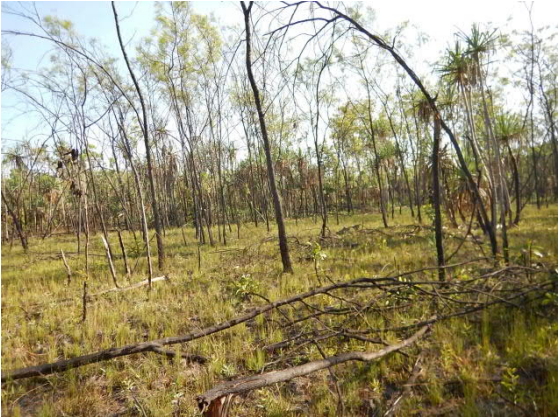
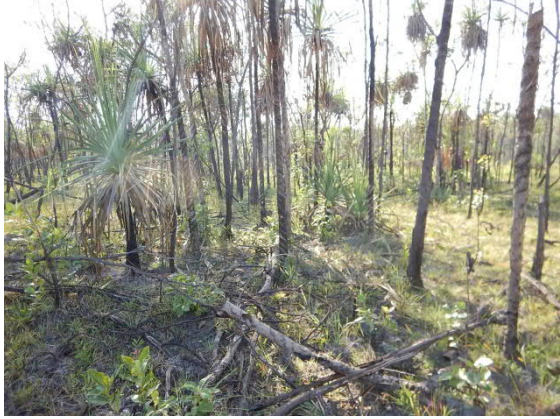
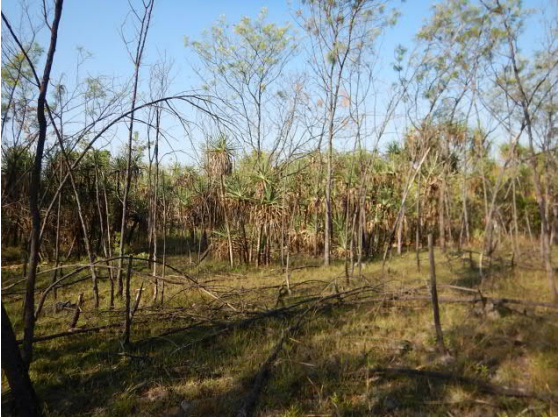
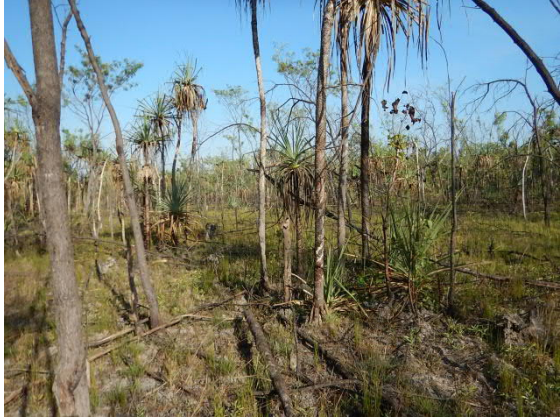
Reference Site		VS7			
Vegetation Type	Open woodland/shrubland	Vegetation Description	<i>Grevillea pteridifolia</i> , <i>Pandanus spiralis</i> Open woodland/shrubland on drainage line		
		Land Unit	5b1

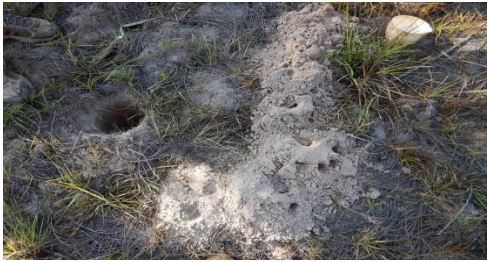
Aspect	South				
Drainage	Poorly drained				
Horizon	Depth	Colour	Texture	Coarse aggregates (%)	Soil type
A1	0-10 cm	Grey	Loamy sand	0	Hydrosol
A2	10-50 cm	Grey	Sand	0

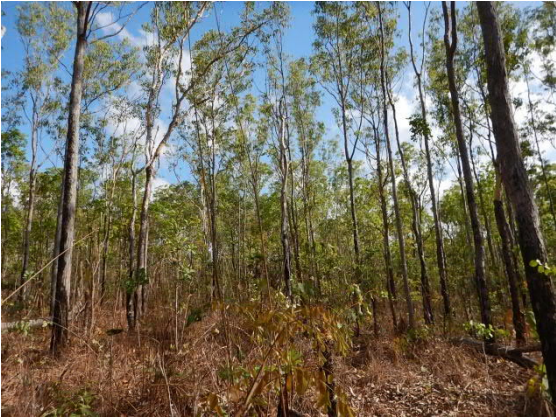
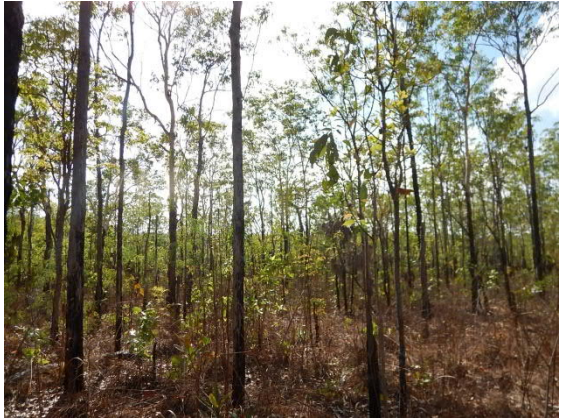
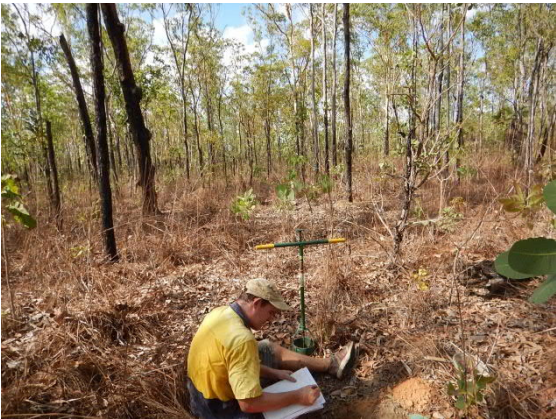
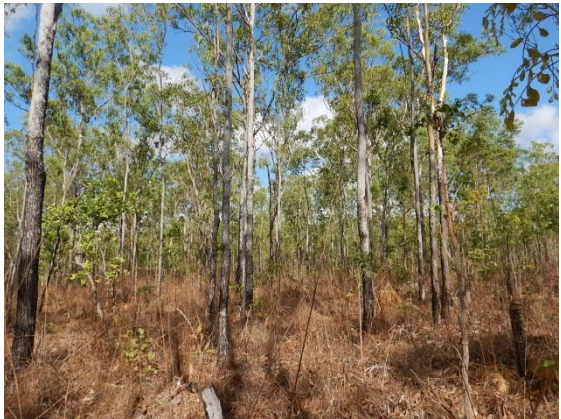
Reference Site		VS8			
Vegetation Type	Eucalypt Woodland	Vegetation Description		<i>Eucalyptus tetrodonta</i> , <i>E. miniata</i> Woodland, over <i>S. intrans</i> and <i>H. triticeus</i> .	
		Land Unit		1c

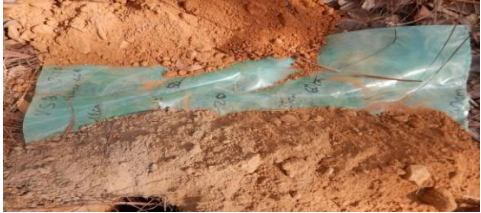
Horizon	Depth	Colour	Texture	Coarse aggregates (%)	Soil type
A1	0-15 cm	Dark greyish brown	Sandy loam	40	Kandosol
A3	15-30 cm	Dark yellowish brown	Loam	15	
B1	30-60 cm	Yellowish brown	Clay loam	50

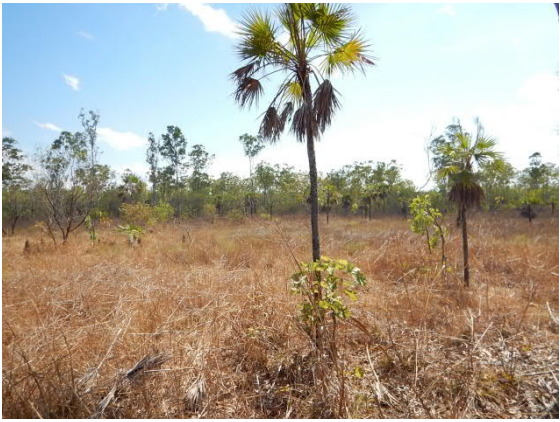
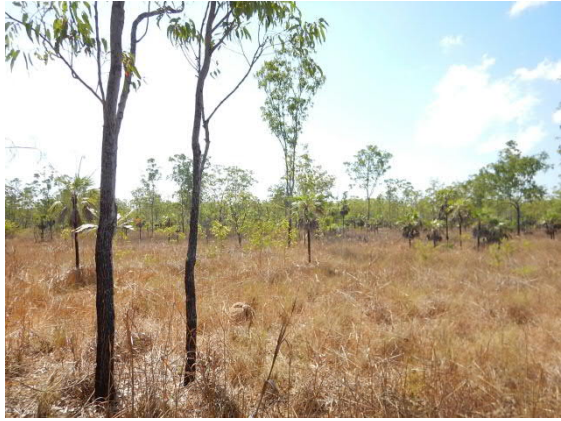
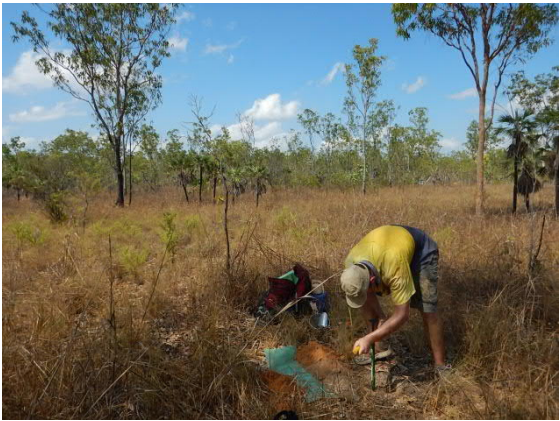
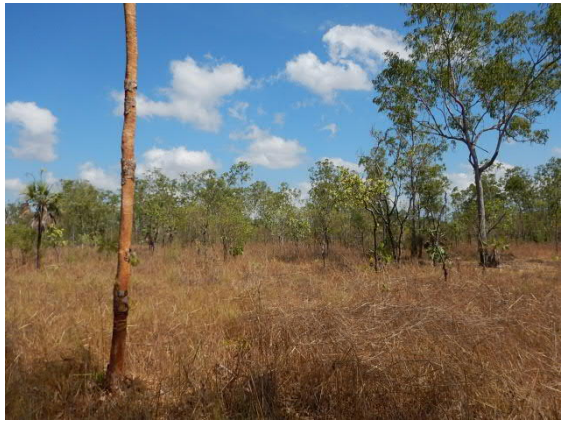
Reference Site		VS9			
Vegetation Type	Low Open Woodland	Vegetation Description		<i>Corymbia latifolia</i> , <i>E. tectifera</i> Low Open Woodland, over <i>S. intrans</i> and <i>H. triticeus</i> .	
		Land Unit		3c

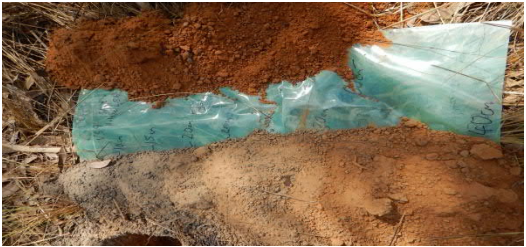
A1	0-15 cm	Dark grey	Loamy sand	50	Kandosol
B1	15-35 cm	Yellowish brown	Sandy loam	60	
B2	35-60 cm	Strong brown	Loam	60

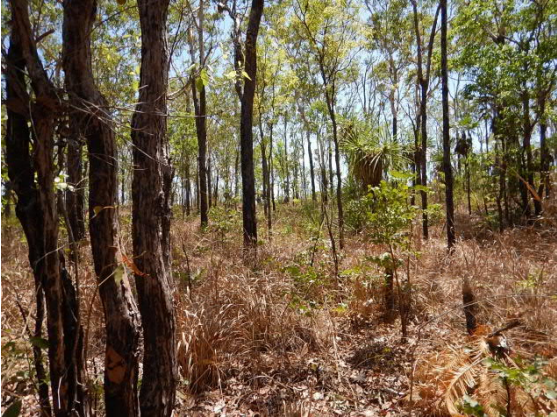
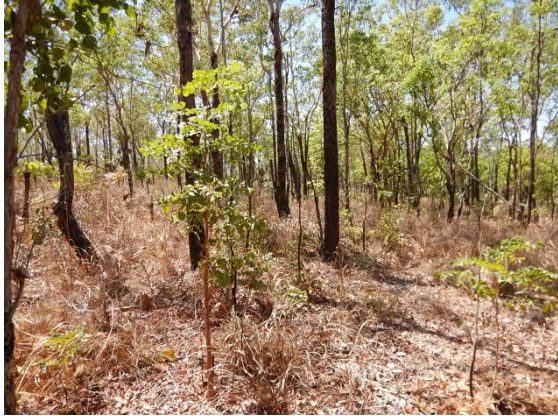
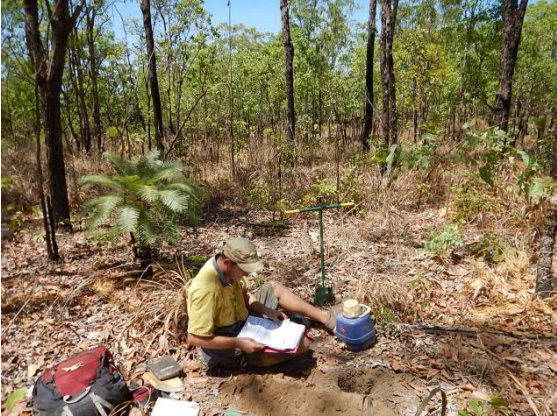
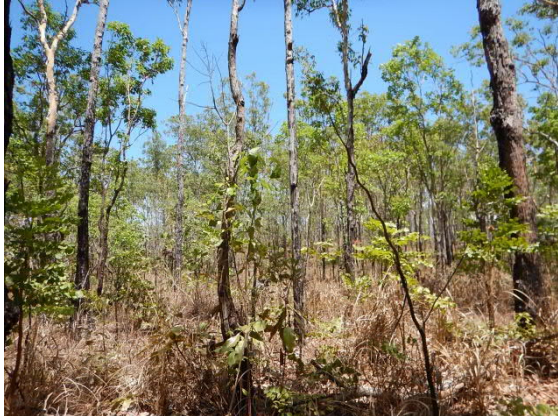
Reference Site		VS10			
Vegetation Type	Open Forest	Vegetation Description		<i>Eucalyptus tetradonta</i> , <i>E. miniata</i> Woodland, over <i>S. intrans</i> and <i>H. triticeus</i> .	
		Land Unit		1c

<p style="text-align: center;">West</p>			
Vegetation					
Upper Stratum Cover: 60 % Height range: 15-20 m Average height: 10 m		Mid Stratum Cover: 20 % Height range: 1.5-8 m		Ground Stratum Cover: 70 %	
<i>Eucalyptus miniata</i> (40%)		<i>Erythrophleum chlorostachys</i> (15%)		<i>Mnesithea rottboellioides</i>	
<i>Eucalyptus tetradonta</i> (10%)		<i>Livistona humilis</i> (3%)		<i>Sorghum intrans</i>	
<i>Lophostemon lactifluus</i> (10%)		<i>Planchonia careya</i> (2%)			
Soil					
Slope	~10 %

Aspect	South-east				
Drainage	Imperfectly drained				
Horizon	Depth	Colour	Texture	Coarse aggregates (%)	Soil type

A1	0-10 cm	Very dark grey	Sandy loam	20	Organosol
A2	10-40 cm	Dark greyish brown	Sandy loam	5	
A21	40-60 cm	Very dark greyish brown	Loam	20

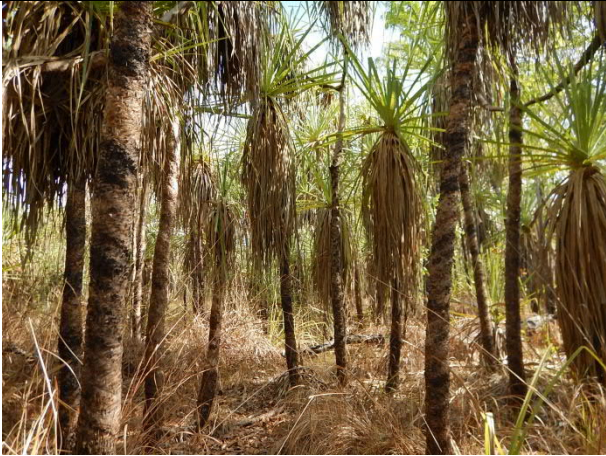
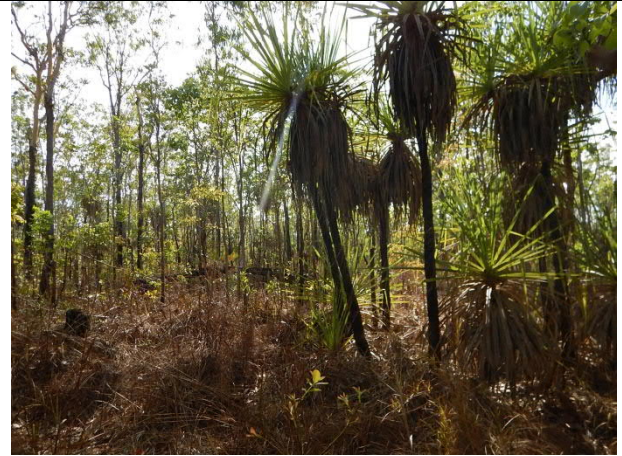
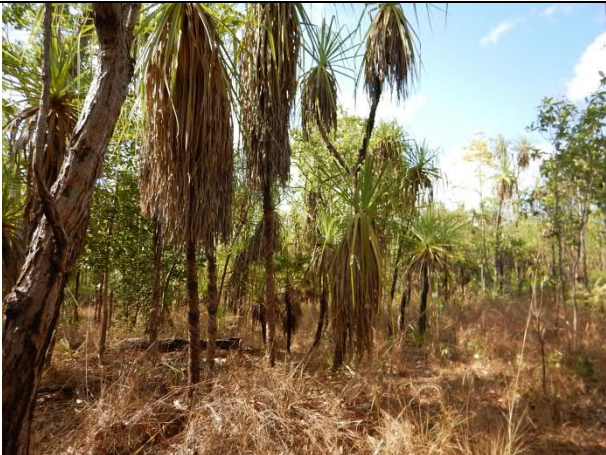
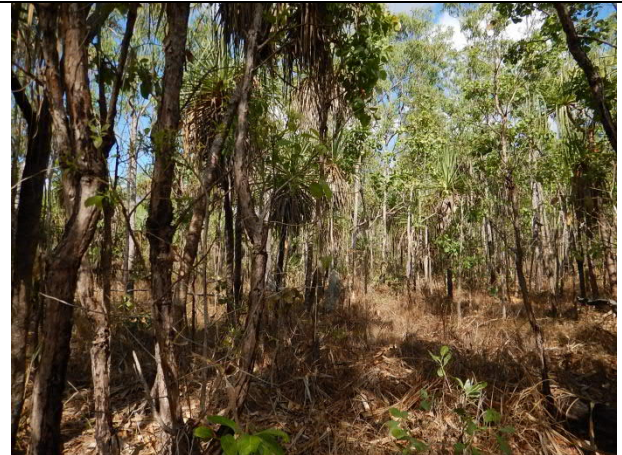
Check site	CS1
Site description	Drainage line
Vegetation	<i>Pandanus spiralis</i> , <i>Lophostemon lactifluus</i> , <i>Planchonia careya</i>
Slope	1-2 %

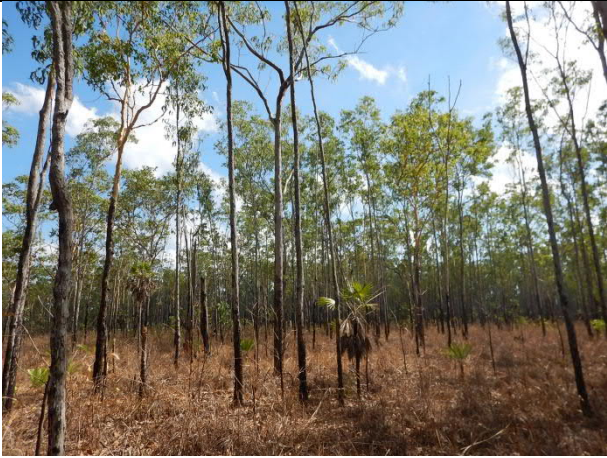
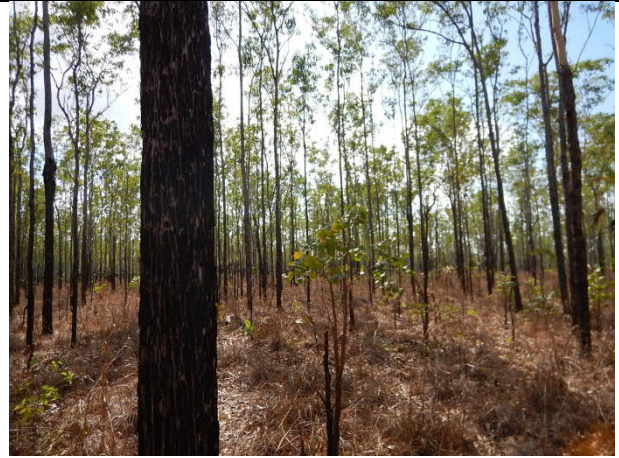
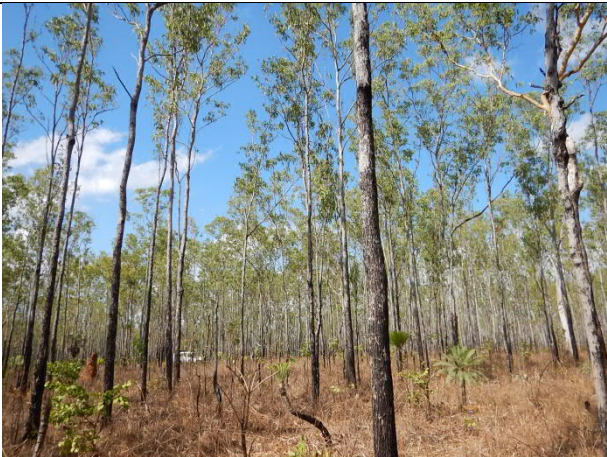
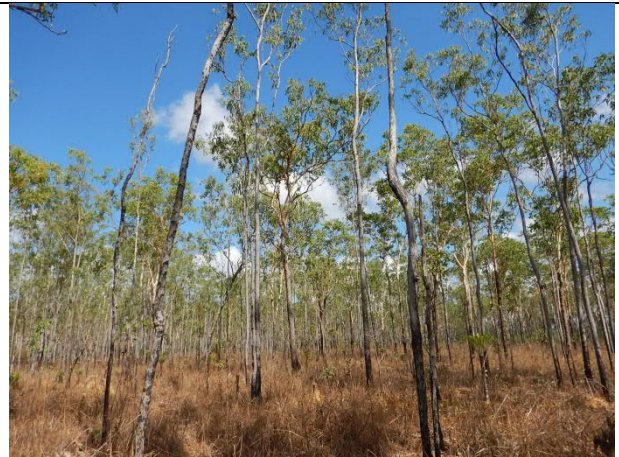
Check site	CS2
Site description	Open forest, slope 5%
Vegetation	<i>Eucalyptus tetradonta</i> , <i>Eucalyptus miniata</i> , <i>Livistona humilis</i>
Slope	0-1 %

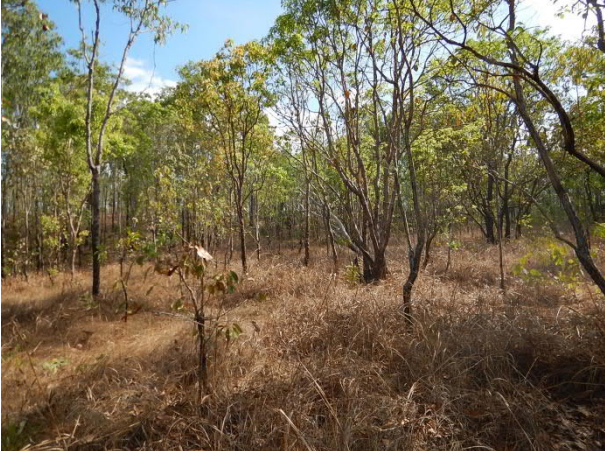
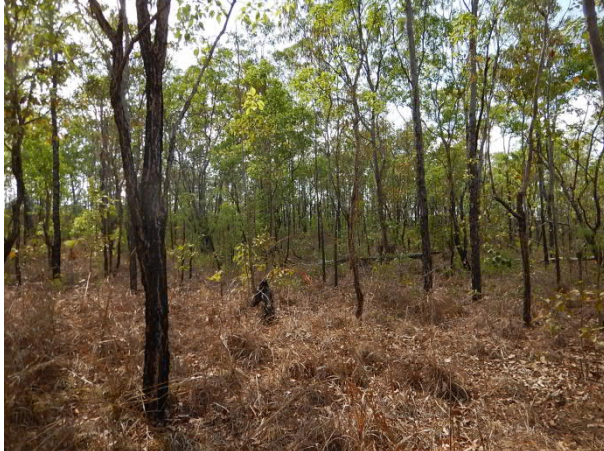
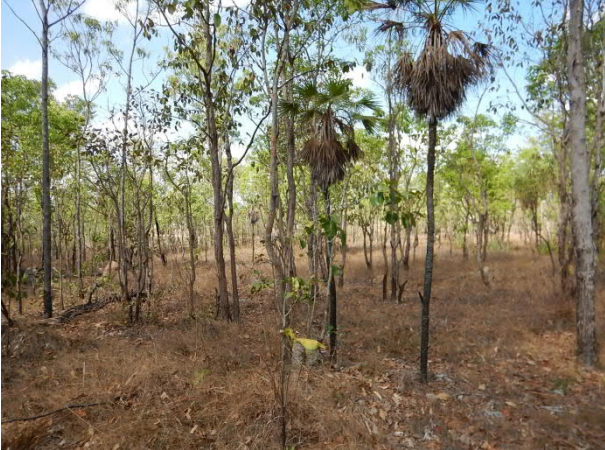
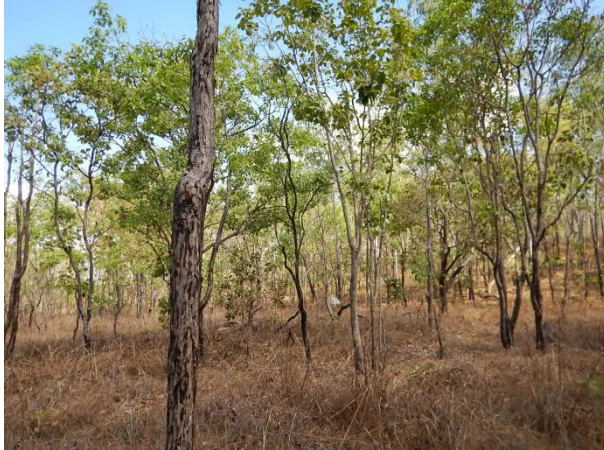
Check site	CS3	
Site description	Lower slope, minor drainage line	
Vegetation	<i>Eucalyptus tetradonta</i> , <i>Livistona humilis</i> , <i>Pandanus spiralis</i> , <i>Lophostemon lactifluus</i>	
Slope	4-5 %

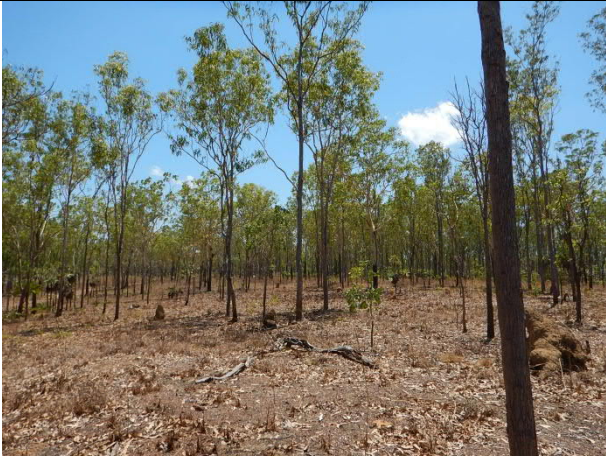
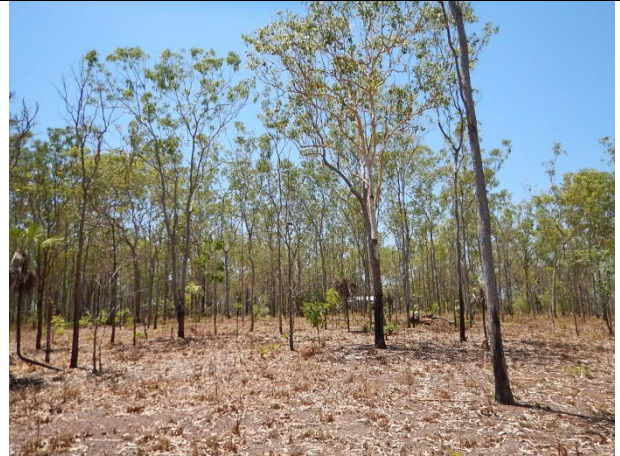
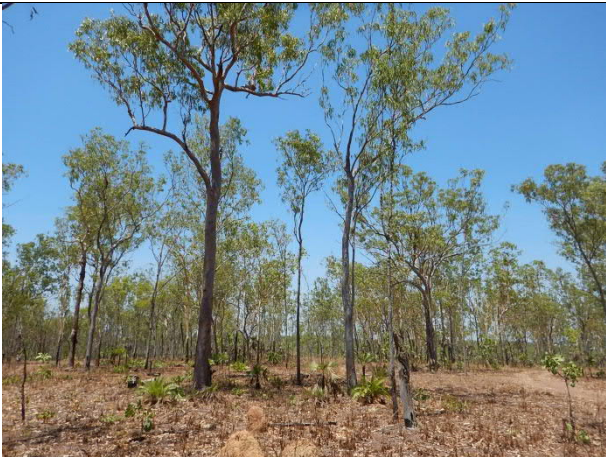
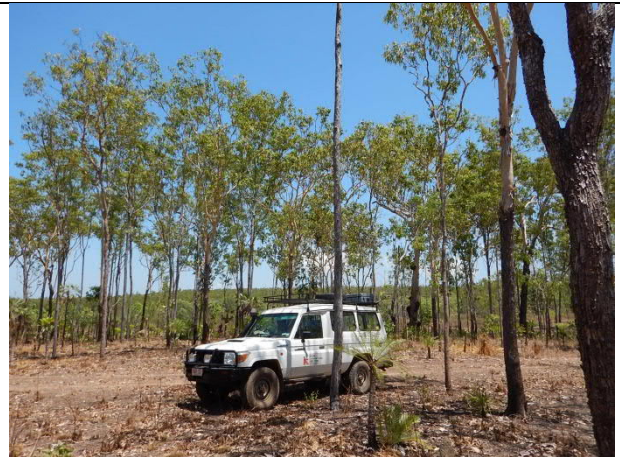
Check site	CS4
Site description	Woodland
Vegetation	<i>Eucalyptus tetradonta</i> , <i>Eucalyptus miniata</i> , <i>Livistona humilis</i> , <i>Cycas armstrongii</i>
Slope	1-2 %

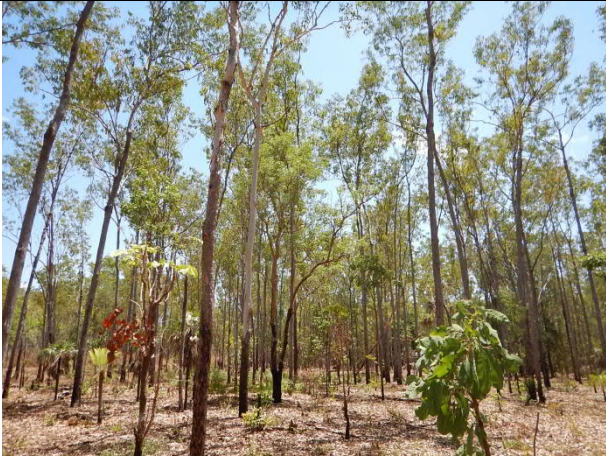
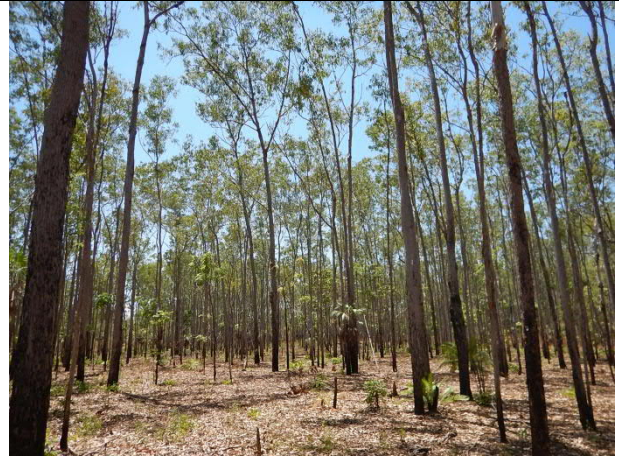
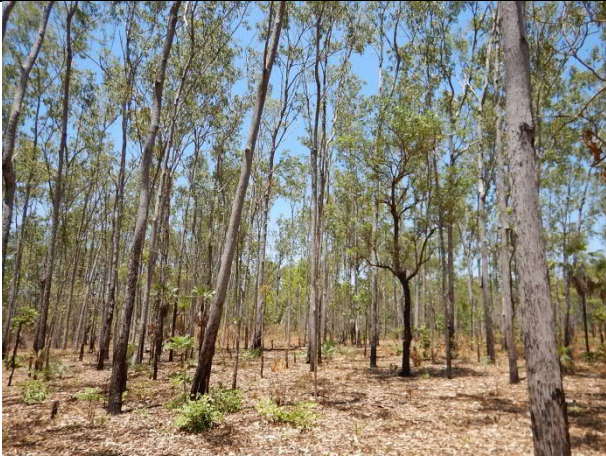
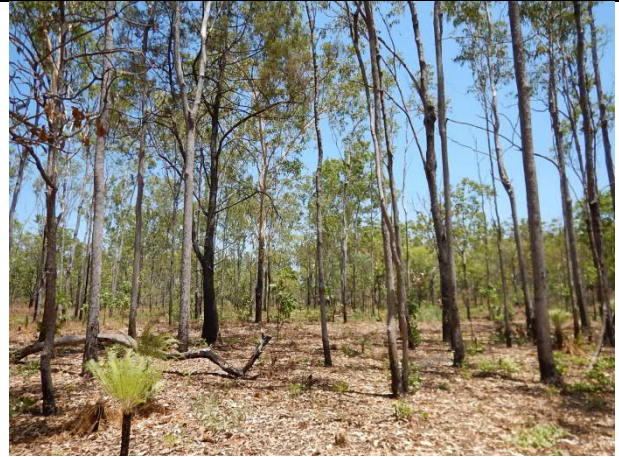
Check site	CS5
Site description	Open forest
Vegetation	<i>Eucalyptus tetradonta</i> , <i>Eucalyptus miniata</i> , <i>Livistona humilis</i> , <i>Cycas armstrongii</i>
Slope	1-2 %

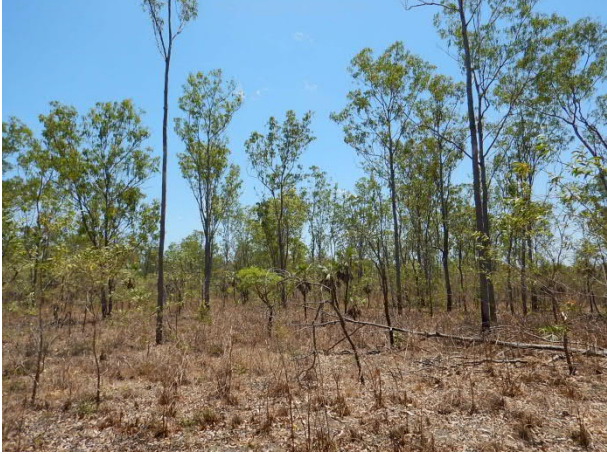
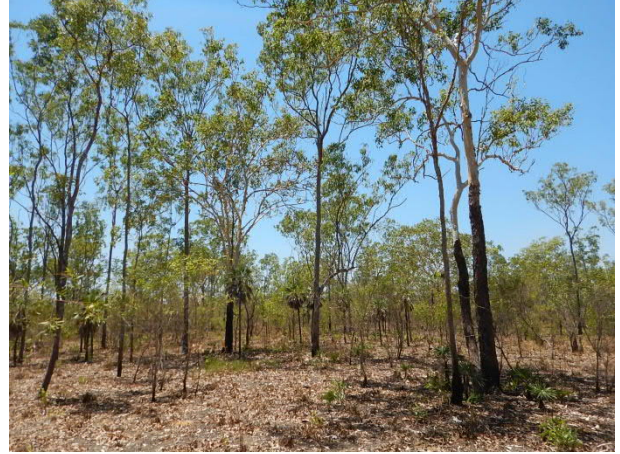
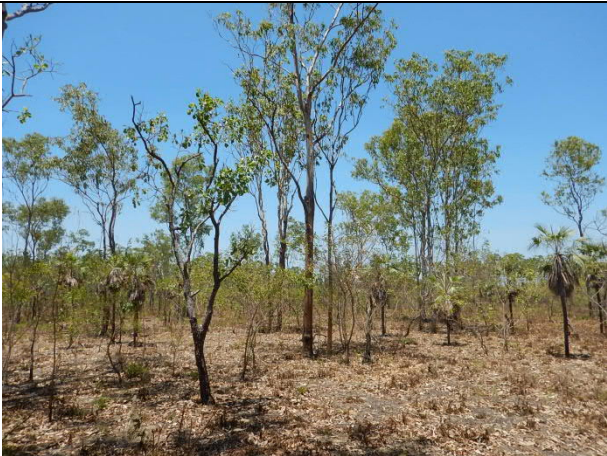
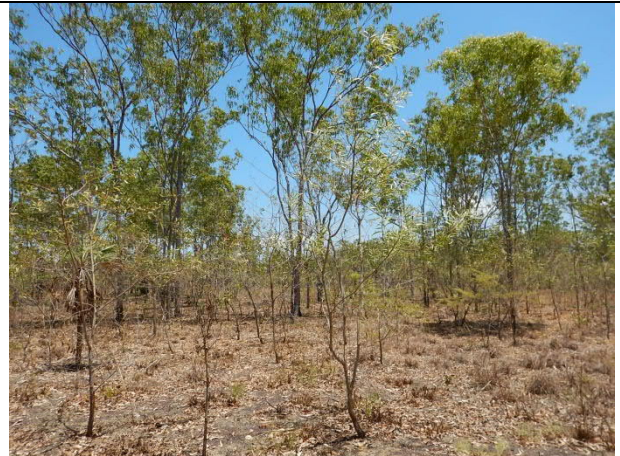
Check site	CS6
Site description	Open woodland, tall trees
Vegetation	<i>Eucalyptus tetradonta</i> , <i>Eucalyptus miniata</i> , <i>Erythrophleum chlorostachys</i> , <i>Livistona humilis</i>
Slope	0 %
