# Geotechnical Assessment

## Darwin Integrated Live Export Facility

Report Number 41009.80266

**Wellard Rural Exports  
Pty Ltd**

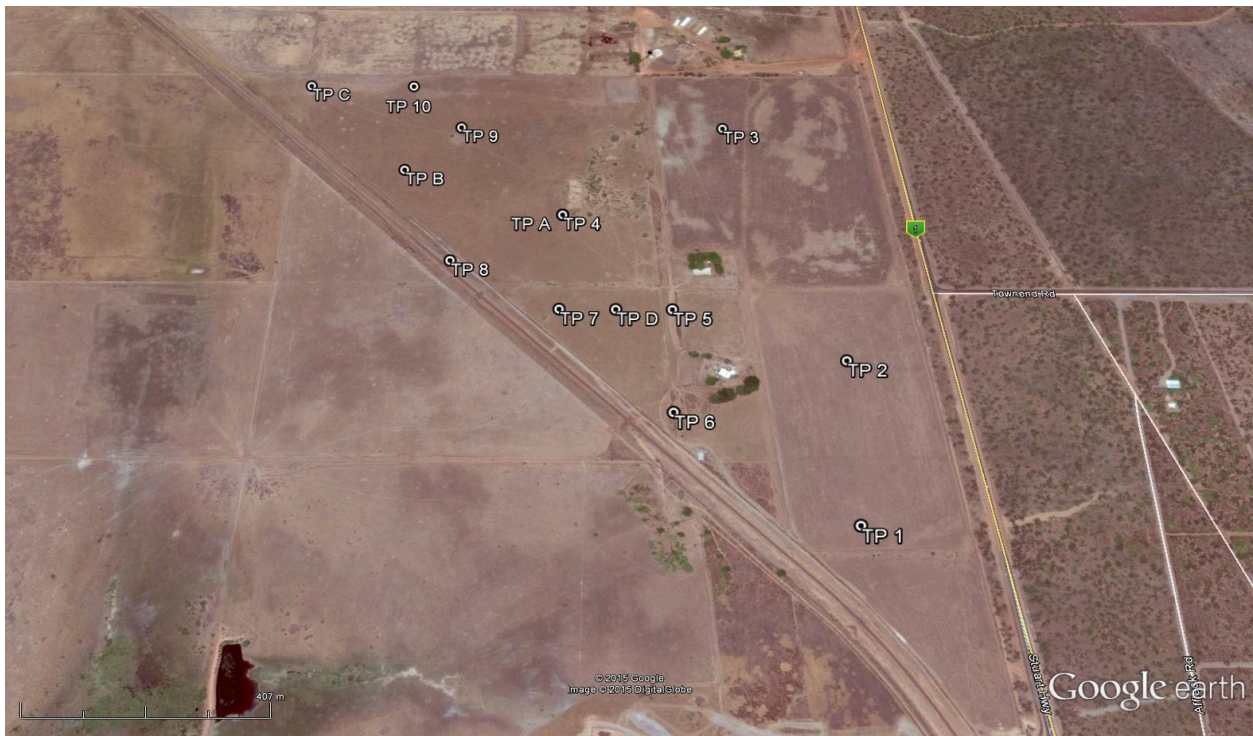
**Figure 5** Soil test pit locations (Samples taken on the 9<sup>th</sup> January 2015 are numerical, 2<sup>nd</sup> June are alphabetical)

Fourteen test pits (14) were dug with a backhoe to the depth of refusal, varying from 0.5 to 1.2m. The test pit locations are shown in Figure 5.

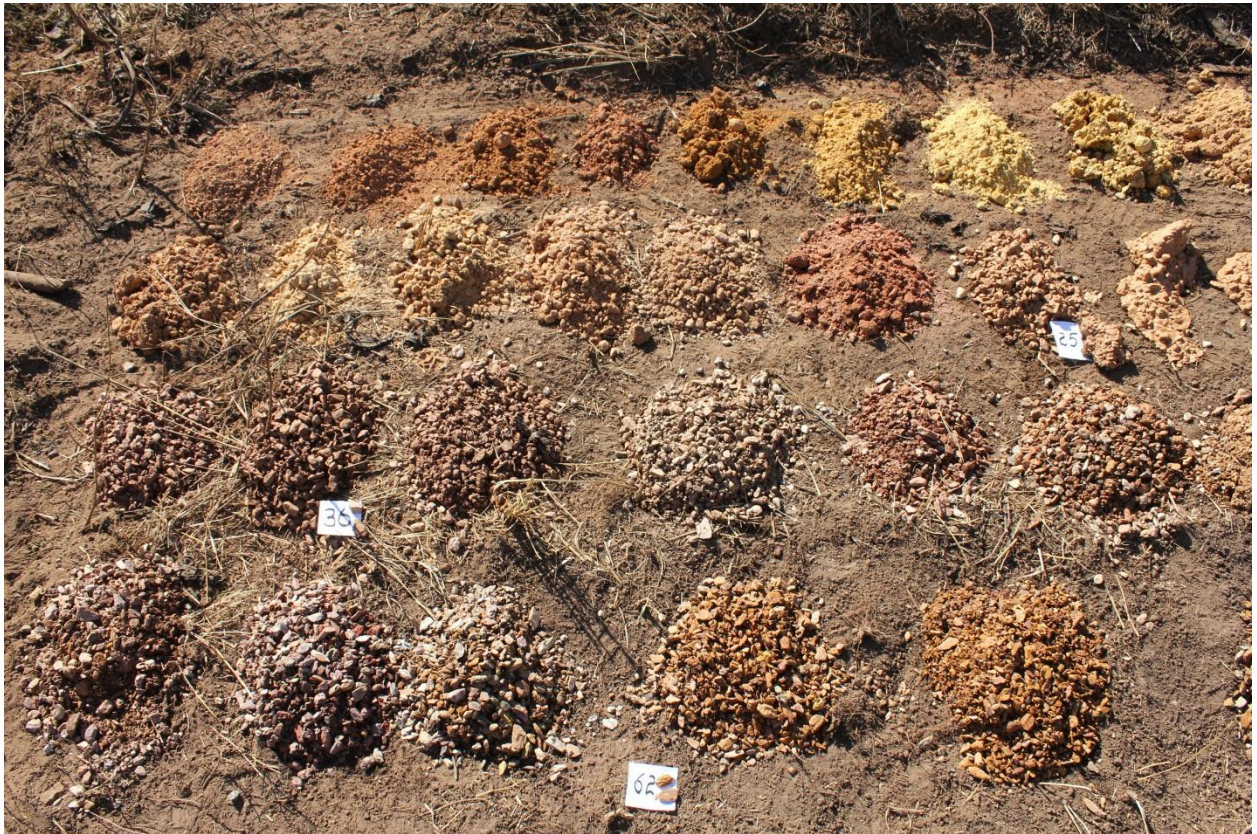
**Figure 6**      **Test bore logs**

The test bore stratigraphy generally matches that of the existing bores on the property. These bores, while drilled some time ago, were very well logged by the Australian Army.

A dense moderate to heavy clay was found at 7-10m. This impermeable layer of clay observed at 7-10 metres may be utilised as a viable base lining for holding and storage dams.

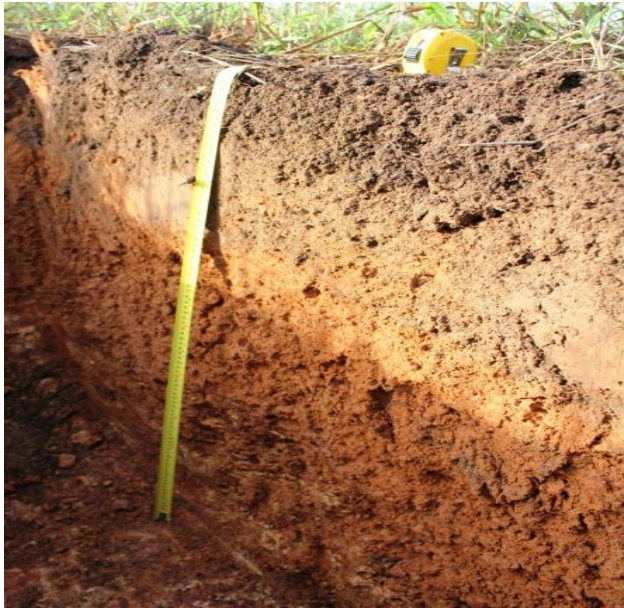
**Figure 8**      **Test Pit 1**

Test pits profiles are illustrated in Figure 8 to Figure 13.

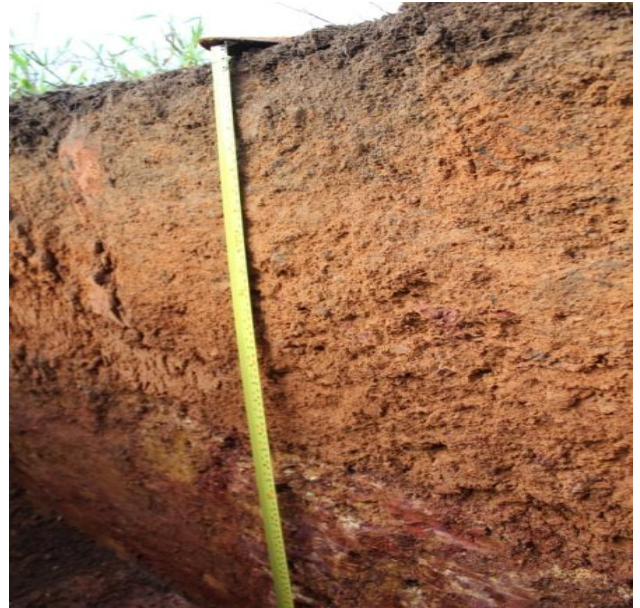
**Figure 9**      **Test Pit 2**

- The A1 horizon consisted of a dark brown silty-sand top soil 0-0.10 m. The A2 horizon was reasonably shallow ranging in depth between 0.10 m and 0.35 m and consisted of a yellow to light yellow-brown sandy silt.
- The B horizon consisted of an orange yellow clayey sandy silt overlying a red silty clay with gravel between a depth of 0.30 m and 0.90m.
- The C horizon consisted of ferricrete and refusal between 0.70 to 1.20 m. In test pit 7 the ferricrete was broken through and a reddish yellow clay with <30 mm sub angular-rounded gravel to 1.50 mm was noted.

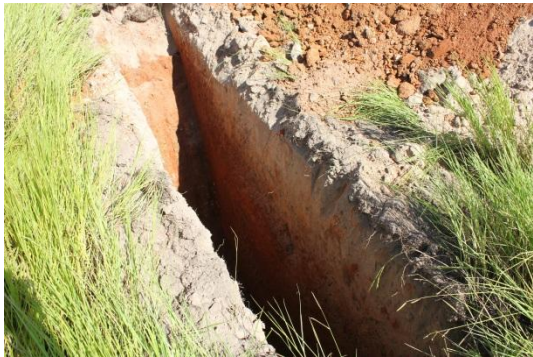
| <b>Photo</b><br> | <b>Other comments:</b> | <b>Parent material:</b> | Silt and sandstones |

| Sample No | Horizon | Horizon depth (mm) | Munsell Colour | Texture | Structure | Comments | pH | Mottles | Roots | Cracks |
|---|---|---|---|---|---|---|---|---|---|---|
| Sample | B3 | 1500-2500 | Red | Silty, sandy gravel | Nil | Decomposed materials | NA | Nil | Nil | Nil |

| | | <b>Surface slope:</b> | 1% |

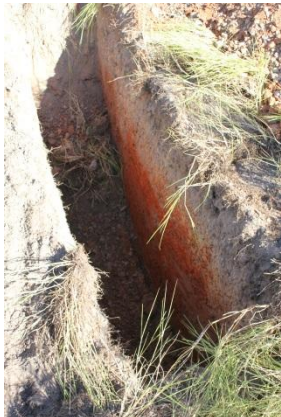
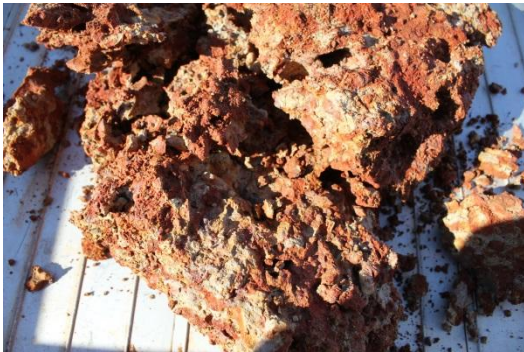
| | Ferricrete is porous and massive | Surface drainage: | Good |

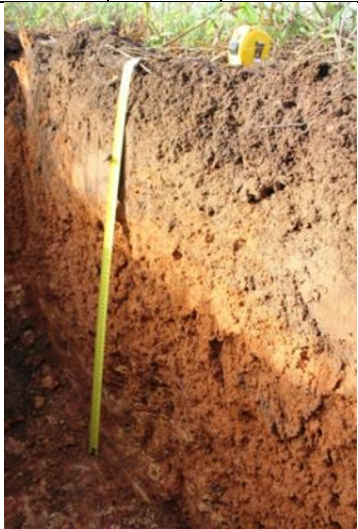
| | Other comments:<br>Refusal in Ferricrete at 1200mm | | | | | | Parent material: | Sedimentary Formations |

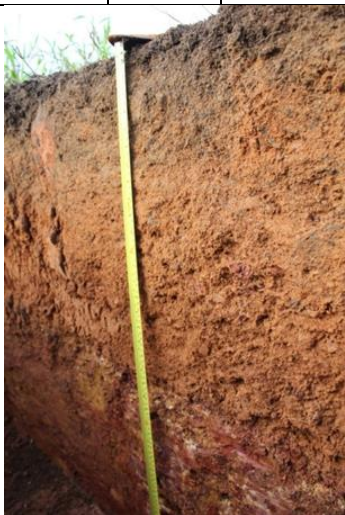
| | Refusal into weathered ferricrete 1.1m<br>Macro-pores noted at 1.1m | Surface drainage: | Good |

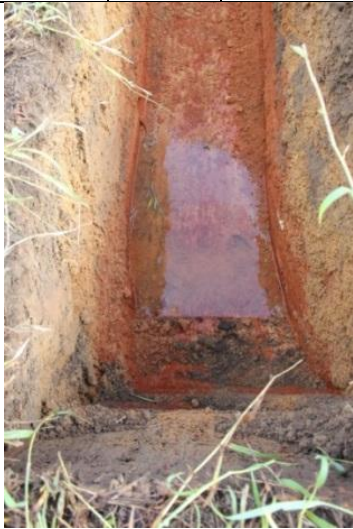
| | Other comments:<br><br>Refusal at 1150mm on Ferricrete<br>Water ingress at 1100mm; standing water level at 1500mm | | | | | | Parent material: | Sedimentary Formations |

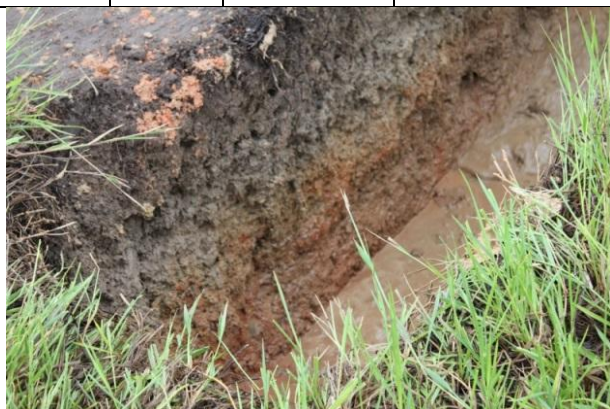
| <p>Other comments:</p> <p>Transient flowing water in A2 horizon overlying B1</p> <p>Transient flow in B2 overlying Ferricrete</p> | Parent material: | Sedimentary Formations |

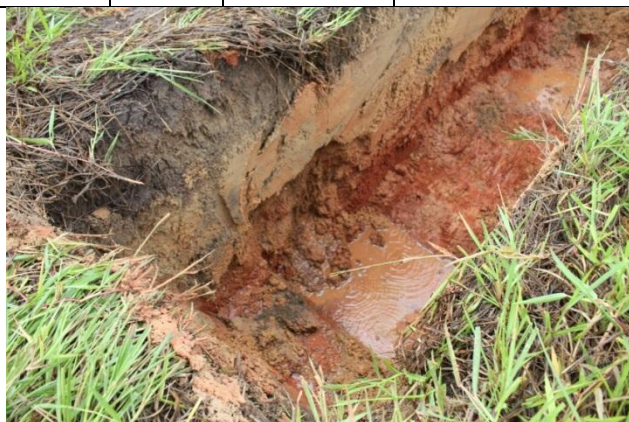
| <p>Other comments:</p> <p>Transient flows in B3</p> <p>Water rises through Ferricrete through macro pores</p> | Parent material: | Sedimentary Formations |

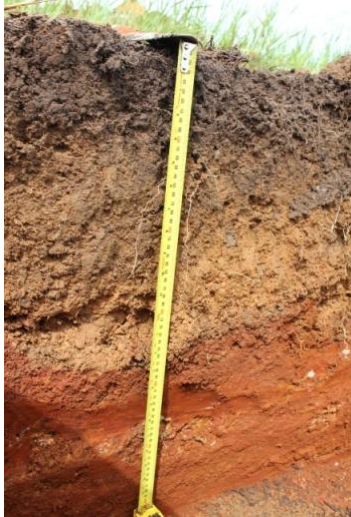
| | Quartz gravel enclaves in B1 and B2; very angular | Surface drainage | Good |
| | Refusal at 70cm | Surface slope: | 1-2% |

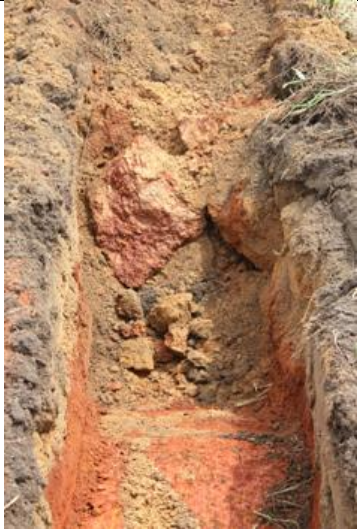
| | <p>Other comments:</p> <p>Ferricrete weaker than in other test pits; broke through Ferricrete; clayey gravel beneath; bulk sample collected.</p> | | | | | | Parent material: | Sedimentary Formations |

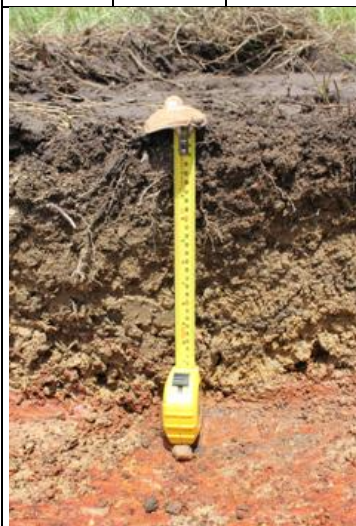
| <p>Other comments:</p> <p>Very shallow profile. Some water transient above ferricrete.</p> | Parent material: | Sedimentary Formations |

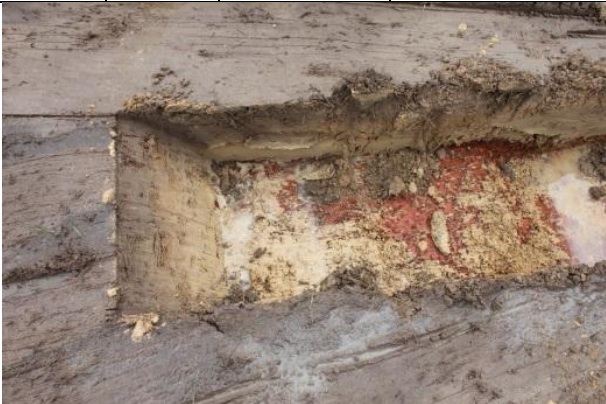
| | Land very saturated and soft<br>Test pit filled with water from transient flows | Surface drainage | Very poor |

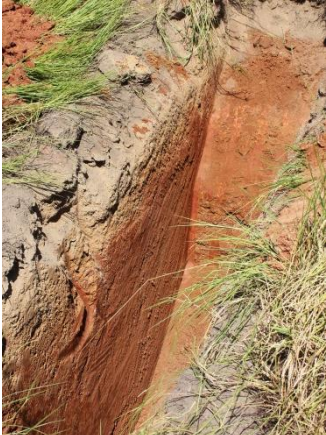
| <b>Photo</b><br> | <b>Other comments:</b> | <b>Parent material:</b> | Silt and sandstones |

| Sample No | Horizon | Horizon depth (mm) | Munsell Colour | Texture | Structure | Comments | pH | Mottles | Roots | Cracks |
|---|---|---|---|---|---|---|---|---|---|---|
| Sample | B3 | 1800-2500 | Red | Silty, sandy gravel | Nil | Decomposed materials | NA | Nil | Nil | Nil |

| | | <b>Surface slope:</b> | 1% |
