*Supplementary*  
*Archaeological and Historic Surveys*  
*for the*  
*Open Cut Pit Project*  
*McArthur River Mine, NT*  
*Draft report*

A report for URS on behalf of McArthur River Mines

Prepared by: Begnaze Pty. Ltd.

September 2005

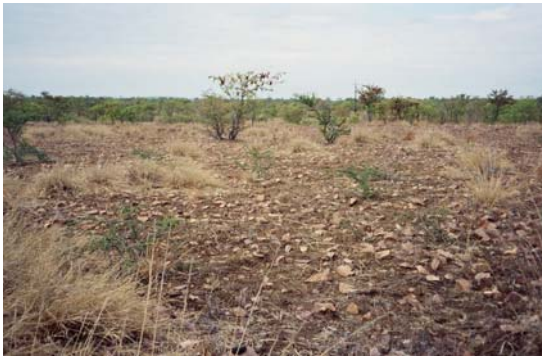
Photo 7. MRM4, facing north.

This site is situated on the eastern side of the road that goes to Emu Bore North on a gently undulating hill covered in a fine grained sandstone and siltstone cobbles that are floating in cracking clay soils. No areas of bedrock were observed. The density of the non-artefactual stone is approximately 30 per square metre. The area is covered by clumping grasses and isolated scrub that has been disturbed by cattle. The southern section of the site has been disturbed by shallow gully erosion.

The fracture planes on the majority of the artefacts manufactured from the local siltstone appeared quite fresh. This appearance is probably related more to the nature of the rock rather than any evidence that the artefacts were manufactured recently. There was evidence of a small proportion of the artefacts and non-artefactual stone being damaged by cattle trampling. The artefacts consisted of cores, that ranged in length from 40-170cm in length, with an average length of 70cm, and flakes that ranged from less than 10cm to 90cm in length with an average length of 60cm. There were very few small flakes, which was possibly caused by these artefacts falling between the cracks in the clays during the annual dry seasons. Only two artefacts were located from non-local rock. They were two unretouched dark grey siltstone flakes that appeared to be manufactured from a similar raw material to that identified in the quarries MRM3 and MRM4

*Site's relationship to the development.* This site is located within the boundaries of OEF and will be destroyed by the proposed development.

*Archaeological significance:* The size and concentration of artefacts identified at MRM4 suggest that this site was an important location for the procurement of the raw material used in the manufacture of stone artefacts. While cattle and the possible movement of smaller stone artefacts through the clay deposit have disturbed the site, it does have the potential to answer questions regarding stone reduction sequences and procurement methods for the region and has been assessed as having medium to high archaeological significance

- MRM4  
*Location:* 53 618364E 8184969N (datum WGS84)  
The site has been assessed as having moderate to high archaeological significance. If the area for the proposed Overburden Emplacement Facility cannot be moved to avoid this site it is recommended that before the Open Cut Project commences, permission should be sought from the Minister of the Environment and Heritage to destroy the site with the proviso that there is a detailed surface recording including a sample collection of artefacts and test pit excavation at the site.

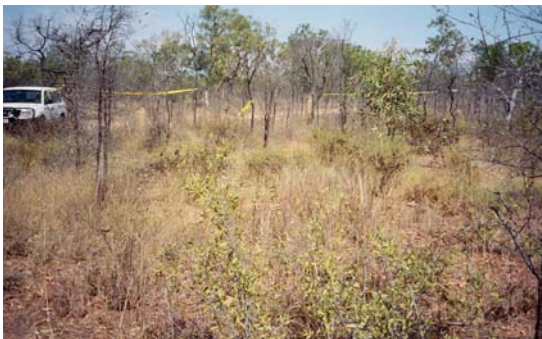
Photo 8. MRM5, facing west.

This small site is situated on a low gravely and stony rise located on a cracking clay plain covered in open scrub and clumping grasses. There are termite mounds in the vicinity. It is adjacent to the northern side of a track that goes to a water bore used by cattle and is 460 metre from the Carpentaria Highway. The main concentration of artefacts has not been disturbed by any road construction or maintenance. A relatively large billabong, that was dry at the time of the survey, is located 300 metres to the north.

The quarry is located over a low stone outcrop on a gravely rise that has an average of 80 non-artefactual stones per square metre that range in size from gravel to cobbles. The outcrop consists of sandstone through to siltstone and quartzite. The artefacts are manufactured from a very dark grey siltstone that weathers to a light grey colour and is similar in appearance to artefacts found in the quarry MRM3

*Site's relationship to the development.* This site is located outside the boundaries of the OEF and will not be disturbed by the proposed development.

*Archaeological significance:* This small site has been assessed as having low to medium archaeological significance. The main research potential for this site is that the contents of this site can be used as a comparison with MRM3 where a similar raw material has been quarried.

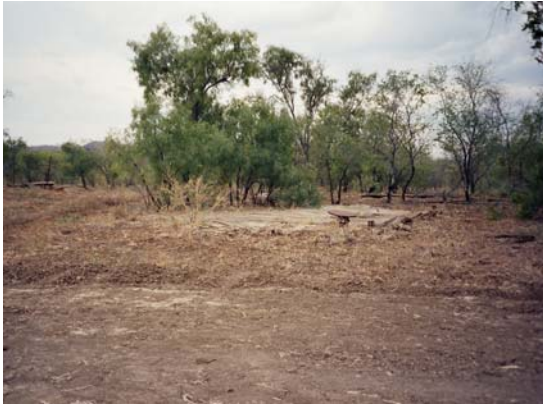
Photo 9. MRMH1, facing east

This mining campsite consists of three concrete floors and a rubbish dump located around the intersection of two tracks. The concrete floors consisted a larger floor, possibly the living quarters, a smaller toilet block floor (identified by the presence of a broken toilet bowl) and a generator floor (identified by the presence of metal bolts used to attach the generator to the floor). Other items scattered around the area included the remains of a refrigerator, wooden palettes, galvanised pipes, the rubber base of a shoe, a mattock head and beer stubby bottles. The rubbish dump contained mostly the remains of tins of food. Other items included 'Tarax' aluminium orange drink cans, a 'Castelmaine XXXX' beer can with '13 fluid oz' of beer, a Union Carbide battery, a tube of toothpaste labelled 'Colgate dental cream with gardal' and the remains of crockery manufactured in Australia marked 'Bristile' 'Hotel China'. One unusual item was a chain made from the ring-pull tabs on soft drink cans.

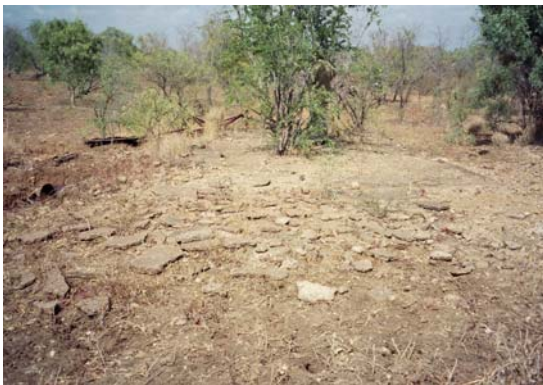
Photo 12. MRMH2, largest concrete floor

The remains of this mining campsite are approximately 400 metres southeast of MRMH1 and located on the southern side of a track that goes to MRMH1. It is adjacent to a small ephemeral creek. The remains include a broken concrete slab floor, a stone arrangement that is possibly the remains of a camp fire, a smaller concrete floor, 2 x 2m, that slopes slightly in one direction and is possibly the remains of a toilet block, and seven aligned areas that have been levelled and covered in small stones. These may represent areas that were covered by small tents possibly for sleeping. There were several large tent pegs still implanted in the ground next to the cleared areas. Other smaller items in the area were a man's metal watchband, sections of core drills, metal tools and bits, 44-gallon drums, galvanised sheets, star pickets and car tyres.
