## Aquatic Fauna Assessment

## Vista Gold Australia Pty Ltd

Mt Todd Gold Project  
Aquatic Fauna Study

May 2013

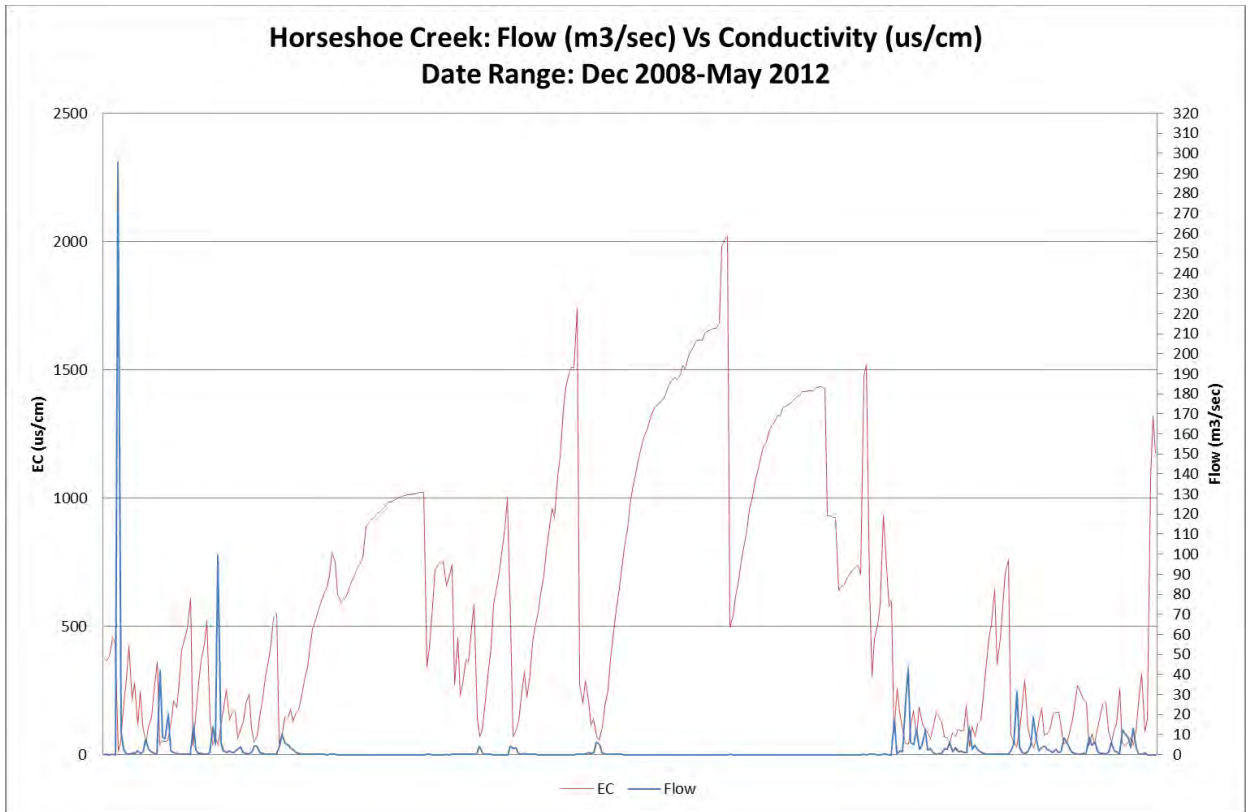
There is an existing gauging station located on Horseshoe Creek which monitors continuous flow, electrical conductivity and pH. Records for this gauging station date back to 17/12/2008 (Envirotech Monitoring 2012). Demonstrated in Figure 6, this figure shows a strong relationship between flow and electrical conductivity where low flow periods directly correspond with high conductivity levels, providing further evidence that seepage has an influence on Horseshoe Creek.

**Figure 6** Horseshoe Creek SW11 Gauging Data (Daily Average)

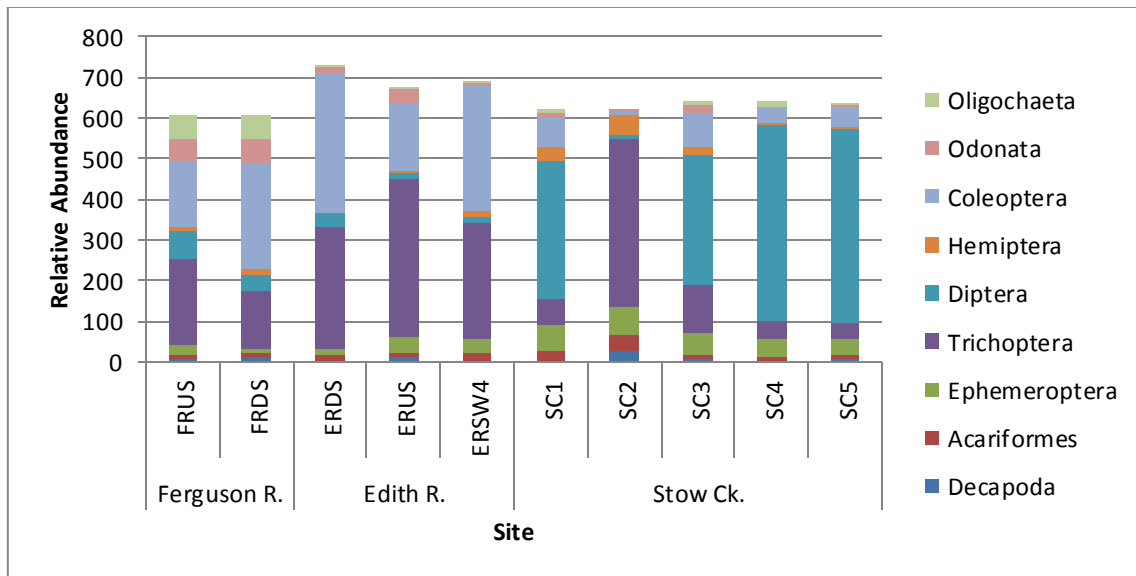
Figure 11 lists the macroinvertebrate orders that dominated the community assemblage at each site. This figure is a combined total of each of the three replicates. Community composition varied across the three waterways. The Fergusson River and Edith River communities were relatively similar with Trichoptera and Coleoptera taxa dominating the community assemblage. Trichoptera taxa are generally regarded as pollution sensitive and the high representation of these taxa in Edith and Fergusson River indicates that the water quality and habitat are of good quality.

Trichoptera and Coleoptera taxa were present in Stow Creek although Dipteran taxa dominated the community. Dipterans are known to have a wide tolerance to pollution. The high representation of these taxa in Stow Creek indicates a possibly higher level of impact to this waterway.

**Figure 11 Relative Abundance of Macroinvertebrate Taxa**

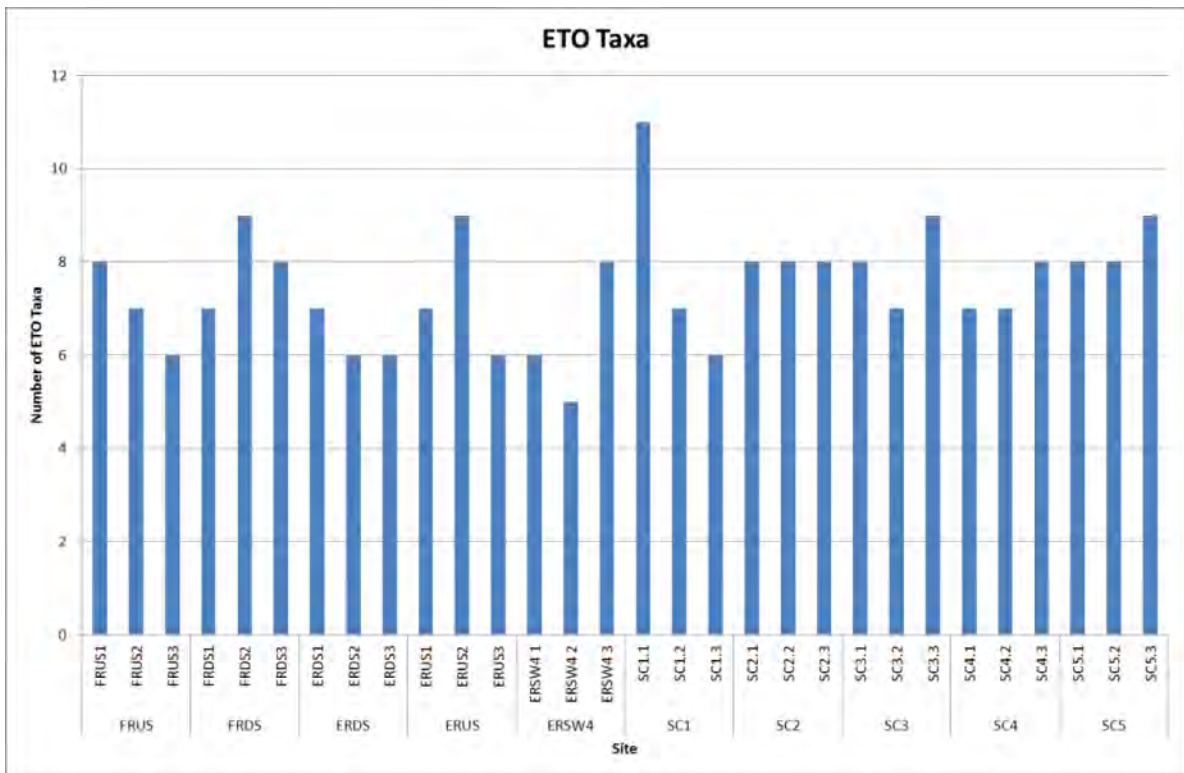
The ETO ratio of the macroinvertebrate data indicate that the diversity of disturbance sensitive taxa across all sample sites was relatively consistent (Figure 13) with the ratio varying between 0.33 and 0.44 (Table 10).

Figure 13 Overall Number of ETO Taxa Sampled During 2011 Survey

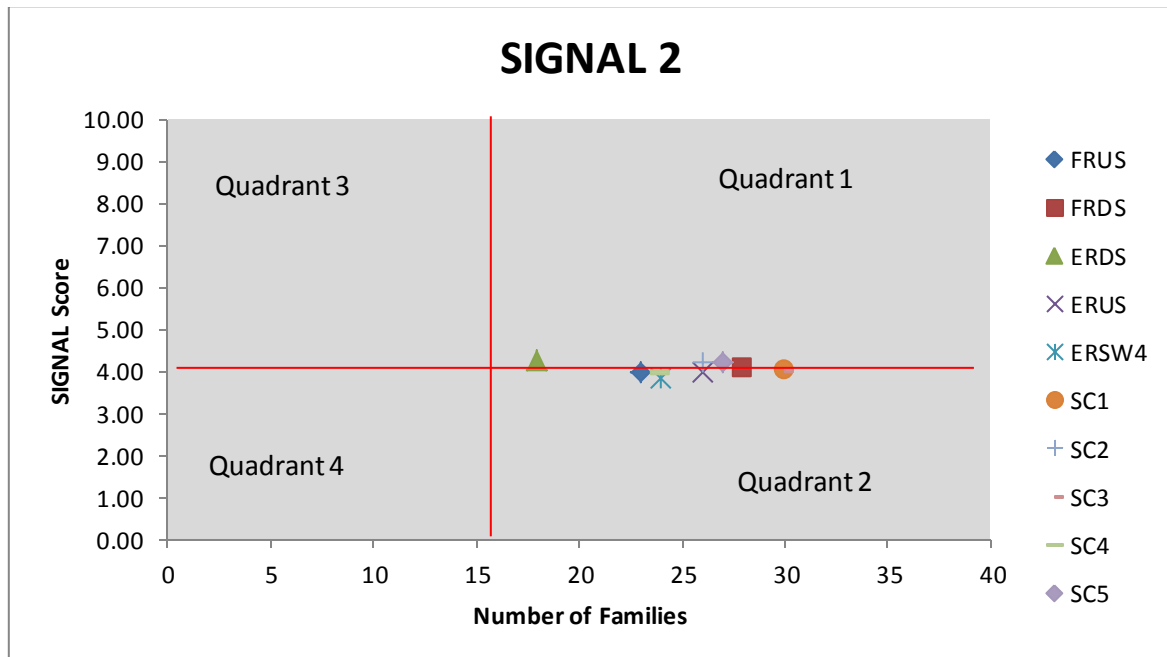
The SIGNAL 2 analysis indicates that the macroinvertebrate habitat and water quality is of good condition with all sites falling on the cusp of Quadrant 1 and 2 (Figure 14).

**Figure 14 SIGNAL 2 Biplot for Mt Todd Sample Sites.**

Samples in Quadrant 1 have relatively high diversity and SIGNAL 2 score, which suggest that the sample was collected from an area with high habitat diversity and an absence of toxic chemicals and harsh physical conditions.

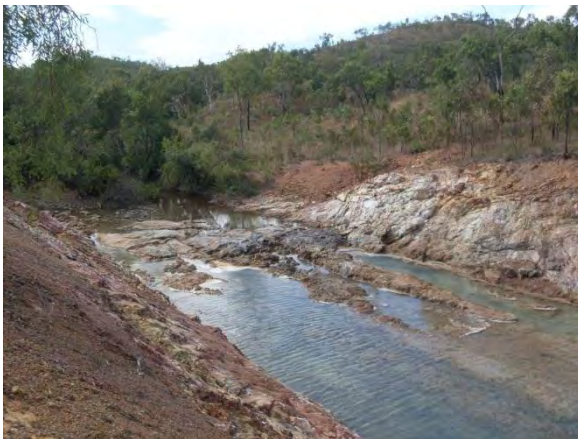
**Photo 21 Horseshoe Creek existing upstream diversion**

The creek line downstream of the raw water storage overflow had steep earthen banks with some exposed roots at the water's edge. Fallen trees with collected organic litter extended from the edge to well into the stream. The principal in stream habitats were rock cobble substrate (80%) and 20% sand silt. Horseshoe Creek lacks sand beds/bars such as occur in Stow Creek and the Edith River. It is unlikely to provide nesting habitat for the freshwater crocodile.

The channel varies in width from approximately 3 to 10 m, with depths from 0 m (dry sections) to greater than 2 metres in the holes. The width of the stream between the tops of the banks varied along the stream from 10 to 40 metres.

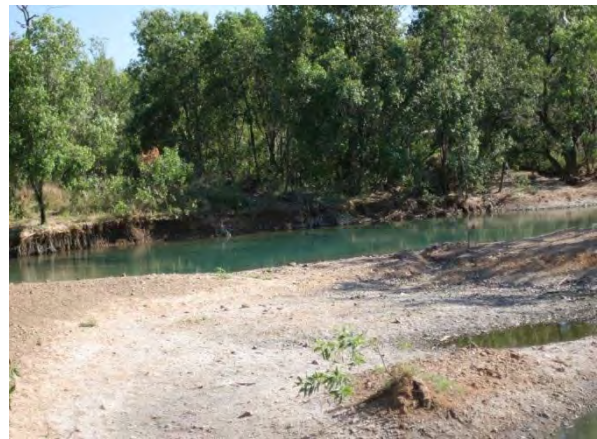
**Photo 22 Location of proposed diversion**

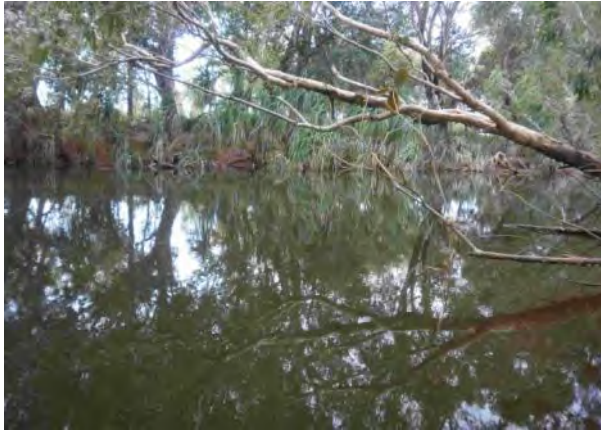
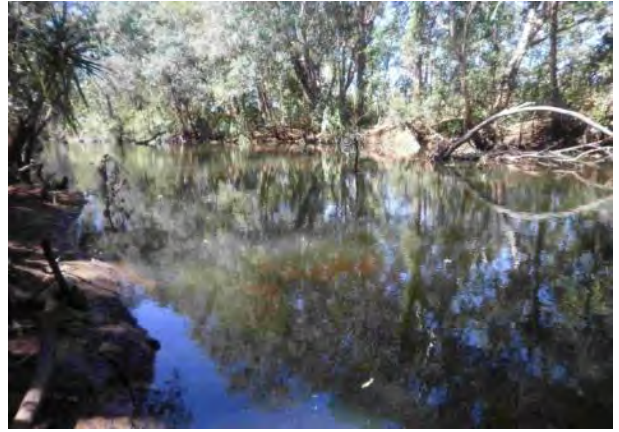
**Edith River Downstream (ERDS)**

Site Location	Site ERDS is located on Edith River, approximately 0.75 km downstream of its confluence with Stow Creek.
Surrounding Land Use	The land use on both sides of the creek at the sampling site is 'native woodland' forestry with no evidence of human impact and no evidence of fires beyond the levee banks.
Stream Dimensions & Flow	The channel sampled varied in width from approximately 16 to 45 meters, and from 0.5 to 1.6 meters in depth. The width of the stream between banks varied along the study site between 75 and 140 meters. At the time of sampling flow conditions in the river were low.
Riparian Zone and Bank Composition	<p>The riparian zone was approximately 10 m on the left bank and &gt;50 m on the right bank. Vegetation cover of the river ranged between 5-45% and was dominated by a range of small trees and shrubs (&lt;5 m) and larger trees (&gt;15 m). All riparian vegetation observed was native with no evidence of recent fires.</p> <p>The creek banks at the sampling location were earthen on both sides with some embedded cobbles. Bank stability appeared to be good.</p>

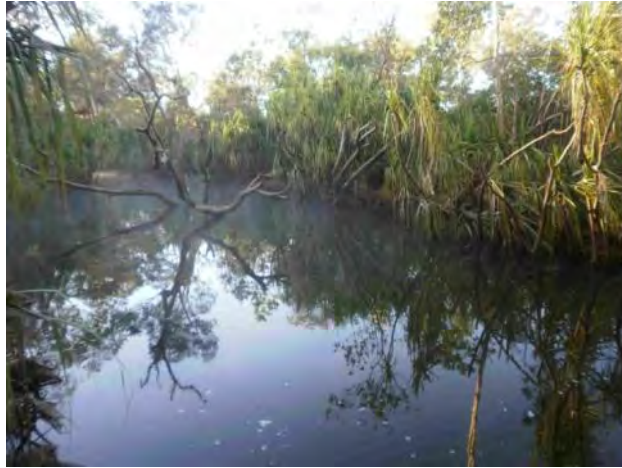
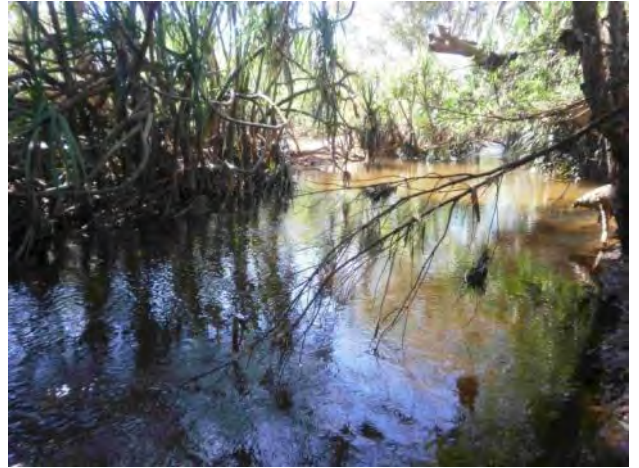
## Edith River Upstream (EDUS)

Site Location	Site EDUS is located on the Edith River, approximately 0.55 km upstream of its confluence with Stow Creek.
Surrounding Land Use	The land use on both sides of the creek at the sampling site is 'native woodland' forestry with no evidence of human impact and no evidence of fires beyond the levee banks.
Stream Dimensions & Flow	The channel sampled varied in width from approximately 5 to 15 meters, and from 0.3 to 1.5 metres in depth. The width of the stream between banks varied along the study site between 130 and 200 metres. At the time of sampling flow conditions in the river were low to almost no flow.
Riparian Zone and Bank Composition	The riparian zone was approximately 10 m on the left bank and 25 m on the right bank. Vegetation cover of the river was between 10 – 50% and was dominated by a range of small trees and shrubs (<10 m) and a few larger trees (>10 m). All riparian vegetation observed was native with no evidence of fires. The creek banks at the sampling location were earthen on both sides with some embedded cobbles. Bank stability appeared to be good, but some areas indicated some minor erosion of the bank.

Floodplain Characteristics	The floodplain for this river can be characterised as a broad valley
Available Habitat	<p>In the reach, the edge habitat comprised steep to shallow earth banks with some exposed roots of large trees at the water's edge. Fallen trees with collected organic litter extended well into the stream from the edge.</p> <p>In the stream, principle habitats comprised macrophytes (95%) and either sand/silt (45%) or gravel/rock substrates (55%) with some riffles (10-60%).</p>

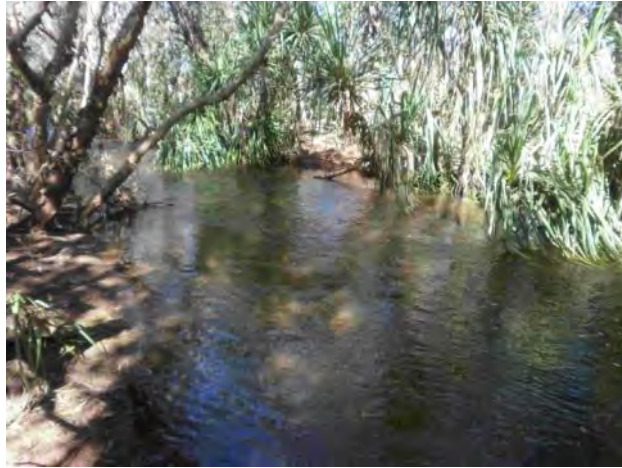
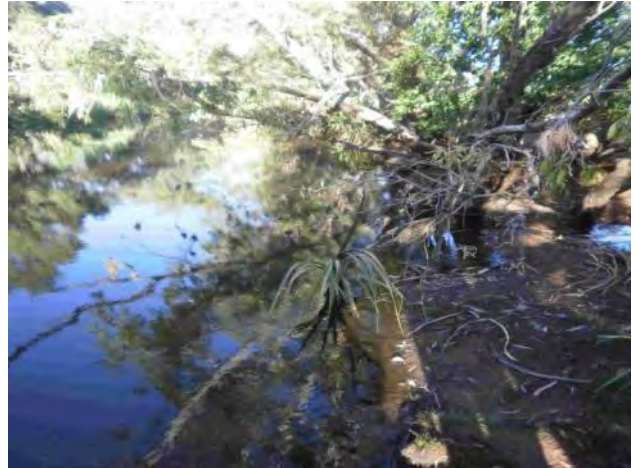
### Edith River Surface Water Site (ERSW4)

Site Location	Site ERSW4 is located on the Edith River, approximately 1.4 km downstream of its confluence with Stow Creek.
Surrounding Land Use	The land use on both sides of the creek at the sampling site consisted entirely of 'native woodland' forestry little evidence of human impact. There was no evidence of fires between the river channel and the levee banks.
Stream Dimensions & Flow	The channel varied in width from approximately 4 to 25 metres, and from 0.3 to to depth greater than 1.5 metres.  At the time of sampling flow conditions in the river were low to moderate, with riffles present at the shallower areas of the study site.
Riparian Zone and Bank Composition	The riparian zone was approximately 15 m on the left bank and 50 m on the right bank. Vegetation cover of the river ranged between 10 – 40% and was dominated by a range of small trees and shrubs (<8 m) and a few larger trees (>15 m). All riparian vegetation observed was native with no evidence weed infestation.  The creek banks at the sampling location were mostly earthen on both sides with some embedded cobbles, and some rock bars running into the water. Bank stability appeared to be good.

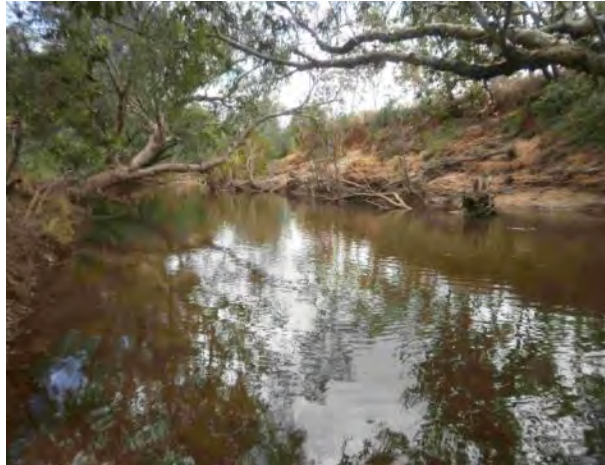
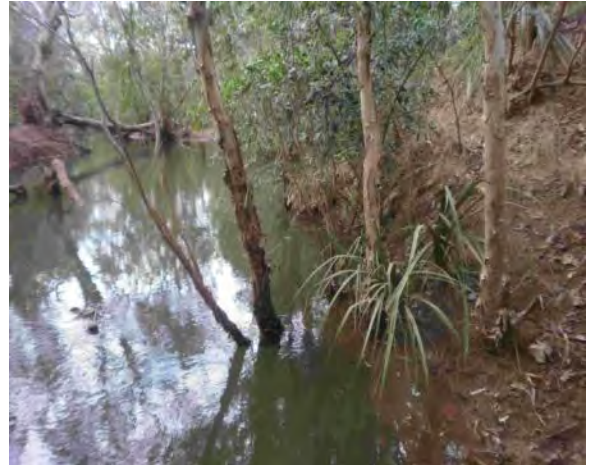
**Fergusson River Upstream (FRUS)**

Site Location	Site FRUS is located on the Fergusson River, approximately 20km northeast of the mine site.
Surrounding Land Use	The land use on both sides of the creek at the sampling site is 'native woodland' with no evidence of human impact and no evidence of recent fires beyond the levee banks.
Stream Dimensions & Flow	The channel sampled varied in width from approximately 7 to 20 meters, and from 1 to depths greater than 2 metres. The width of the stream between the top of the banks varied along the study site between 45 and 80 metres. At the time of sampling flow conditions in the river were low.
Riparian Zone and Bank Composition	<p>The width of the riparian zone ranged from 25m on the left bank and 10m on the right bank. Vegetation cover of the river ranged between 10 – 40% and was dominated by a mix of small trees and shrubs (&lt;4m) and a few larger trees (&gt;20m).</p> <p>All riparian vegetation observed was native with no evidence of fires or weed infestation. The creek banks at the sampling location were mostly steep and earthen on both sides with some embedded cobbles, and some rock facades running into the water. Bank stability appeared to be good.</p>

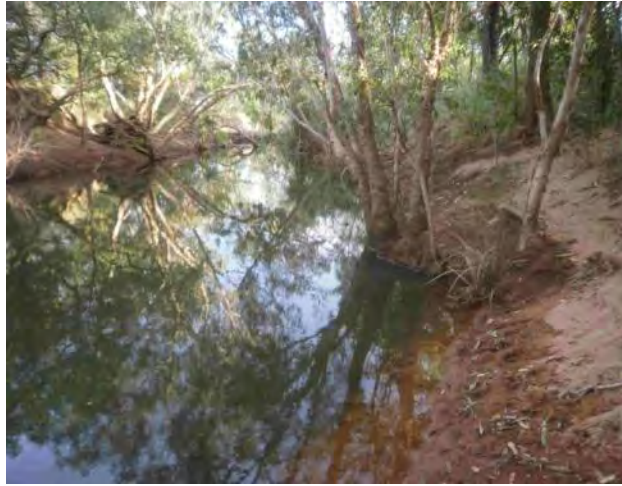
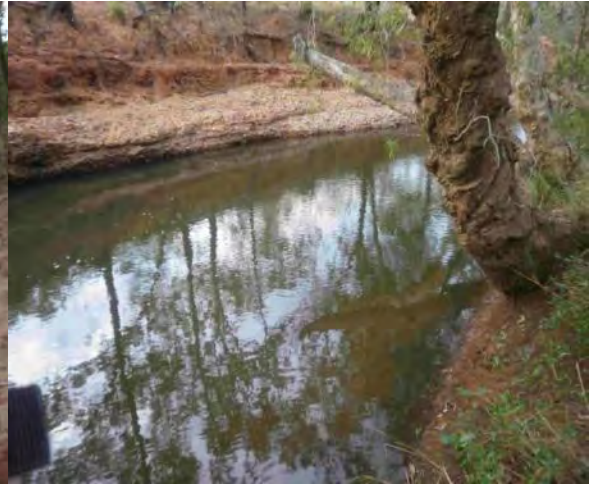
## Fergusson River Downstream (FRDS)

Site Location	Site FRUS is located on the Fergusson River, approximately 22km northeast of the mine site.
Surrounding Land Use	The land use on both sides of the creek at the sampling site consists entirely of 'native woodland' with no evidence of human impact and no evidence of recent fires beyond the levee banks.
Stream Dimensions & Flow	<p>The channel width varied in from approximately 6 to 22 metres, and depth ranged between 0.5 to depths greater than 2 metres. The width of the stream between the tops of the banks varied between 30 and 50 metres.</p> <p>At the time of sampling flow conditions in the river were moderate.</p>
Riparian Zone and Bank Composition	The riparian zone was approximately 50m on the left bank and 15m on the right bank. Vegetation cover of the river was between 0 - 30% and was dominated by a range of small trees and shrubs (<3m) and a few larger trees (>15m). All riparian vegetation observed was native with no evidence of fires. The creek banks at the sampling location were mostly steep and earthen on both sides with some embedded cobbles, and some rock facades running into the water. Bank stability appeared to be good.
