# 1. Executive Summary

## 1.1 The Proposal

The Northern Territory University (NTU) as part of its 10<sup>th</sup> year anniversary celebrations desires to construct an ornamental lake and ceremonial entrance to the university. The site for the proposed ornamental lake and ceremonial entrance is along the southern boundary of the University's Casuarina Campus, which is situated in the northern suburbs of Darwin, approximately 12km from the city centre. Ceremonial Drive will link Lakeside Drive with the University's Southern Ring Road to the north.

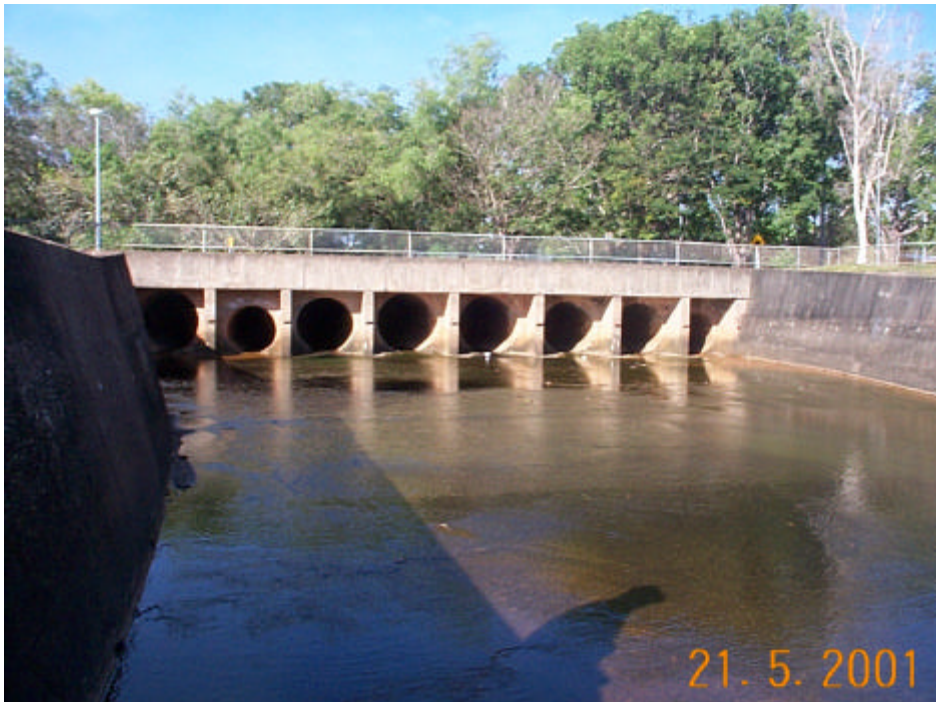
■ Figure 3.1: Upstream end of concrete lined drain showing culverts. Note low dry season flow.

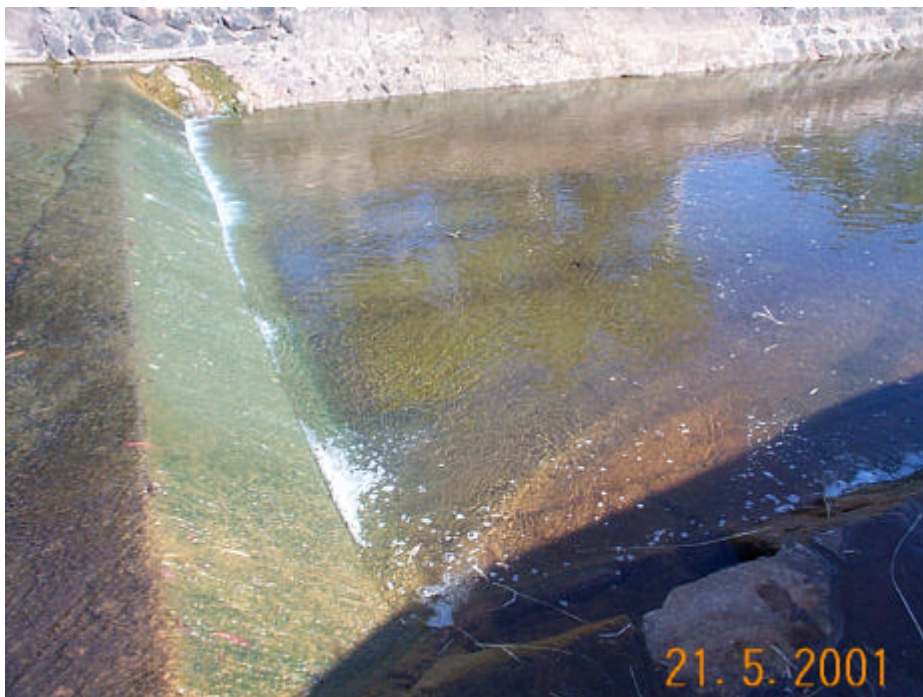
■ Figure 3.2: Step in drain downstream of culverts. Note presence of film of algae on substrate above and below step.

Presently there is no restriction of access for marine fauna except that caused by decreasing depth of the drain toward the stormwater pipes, and the presence of the step in front of the culverts. Following construction of the lake, there will be some reduction of access upstream of the proposed weir. However, movement into and out of the lake will still be possible for marine fauna due to the design of the weir that allows tidal intrusion approximately 15 times per month.

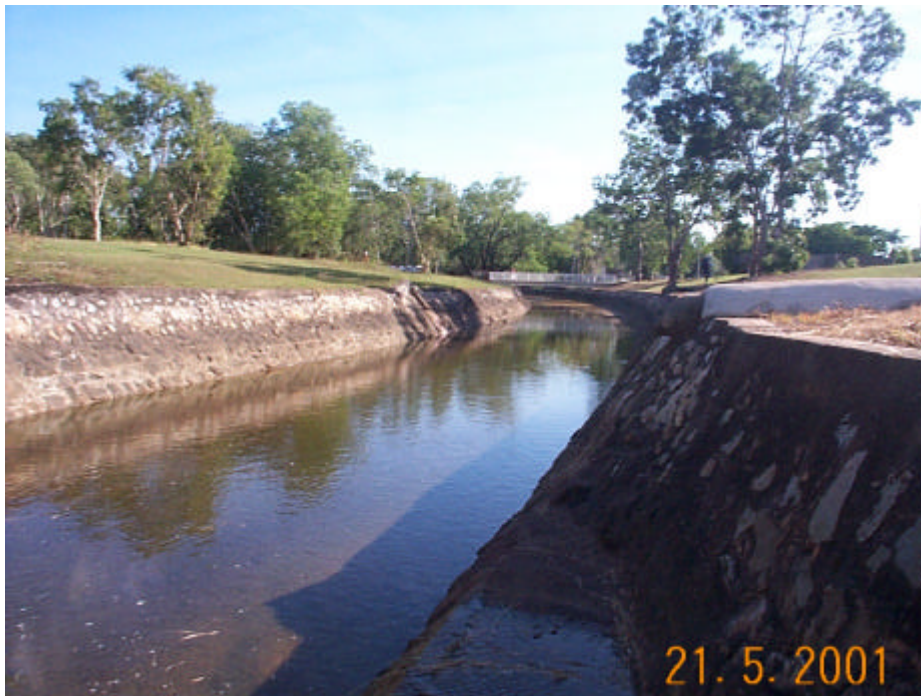
■ Figure 3.3: View looking downstream toward footbridge at low tide, dry season.

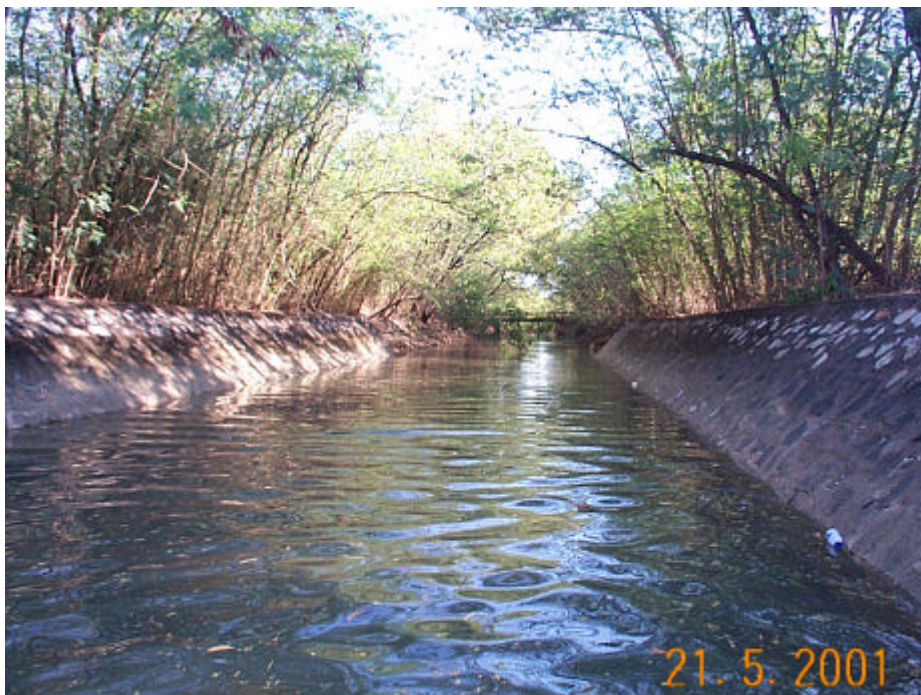
■ Figure 3.4: View of lower end of formed drain on rising tide, with lower footbridge in distance. Note thickets of coffee bush on both banks.

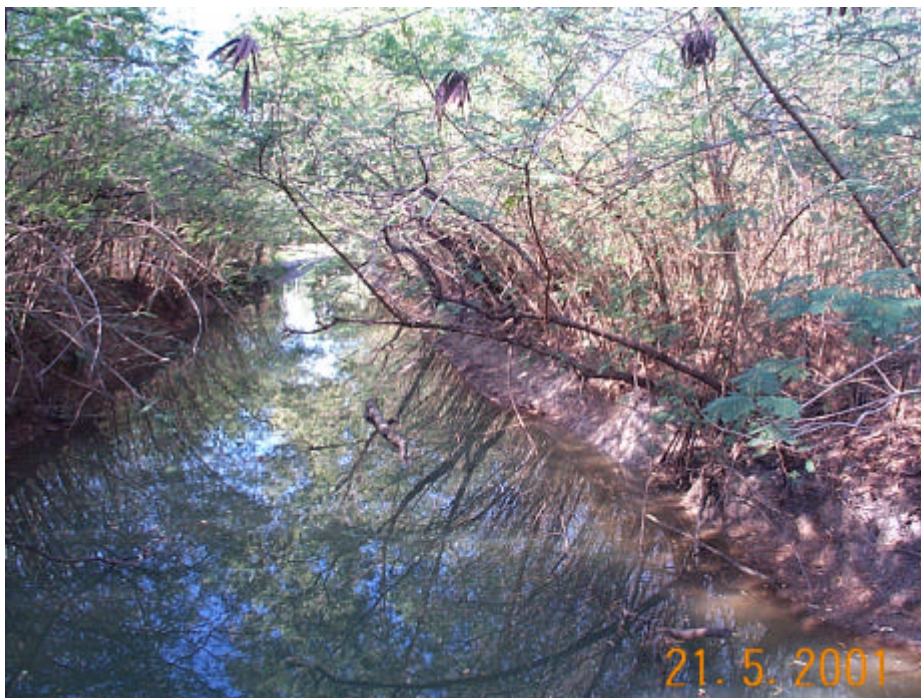
- **Figure 3.5: View looking upstream from lower footbridge. Here the substrate is a mixture of sand, gravel and rocks with some pieces of timber and rotting vegetation.**

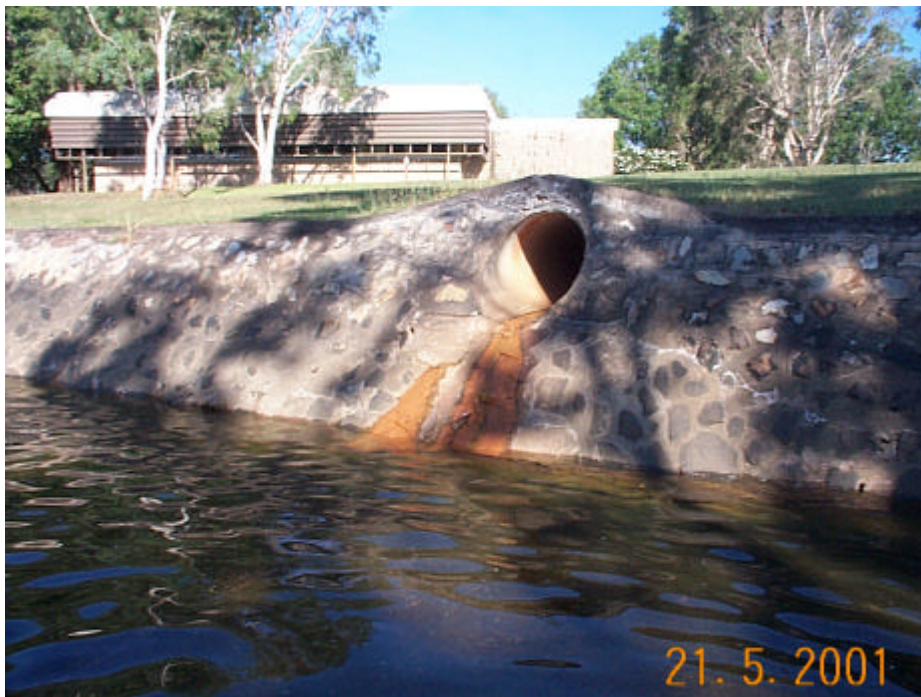
- Figure 3.6: The largest formed stormwater drain that discharges into the NTU drain. Note brown stain of algae growing in effluent stream.

Smaller open drains and stormwater pipes discharge runoff into Rapid Creek or the large open drain. **Figure 3.6** shows the end of a stormwater drain that discharges into the larger NTU drain in the area where the proposed lake will be sited.

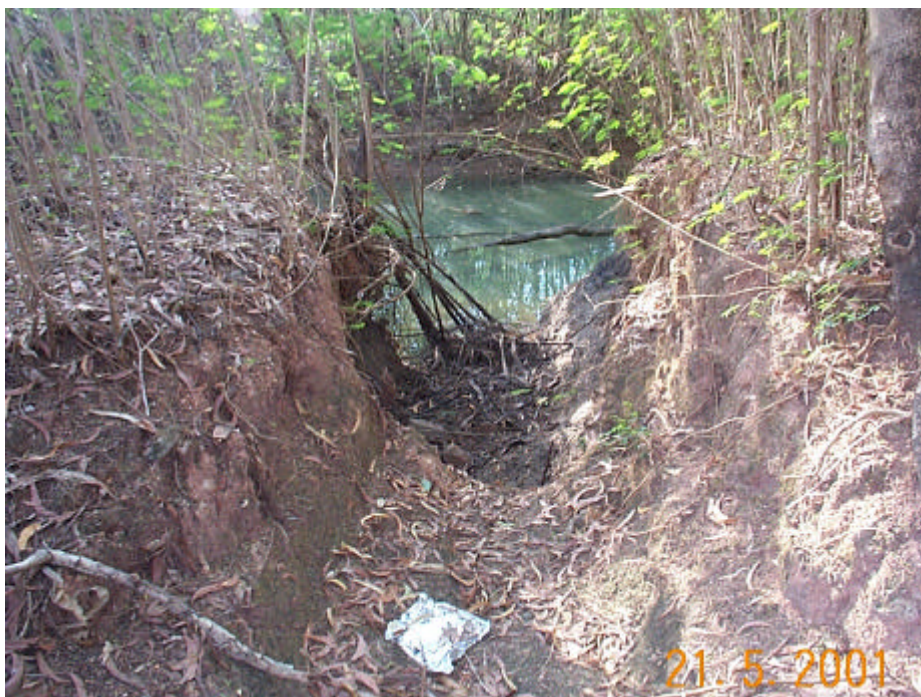
- Figure 3.7: Large drainage channel discharging into lower end of NTU drain just upstream of lower footbridge. Note evidence of erosion of banks and presence of rubbish.

**Figure 3.7** shows a unformed drainage channel with erosional features that drains a small patch of disturbed forest before entering the NTU drain just upstream of the lower footbridge.

The smaller channels are typically steep sided and deep, providing optimum conditions for weed growth and mosquito habitat if water ponds during periods of low flow. They are, therefore, undesirable features in the landscape.
