## Technical memorandum

The following document outlines the outcome of drone surveys undertaken over identified potential groundwater dependent ecosystems (GDEs) near the Fountain Head Gold Project.

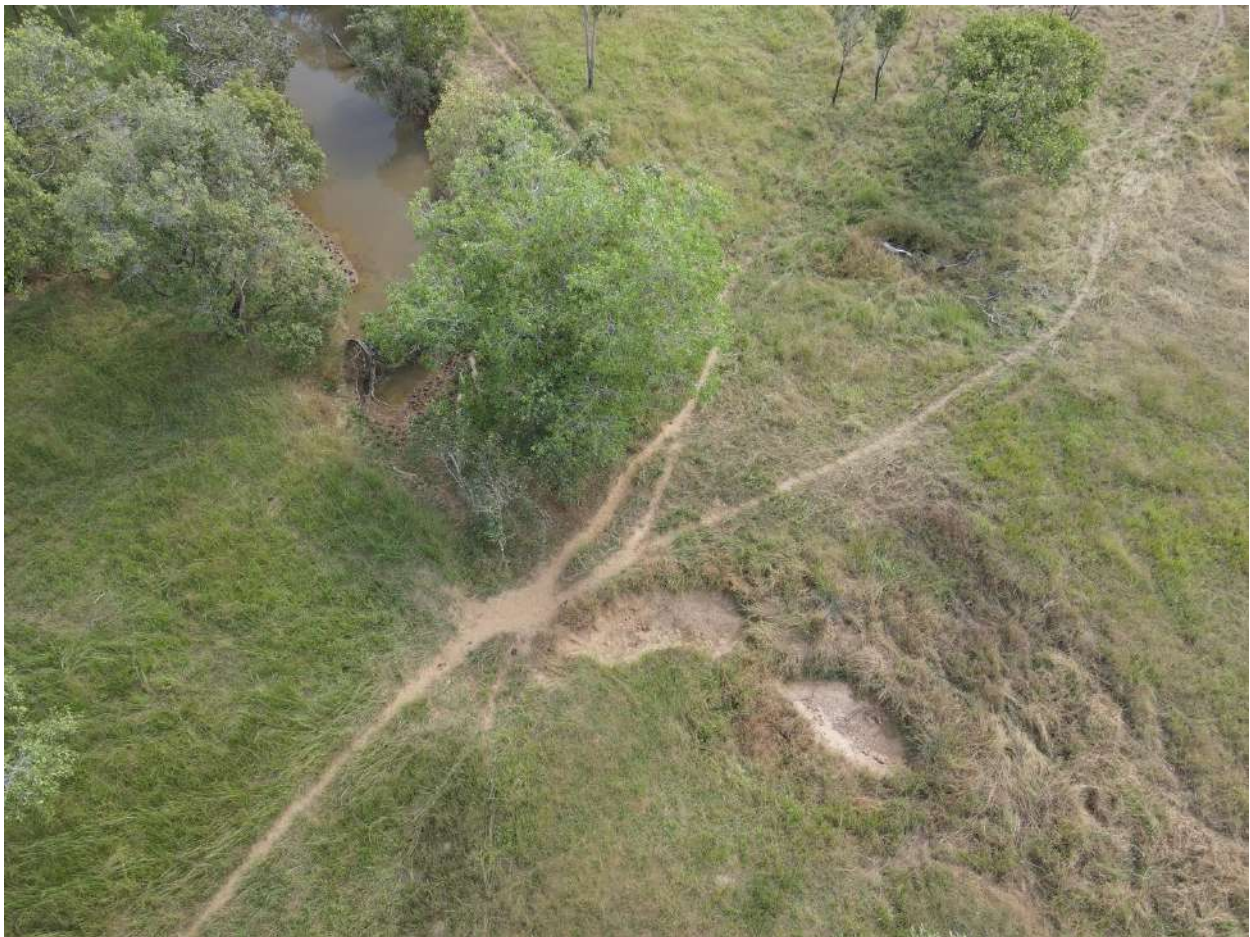
Drone surveys were completed on 27<sup>th</sup> April 2022. A total of 4.2km was surveyed by from Ban Ban Springs Road crossing to the Billabong inflow. A section of approximately 200m towards the centre of the unnamed creek was not able to be processed into an orthomosaic layer due to file corruption, and the result of the survey is presented in Figure 1. The creek was characterised by an incised, meandering channel. Standing water was present along the length of the creek in the form of isolated pools, and flow was not observed. The riparian zone of the creek was narrow and discontinuous and was obviously disturbed by cattle grazing and wallowing of livestock (Photo 1).

*Photo 1 – Several wallows and cattle tracks present in the riparian grassland adjacent to the Unnamed Creek*

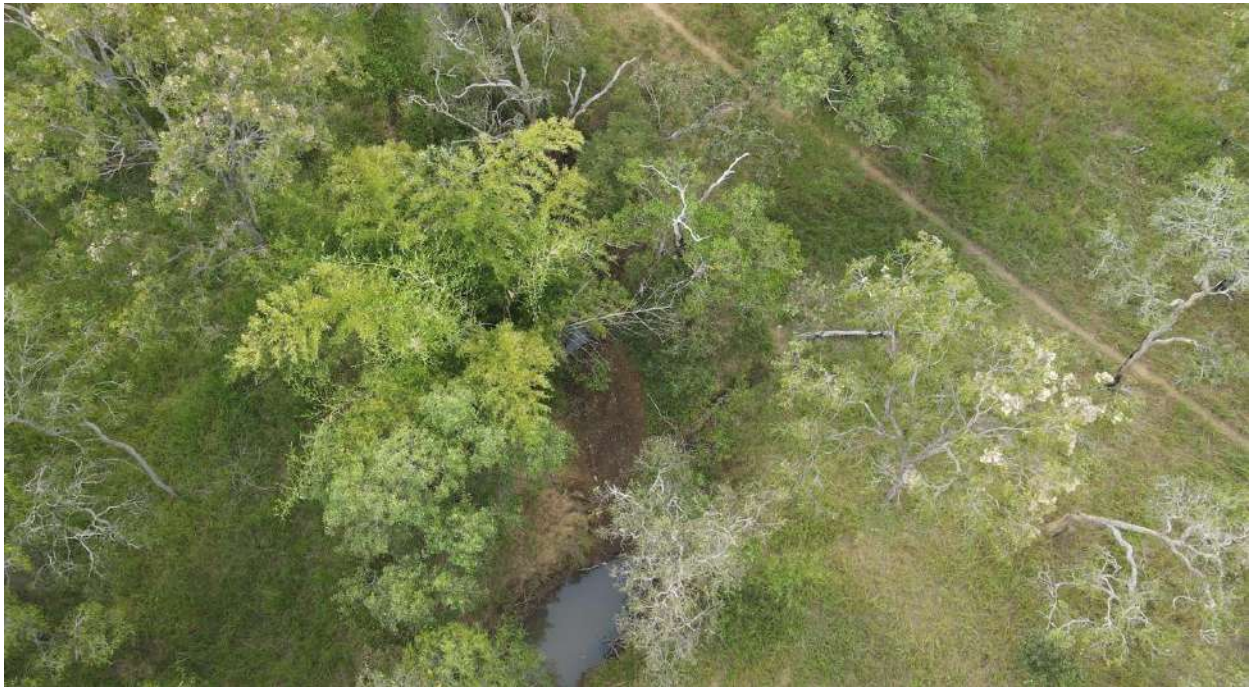
Riparian vegetation was dominated by an understorey of native and pasture grasses, broad leaf tea-tree (*Melaleuca viridiflora*), ear-pod wattle (*Acacia auriculiformis*) and northern swamp mahogany (*Lophostemon grandiflorus*) with mix of other dry scrub and sclerophyllous shrub species. These species are considered shallow-rooted and would be resilient against drying of surface and pore water (Boland 1990; Skull and Congdon 2008). These tree species can be reliant on overland flow, creek flows and soil saturation during the wet season. Bamboo (*Bambusa arnhemica*) was also common but growing sparsely

on the banks of the unnamed Creek (Photo 2). The species is naturalised in the NT and is associated with the riparian zone of ephemeral creeks, and able to withstand low soil moisture for prolonged periods (Franklin 2004).

*Photo 2 – Bamboo growing on edges of the Unnamed Creek*

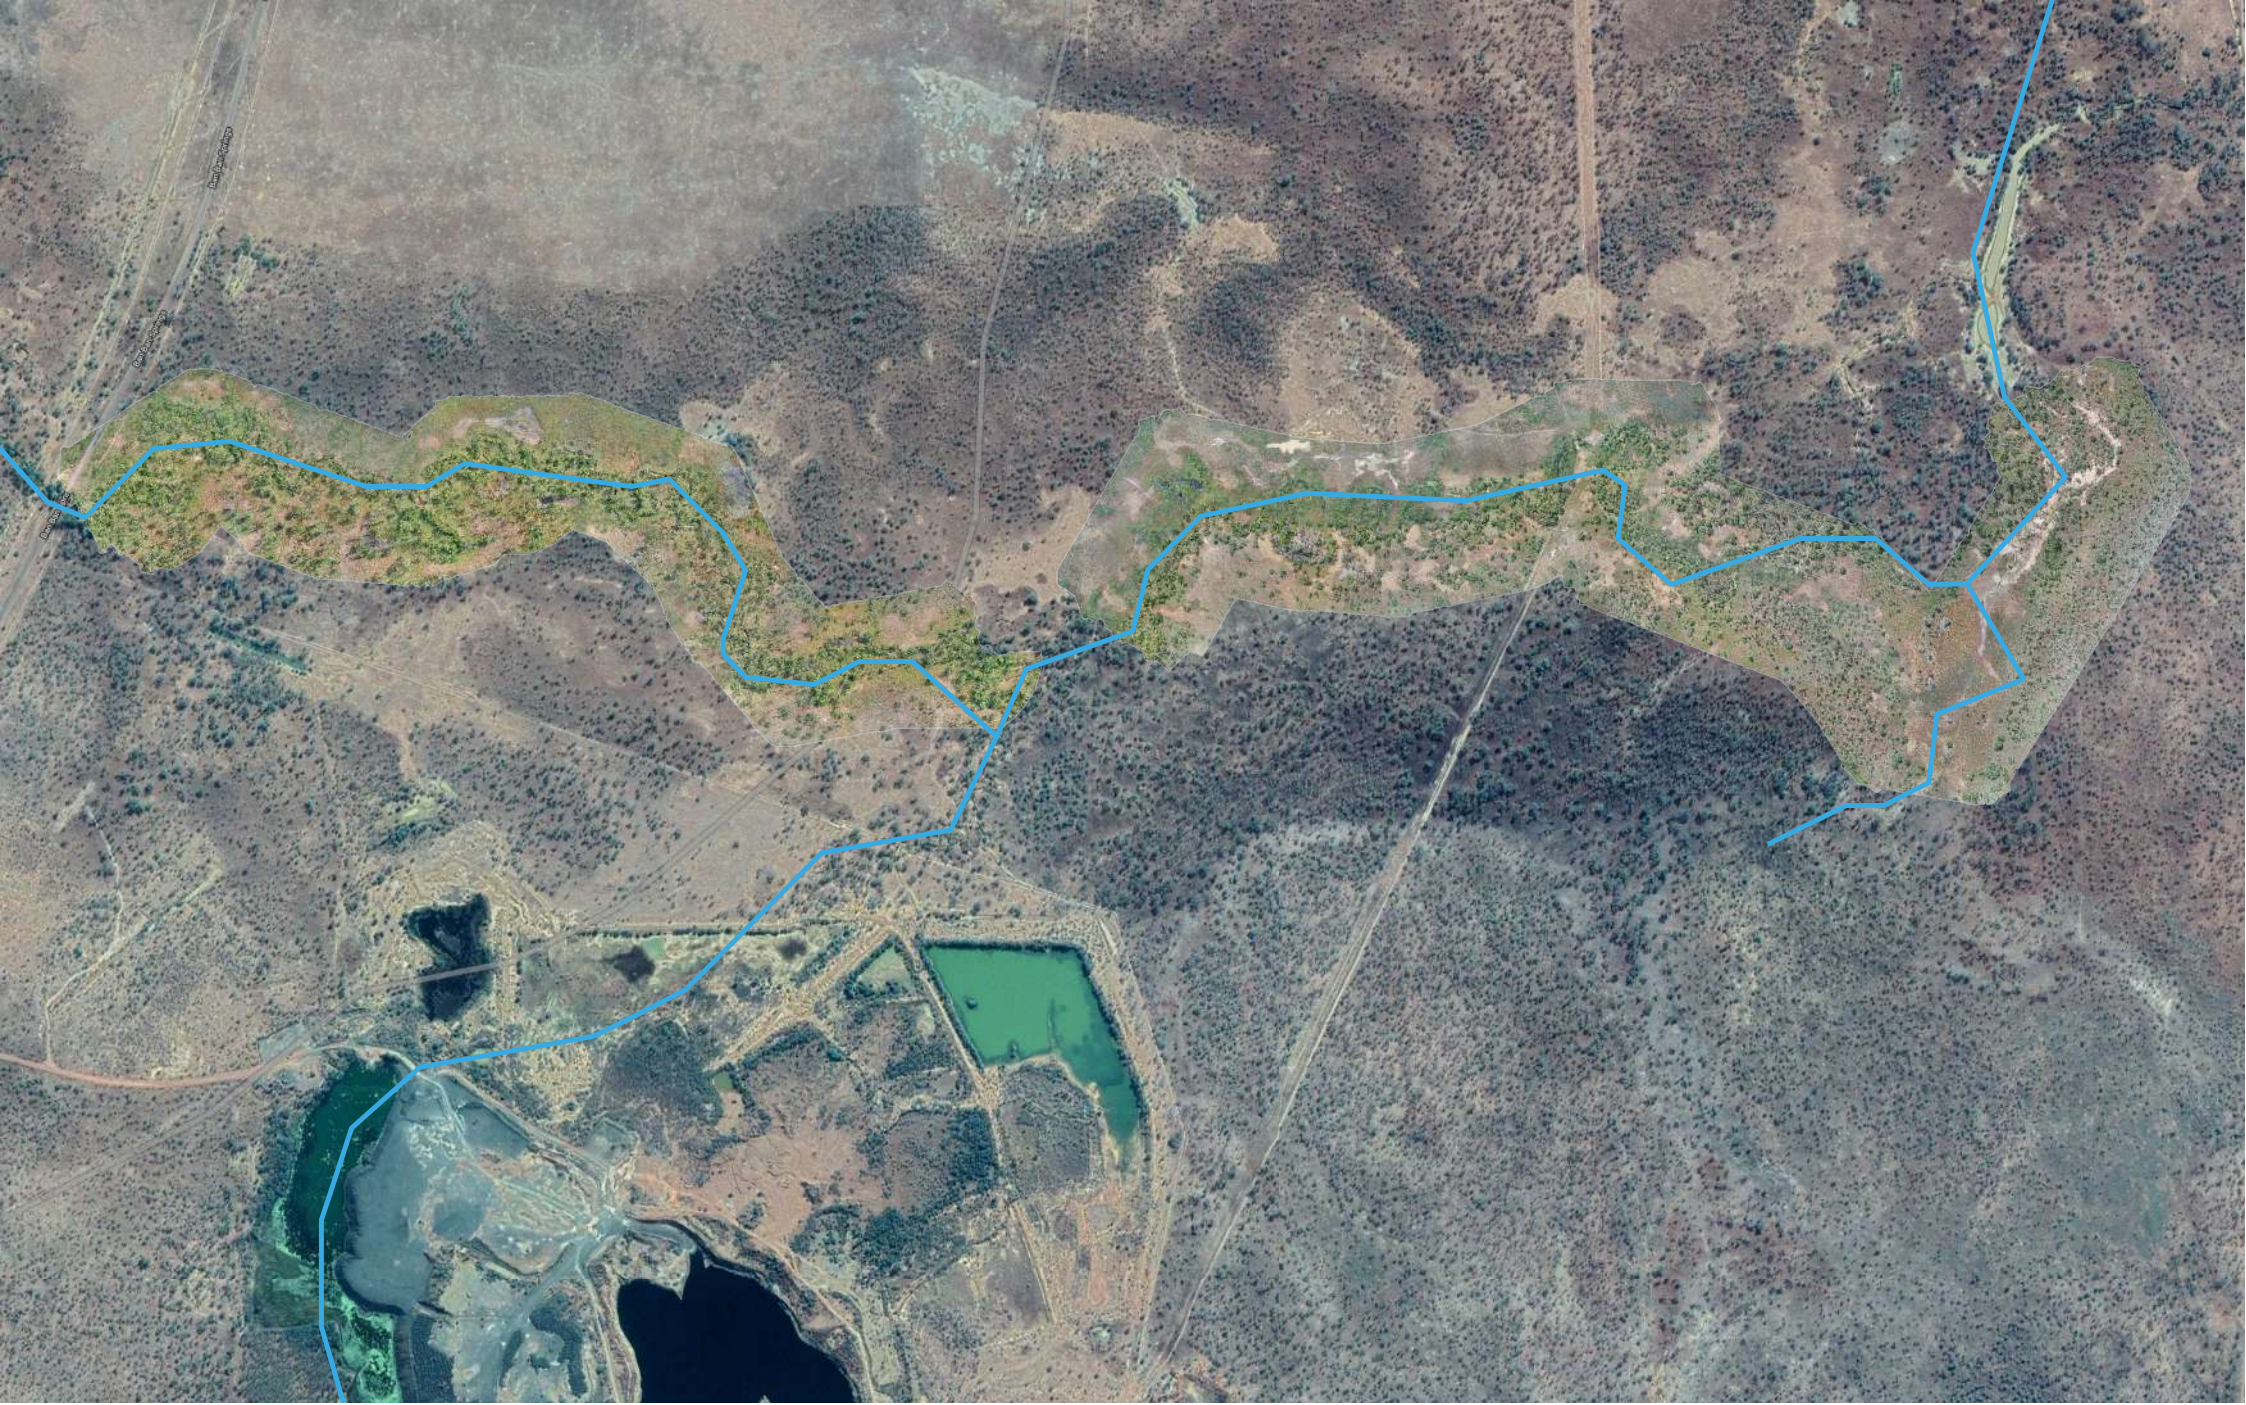
Fountain Head Gold Project Groundwater Dependent Ecosystem Survey  
Figure 1 - Unnamed Creek mapped using drone photogrammetry, April 2022

The survey timing suggests that surface water observed in the Unnamed Creek is the result of wet season rainfall, rather than groundwater baseflows. The lack of surface water flows does not necessarily discount the presence of groundwater baseflows, as these may be present as subsurface flow connecting pools. However, the riparian vegetation observed does not give a strong indication that pore water is perennially present within the root zone of the vegetation. The Unnamed Creek is unlikely to be a terrestrial GDE and its “low potential” as mapped in the GDE Atlas appears to be correct.

It should be noted that the shallow-rooted nature of the vegetation that is present has the potential to be impacted by drawdown that alters availability of alluvial groundwater. Further surveys would be required if drawdown modelling suggests the unnamed creek would be impacted by dewatering at FHGP. A follow-up survey in the late dry season to establish surface and sub-surface water availability including leaf-water potential is required to accurately define the Unnamed Creek as a GDE, but this appears unlikely.

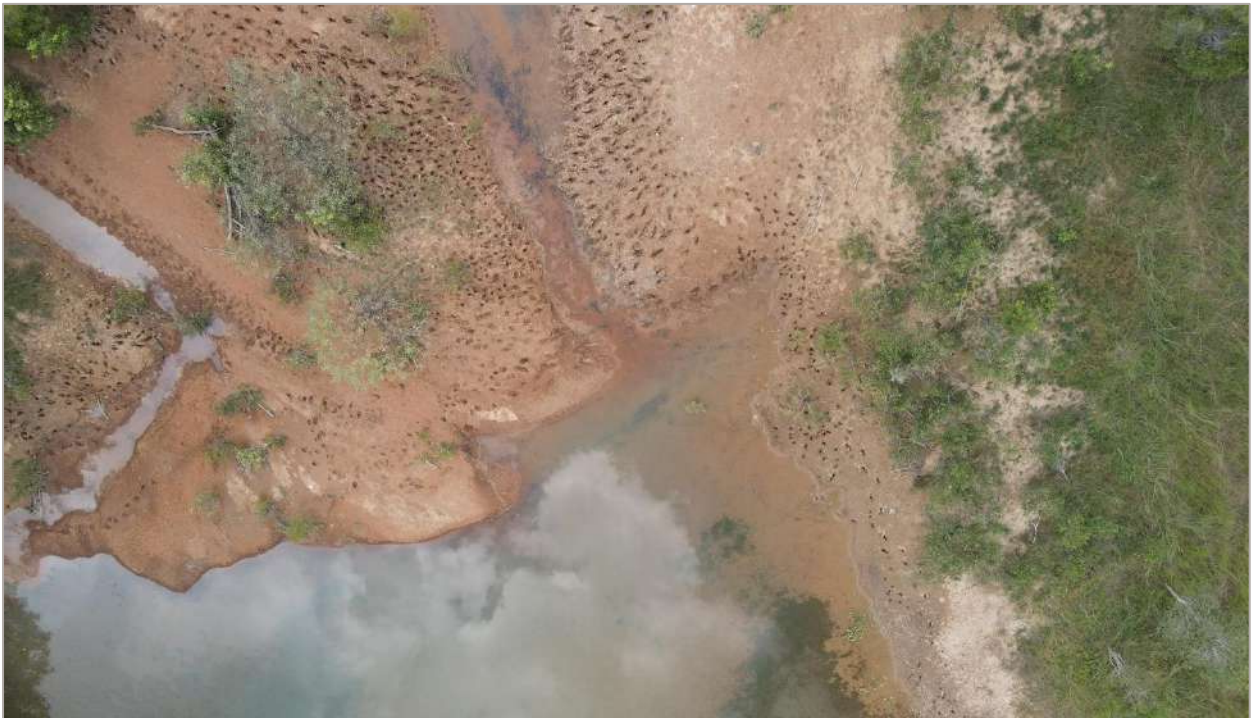
Water in the southern pool was clear and with a mixture of submerged and floating macrophytes and appeared to be around 1-2m deep. The billabong showed signs of being accessed by livestock, and pugging along banks associated with cattle or other hard-hoofed animals was evident (Photo 3). Wallows, cattle pads, and tracks were also observed surrounding the billabong. The Northern pool was turbid, with steeper banks than the southern pool and fringed by floating macrophytes. Due to low water clarity the depth of the northern pool could not be determined, but the wetted banks indicated that the water level had dropped recently by around 0.5m (Photo 4).

*Photo 3 – Cattle tracks (pugging) on banks of the billabong*

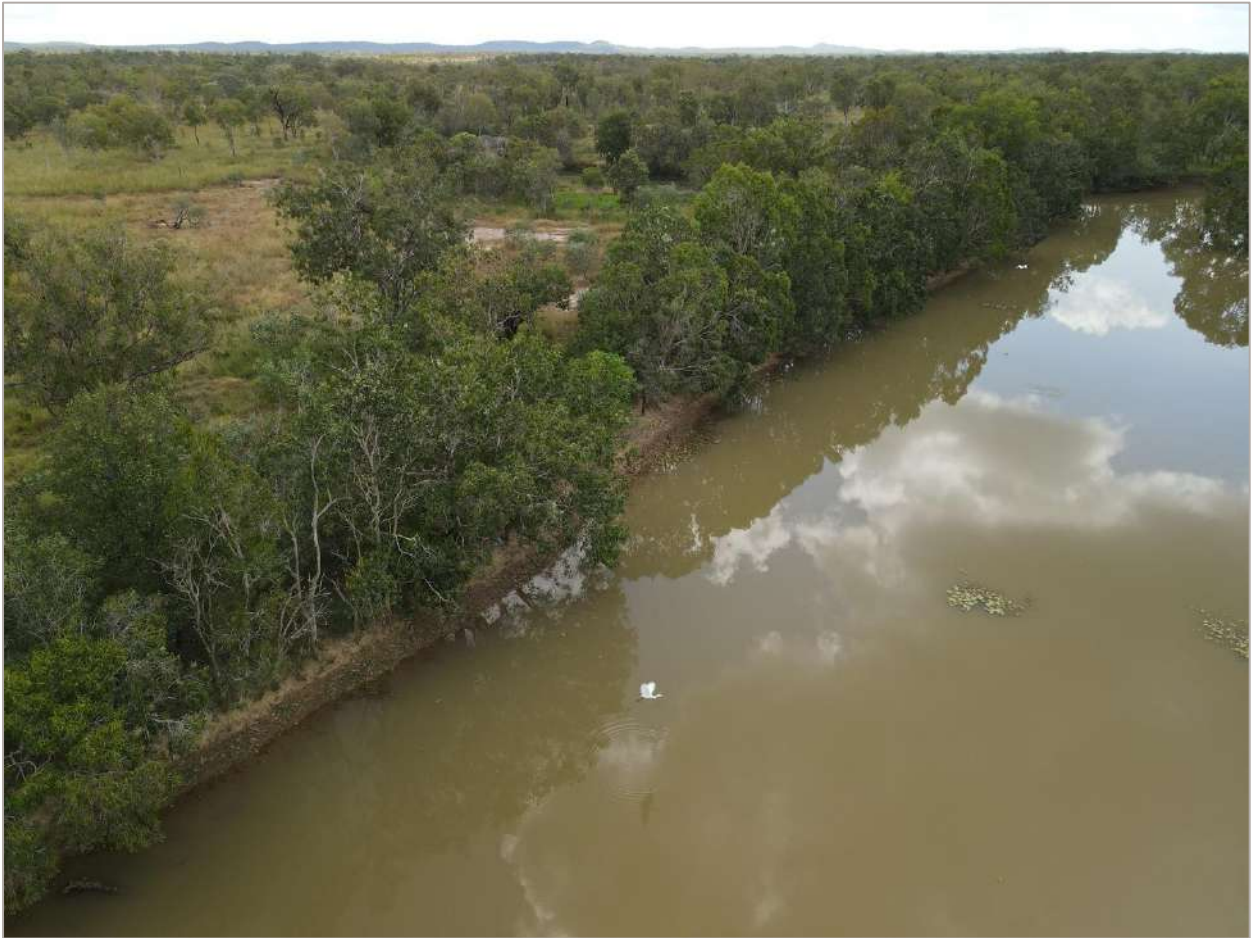
Vegetation surrounding the billabong was dominated by broad leaf tea-tree. There were narrow, dense stands of vegetation along the banks of the northern pool (Photo 4), which were taller than the same trees growing along the Unnamed Creek, but vegetation was not continuous around the entirety of the billabong. The composition of riparian vegetation was similar to the Unnamed Creek but did not contain any bamboo. The understorey of the riparian zone was also a mix of pasture grasses and broad areas of bare ground that were potentially covered by surface water until a short time earlier (including the area of bare ground separating the two pools).

*Photo 4 – Riparian vegetation along the northern pool of the billabong*

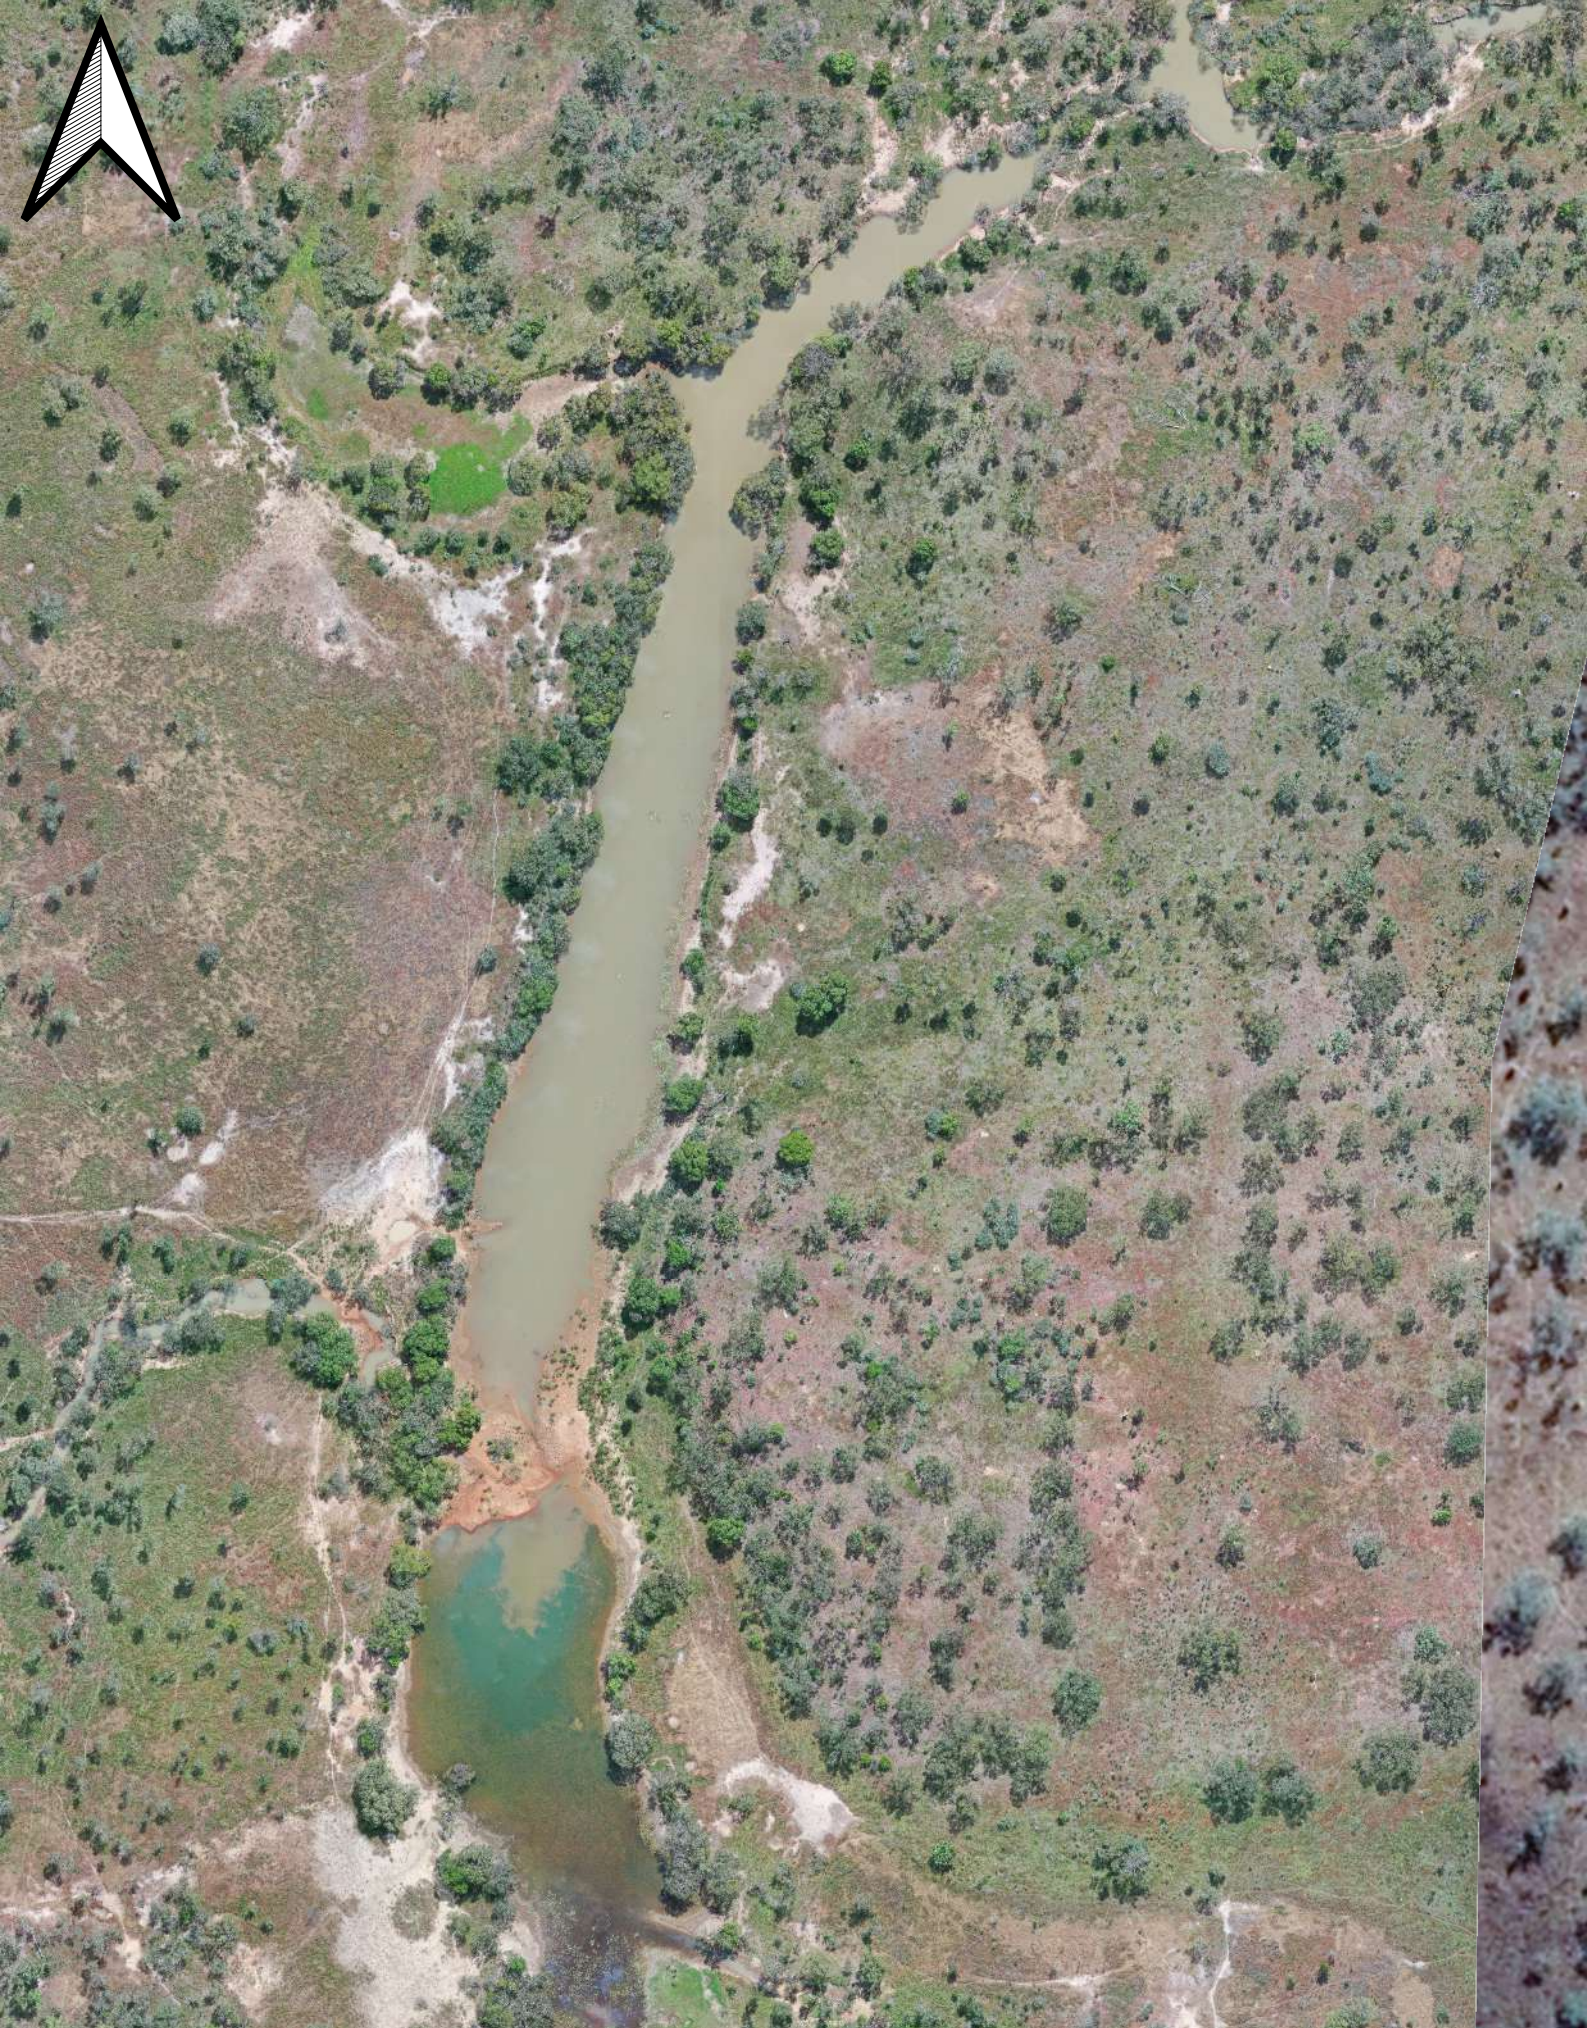
An area of 33 hectares was surveyed by drone to map the extent of surface water and associated riparian vegetation at the billabong located north-east of the FHGP (Figure 2). The billabong covered approximately 1.3 hectares of the survey area and was divided into two main pools. The two pools were connected by a narrow channel that was flowing slowly from the southern pool to the northern pool. There were two surface water inflows to the billabong, the unnamed creek to the west (surveyed area) and an unnamed creek to the south. A channel on the northern tip of the billabong appeared to head north-east towards the Margaret River. There was no inflow/outflow observable at the time of the survey.

Fountain Head Gold Project Groundwater Dependent Ecosystem Survey  
Figure 2 - Billabong mapped using drone photogrammetry, April 2022

The height and density of vegetation surrounding the billabong, along with aquatic vegetation indicates that soil moisture is present for longer than in creeks and is likely to be permanent. The low-lying area in which the billabong is situated indicates that soil is likely to stay saturated by rainfall for a long period of time following the wet season, and may be resulting in slow, subsurface water flow to the billabong, maintaining its surface water height. Water accumulated in the billabong at the time of the survey was likely to be from creek inflows, but appears to be deeper than creeks and may intersect an alluvial aquifer. The intersection of an alluvial aquifer, or groundwater baseflow from the Unnamed Creek would maintain surface water in the billabong and classify the water body as a GDE.

The timing of this survey in the early dry season makes a clear determination of water permanency and its origin difficult. The GDE Atlas determined the billabong as a high potential aquatic GDE, which appears to be correct and could be confirmed through a follow-up drone survey and analysis of surface water remaining later in the dry season. Should water permanency be confirmed, the billabong would be an important refugial area for aquatic species, particularly when below average wet season rainfall occurs.

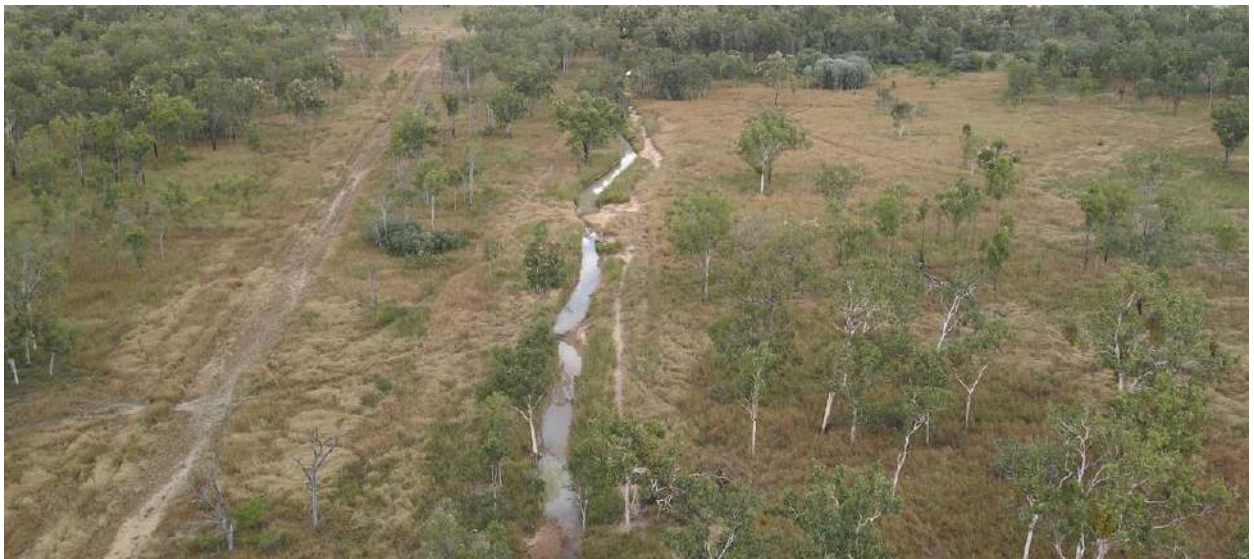
To the north-east of the billabong a channel and wetland area that appeared to be fed by outflow from the billabong was observed. At the time of the survey there was no discernible flow from the billabong, but the channel was incised, indicating flow occurs in the wet season. The channel was a series of isolated pools at the time of the survey and appeared to be drying rapidly. The channel was largely surrounded by grass, with only a small number of trees along the edges. Water was observed flowing north of the wetland but was not in a defined channel and appeared to be overland flow into a dense forest. Vegetation surrounding and within the wetland was a mixture of pasture grasses and broad leaf tea tree. Sedges were also present, but could not be identified. Cattle and buffalo were observed along edges of the wetland and in the surrounding vegetation. Cattle tracks were common along the channel and surrounding the wetland.

*Photo 5 – Channel leading north from billabong*

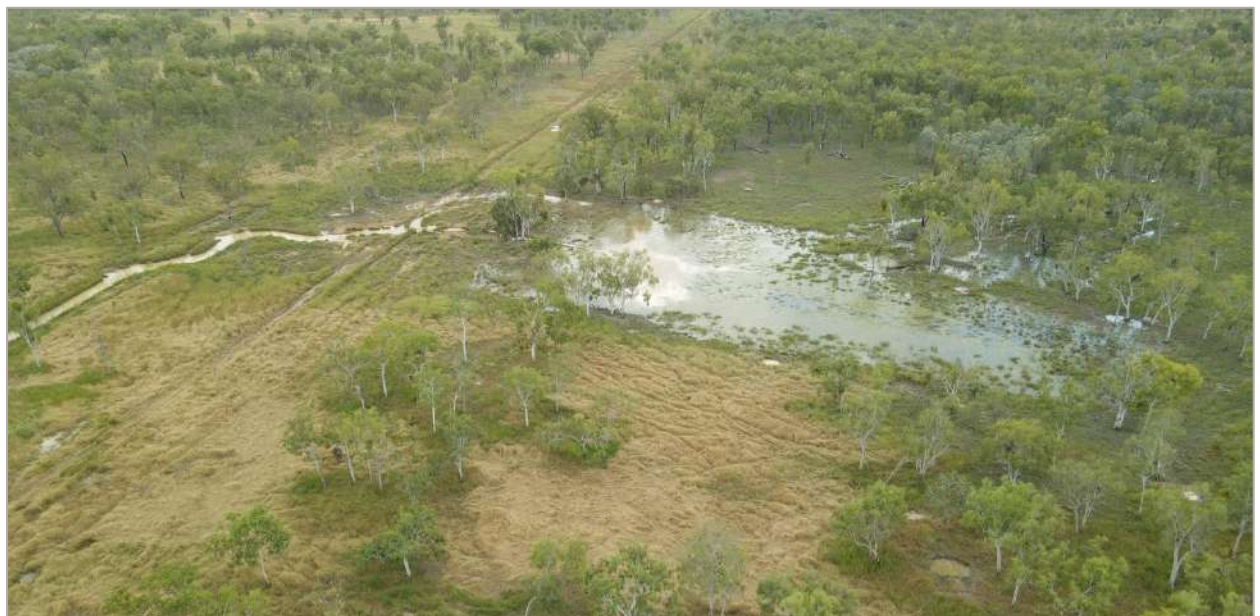
*Photo 6 – Channel north of billabong leading to wetland area, overland flow north of wetland*

Surface water present to the north overflows from the billabong, but was not flowing by the early dry season. It is considered unlikely that surface water present north of the billabong is permanent, and is likely the result of overflow of surface water flows during the wet season that are receding. Should the surface water in the billabong be permanent, water flowing to the downstream wetland and channel to the north should be investigated further. A late dry season survey of the billabong will determine if water is present to the north and if billabong outflow or subsurface connection occurs. Analysis of surface water (if) present to the north would determine if there is connectivity from the billabong.
