## GEOTECHNICAL INVESTIGATION - TOWNS RIVER REALIGNMENT

# Roper Bar Iron Ore Project

**Report Number.** 127646013-002-R-Rev1

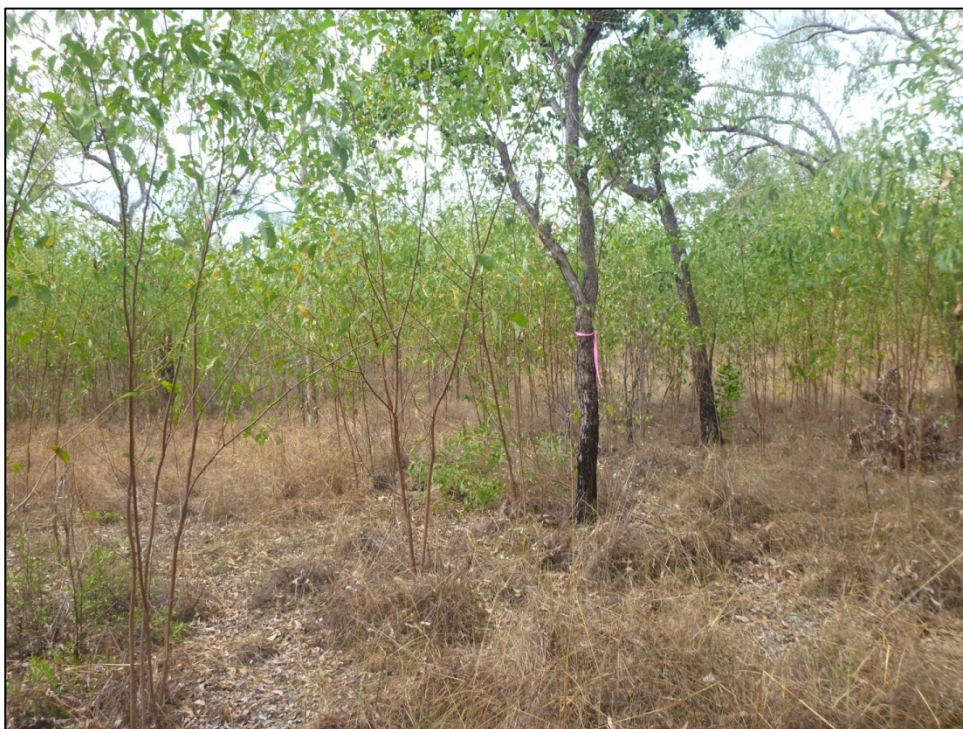
The vegetation along this section was typically light saplings densely spaced. Surface hand excavations to less than 200 mm below the ground surface generally revealed fine to medium grained sand materials with organic matter. Figure 3 is a photograph taken along this section which shows the typical vegetation.

**Figure 3 CH0 to CH1000 typical vegetation**

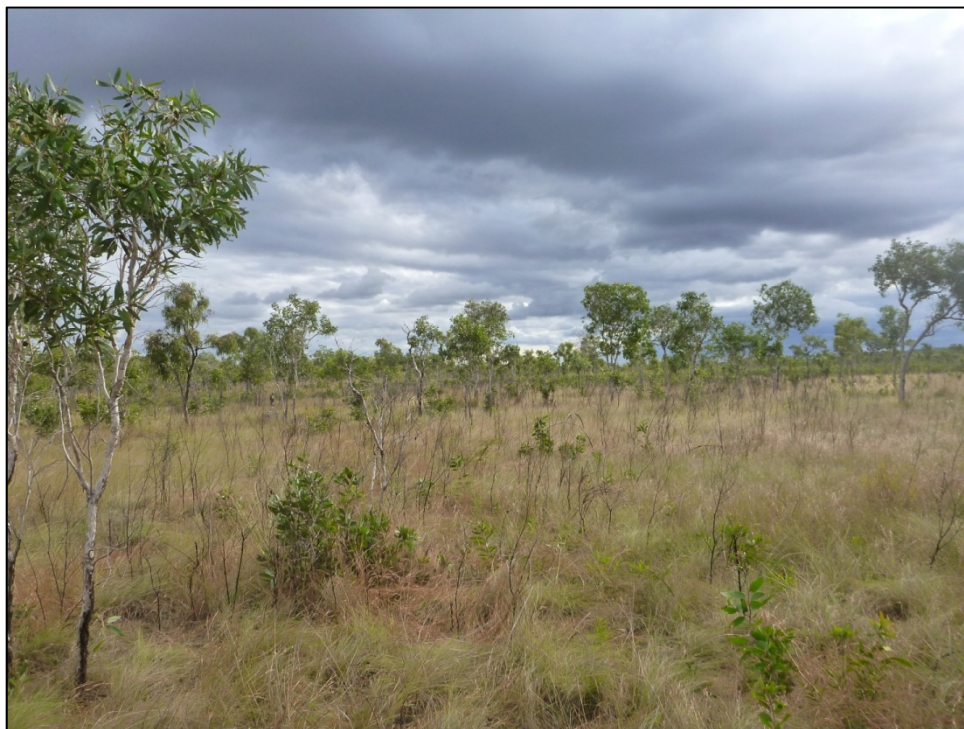
The vegetation density along the Option A alignment from approximately CH1000 to the eastern end was markedly different from that between CH0 and CH1000. Dense low grasses were present between sparsely spaced mature trees. Figure 4 presents the typical vegetation in this section.

**Figure 4 CH1000 to CH4570 typical vegetation**

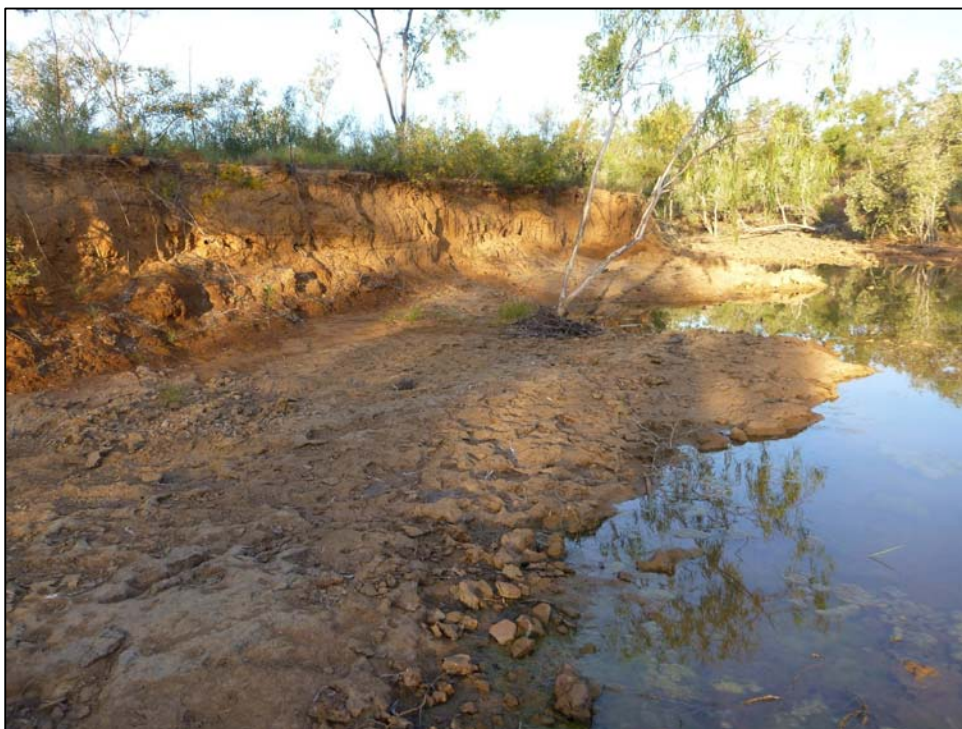
The river bank material was observed to consist of fine grained materials comprising sand and clay. Along the straighter sections of the river, the river banks were observed to be generally inclined steeper than two horizontal to one vertical (2H:1V). On the outer side of the river bends, where water flow had been concentrated, the banks were generally steep to sub-vertical. River banks were observed to be up to about 2.5 m high above the existing river bed. Roots of mature trees were commonly exposed on the face of the river banks indicating erosion of materials surrounding the roots had occurred.

The river bed generally had an approximately flat and horizontal (in cross section) profile and medium strength, highly weathered siltstone was exposed over the river bed surface in places. Weathering of this material had resulted in a 'pitted' surface. Gravel to cobble sized sandstone rock fragments were present on the river bed in sections of the river.

**Figure 5 River bend with outer side of the river on the left side. Sub-vertical river bank with horizontal channel floor.**

We recommend channels constructed in these materials have batters of three horizontal to one vertical (3H:1V) in the Unit A materials. The batters may be steepened to two horizontal to one vertical (2H:1V) in the Unit B and Unit C materials.

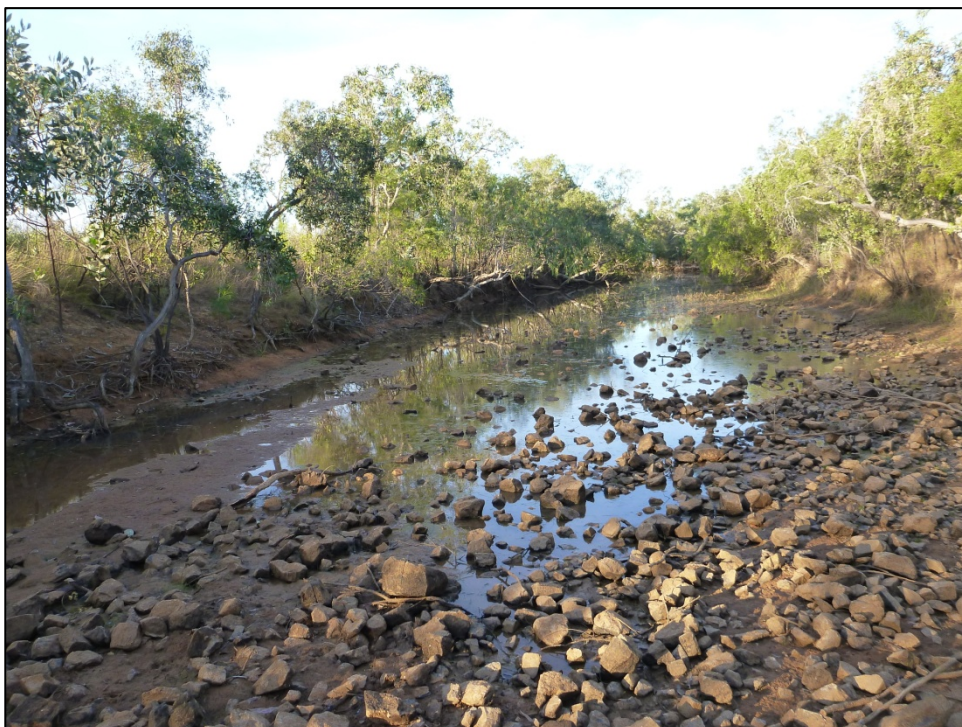
**Figure 6 Straight section of the river. Steep sided river bank and horizontal channel floor with siltstone gravel and cobbles.**
