# Rum Jungle Pit Rim Investigations Factual Report

# Rum Jungle Main Pit Rim Investigations Factual Data Report

Project No: 1AR001.015

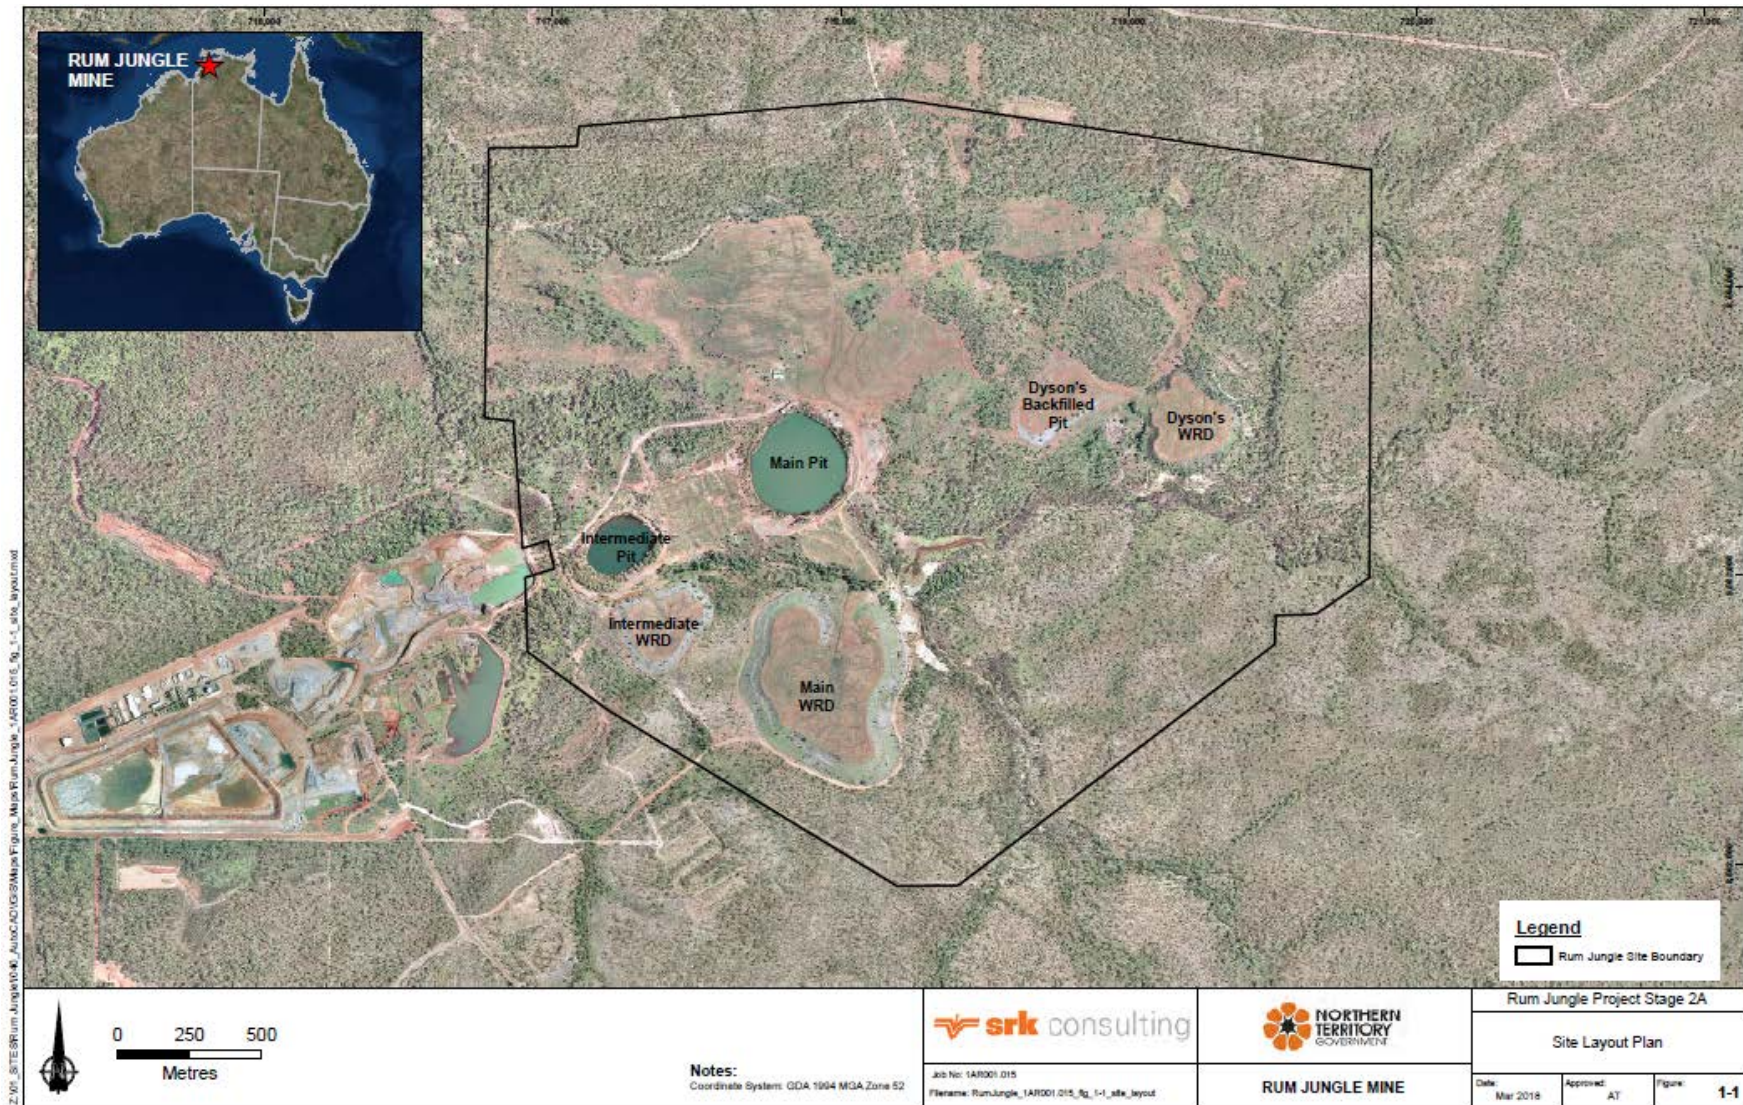
Figure 1-1 – site layout plan

The Northern Territory Department of Primary Industry and Resources (DPIR) is rehabilitating the former Rum Jungle mine site in Northern Territory, Australia (Figure 1-1). These efforts were initiated with a Conceptual Rehabilitation Plan and are advancing with detailed investigations and engineering design. The Conceptual Rehabilitation Plan includes backfilling the Main Pit with waste rock from the historical dumps on the site. Access would be via haul road established on the western half of the pit to be constructed by pushing back the pit wall.

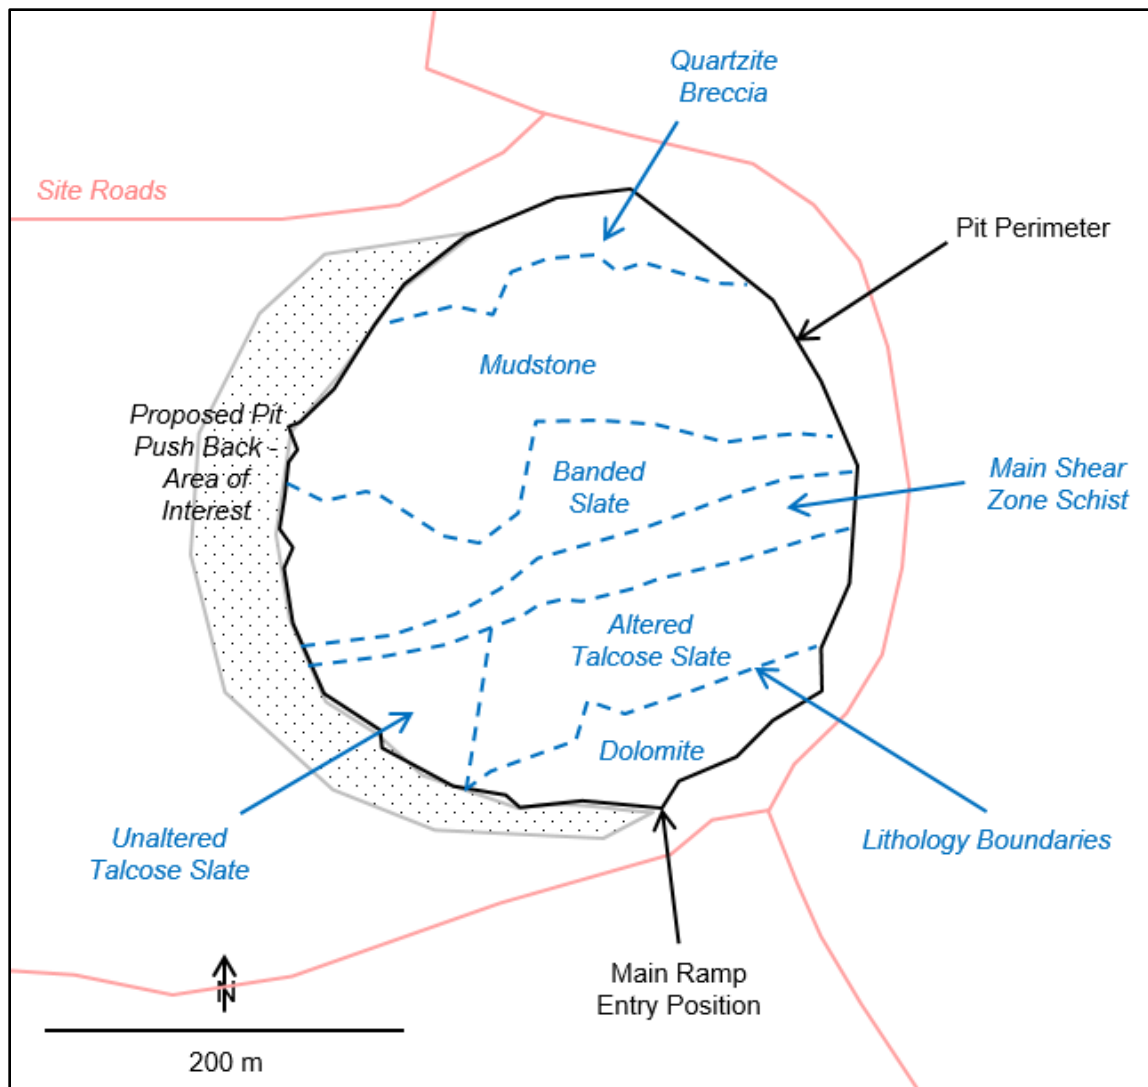
**Figure 4-1 – approximate lithology and structural features exposed in the Main Pit (after NT DTW, 1981)**

The composite pit geology map (NT DTW, 1981) shows that the northern half of the pit consists mostly of mudstone, and the southern half is slate except for a significant zone of dolostone in the south south-east. An intensely sheared zone trending approximately east-west, called the 'main shear zone', bisects the pit. A north-south fault and east-west fault associated with tectonic shattering truncated the ore body at depth. A simplified version of this map for the Main Pit and the approximate lithology boundaries is shown in Figure 4-1.

Also shown on the map (stippled area) is the area of interest for the pit push back and the focus of this study. This zone is shown to intersect six geological units; Dolomite, Unaltered Talcose Slate, Main Shear Zone Schist, Banded Slate, Mudstone and Quartzite Breccia.

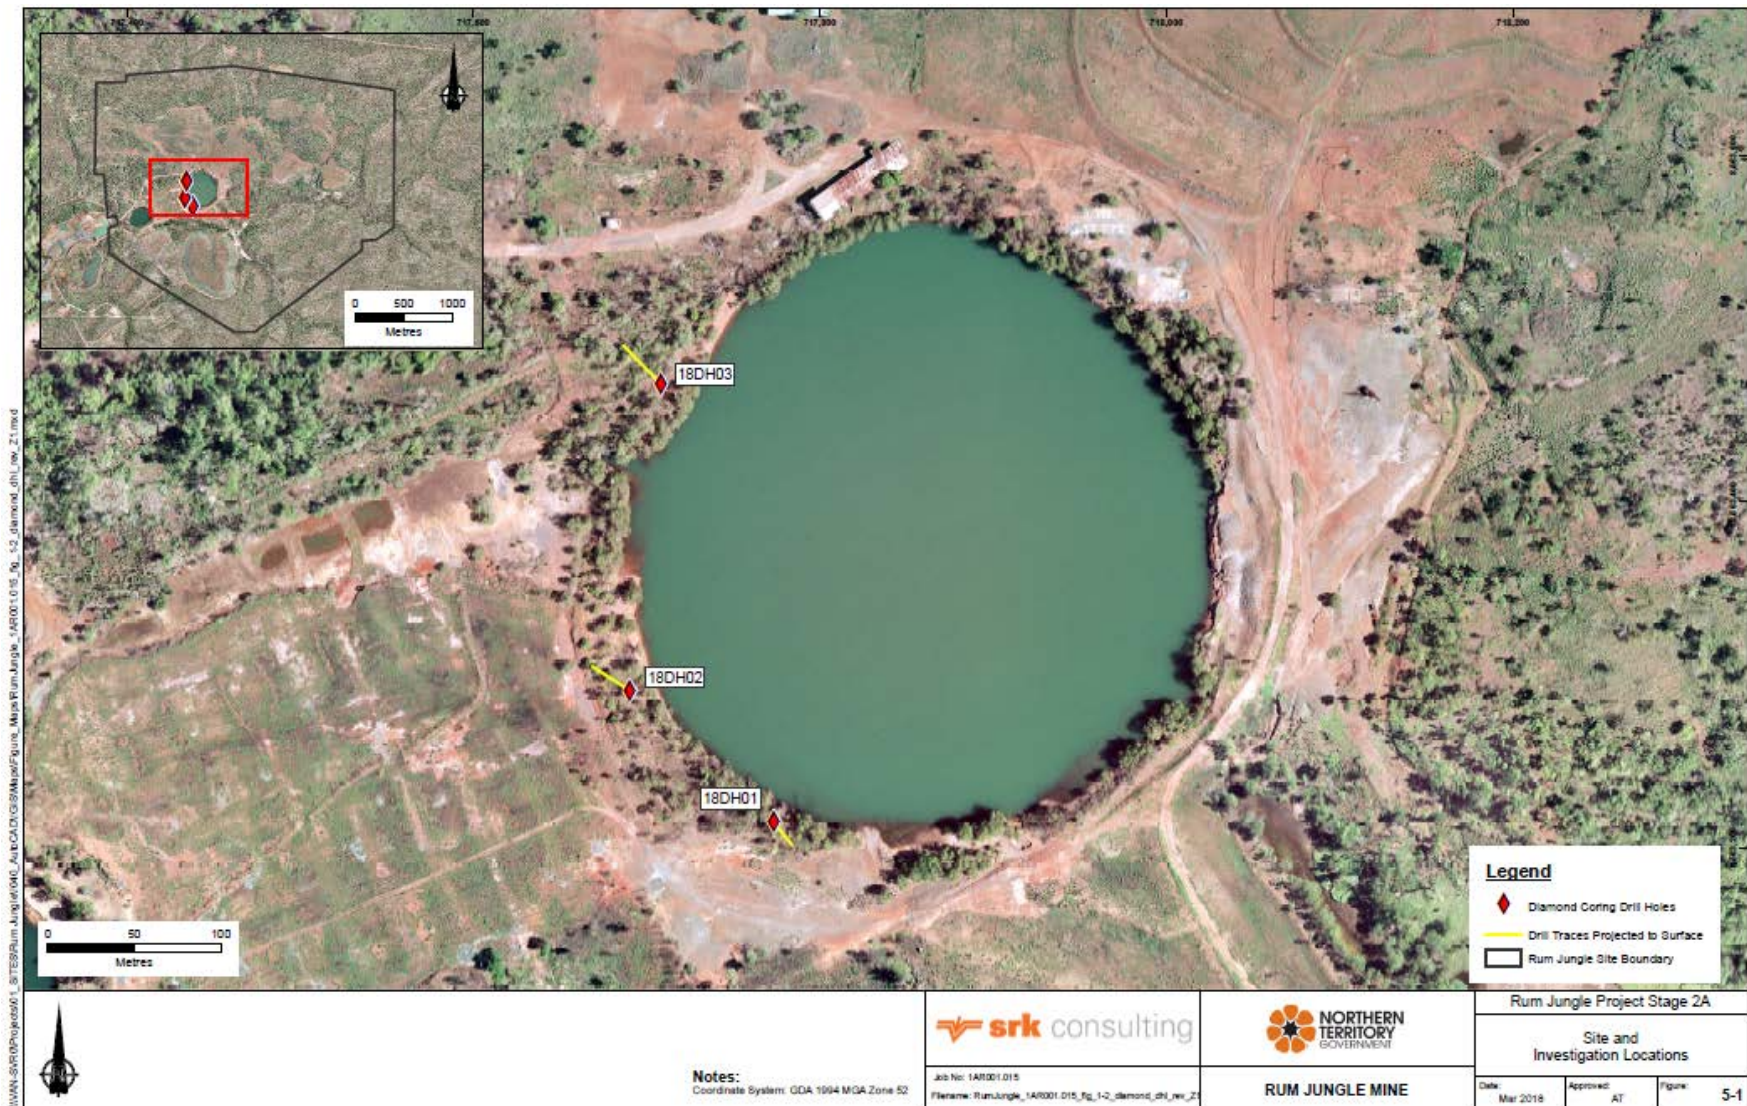
Figure 5-1 – site investigation locations

With SRK's knowledge of the pit geometry and geology (Section 4.2), observed contacts surface expressions were conceptually projected to depth. The drillhole collar locations, orientations and inclinations were selected with the intent of intersecting these contact surfaces. Details of the final design for the drillhole collars are in Table 5-2 and shown in Figure 5-1.

The drilling meterage allowance for drillhole 18DH01 was reduced to 50 m, the rods jammed in drillhole 18DH02 and the hole had to be aborted at 51.2 m, and at the request of the DPIR drillhole 18DG03 was stopped before reaching target depth.

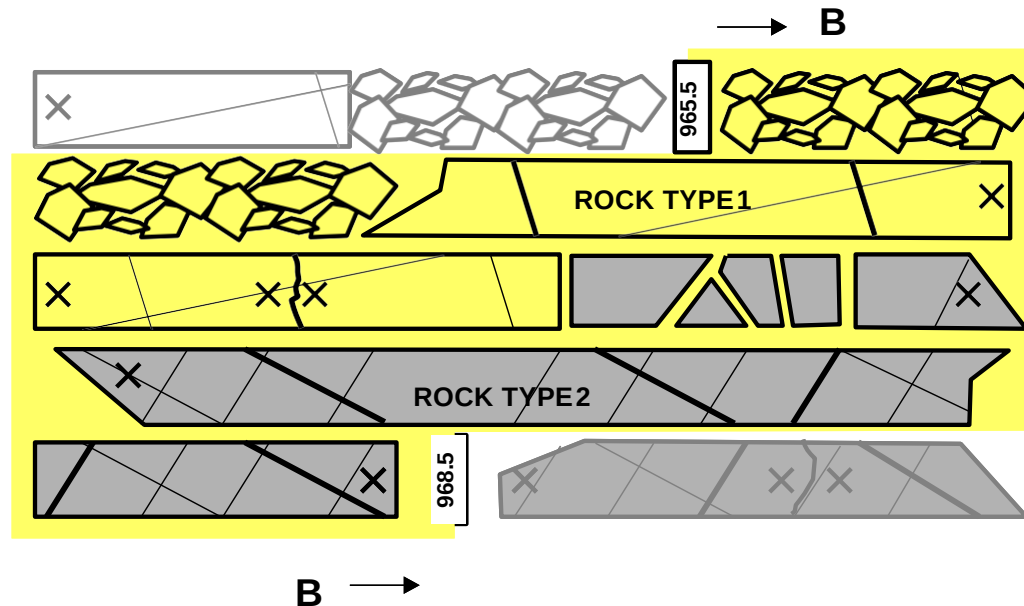
# TOTAL CORE RECOVERY (TCR), METHODOLOGY

- TCR is defined as the sum of all measureable core recovered in one drill run;
- Fit the core together as best as possible to minimize measuring the gaps in with the core;
- For the broken zones, push the material together so that it approximately resembles a core volume;
- Measure the total length of core recovered, which includes the solid and broken zones, and;
- The **TCR** (yellow shaded area) of interval B is approximately 2.4 m ( $2.4 / 3.0 \times 100 = 80\%$ ) while the indicated drill run is 3.0 m.

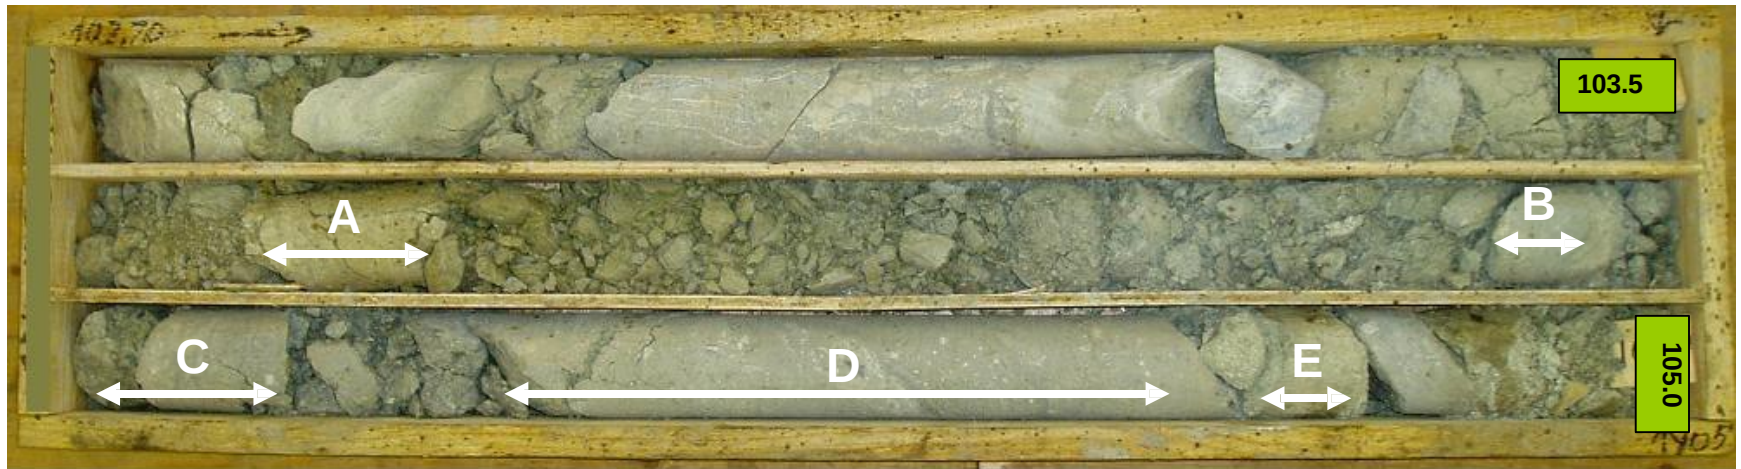
# SOLID CORE RECOVERY (SCR), METHODOLOGY

- The SCR is defined as the sum of all sections of the core run that are greater than 1 core diameter;
  - For HQ/HQ3, this is 6 cm; and
  - For NQ/NQ3 this is 4.5 cm.
- This measurement is aimed at quantifying drilling-induced damage in weaker rocks in which no identifiable joints contribute to the breakage;
- In the above case, the  $SCR = A+B+C+D+E$  (between 103.50m to 105.00m).

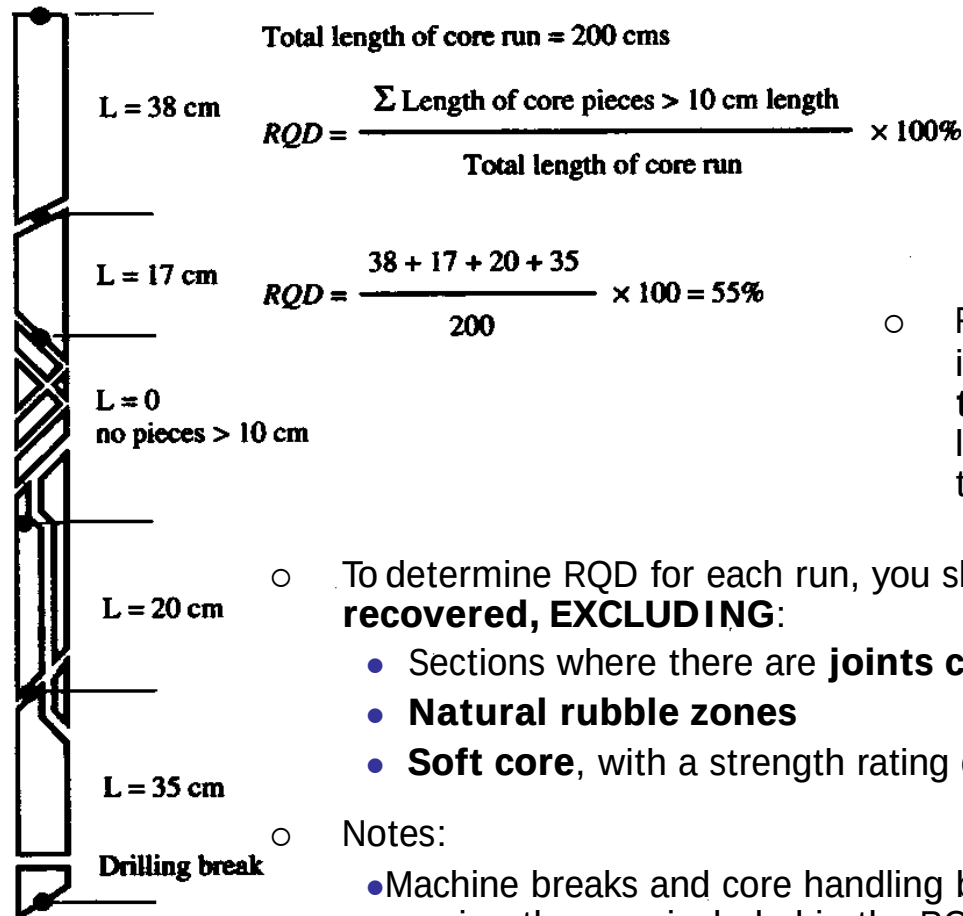
# ROCK QUALITY DESIGNATION (RQD), METHODOLOGY

- Rock Quality Designation (RQD) is an indication of **how jointed and weak the rock is**, measured as the total length of core pieces that are longer than 10cm.

- To determine RQD for each run, you should measure the **length of core recovered, EXCLUDING**:
  - Sections where there are **joints closer than 10cm** together
  - **Natural rubble zones**
  - **Soft core**, with a strength rating of **R0-1** (discussed later)
- Notes:
  - Machine breaks and core handling breaks should be considered solid core, i.e. they are included in the RQD measurement
  - Joints along the core axis should be considered solid core, i.e. included in the RQD measurement.

- The RQD of interval B in the example illustrated is approximately 1.5 m ( $1.5 / 3.0 \times 100 = 50\%$ ). Areas not counted are circled;
- Solid core is measured along the axis of the core, and;
- If a single joint runs parallel to the core axis but does not intersect it, then it is considered as a solid piece.

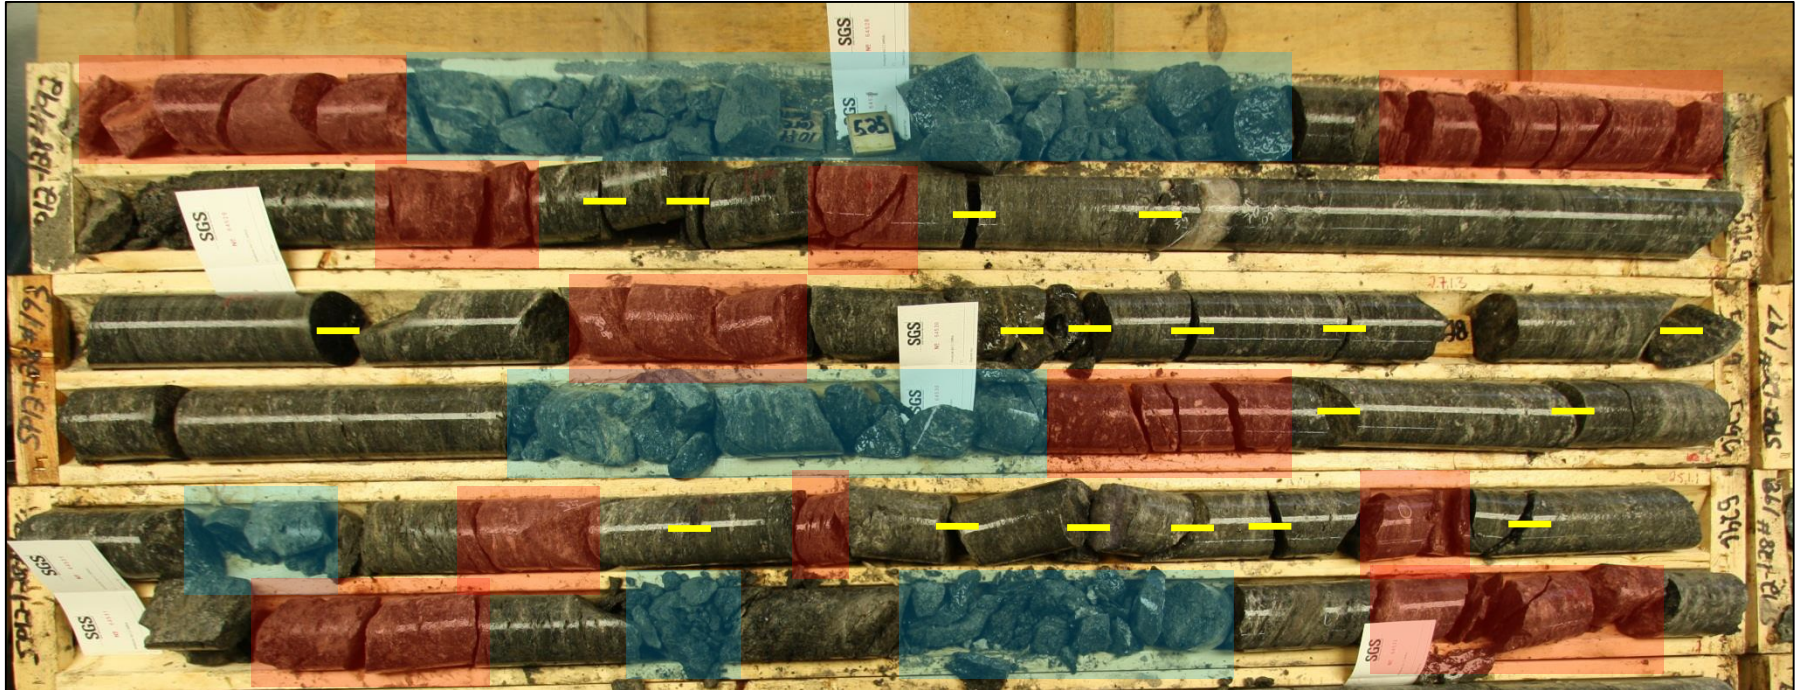
In the example provided above:

- Red-shaded areas are not considered 'solid' core (and are not included in the total length measured to determine the RQD) – these are areas of *in situ* jointing;
- Blue-shaded areas are rubble zones, not 'solid' core, and are counted at a rate of 4 joints per 10 cm and excluded from the 'solid-core' length for RQD, and;
- Yellow lines are considered 'solid' core (as they represent drill-breaks which do not affect RQD).

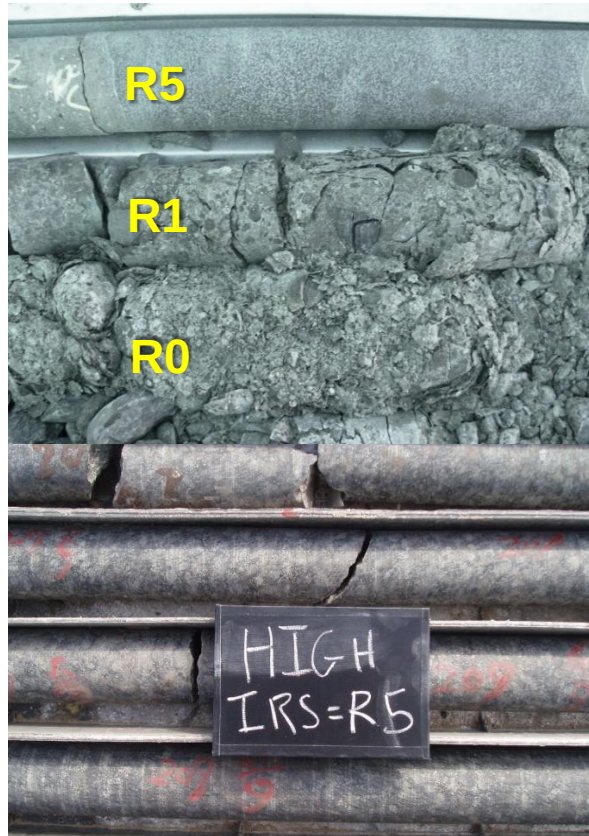
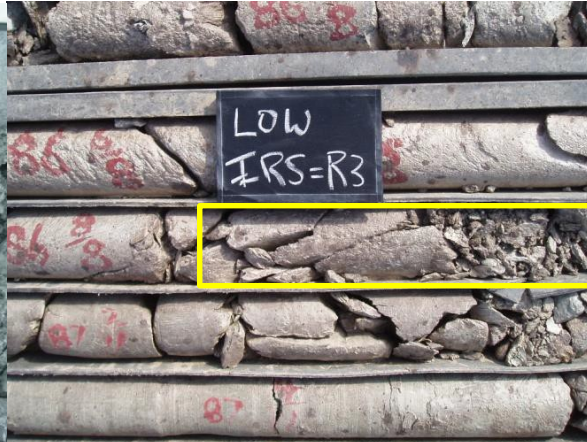
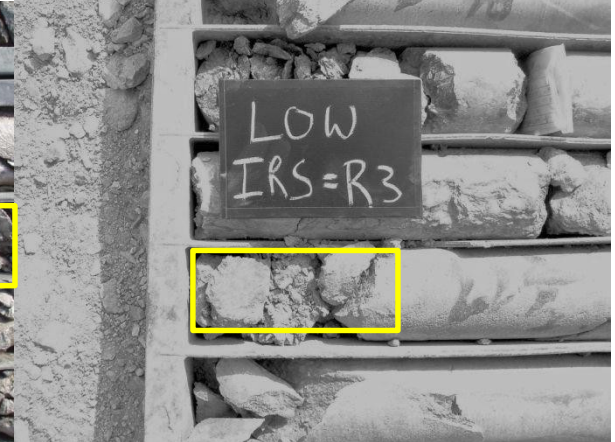
# INTACT ROCK STRENGTH (IRS) ESTIMATES

Technique to test core strength  
with a rock pick

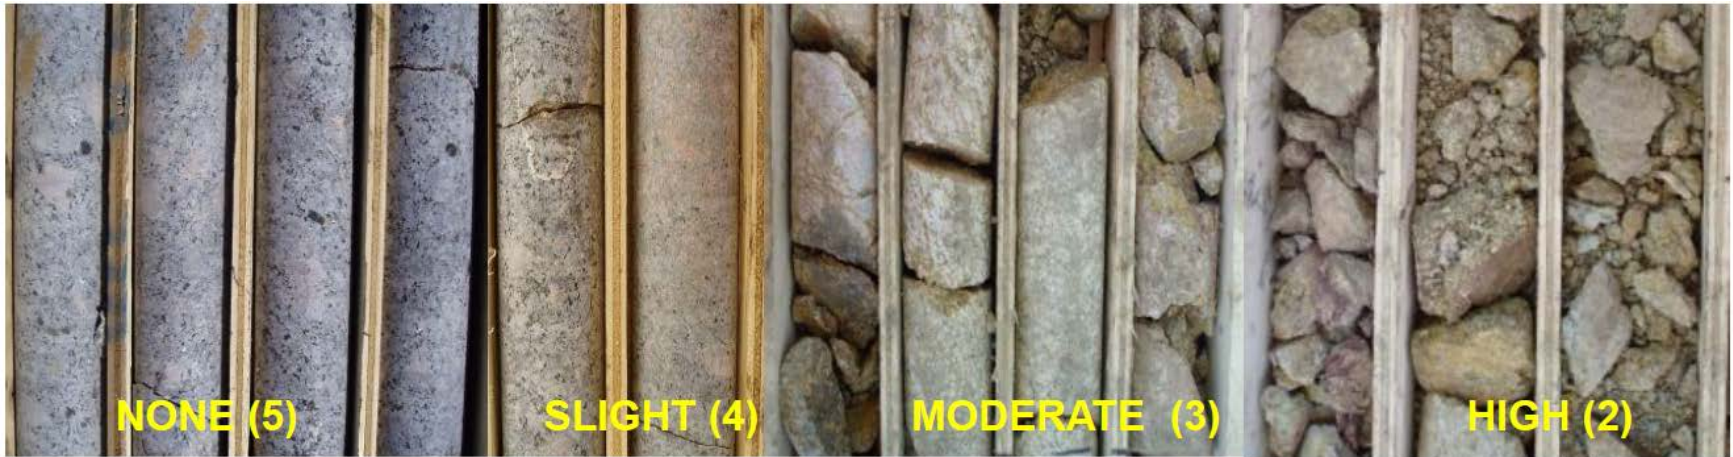
# ROCK MASS WEATHERING

The “weathering” or degradation of the intact rock results from fluids moving along the joints and through permeable zones and altering the surrounding rock composition.

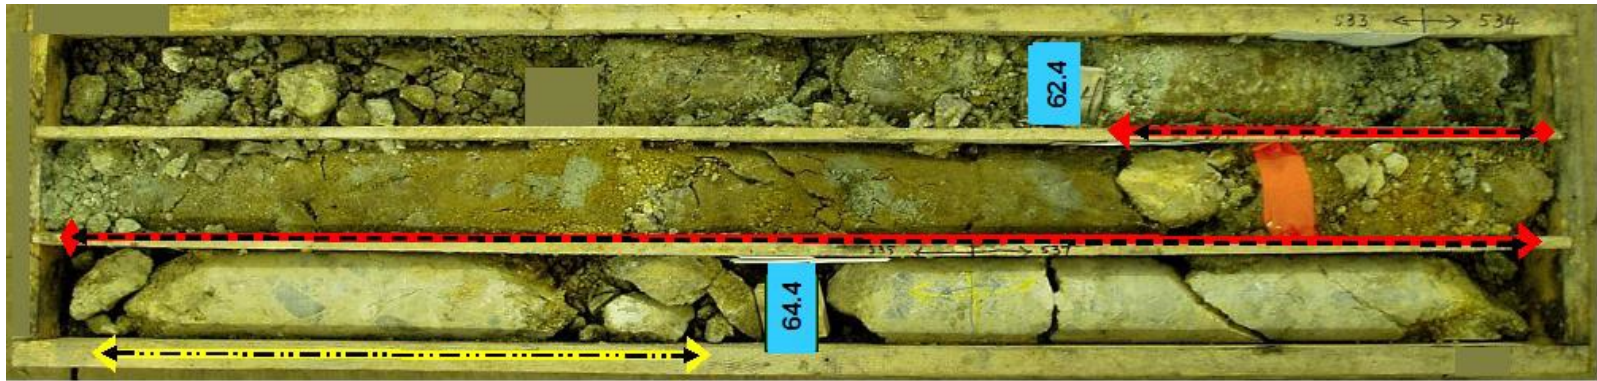
# INTACT ROCK STRENGTH (IRS) EMPIRICAL METHODS

1. Start with the hammer test in what is likely to be the stronger rock, and then continue further intra-run tests to determine if 'weaker-rock' rock intervals exist;
2. Concentrate on only the strongest and weakest rock for which at least 0.1 m are represented in the interval being logged;
3. Assign the highest strength-index, for example R5, and then define the length of the run (or domain) which is represented by the weakest index, for example R0, and;
4. Record the IRS-strong = R5, and the IRS-weak = R0 metres and %weak will be calculated at a later stage (which in this example  $\approx 80\%$ ).

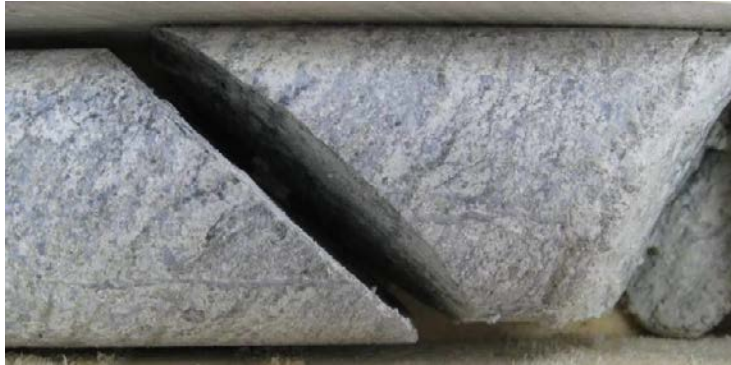
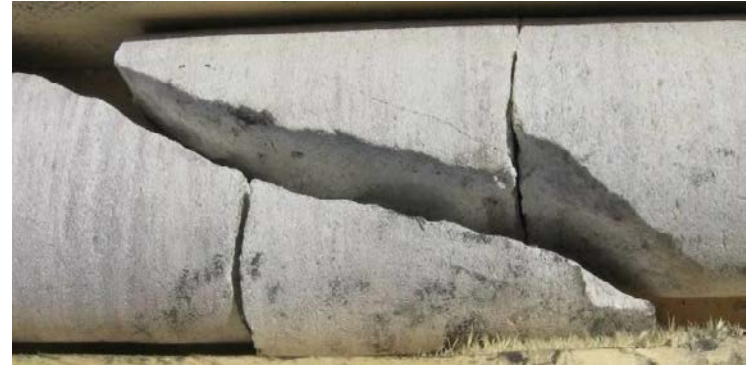
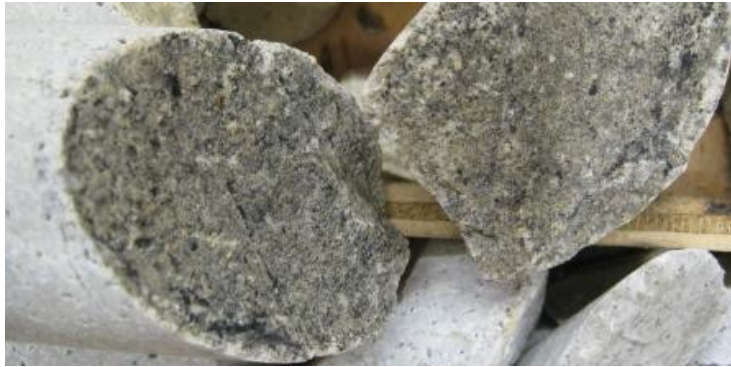
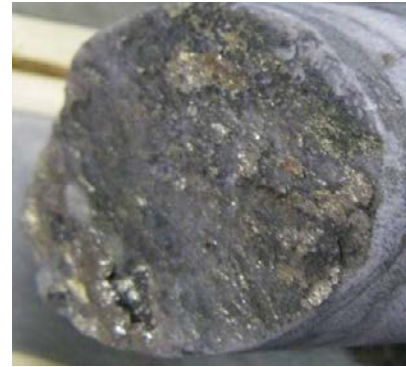
# JOINT CHARACTERISTICS

- A joint is a planar discontinuity within a rock-mass;
- Joints exhibit little or no tensile strength in tension, and separate solid (intact) core pieces for purposes of RQD calculation;
- Joints tend to have weathered faces and are sometimes stained and-or have some type of coating or fill which implies recent exposure to ground-water, and;
- Joints often occur as sets, recognized by multiple joints with a similar orientation.

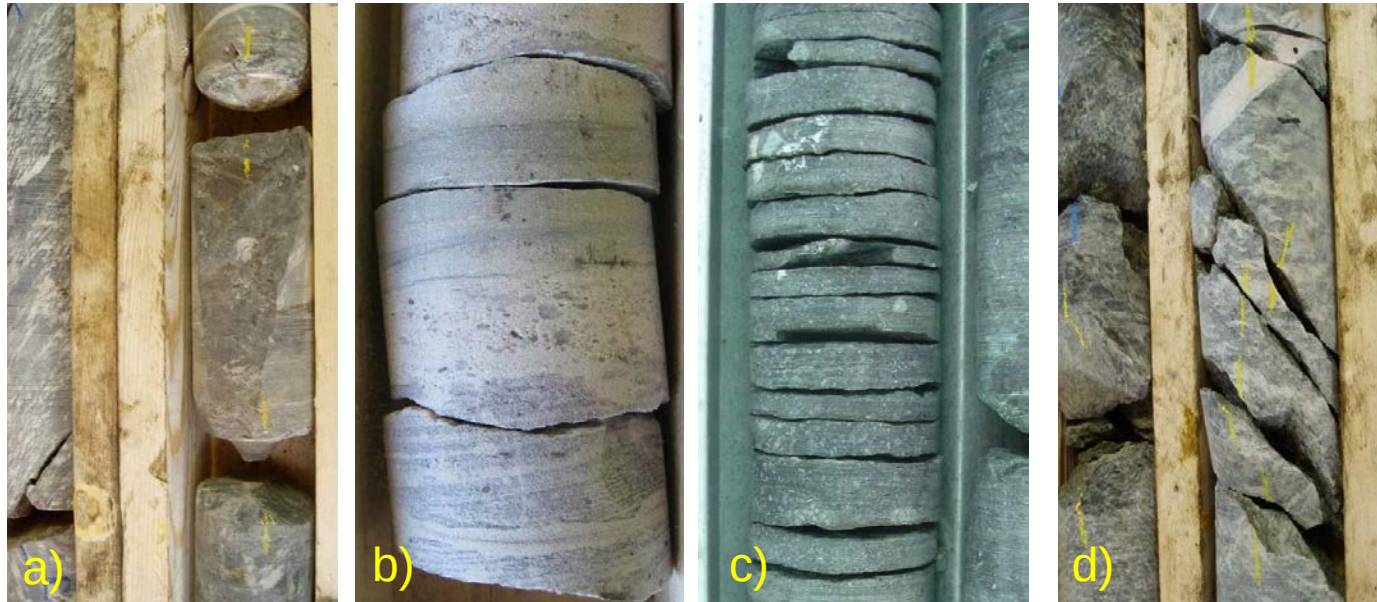
# DRILL-BREAK CHARACTERISTICS

- a. 'Drill spin' is an indication of either induced damage and/or a high-alpha joint;
- b. A non-planar break in which individual recently broken mineral grains can be seen;
- c. High angle 'discing' is considered to be drilling-induced damage, and;
- d. Breaks may form clusters of sub-parallel breaks, sometimes rough and angular.

Note: Once the core has been snapped off-bottom, no more drill-breaks can be formed – they are then considered 'hammer' breaks.

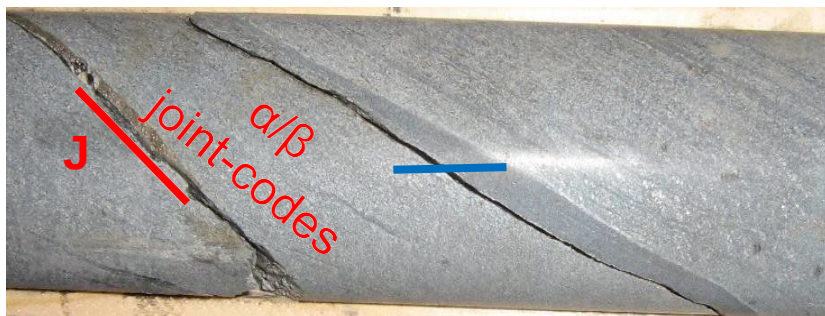
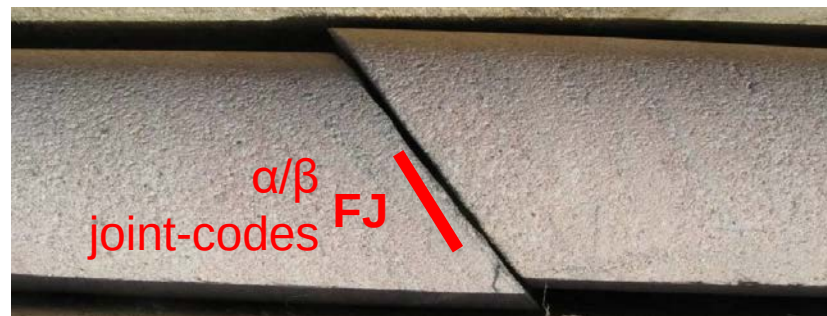
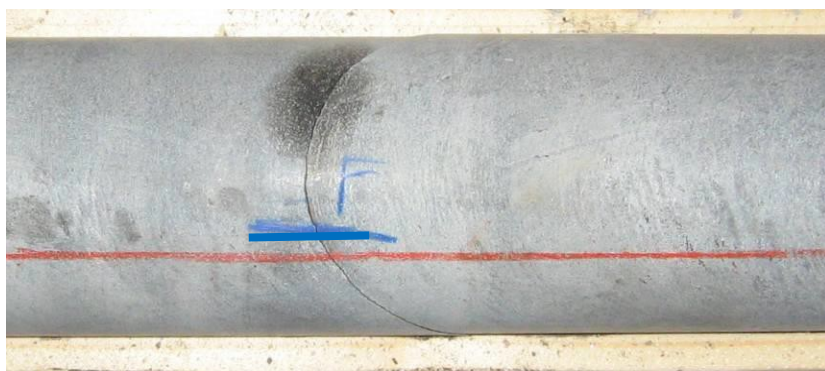
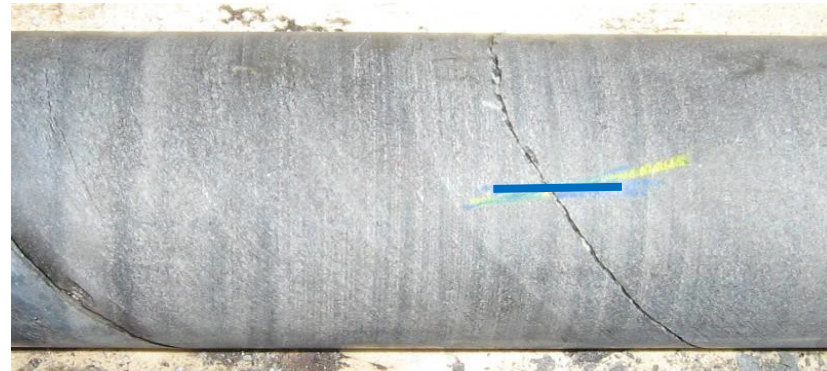
# JOINTS, FABRIC AND BEDDING PLANES

1. Look at surfaces for evidence of fluid movement or oxidation/precipitation from recent ground-water activity (for example; staining, coating of discontinuity surface, soft calcite fill, or 'dirty' appearance) – these are **J**s, and if parallel with the rock fabric or bedding planes then they are assigned to **FJ**;
2. Record the number of **J**s and **FJ**s – remembering that only the **J**s and **FJ**s are used for RQD and joint-set allocations;
3. Add the total joint-count to the count of drilling induced breaks (drill-breaks) along foliation/bedding which are annotated as YELLOW (---) in the Fractures-All column along with the joint-count.

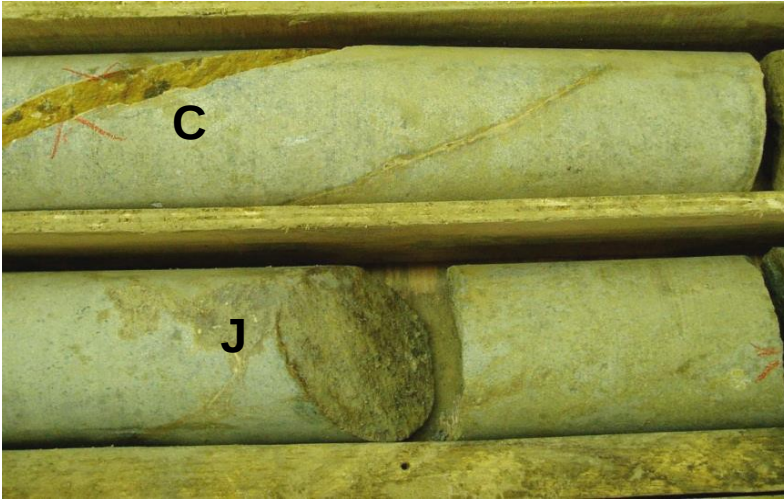
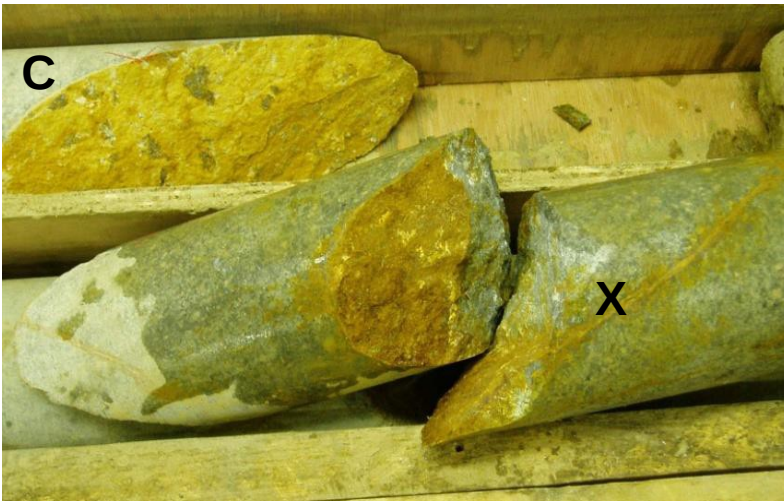
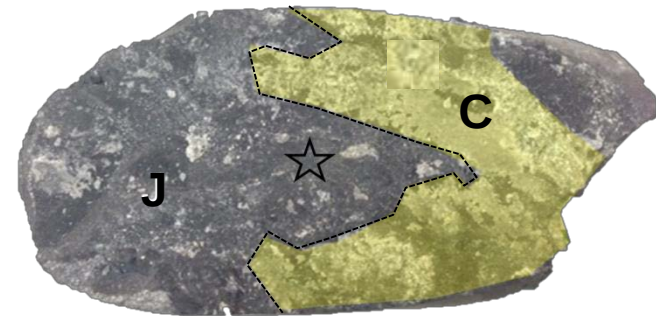
# JOINTS OR PARTIAL-JOINTS?

1. Evaluate the appearance of the surface of the discontinuity and determine if the centre of the face (which is along the axis) has the appearance of being a joint;
2. If (on the axis) it has joint-like properties, allocate it to Joints;
3. If (on the axis) it appears to be freshly broken during the drilling process, but it still has joint like properties elsewhere on the face, then assign it to the partial-joint category C;
4. If it is unclear as to whether or not it is a partial-joint or a joint, then err on the side of caution and classify it as a joint.

For a surface that looks like J and C, make the determination on the axis of the core. In the example above, half (or more) is a J while the rest is a C. The example provided is a J because on-axis it has J-properties.

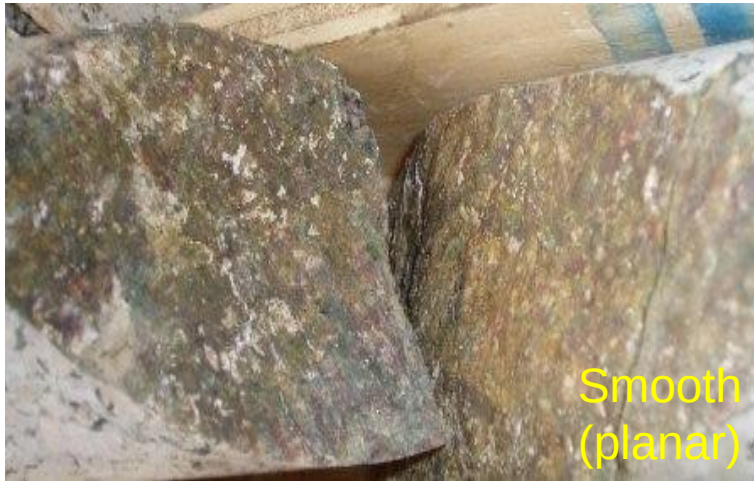
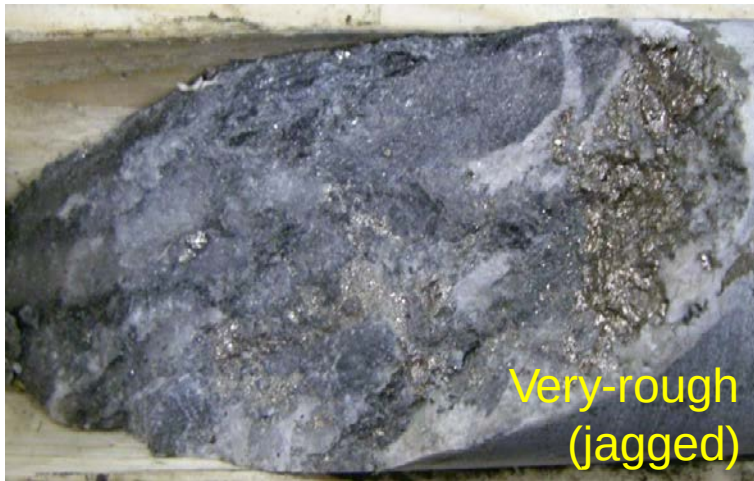
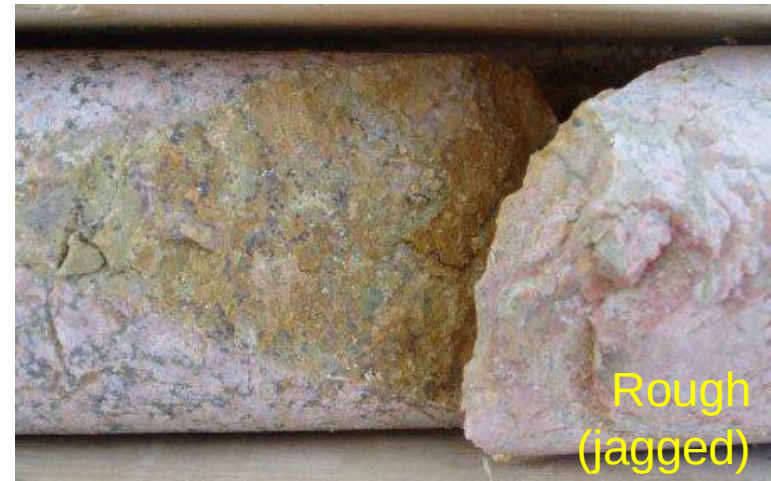
# JOINT IDENTIFICATION

- No Tensile Strength – joints separate solid (intact) core pieces and exhibit no tensile strength, and;
- Freshness – Joints tend not to look fresh and often are stained or have some type of coating/fill.

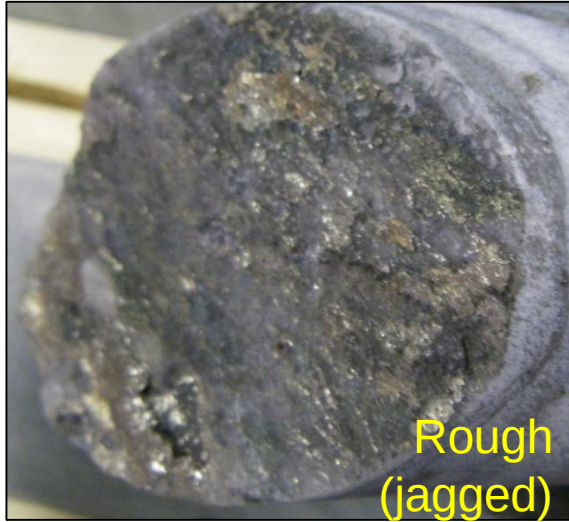
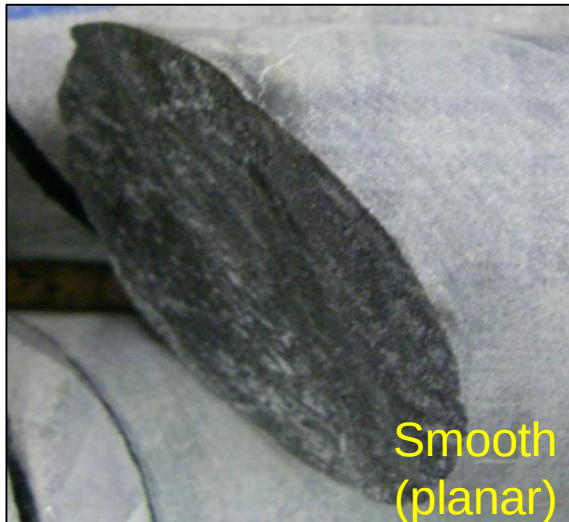
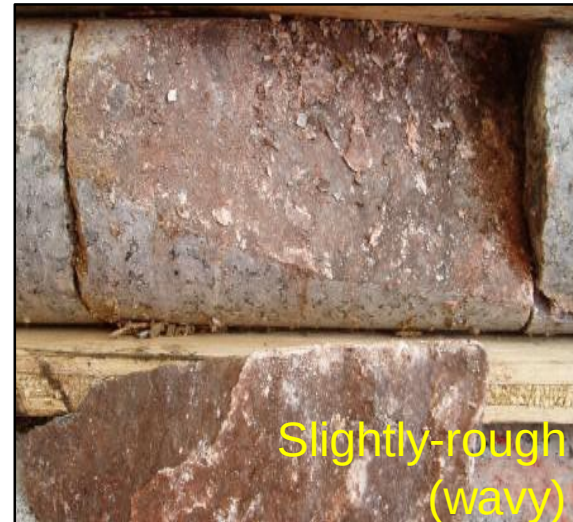
## JOINT IDENTIFICATION (page 2 of 2)

- No Tensile Strength: Joints separate solid (intact) core pieces and exhibit no tensile strength, and;
- Freshness: Joints tend not to look fresh and often are stained or have some type of coating/fill.

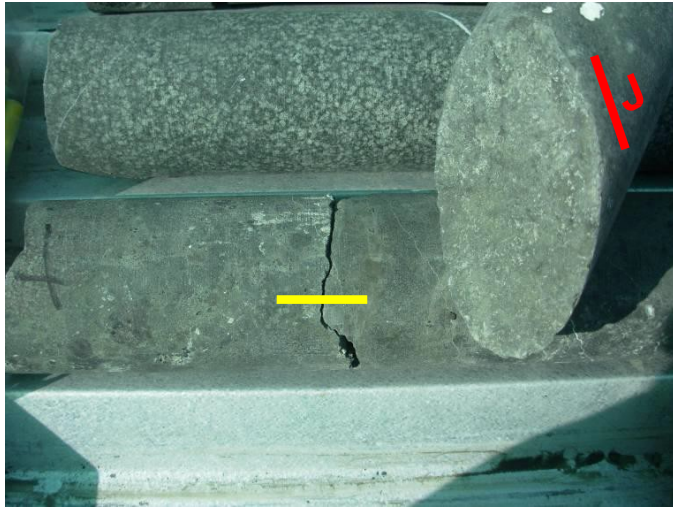
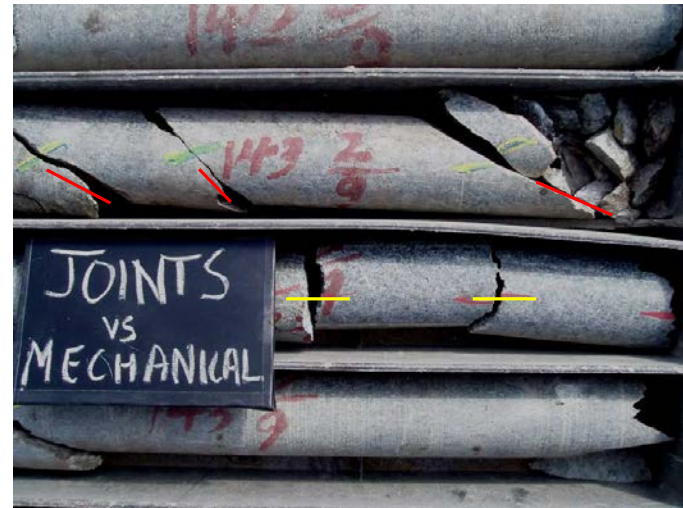
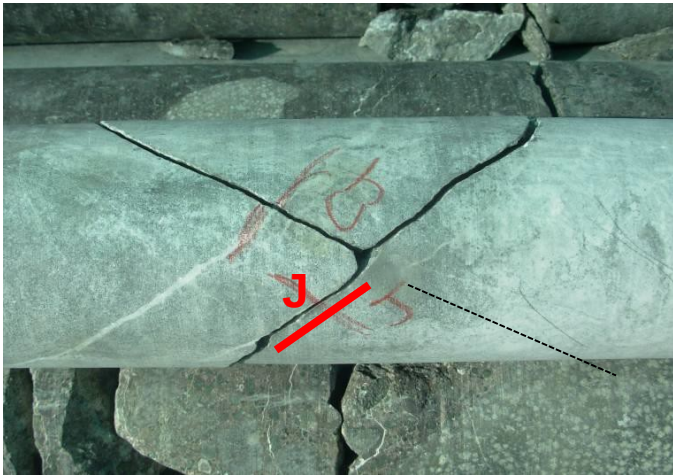
# DRILL-BREAKS VERSUS JOINTS

- Heavy-handling after the drilling process can induce damage that looks like a joint, however it is unlikely to have drill-mud and/or rock flour on the joint-face;
- The differences in edge-sharpness, surface-fill, orientation, and staining can assist in differentiating these.

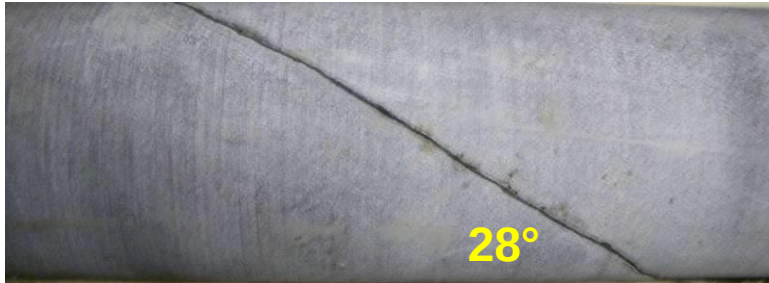
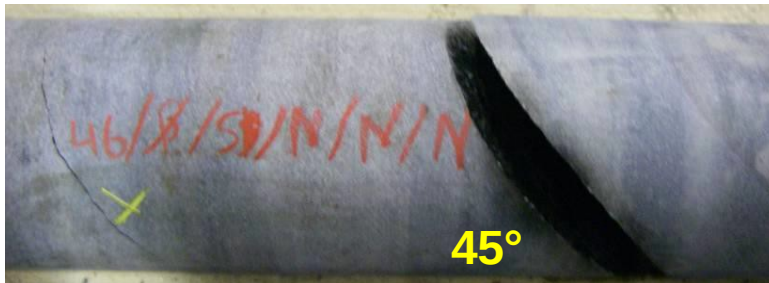
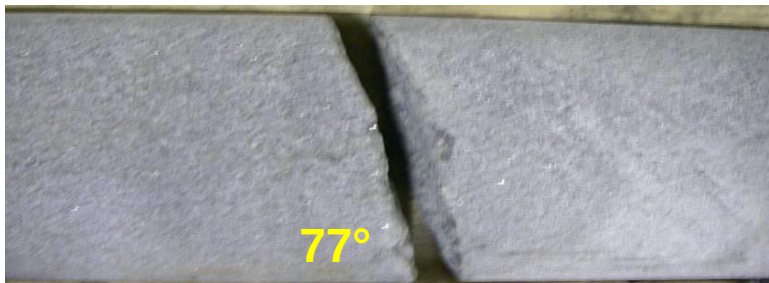
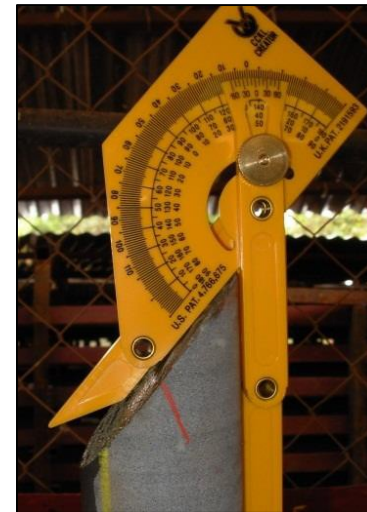
# JOINT ANGLE

- For detailed geotechnical logging, joint angle (alpha and beta-angles) and joint conditions need to be measured for each of the main discontinuity classes encountered;
- This angle is measured from the core-axis, looking down-hole. For example, 0° is parallel to the core axis;
- For geotechnical purposes, concentrate on the J and FJ classes. Remembering that only Js and FJs are considered when determining the length of solid core for RQD, and;
- Where core-orientation is not available, the alpha-angle and joint conditions still need to be evaluated.

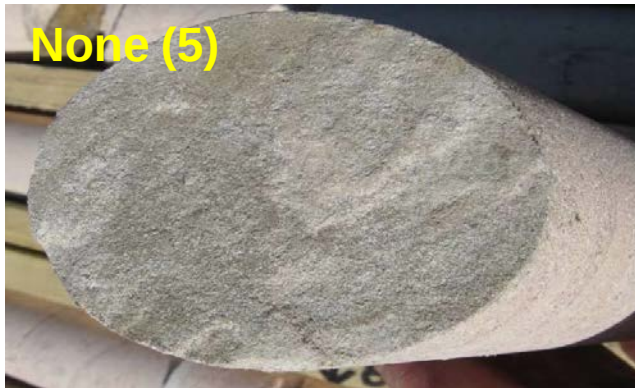
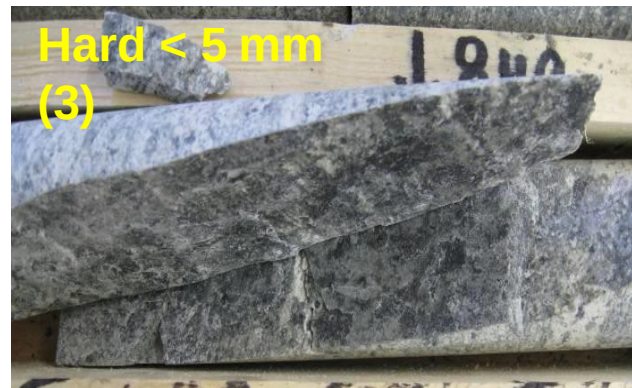
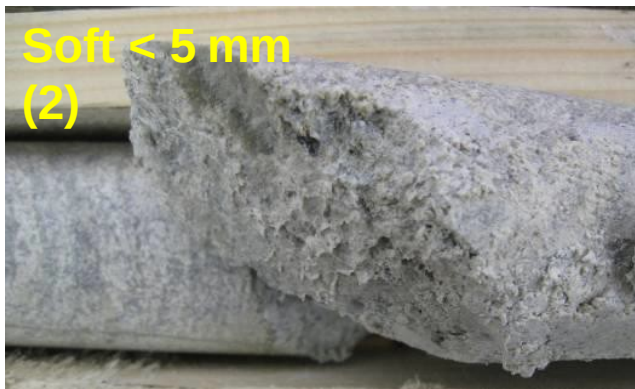
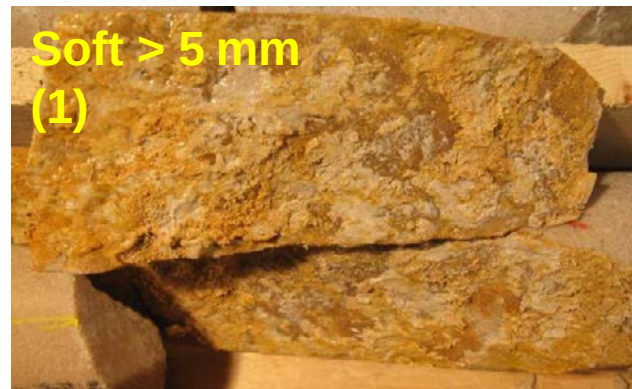
# JOINT FILL TYPE EXAMPLES

- Joint fill and type of fill needs to be recorded for each joint logged in the drill run, and;
- Fill strength is based on softening, or non-softening material types, gouge, staining, and by the width of the material. In essence; hard or soft, more or less than 5 mm.
