# Rum Jungle Pit Rim Investigations Factual Report

# Rum Jungle Main Pit Rim Investigations Factual Data Report

Project No: 1AR001.015

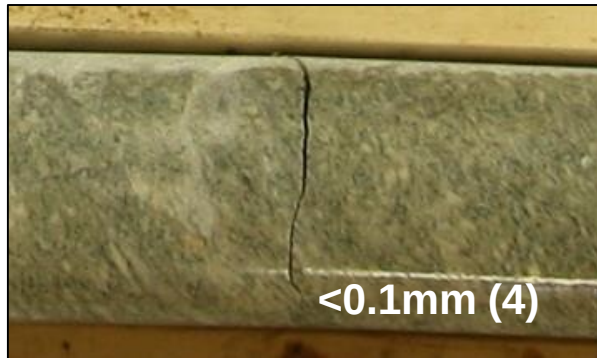
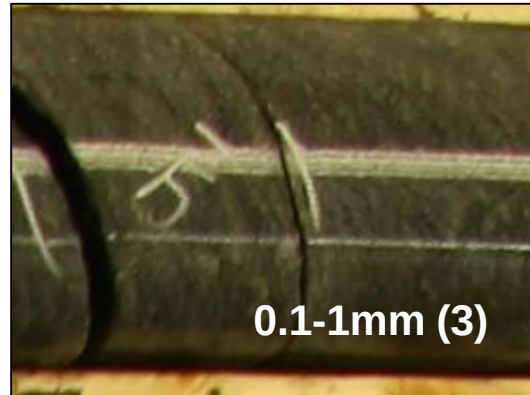
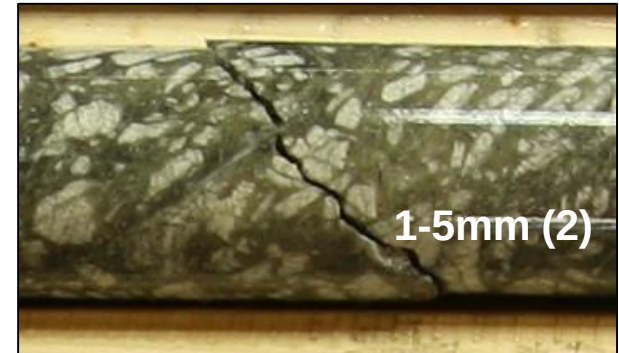
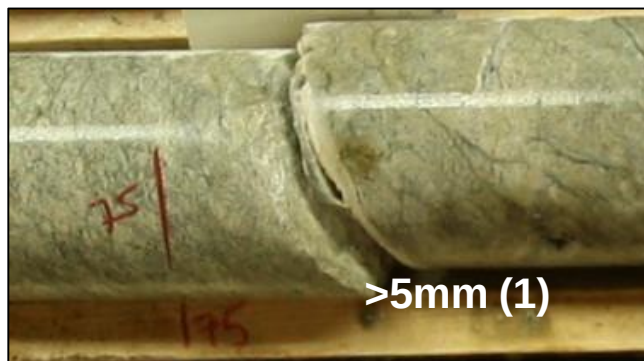
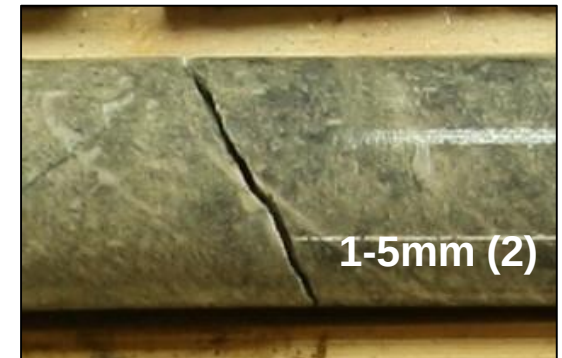
# JOINT APERTURE EXAMPLES

Joint aperture measures the openness of the joint.

Estimated based on how tight the joint fits back together

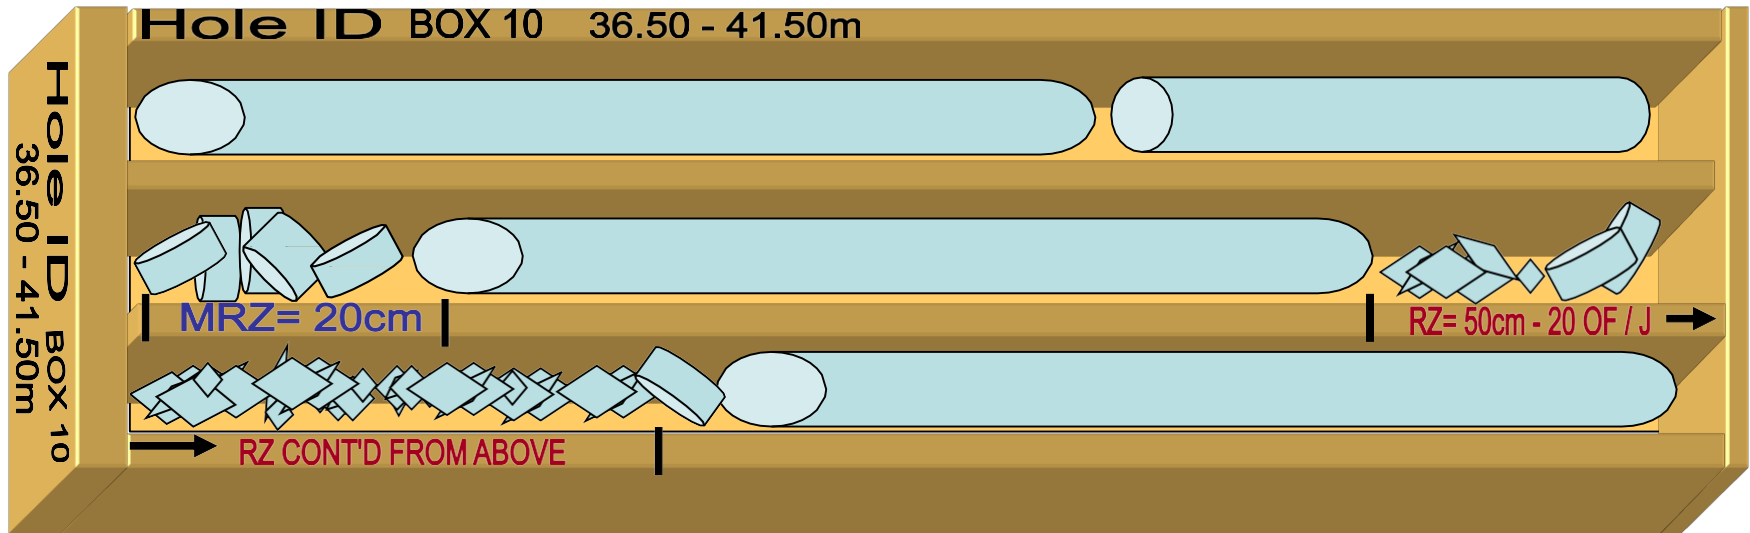
# ZONES OF BROKEN ROCK

- Rubble zones (RZ) should include all natural damage (possibly around faults);
- If there is uncertainty as to whether it is a true rubble zone, or induced damage (MRZ), err on the side of caution and count it as a RZ;
- 3 Joints for each 10 cm of RZ is added to the joint-count;
- MRZ are caused by the drilling process, or induced during handling, look for signs of fresh breaks, and fresh surfaces of the pieces of core, and;
- Natural rubble zones are not considered 'solid-core' for the purposes of RQD measurements – MRZs are not.

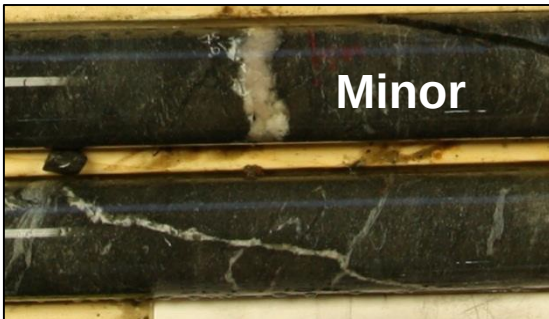
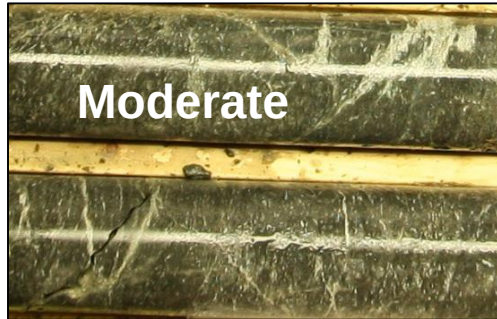
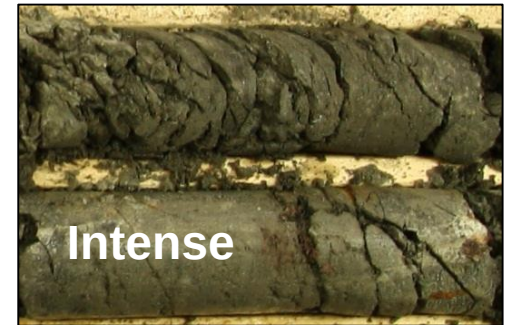
- As part of the detailed log, you need to rate the intensity of microdefects for run (if present). Microdefects include both veinlet/stringers (usually filled with carbonate or quartz), voids and/or very small (mm scale) fractures.
- The intensity of the microdefects in run is averaged over the run and rated as either:
  - 0 = **None**
  - 1 = **Minor**
  - 2 = **Moderate**
  - 3 = **Intense**

- The strength of the microdefects in run is averaged over the run and rated as either:
  - 0 = **Strong** (none of the MDs break)
  - 1 = **Moderate** (some of the MDs break)
  - 2 = **Weak** (all of the MDs break)

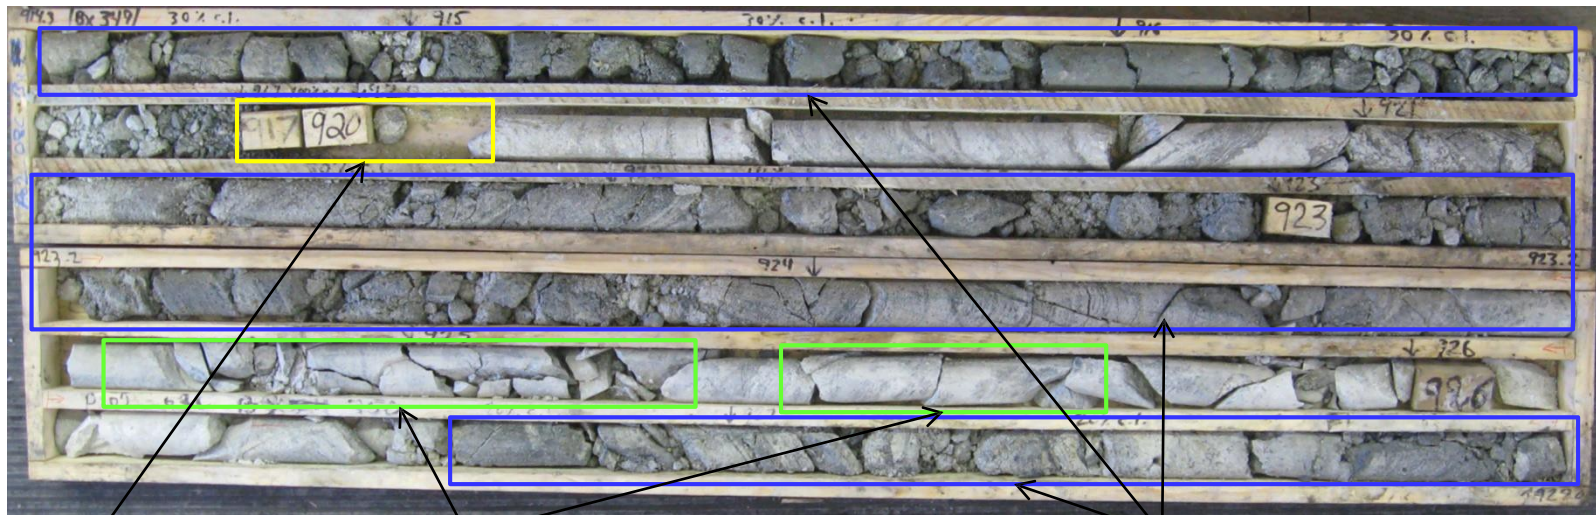
# LOGGING EXAMPLES

**Core Loss:** Do not add joints for core loss. If an entire run has been lost, leave the parameters blank.

**Drill-damage:** Consider as intact core – check for indications of jointing.

**R0 and R1 strength material:** Add 4 joint per 10 cm to Joint Column and add calculated joints to a J-set. If no joints exist, estimate joint conditions. Use pocket penetrometer to record unconfined strength.

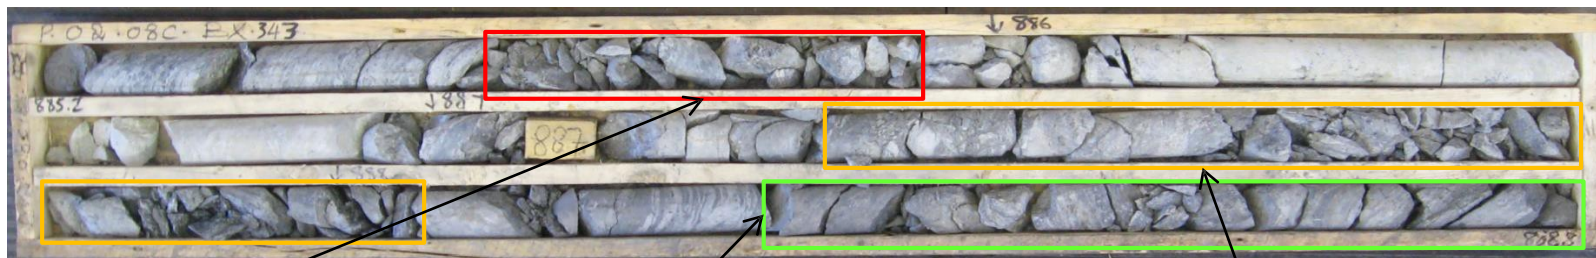
**Natural rubble zone:** Clayey gouge on fragments, shattered rock. Add 3 joints per 10 cm to Joint column and put calculated joints in a J-set.

**Drill damage:** Consider as intact core – check first for indications of jointing.

**Breccia:** Look for indications of weak matrix (if R0 or R1 add 4 joint per 10 cm to Joint column, estimate joint conditions and add to a J-set depending on the alpha angle); or if purely mechanical damage, consider as intact core.

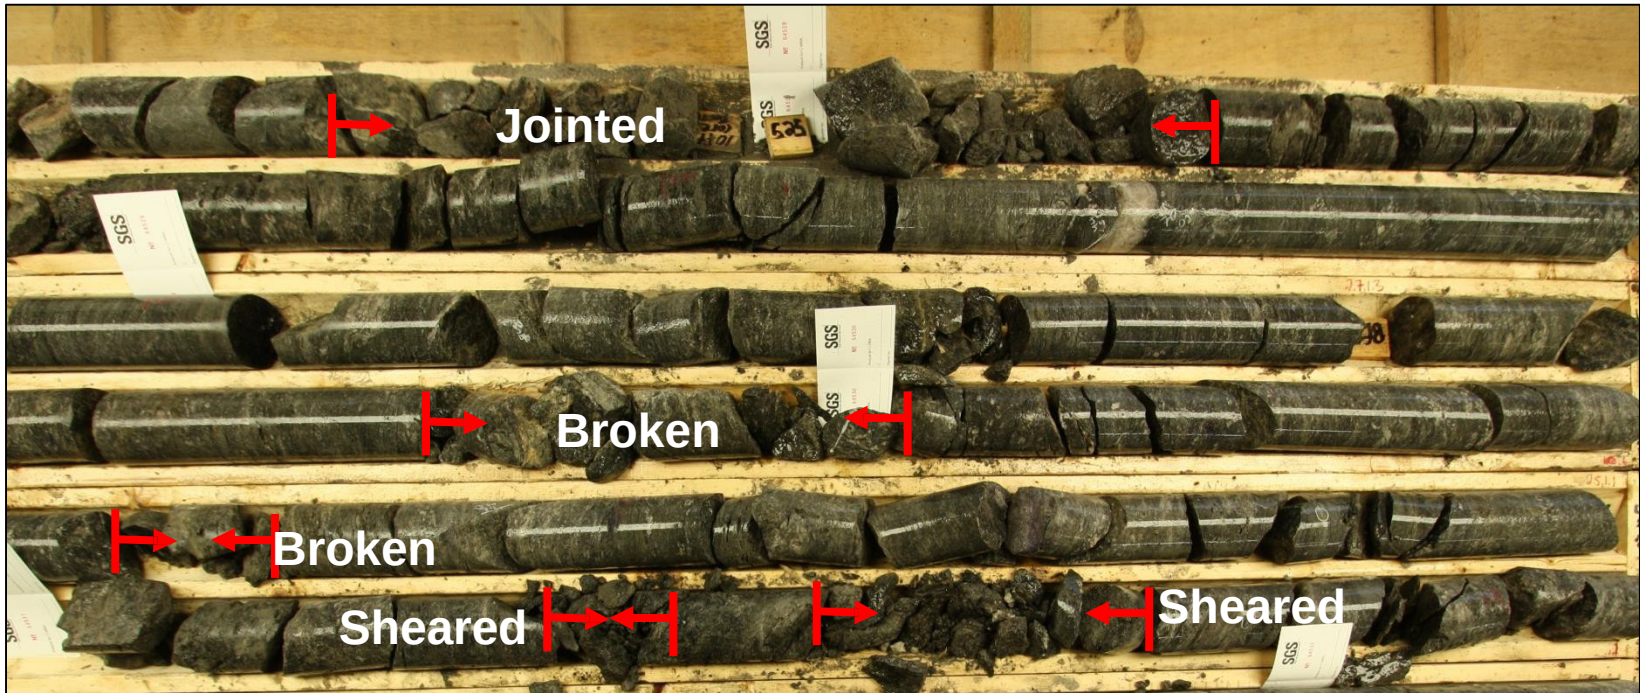
# RUBBLE ZONE CATAGORIES

- Rubble zones are classified into four different categories:
  - **Gouge** - Containing mostly clay or very finely ground rock.
  - **Sheared** - Containing a mix of clay/finely ground rock with some larger core pieces.
  - **Jointed** - Core is fragmented but most of the core pieces are smaller than the core diameter.
  - **Broken** - Core is fragmented but most of the core pieces are larger than the core diameter.

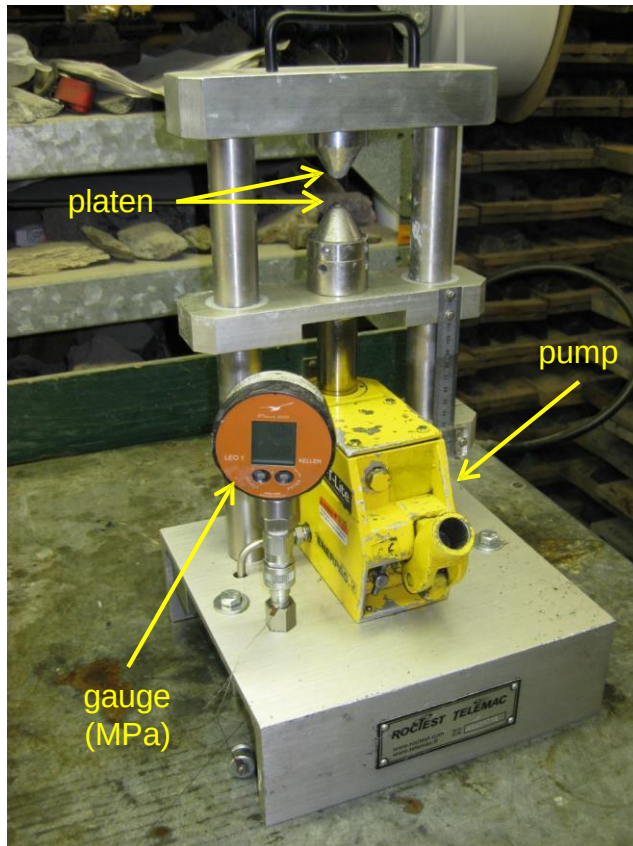
# POINT LOADING TESTING, OVERVIEW

- The system consists of a point load testing unit connected to a hydraulic gauge reading unit or digital gauge;
- The point load tester consists of a hydraulic pump and a ram;
- The hydraulic ram can be adjusted to suit the size of core or grab sample being tested;
- The attached gauge is also for the evaluation of the loading rate. The failure load is also read from this unit – normally in MPa;
- Use 20 MPa on HQ-core as a maximum reference – at which stage the test should be abandoned, and;
- Record HoleID, depth (m), angle to foliation, diameter of core which is equal to the distance between platen (mm) for a diametral test, type of test, angle to foliation, maximum gauge pressure (MPa), and test failure-code.

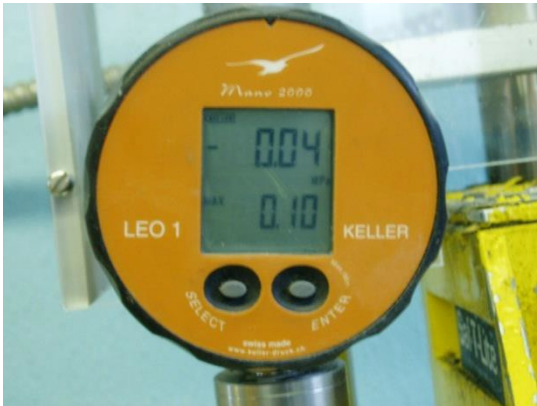
# POINT LOAD TESTING PROCEDURE

1. Always wear safety goggles;
2. Measure and mark the loading points on the core;
3. Open the relief valve and push down the platen to allow the core to be inserted;
4. Close the pump relief valve;
5. Press the **Select** and **Enter** buttons to turn the gauge system on;
6. Set the lower value close to zero by pushing **Enter**;
7. Place the core in the hydraulic ram and begin pumping;
8. Pump at a slow, even loading rate until the rock fails;
9. Note down the maximum load achieved, and;
10. Release the relief valve.

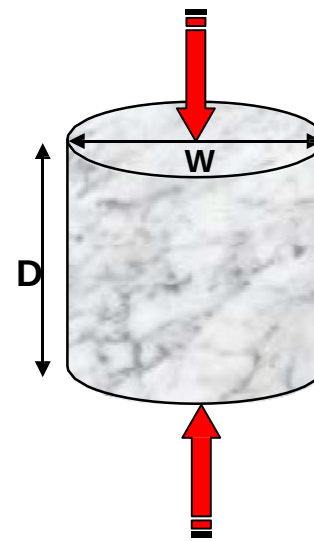
AXIAL, TYPE-2

$$0.3W < D < W$$

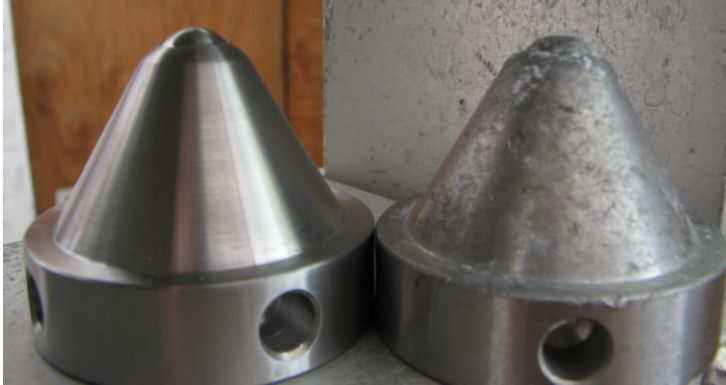
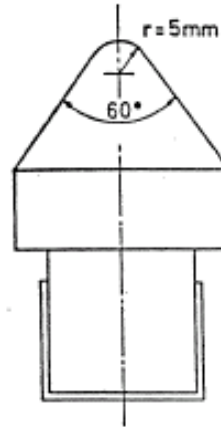
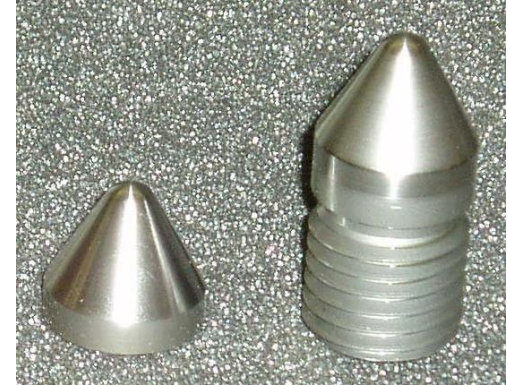
# POINT LOADING TESTING, PLATEN CONDITION

- The points can be damaged by stronger rocks ( $> 200$  MPa);
- Platen should be checked regularly for 'flattening' of the specified 5 mm radius;
- Flat platens generate excessively higher failure loads, and;
- Once these become too flattened (radius  $> 6$  mm), the platens should be replaced.

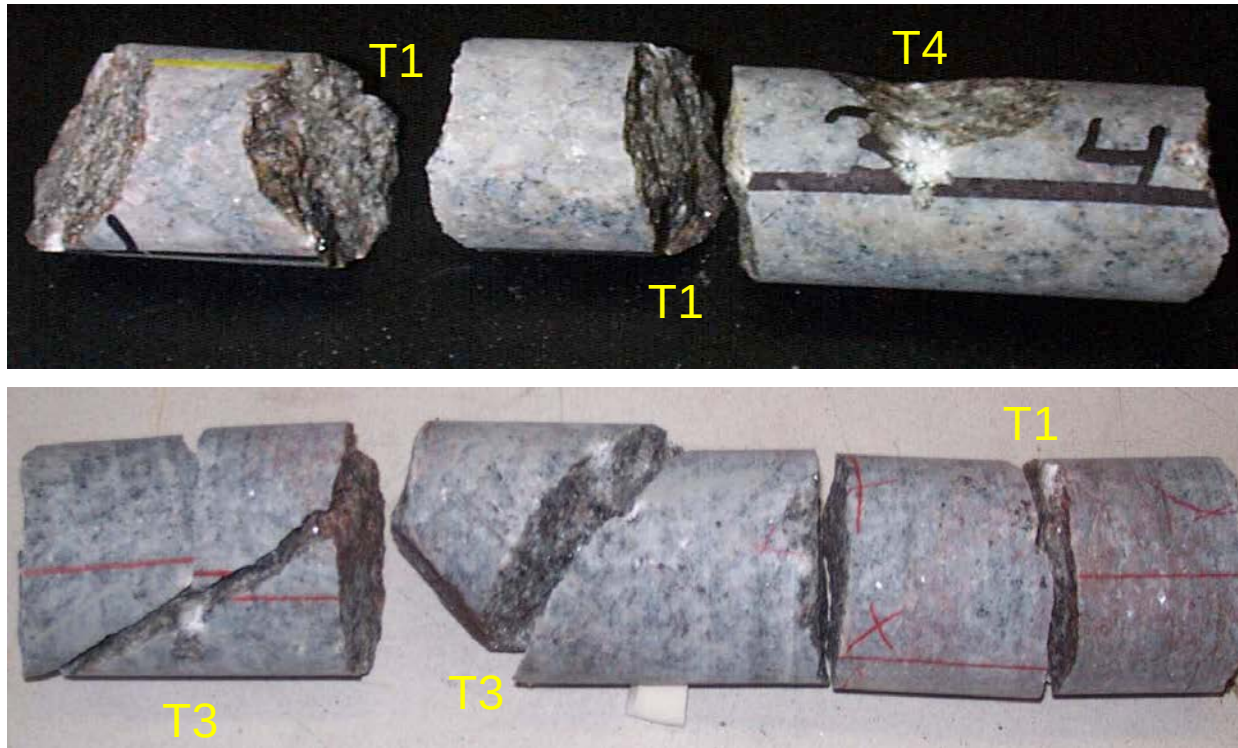
# POINT LOADING TESTING, RESULT REPORTING

| Test | Comment |
|---|---|
| T1 | Good test (failed across diameter through intact rock) |
| T2 | Failure along fabric (foliation/bedding; >50% along plane) |
| T3 | Failure along CJ or vein (>50% along plane) |
| T4 | Failed test; slipped, chipped or rock mass indent (soft) |

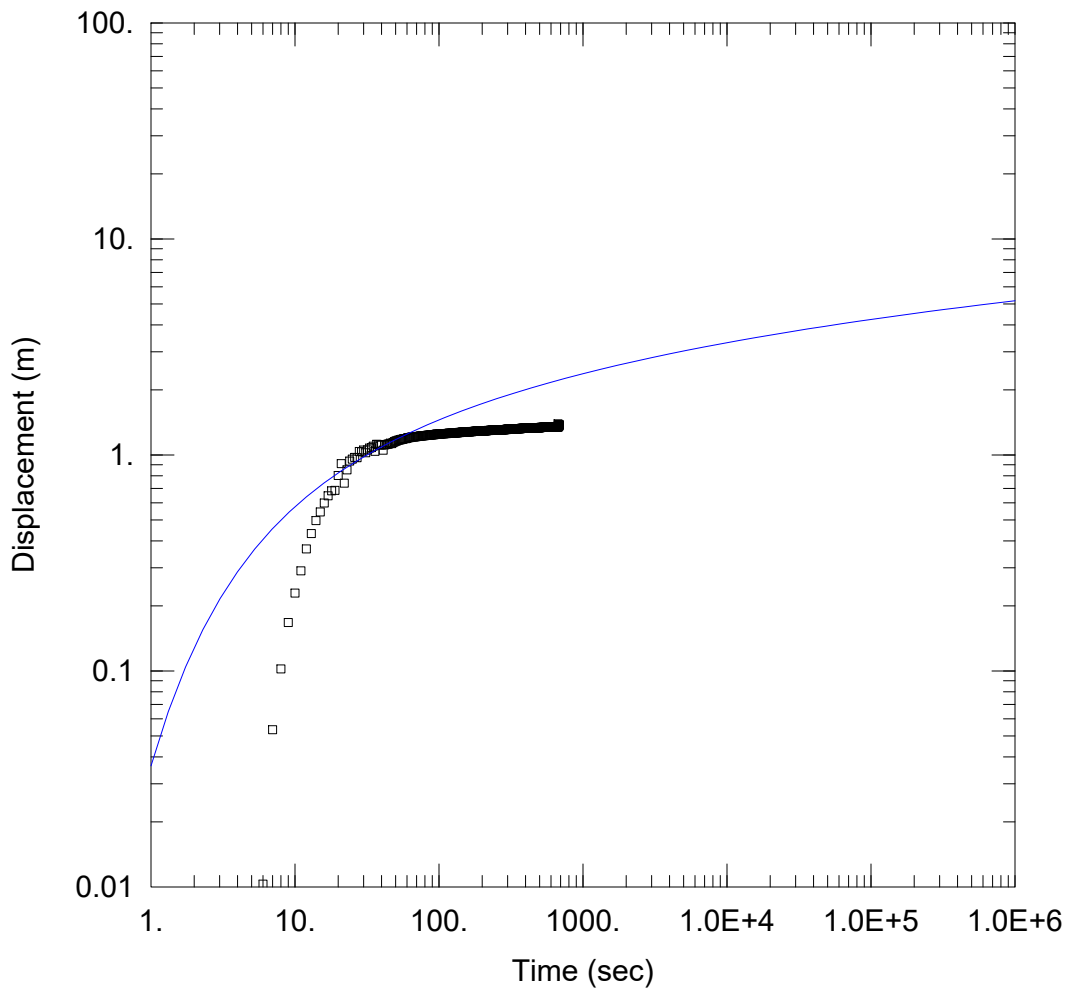
### WELL TEST ANALYSIS

Kz/Kr = 1.

b = 14.72 m

Data Set: \...\Rum\_Jungle\_18DH01-02\_dv.aqt

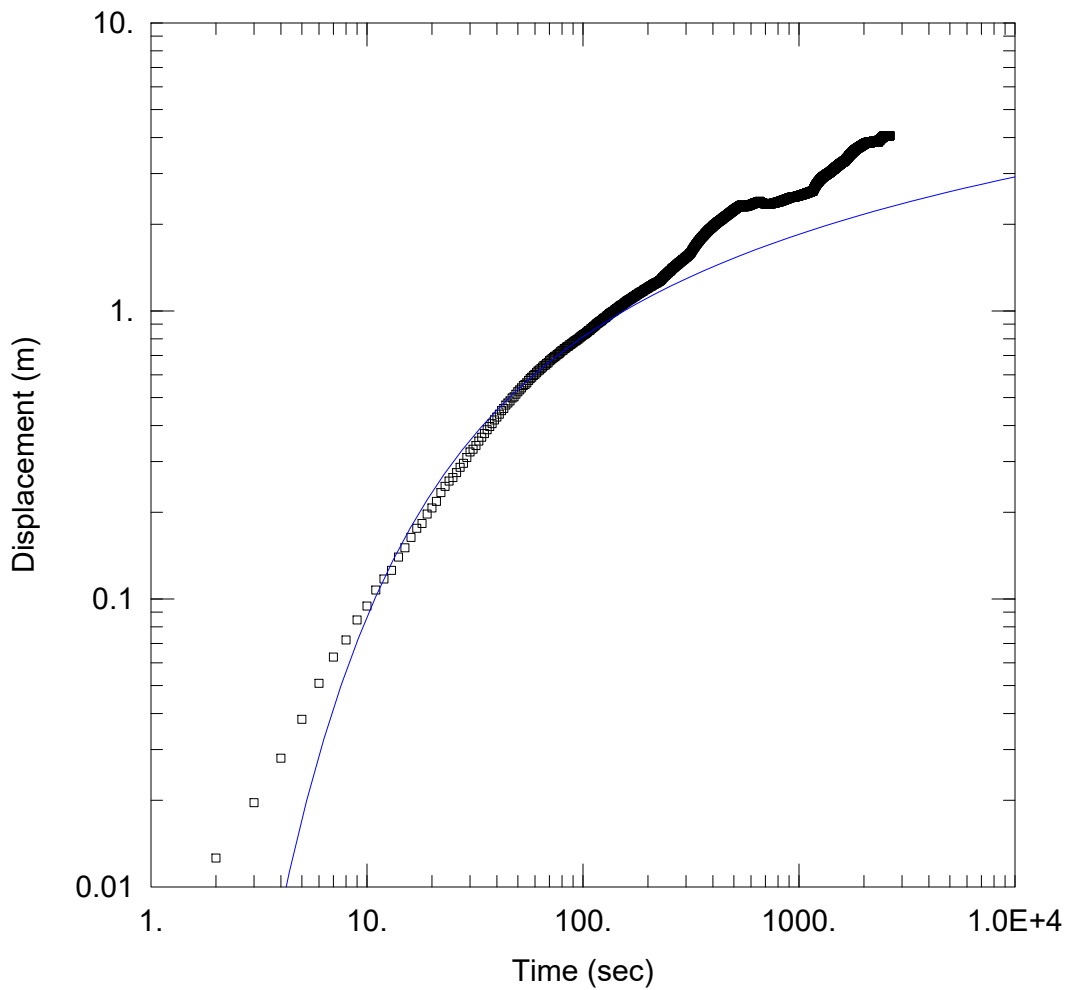
### WELL TEST ANALYSIS

Kz/Kr = 1.

b = 19.4 m

Data Set: \...\Rum\_Jungle\_18DH02-02.aqt
