Appendix J - Draft Mine Closure Plan

RUSTLERS ROOST & Q29 OPEN CUT MINE REDEVELOPMENT MINE CLOSURE PLAN 2021

Tenements: ML 1083, ML 29783, ML 29814

Project Name: Mine Closure Plan -Rustlers Roost and Quest 29 open cut mine redevelopment

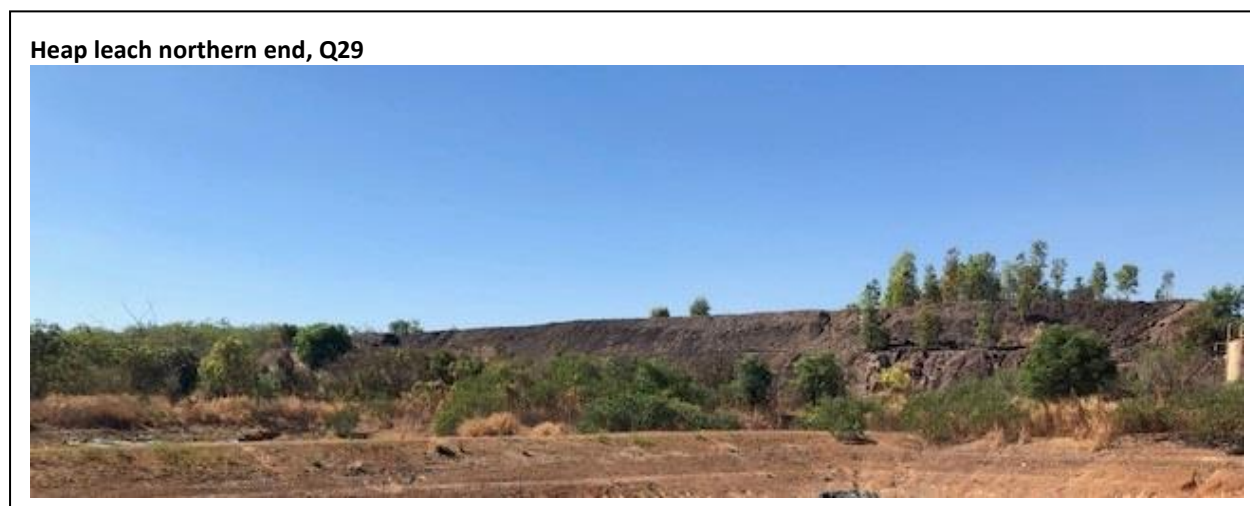
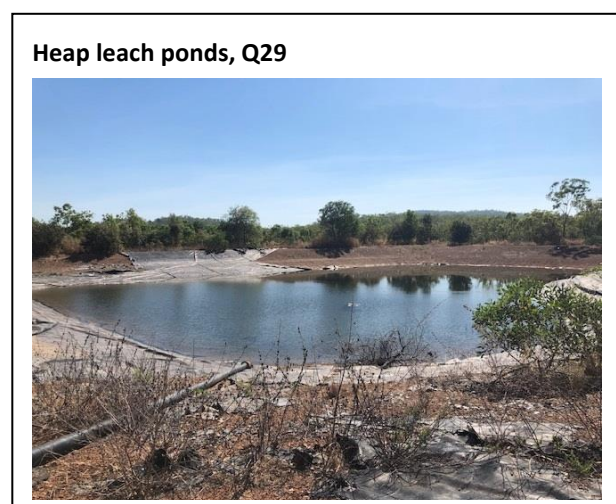
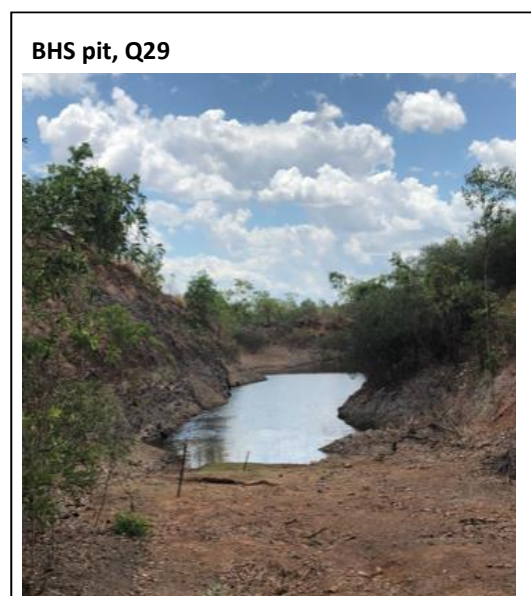
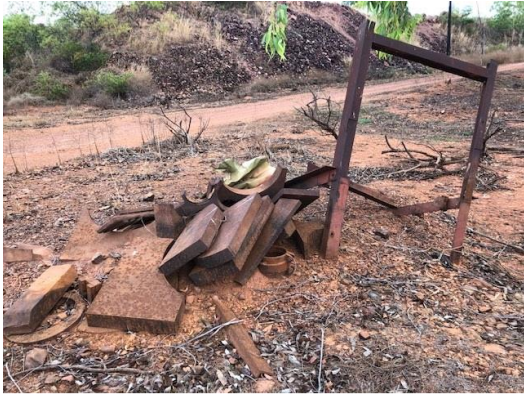
Below are various photos taken in 2021 of some existing disturbances at Rustlers Roost and Q29 sites.

Scrap steel, Rustlers Roost

Concrete footings and pads, Rustlers Roost

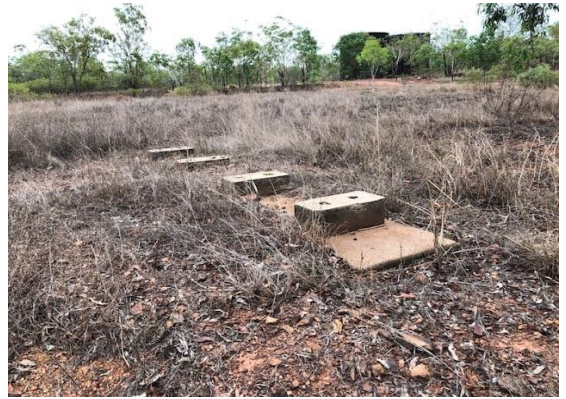
Stormwater pond, Rustler Roost

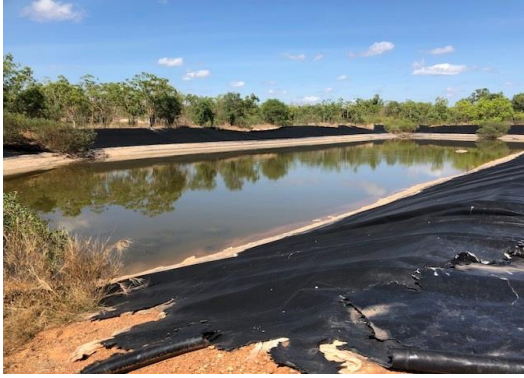
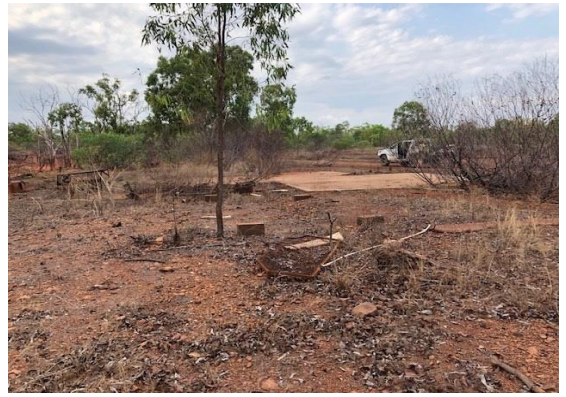
Annie's Dam, Rustlers Roost

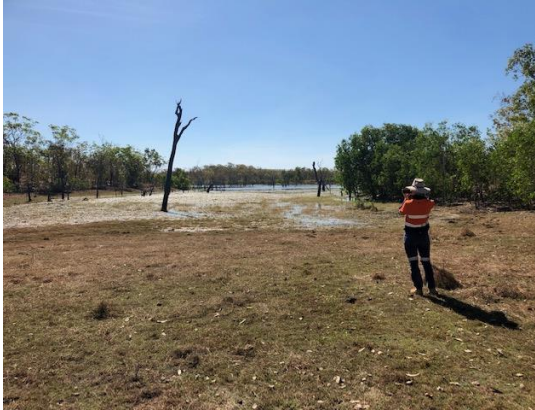
Main pit, Rustlers Roost

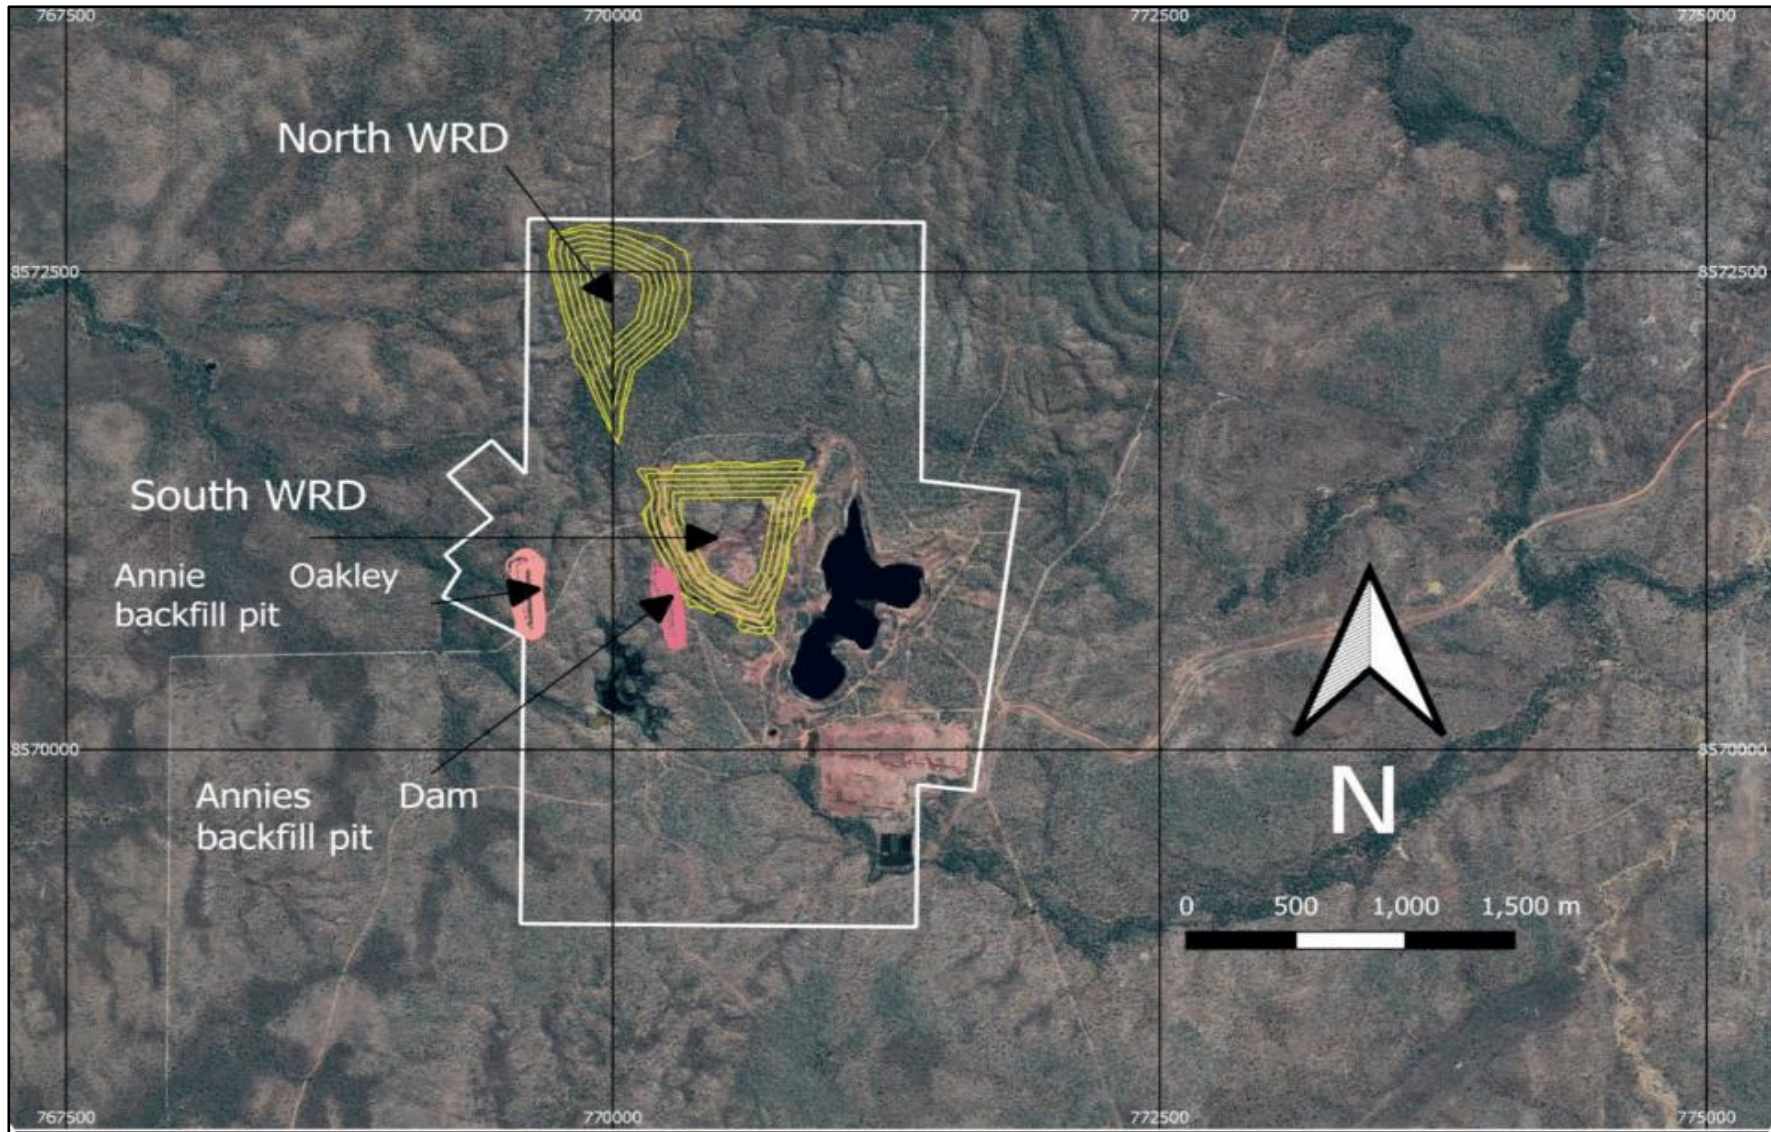
Figure 10 Rustlers Roost North and South waste rock dump profiles

On completion of mining Zamu pit, the pit will be backfilled with waste material from mining of the remaining pits. Volumes and placement of waste material produced at Q29 is detailed below.

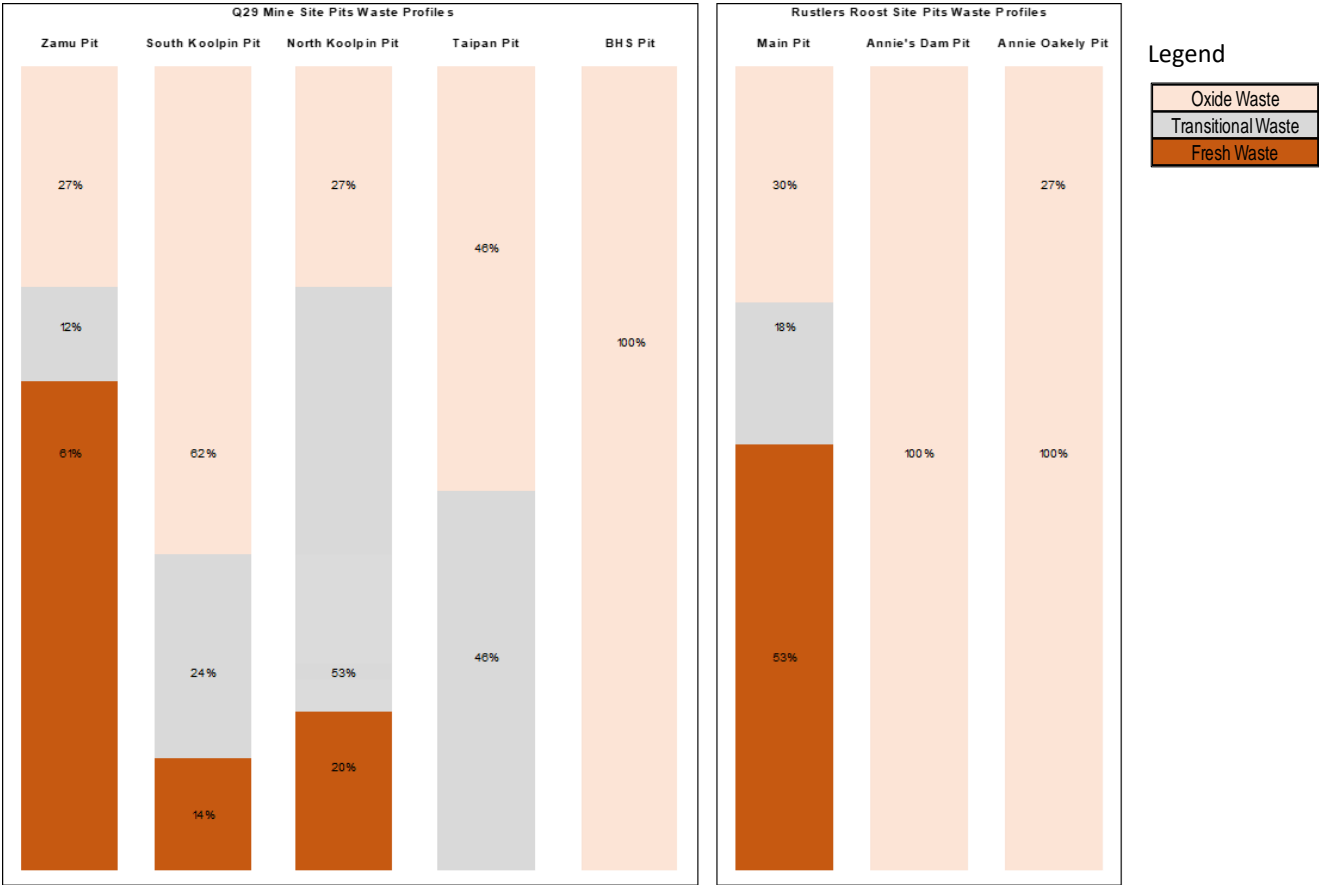
Figure 12 Project mined waste rock weathered profile volumes expressed as a percent of total pit waste

Total waste rock weathered profiles expressed as a % of total waste for each pit is illustrated in Figure 12.

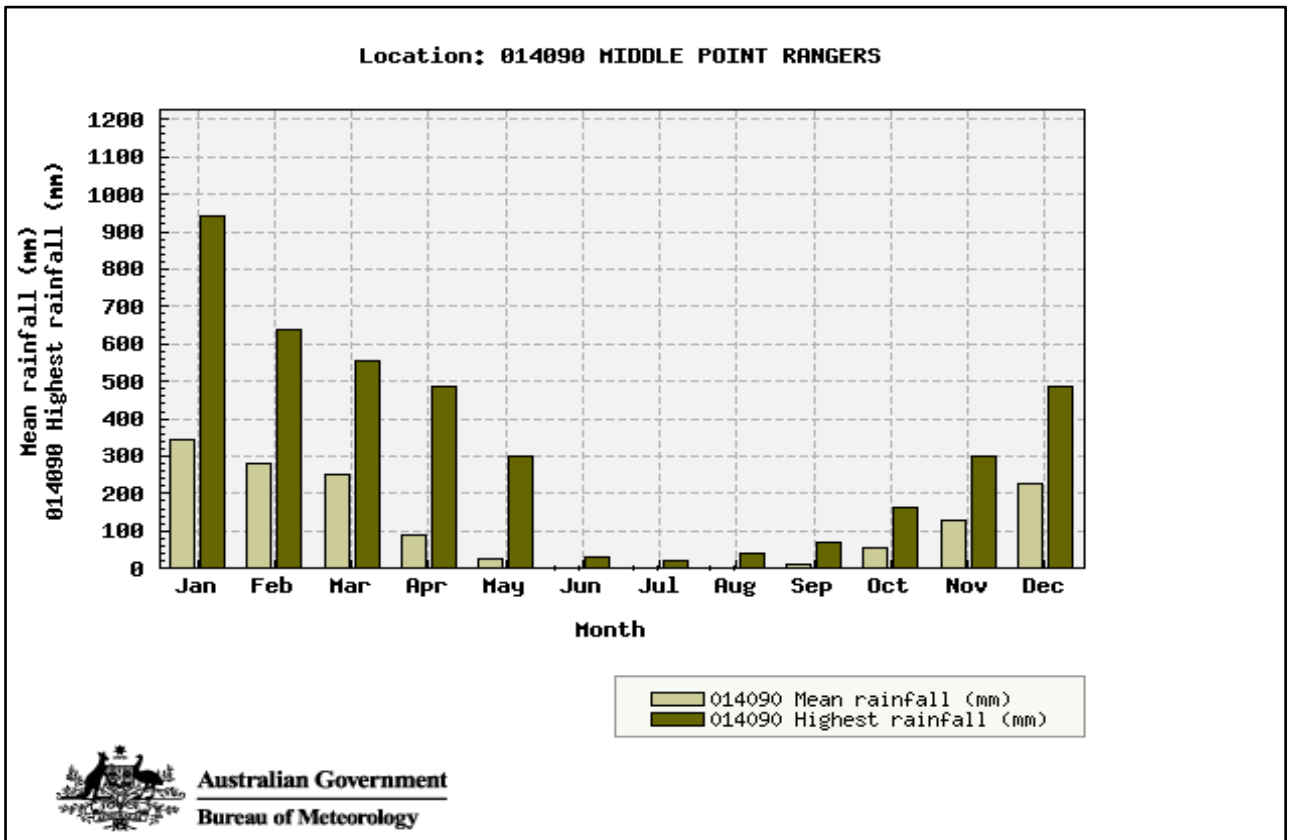
Figure 18 Middle Point Rangers weather station (#014090) mean and highest rainfall (BOM, 2021)

Month	Mean Rainfall	Highest Rainfall	Lowest Rainfall	Mean No. Days of Rain	Mean No. Days ≥ 10 mm	Mean No. Days ≥ 25 mm
Jan	346.5	942.1	40.8	20.9	9.6	4.4
Feb	279.9	638.8	78.0	20.3	7.9	3.4
Mar	249.2	552.9	0.0	17.8	7.2	3.3
Apr	88.7	488.2	0.8	7.9	2.6	0.9
May	23.9	298.4	0.0	2.6	0.6	0.3
Jun	1.4	30.0	0.0	0.3	0.0	0.0
Jul	0.7	22.4	0.0	0.4	0.0	0.0
Aug	2.2	38.5	0.0	0.5	0.1	0.0
Sep	12.9	67.8	0.0	2.0	0.4	0.1
Oct	57.3	162.6	0.0	6.1	1.9	0.7
Nov	130.0	300.8	29.0	12.3	4.2	1.4
Dec	227.8	484.3	19.0	17.5	6.5	2.8
Annual	1,433.5	2,198.3	874.9	108.6	41.0	17.3

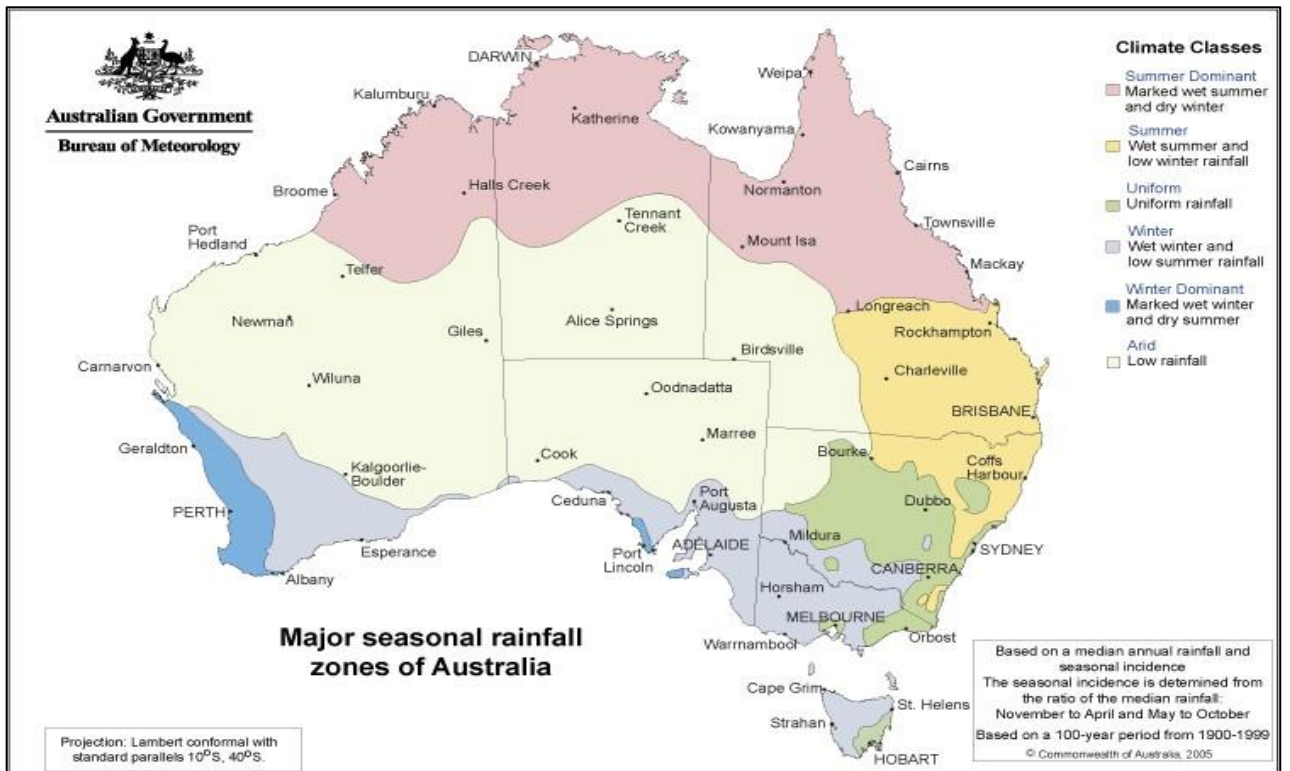
Figure 19 Australian climate zones based on rainfall (BOM, 2021)

The seasonal rainfall map (Figure 20) use the differences between summer and winter rainfall across Australia to identify six (6) major climate zones. Rainfall is also based around climate zones and is illustrated in Figure 19 and Figure 20. These maps use the median annual rainfall (based on the 100 year period from 1900 to 1999) and seasonal incidence (the ratio of the median rainfall over the period November to April to the period May to October) to identify these six (6) major zones. This map indicates that the Project area is within the summer dominant hot humid climate class with a marked wet summer and dry winter.

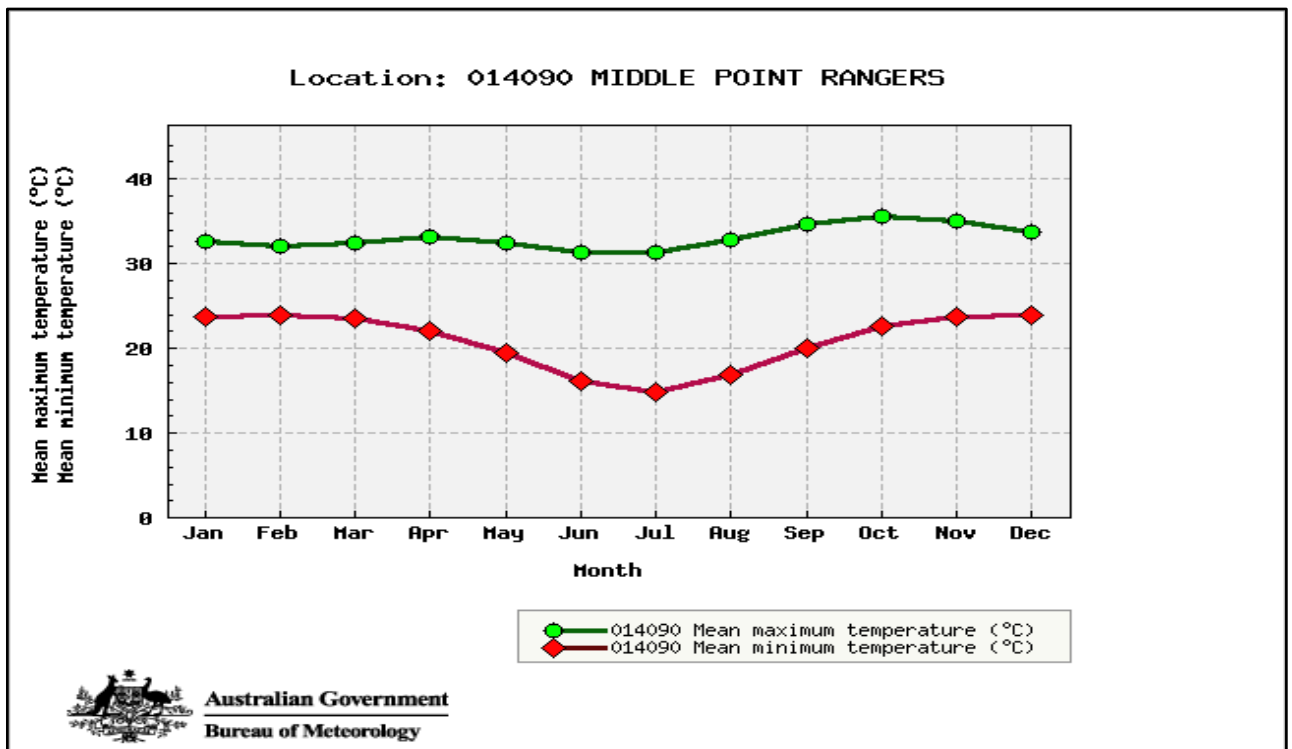
Figure 21 Middle Point Rangers weather station (#014090) mean maximum and minimum temperature (BOM, 2021)

Month	Mean Daily Maximum	Mean Daily Minimum	Highest Daily Maximum	Lowest Daily Minimum	Mean No. Days Maximum \geq 35.0°C	Mean No. Days Minimum \leq 2.0°C
Jan	32.6	23.8	38.2	20.2	3.2	0.0
Feb	32.0	23.9	36.2	19.3	1.0	0.0
Mar	32.4	23.6	37.5	17.3	1.5	0.0
Apr	33.1	22.1	39.0	13.1	1.6	0.0
May	32.5	19.4	35.9	8.2	0.5	0.0
Jun	31.3	16.1	34.9	5.4	0	0.0
Jul	31.3	14.9	35.5	4.6	0.1	0.0
Aug	32.9	16.8	37.1	5.0	2.6	0.0
Sep	34.7	20.1	38.8	9.0	13.7	0.0
Oct	35.6	22.7	40.3	13.5	21.5	0.0
Nov	35.1	23.7	40.2	19.0	16.9	0.0
Dec	33.8	23.9	38.7	18.0	9.4	0.0
Annual	33.1	20.9	40.3	4.6	72.0	0.0

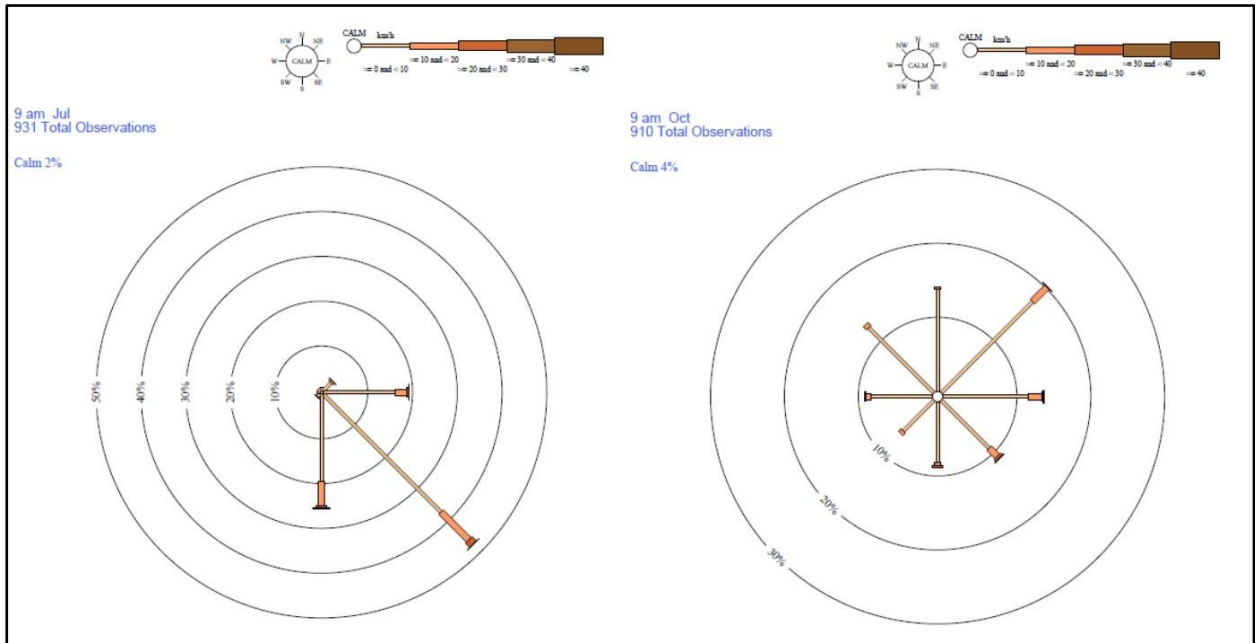
Figure 24 Middle Point Rangers weather station (#014090) wind roses (July-Oct, 9am), (BOM, 2021)

Wind roses are available for the Middle Point Rangers Weather Station (#014090) based on data from 1965 to 1998. During the dry season (i.e., July), winds are expected to be predominantly south-easterly and during the transition from dry to wet season (i.e., October) winds are more variable and trending towards north-easterly, Figure 24. During the wet season (i.e., January) winds are more variable and trending towards west north-westerly and during the transition from wet to dry (i.e., April) winds are south-easterly, Figure 25.

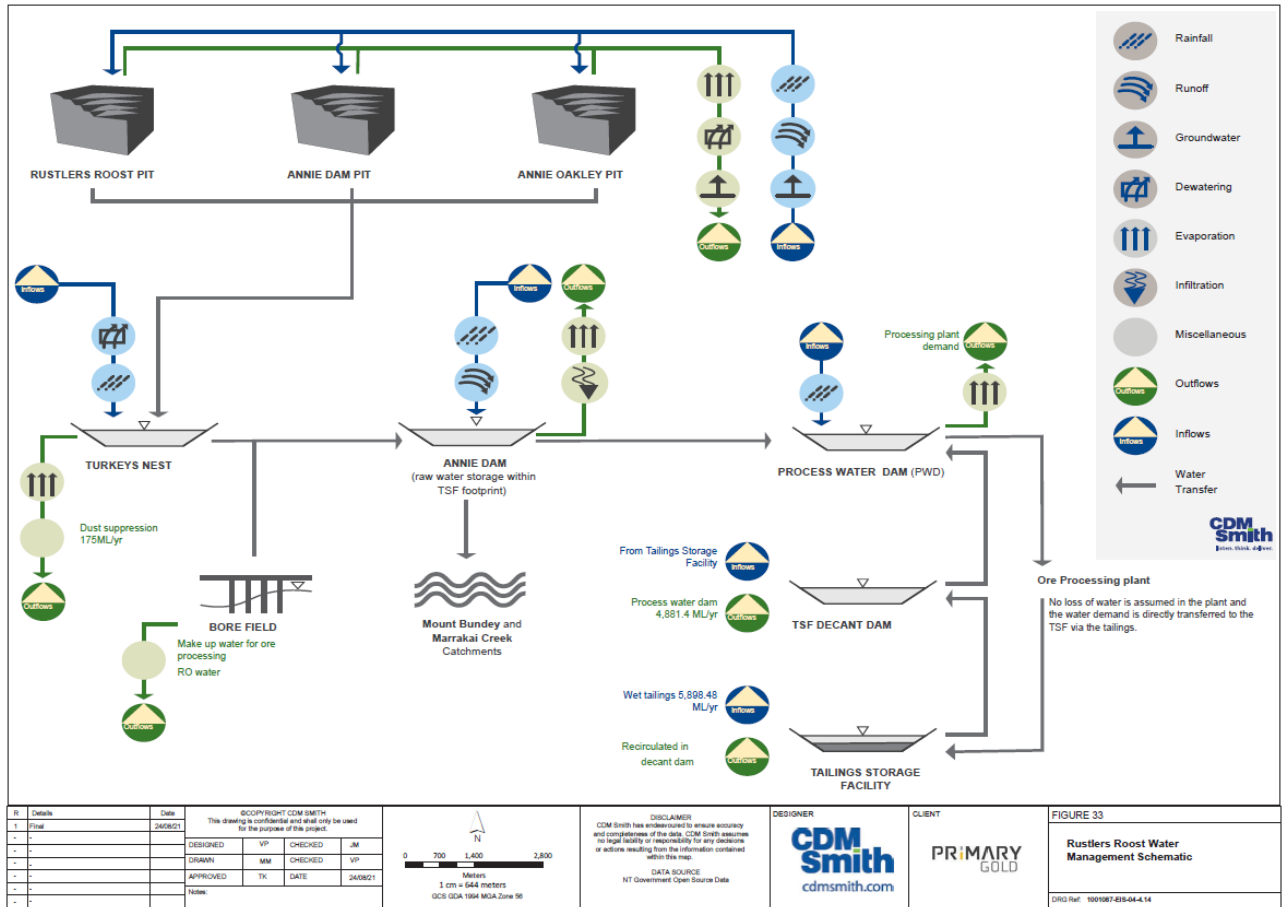
Figure 33 Rustlers Roost site water balance model schematic

Runoff from the catchment is expected to occur rapidly following rainfall events and recession of storm events is also expected to be rapid. Rustlers Roost site is unlikely to be affected by riverine flooding (i.e., flooding generated from further upstream). The dominant flooding mechanism is expected to be the rapid generation of overland flow in response to local catchment rainfall. A flood model has been developed for the project and details included in the projects EIS. To illustrate inflows and outflows, a Site Water Balance model schematic is shown in Figure 33.

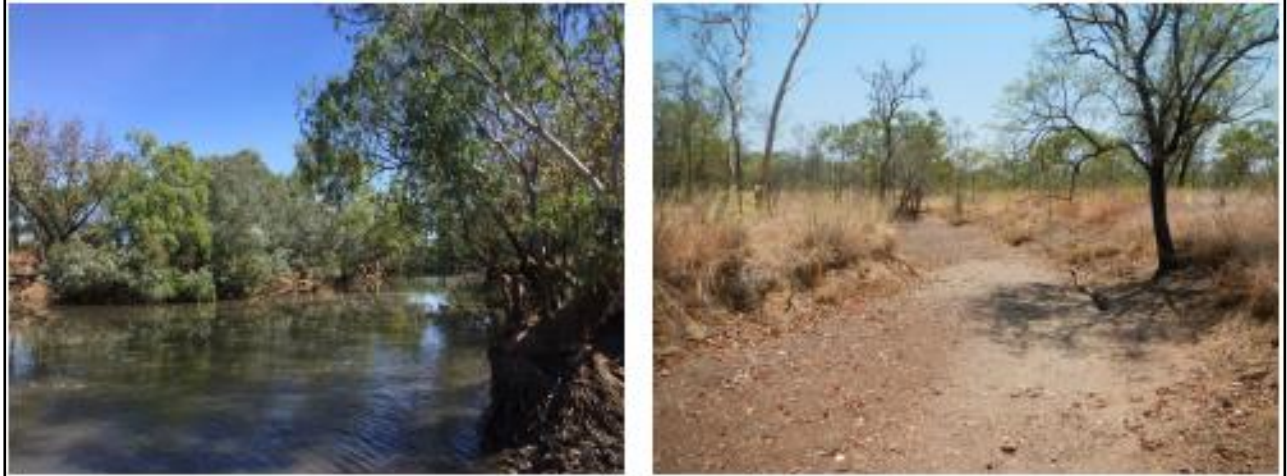
Photo: Examples of significant riparian vegetation (left-photo not taken from project site) compared with drainage line vegetation (right- taken from the Project site.) (Ecoz, 2021)

It is important to note that the haul road riparian habitat assessment has used two term to describe vegetation along a watercourse as per the NT Land Clearing Guidelines (DENR, 2020). These include riparian vegetation and drainage line vegetation. Examples of these two terms are illustrated below. The example to the left is an example of significant riparian vegetation and the photo was not taken from the Project site. The example to the right is a drainage line vegetation and this photo was taken from the Project site.

Outcomes of the Haul Road assessment determined that the overall condition of the drainage/riparian sites was good for the riparian channels considered drainage lines (RP02, RP03 and RP04), noting that drainage lines were degraded in the neighbouring property/s. The condition of the riparian channel RP01 where it intersected the haul road was poor, with two collapsed bridges, cleared areas, weeds and erosion. The riparian/drainage sites RP01 to RP04 were mostly consistent with land unit 6a1, except for RP01 which contained riparian vegetation and is also located on the edge of a river system. However, the scale of land unit mapping is such that RP01 is most reasonably considered to be 6a1. (Ecoz, 2021).
