## **Appendix S - Aquatic Ecology Survey Reports**

## **Appendix S-1 - Aquatic Ecology Survey 2020**

# Toms Gully Aquatic Ecology Baseline Studies

*Final Report*

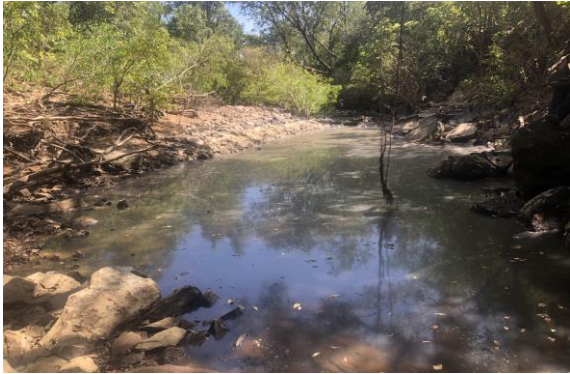
| Site description | Site photo |
|---|---|
| <p><b>SWTG1C - Upstream</b></p> <p>The site was made up of a number of isolated pools bound by bedrock. Water was clear. Bed material was a mixture of bedrock, cobbles and sand. The riparian zone was continuous, and overhanging vegetation trailed in water. Exposed roots and undercut banks were common, along with leaf packs and sticks. A large pool was located upstream, which showed evidence of crocodiles inhabiting the area.</p> | |

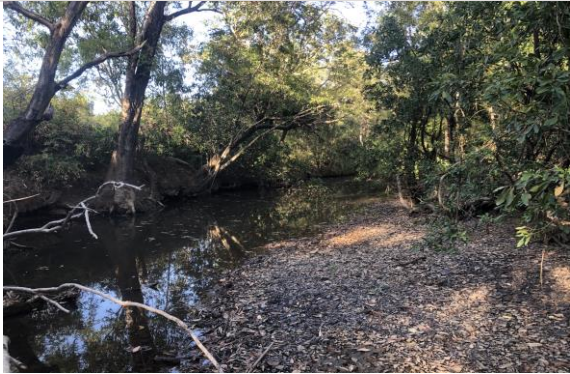
| Site description | Site photo |
|---|---|
| <p><b>SWTG1A – Upstream</b></p> <p>The site was made up of a series of large pools. There was no visible flow at the time of sampling, but subsurface connection is assumed. The creek was lined by a closed canopy of riparian vegetation and so shading was high. The left bank was steep, and a mixture of consolidated clay and gravel with</p> | |

| Site description | Site photo |
|---|---|
| <p>sections of bedrock, while the right bank was a gentle slope and consisted of cobbles and pebbles.</p> | |

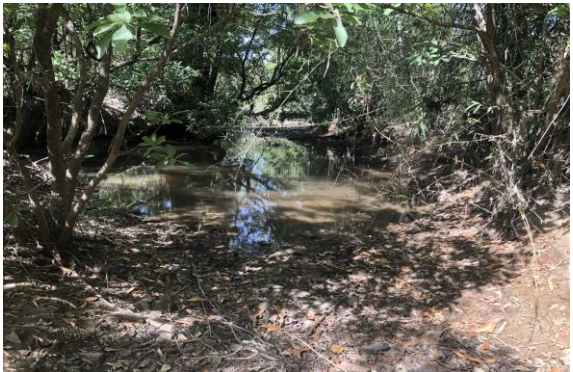
| Site description | Site photo |
|---|---|
| <p><b>SWTG09 – Adjacent</b></p> <p>The site was a series of isolated pools separated by bedrock located on a tributary of Mount Bundey Creek. The pools had vertical banks that were undercut along almost the entire area of all pools. Each end of the pools was lined with bedrock and cobbles. The site had been intersected by a new fence line. Sampling was moved upstream to avoid habitat impacted by the fence line.</p> | |

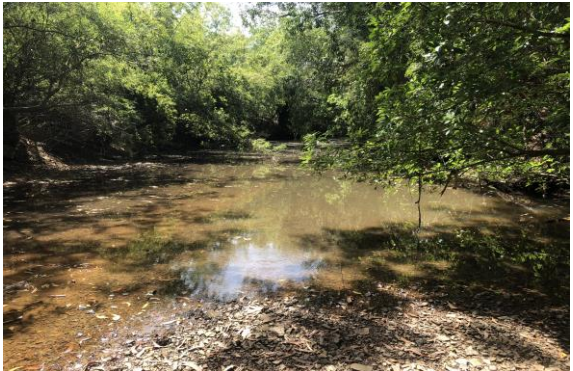
| Site description | Site photo |
|---|---|
| <p><b>SWTG1 – Adjacent</b></p> <p>The site is made up of two large, deep pools, connected by a shallow run. The substrate of both pools is made up of sand and gravel, and the connecting run has substrate made up of pebbles, cobbles and sand. Both banks of the pool are lined by continuous riparian vegetation providing shade and exposed roots. Undercut banks were prevalent, along with leaf packs and small log jams.</p> | |

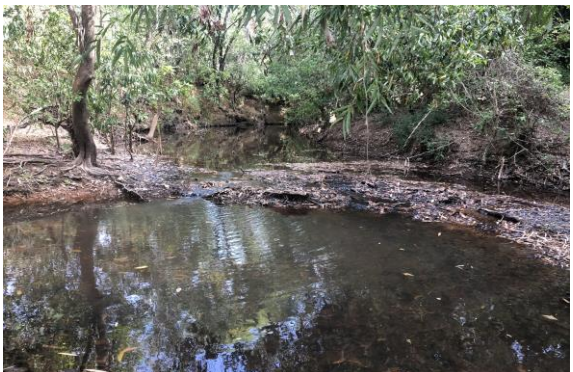
| Site description | Site photo |
|---|---|
| <p><b>MBC0 – Adjacent</b></p> <p>The site is located approximately 100 m upstream of the confluence between a small, unnamed tributary containing site MBC06 and Mount Bundey Creek. The site was well shaded due to a continuous riparian zone, and presence of trees along banks allowed for exposed roots, large woody debris and leaf packs to be common through the site. The majority of substrate at the site was made up of sand and pebbles. Long gliding pools were connected by shallow runs.</p> | |

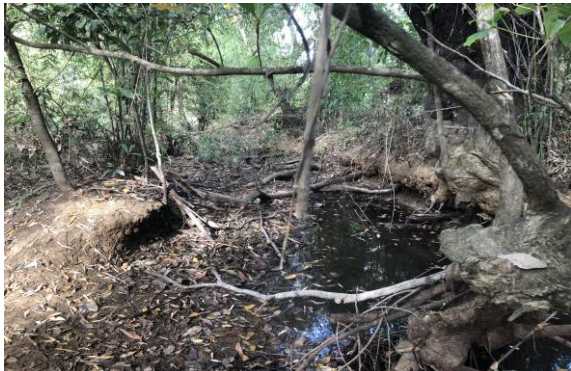
| Site description | Site photo |
|---|---|
| <p><b>MBC06 – Adjacent</b></p> <p>The site is located on a small tributary of Mount Bunday Creek down gradient of EP2. The tributary was almost completely dry, with a number of small, shallow pools remaining. Water and sediment sampling were undertaken, but no biological monitoring was possible. Groundwater flowing from groundwater bores up-gradient of the creek was observed, and iron producing bacteria was seen on the substrate in pools.</p> | |

- Salinity, hardness and ionic composition of surface water at MBC06 indicates it is influenced by groundwater seepage. For several years groundwater seepage from wells up-gradient of the small tributary of Mount Bunday Creek has been observed. Should Toms Gully Mine begin operations, it is expected that dewatering practices will alleviate seepage at this location.

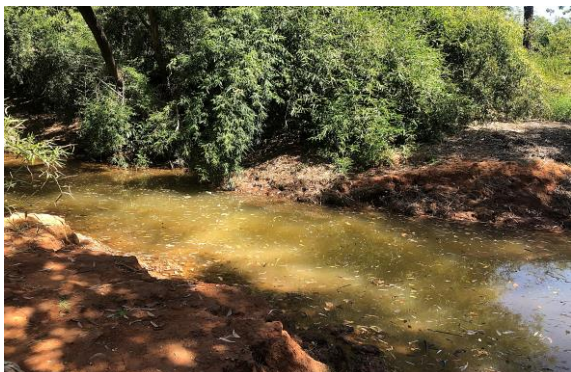
| Site description | Site photo |
|---|---|
| <p><b>MBC01A – Adjacent</b></p> <p>The site is made up of two pools intersected by a cattle crossing. The upstream pool is deep, and has very steep clay banks. The downstream pool is shallow, with undercut banks. Both banks in the downstream pool are steep, and the riparian zone along the entire site is dense and continuous, except for the path leading to the cattle crossing on both sides. The substrate of the downstream pool is mostly sand, with some bedrock.</p> | |

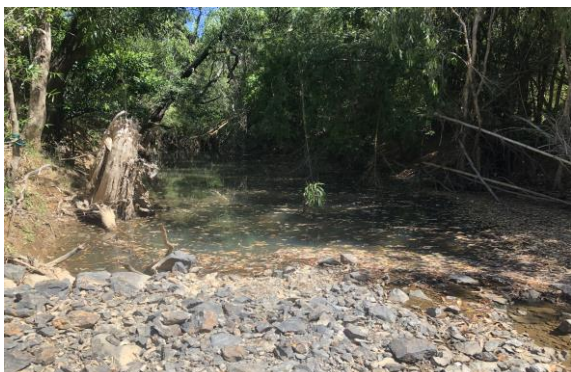
| Site description | Site photo |
|---|---|
| <p><b>SWTG2 - Downstream</b></p> <p>The site is made up of a series of pools connected by runs upstream of a stock crossing. The stock crossing has undergone significant upgrades, which have resulted in erosion and a change in flow through the site from previous years. Downstream of the crossing, the site was a wide, shallow pool. Substrate along the entire reach was a mixture of cobbles, pebbles and sand, with clay banks.</p> | |

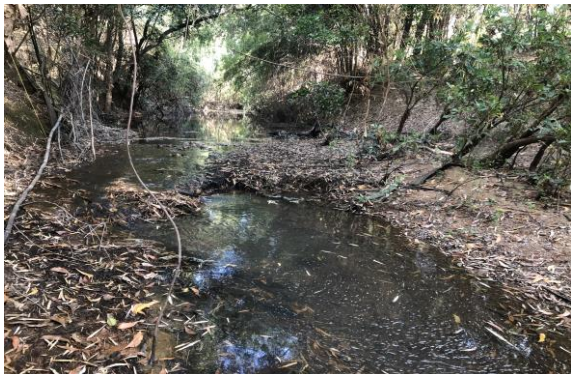
| Site description | Site photo |
|---|---|
| <p><b>MBC03 - Downstream</b></p> <p>The site was characterised by a long shallow run connecting deep pools at either end of the reach. The majority of the run was 0.2 m deep and 3 m wide with some deeper sections adjacent to banks. The substrate was made up mainly of sand and gravel with some accumulation of silt in deeper areas. The creek was highly shaded and undercut banks and exposed fine roots were common on both sides of the creek.</p> | |

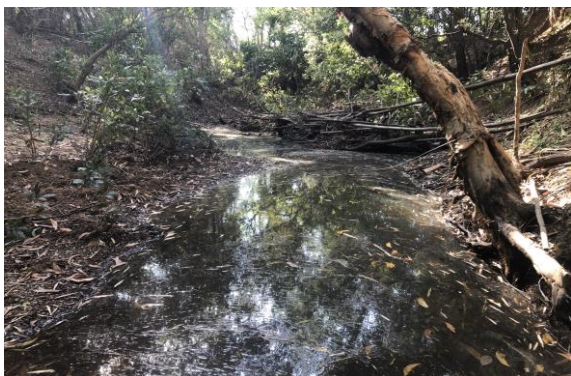
| Site description | Site photo |
|---|---|
| <p><b>SWG3 - Downstream</b></p> <p>The site is the furthest downstream on Mount Bunday Creek, upstream of its confluence with Coulter Creek. The site was characterised by a long pool and run with large woody debris and undercut banks. Substrate was mostly sand, and the substrate was covered for most of the reach by detritus. Bait traps were deployed into a deep pool upstream that was considered unsafe to enter to electrofish.</p> | |

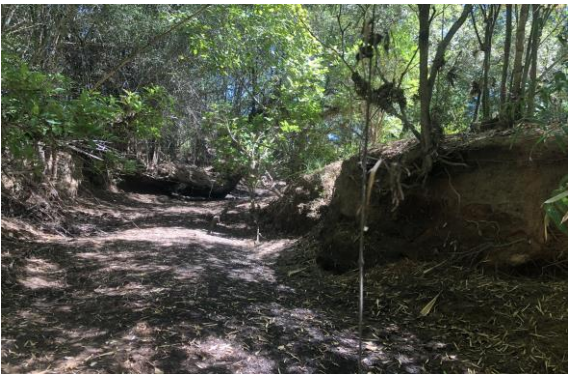
| Site description | Site photo |
|---|---|
| <p><b>CC02 - Reference</b></p> <p>The site is intersected by a ford made of, cobbles and clay. Upstream of the ford was a large, deep pool. The pool was considered unsafe to enter. Downstream of the ford was a series of pools connected by shallow runs that was 2 m wide for the majority of the reach. The creek was shaded by a dense, 5 m wide, native riparian strip on both banks. Beyond the riparian zone was cleared and the land used for grazing.</p> | |

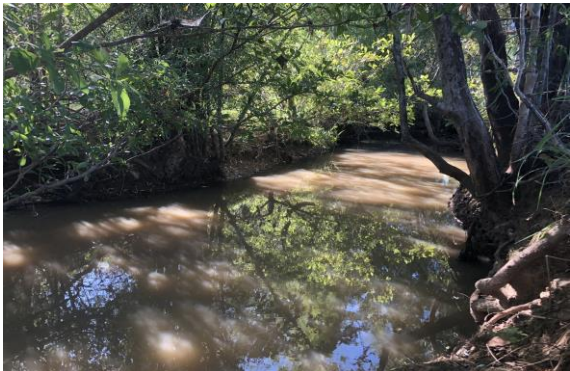
| Site description | Site photo |
|---|---|
| <p><b>CC01 - Reference</b></p> <p>The site is located close to Mount Bunday Creek Station cattle yards, with a ford intersecting the creek. The reach extended from the ford downstream. The site was characterised by a meandering run with some deeper pools. Shading was lower in the downstream parts of the creek, with large patches of filamentous algae observed. Banks were eroded close to areas where cattle had been accessing the creek</p> | |

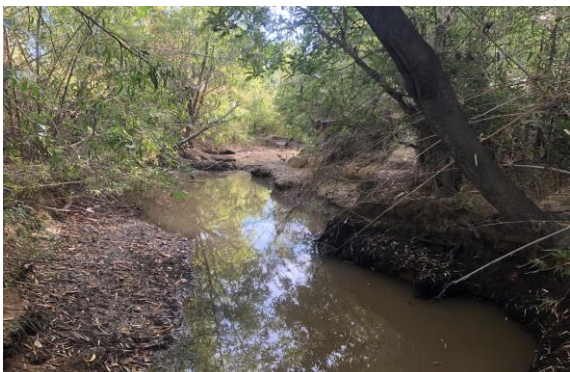
| Site description | Site photo |
|---|---|
| <p><b>CK7 - Reference</b></p> <p>The site is located downstream of the Arnhem Highway and is a routine water quality monitoring location. The surrounding area is made up of cropping and grazing land. The riparian zone and creek itself were in relatively good condition, and included undercut banks, high shading and leaf litter. Water was slightly turbid and evidence of pigs feeding and wallowing in some pools was observed.</p> | |

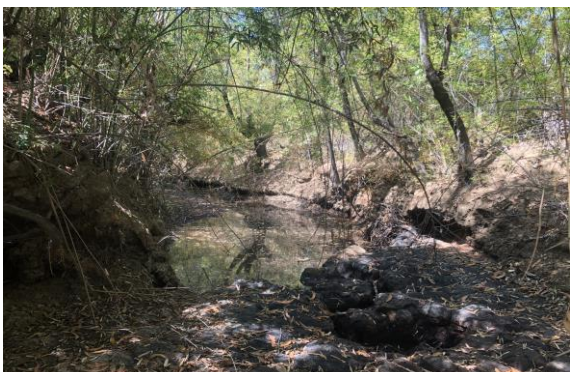
| Site description | Site photo |
|---|---|
| <p><b>CC03 - Reference</b></p> <p>The site is located approximately 1.7km downstream of the Arnhem Highway and is a pool 50 m in length, upstream and downstream of the pool was a shallow run. The pool has a moderate amount of shade, and its banks were heavily eroded with discontinuous riparian vegetation mixed with pasture grasses. The substrate was mostly bedrock, with some deposition of clay and silt in the downstream end of the pool.</p> | |

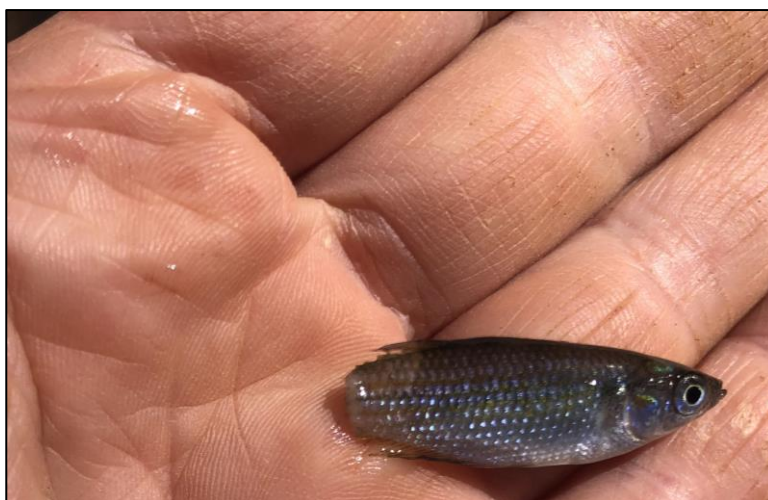
*Plate 1 -Missing tail of Eastern Rainbowfish at SWTG2*

Fin damage in freshwater fish can be a naturally occurring phenomena that is related to fish competition and predation practices. It can also be linked to stress associated with poor water quality (Denton and Burdon-Jones 1989). Although it cannot be determined from this study if these impacts are directly associated with water quality at SWTG2, the site did record dissolved metal concentrations in surface water which could be potentially ecotoxic. Sites upstream without dissolved metals exceedances, and the site sampled downstream where only a single metal exceeded the guidelines did not contain any fish that appeared to be in poor health. Previous studies at Toms Gully Mine have identified ulcers and legions on fish close to TSF2 (GHD 2017). In 2017, fish at SWTG2 were not found to have these issues, and dissolved metals were also recorded at levels above guideline values at that time.

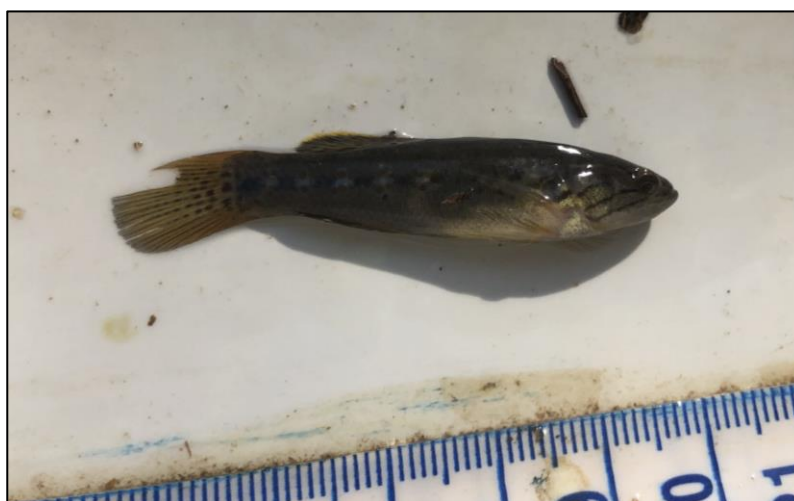
*Plate 2 – Fin erosion and lesion on Purple-spotted Gudgeon*

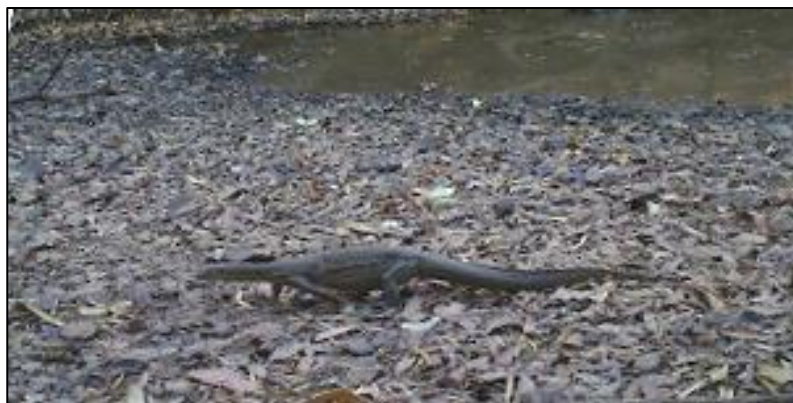
Plate 3 – Mertens Water Monitor (*Varanus mertens*) captured at SWTG3.

A total of 28 animals were identified on cameras between May and September 2020 (Table 14), including 16 species of birds, 8 mammals, 2 frogs and 2 reptiles. The target species, Mertens Water Monitor (*V. mertens*) was captured at the furthest upstream camera site (SWG1) and furthest downstream camera site (SWG3, Plate 3). There were no sightings of *V. mitchelli* on any of the remote camera units in 2020, as has been the case in previous monitoring events. A large number of non-target species were recorded on cameras during deployment, which is an indirect benefit of the monitoring that continues to add to the fauna register at the site.

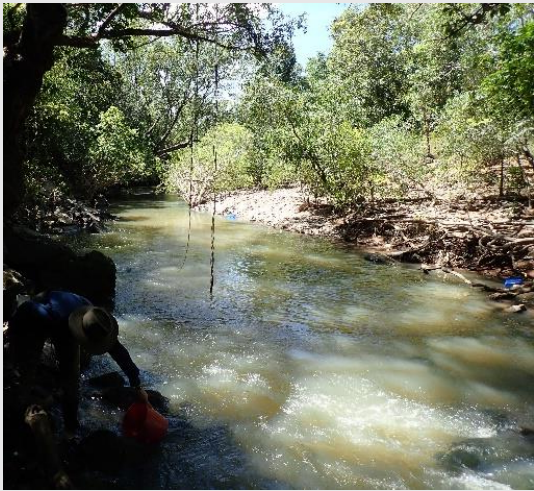
| Site/habitat description | |
|---|---|
| The site was made up of a series of pools connected by riffles. Flow was strong on the right bank, which was steep and made up of bedrock, exposed roots and clay. The right bank was gentle, and the substrate was cobbles and bedrock. The creek did not span the entire channel, and was confined to the right bank. Vegetation in the riparian zone was growing close to the bank and providing shade to the entire creek. The right side of the channel had trees growing in it, denoting that flow did not increase into this section of the channel often. The substrate was mostly cobbles, but some sand pockets were located on the left side of the creek, where flow was gentle. | |

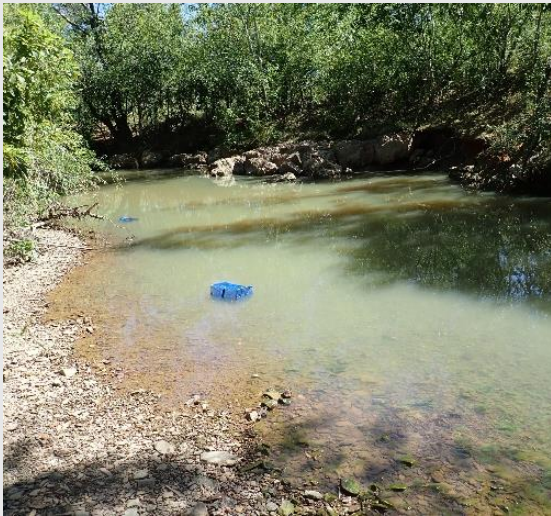
| Site/habitat description | |
|---|---|
| Sampling location was moved 100 m downstream due to depth and water clarity. The site was characterised by a wide, shallow pool with gentle flow. Downstream was a stock crossing and deeper pool. The upstream pool was lined by riparian vegetation which was overhanging, and shaded edges. The left bank was steep, and a mixture of consolidated clay and gravel with sections of bedrock, while the right bank was a gentle slope and consisted of cobbles and pebbles. Flow was observably faster along the left bank. Some SWH and undercut roots were present on the left bank, creating a backwater. The riparian zone was ~30 m wide on both sides, and the pool sampled was around 8 m wide and 30 cm deep. | |

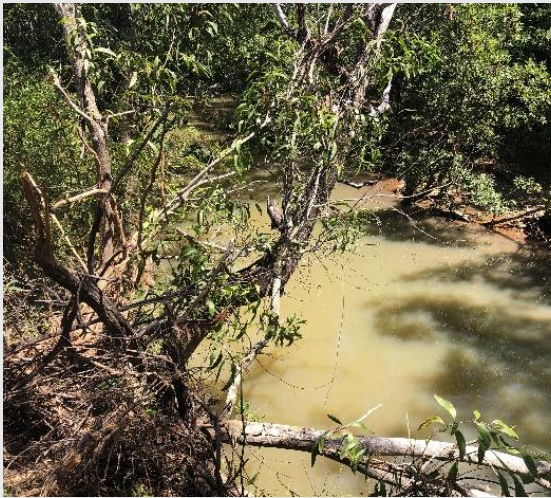
| Site/habitat description | |
|---|---|
| <p>The site was a series of isolated pools separated by bedrock located on a tributary of Mount Bunday Creek. The pools had vertical banks that were undercut along almost the entire area of all pools. Each end of the pools were lined with bedrock and cobbles. Trees lined the site, but the riparian zone was discontinuous. Shade was high, as the creek was narrow (2 m wide) and the canopy was enclosed in some areas. SWH was present in some larger pools, and fine detritus was common. Cattle had been accessing the site, and areas beyond the riparian zone had been disturbed by pigs. Debris on banks indicated that high flow had occurred at some point prior to sampling.</p> | |

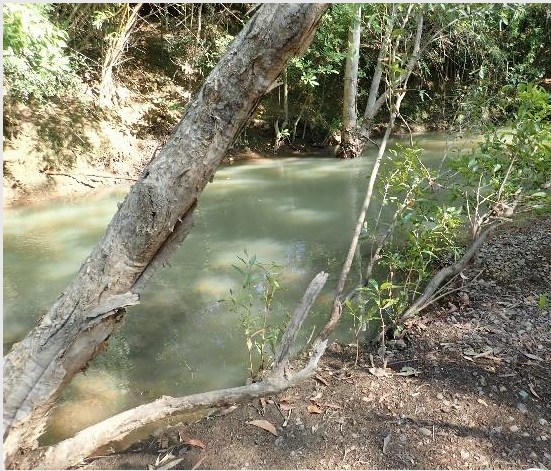
| Site/habitat description | |
|---|---|
| <p>The site is made up of two large, deep pools, connected by a shallow run. The substrate of both pools is made up of sand and gravel, and the connecting run has substrate made up of pebbles, cobbles and sand. SWH was found through the extent of the reach and the right bank was undercut, exposing roots from riparian vegetation. Banks were approximately 3.5 m high and were very steep. Riparian vegetation was thick, extending at least 20 m from each bank. Riparian vegetation was overhanging and shaded most of the creek. Large trees lined the banks, with their roots exposed, creating good habitat for larger fish.</p> | |

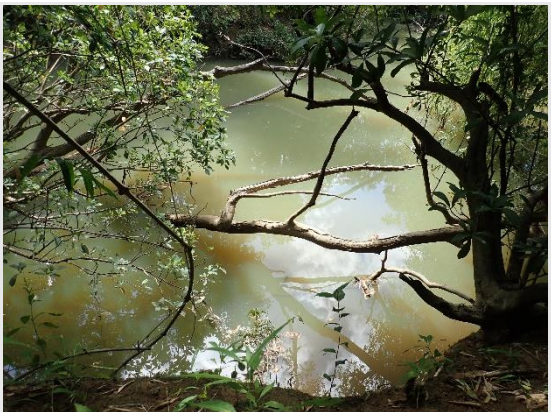
| Site/habitat description | |
|---|---|
| <p>The site was almost completely inundated with water. Given the height of banks observed in previous years, water was estimated to be at least 3 m deep. No sampling was undertaken due to safety risks associated with depth, flow and potential presence of crocodiles.</p> | |

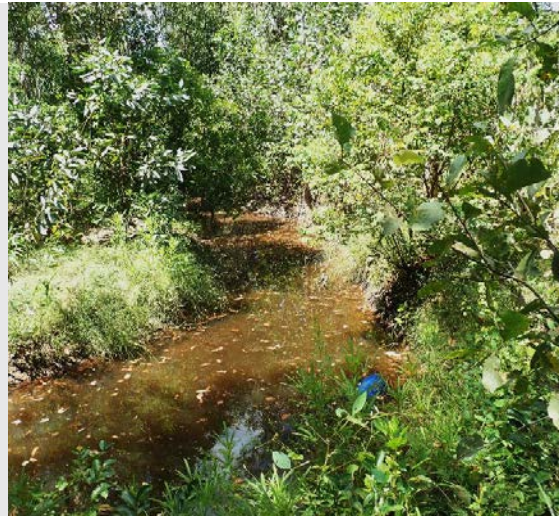
### MBC06

The site is located on a small tributary of Mount Bunday Creek draining away from EP2. The site was made up of a single isolated pool winding along the creek for around 25 m, with an average width of 2 m. The substrate was a mixture of bedrock, cobbles, silt and clay, with small amounts of SWH and leaf packs. An oil slick was observed on the surface. When sampling macroinvertebrates, an anoxic odour was released from sediment. Towards EP2, water was observed seeping from the ground close to a groundwater bore, which was oxidising and iron floc was present. There was no surface water connection to the pool. The riparian zone was narrow, and did not persist for more than 5 m from the water.

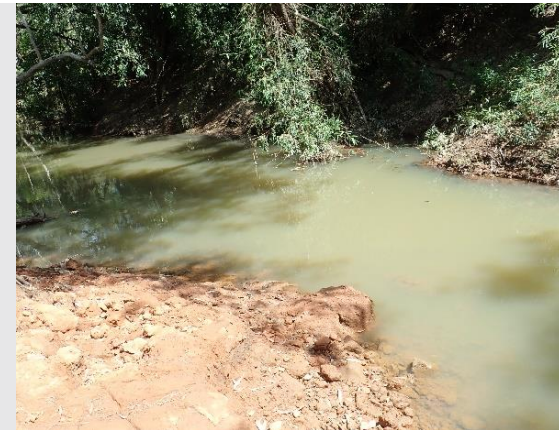
### MBC01A

MBC01 was relocated 700 m downstream based on a recommendation in 2018 report (GHD 2018a). The site is made up of two pools intersected by a cattle crossing. The upstream pool is deep, and has very steep clay banks. The downstream pool is shallow, with SWH and undercut banks. Both banks in the downstream pool are steep, and the riparian zone along the entire site is dense and continuous, except for the path leading to the cattle crossing on both sides. The substrate of the downstream pool is mostly sand, with some bedrock. Detritus was present in backwaters.

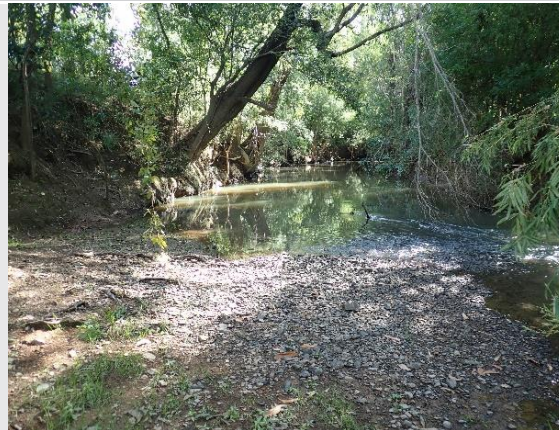
### SWG2

The site is made up of a series of pools connected by runs upstream of a stock crossing. Downstream of the crossing, the site was a wide, shallow pool. Substrate along the entire reach was a mixture of cobbles, pebbles and sand, with clay banks. Continuous riparian vegetation was observed at the site, except through the causeway path, resulting in heavy deposition of detritus and SWH within the creek. Exposed roots were common in deeper pools. Trailing vegetation (parra grass and riparian overhang) was common along the length of the site.

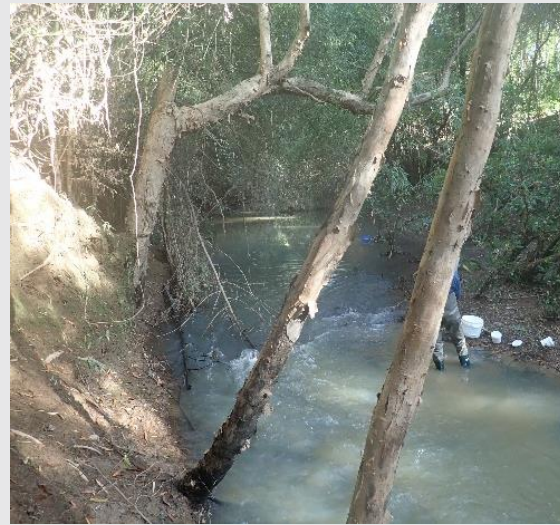
### MBC03

The site is located on a bend and was characterised by a long shallow run connecting deep pools at either end of the reach. The majority of the run was 0.2 m deep and 3 m wide with some deeper sections adjacent to banks. SWH and leaf packs were found through the reach. Substrate was made up mainly of sand and gravel with some silty deposits in deeper areas. The creek was highly shaded and the riparian zone extended for 20 m on the right bank and >30 m on the left bank. The right bank was very steep and 3.5 m high, whereas the left bank was a gentle slope reaching a similar height. Undercut banks and exposed fine roots were common on both sides of the creek.

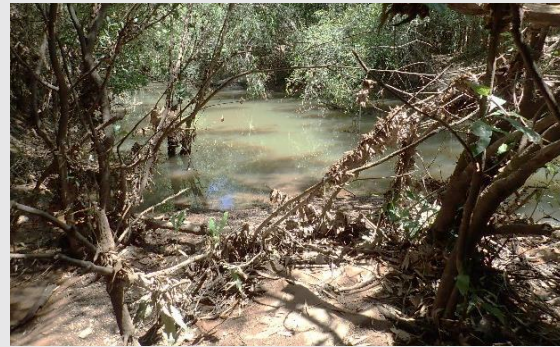
### SWTG3

Remote camera set up and WQ sample taken, but no macros or fish. The site is located downstream of the Coulter Creek confluence, and is the furthest downstream site on Mount Bundey Creek. At the time of sampling, the water level at the site was well above the water mark. Water flow and turbidity were high, and it was deemed to be unsafe to undertake biological sampling. There did not appear to be any changes in the riparian zone from 2018.

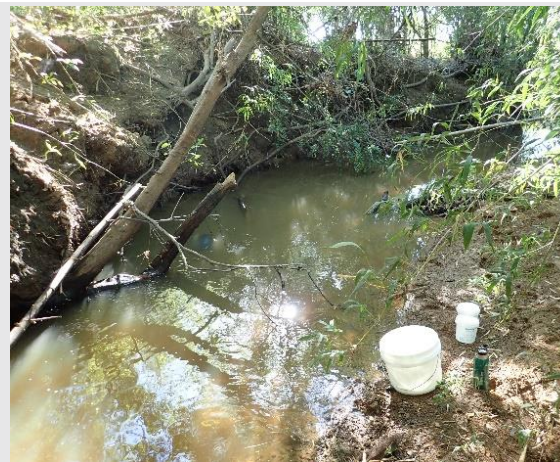
### CC02

This is the furthest upstream site on Coulter Creek, and is intersected by a ford made of boulders, cobbles and clay. Upstream of the ford was a large, deep pool containing SWH. The pool was considered unsafe to enter. Downstream of the ford was a series of pools connected by shallow runs that was 2 m wide for the majority of the reach. The creek was shaded by a dense, 5 m wide, native riparian strip on both banks. Beyond the riparian zone was cleared and the land used for grazing. An oil slick was observed directly downstream of the ford. Macroinvertebrate sampling was undertaken downstream of the ford.

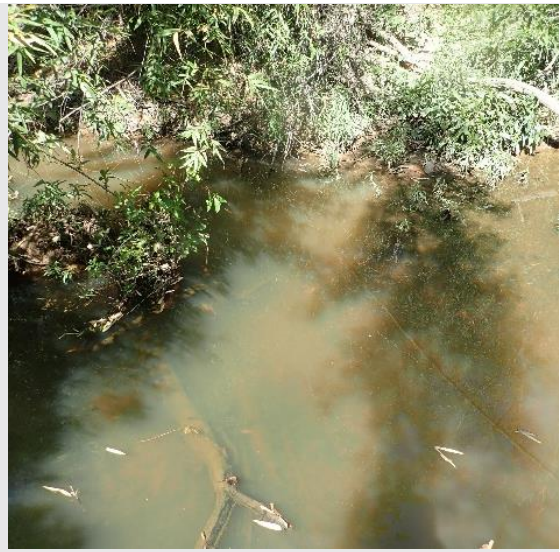
### CC01

The site is normally a set of isolated pools, but was flowing during sampling. The site is located close to Mount Bunday Creek Station cattle yards, with a ford intersecting the creek. The reach extended from the ford downstream. The site was characterised by a meandering run with some deeper pools. Shading was lower in the downstream parts of the creek, with large patches of filamentous algae observed. Banks were eroded close to areas where cattle had been accessing the creek. A representative from Mount Bunday Creek Station advised that cattle were regularly herded through this section of the creek and over the ford. The upstream section of the reach was shaded and had a riparian strip around 5 m wide. Exposed roots and SWH were common.

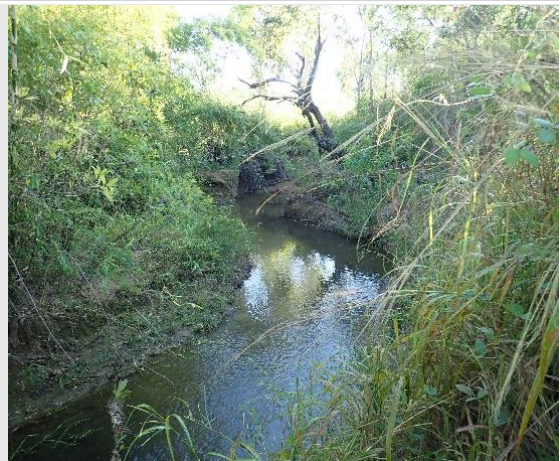
### CK7

The site is an existing water quality monitoring point for Tom's Gully Mine, located on the downstream side of the crossing of Coulter Creek with the Arnhem Highway. The site was made up of a series of deep pools connected by shallow runs. Steep, eroded banks were covered by pasture grasses, and some sparse riparian trees. The substrate was mostly bedrock, with gravel, sand and clay present in areas of low flow. Evidence of cattle and pig access to the creek from both banks was observed. Some undercut banks and exposed roots and shade were present in the deeper pools. Archerfish observed in deep pools.

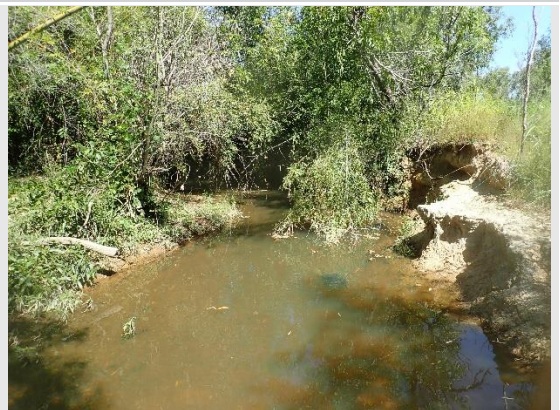
### CC03

Site in previous years of sampling has been a set of isolated pools, but was a connected flowing creek in 2019. The site is located approximately 1.7 km downstream of the Arnhem Highway and is a pool 50 m in length, upstream and downstream of the pool was a shallow run. The pool has a moderate amount of shade, and its banks were heavily eroded with discontinuous riparian vegetation mixed with pasture grasses. The substrate was mostly bedrock, with some deposition of clay and silt in the downstream end of the pool.

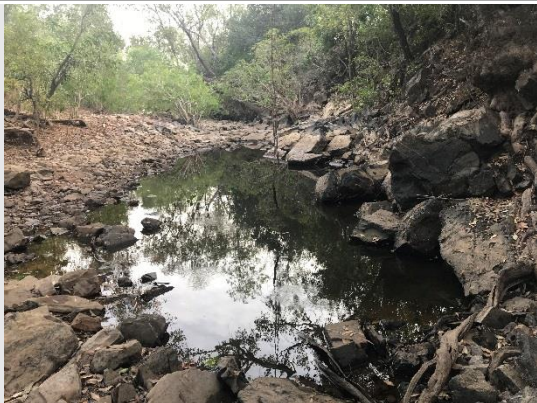
| Site/habitat description | Site photo |
|---|---|
| <b>SWG1C</b><br>SWTG1C was a number of isolated pools bordered by rocks and boulders, with exposed bedrock forming a near vertical bank approximately 8 m high. Substrate consisted of sand and silt with a covering of leaf litter. Riparian vegetation included <i>Ficus</i> sp., <i>Melaleuca</i> sp. and other trees. Instream features included algae covered cobbles and boulders, and exposed roots from riparian vegetation. A large freshwater crocodile was observed at this site. Only a single pool was considered safe to enter and was sampled (pictured right) | |

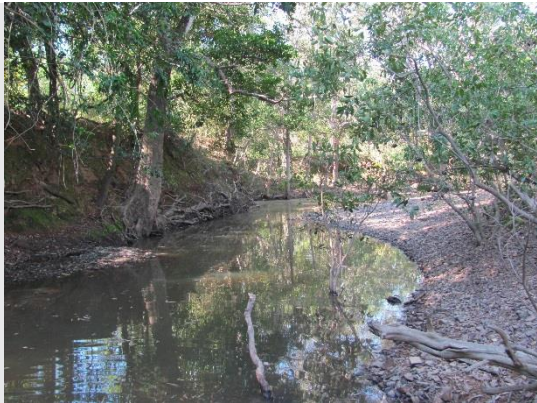
| Site/habitat description | Site photo |
|---|---|
| <b>SWG1A</b><br>SWTG1A consisted of two large pools connected by a small channel, with no flow at the time of sampling. The bottom of the pools was not visible, making it difficult to determine the composition of the substrate, as well as making the site a potential crocodile habitat. Both pools were lined by a thick strip of native vegetation and had steep banks approximately 4 m high. A large amount of woody debris was found at the site, and most of the banks contained exposed roots and undercut banks. | |

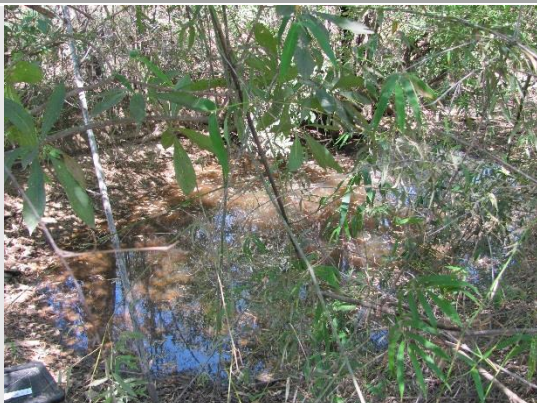
| Site/habitat description | Site photo |
|---|---|
| <b>SWG09</b><br>SWTG09 was made up of two small, clear pools separated by a section of bedrock with no connecting flows. The site was characterised by angled and undercut banks, with exposed roots and snags lining much of the pools, as well as overhanging vegetation. The substrate was a mix of cobbles, pebbles and sand. The larger pool contained leaf packs, while the smaller pool contained algae. Riparian vegetation was a mix of trees, shrubs, grasses and bamboo. | |

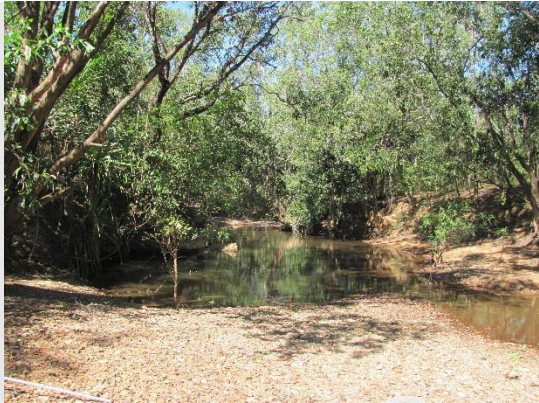
| Site/habitat description | Site photo |
|---|---|
| <p><b>SWTG1</b></p> <p>SWTG1 was a long, shallow channel connecting two large, deep pools. The wetted width was approximately 2.5 m wide in the channel sections and 8 m wide in the pool sections. No flow was observed during sampling. Substrate comprised cobbles and pebbles embedded in gravel and sand. Large woody debris and leaf packs were found through the extent of the reach and banks were undercut, exposing roots from riparian vegetation. Banks were approximately 3.5 m high and were very steep. Riparian vegetation was thick, extending at least 20 m from each bank and shading most of the creek.</p> | |

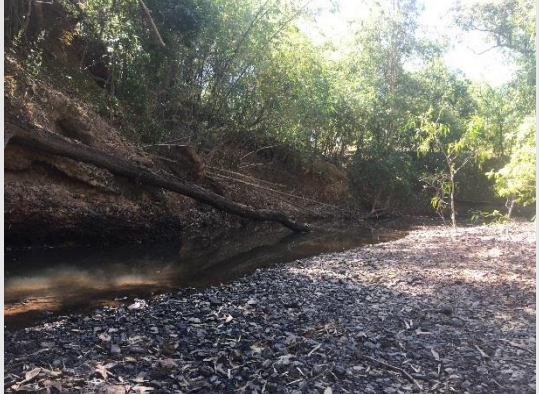
| Site/habitat description | Site photo |
|---|---|
| <p><b>MBC0</b></p> <p>MBC0 consisted of a number of pools separated by a series of short runs. The reach was well shaded due to a continuous riparian zone comprising of Melaleucas and Eucalypts. The presence of trees along banks allowed for exposed roots, snags, large woody debris and leaf packs to be common through the site. The substrate was rocky and contained algal growth.</p> | |

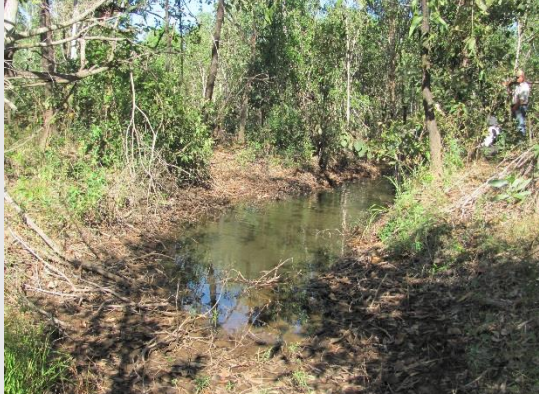
| Site/habitat description | Site photo |
|---|---|
| <p><b>MBC06</b></p> <p>MBC06 consisted of a narrow, isolated pool. Water was clear but an oil slick was present in some areas. The substrate was a mixture of sand, silt and clay. Instream habitats included overhanging vegetation, woody debris, snags and leaf packs. Electrofishing could not be undertaken at this site due to high salinity. More water was observed at the site than on any previous occasion.</p> | |

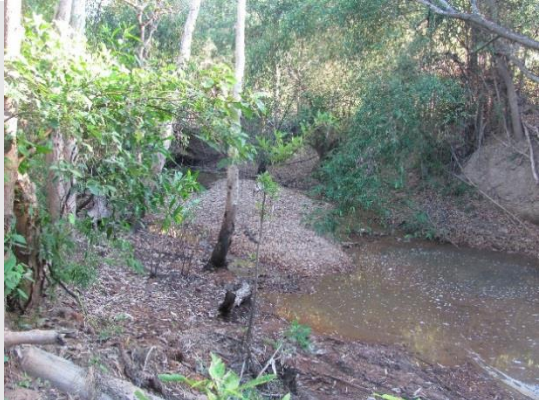
| Site/habitat description | Site photo |
|---|---|
| <p><b>MBC01</b></p> <p>MBC01 had been highly modified in 2018. Details are below in Section 4.1.2. A large pool with an average width of 5 m was slightly turbid, and was located upstream of a narrow run, which entered another deep, wide pool. The depth and turbidity of the pools meant the bottom was not visible, making the site a potential crocodile habitat and inaccessible for electrofishing. The creek was heavily shaded, with the riparian vegetation made up of Pandanus, native bamboo and riparian trees. Undercut banks, exposed roots, snags and overhanging vegetation were present.</p> | |

In 2018, two sites were observed to have been modified significantly to allow for cattle crossings to occur. The first was located on Mount Bunday Creek at site MBC01. A large crossing had been pushed across the channel of Mount Bunday Creek after the wet season, which had then washed out (Figure 4-1). The area downstream of the site changed from a shallow pool to a deep one, with the upstream area collecting large trees creating a large pool (Figure 4-2). The pools were connected by a shallow run. Heavy erosion and vegetation removal was evident on the banks at the site.

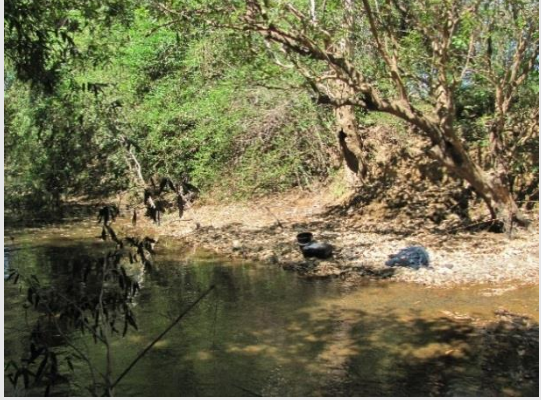
| Site/habitat description | Site photo |
|---|---|
| <p><b>SWTG2</b></p> <p>SWTG2 is intersected by a causeway, with upstream sections of the creek made up of a series of deep pools connected by runs. Downstream of the causeway, the site was a wide, shallow pool, with clear water. Substrate along the entire reach was a mixture of cobbles, pebbles and sand, and banks were made of clay. Riparian vegetation was dense and comprised of native trees and bamboo. Banks were undercut exposing roots, while overhanging vegetation, snags and leaf packs were common.</p> | |

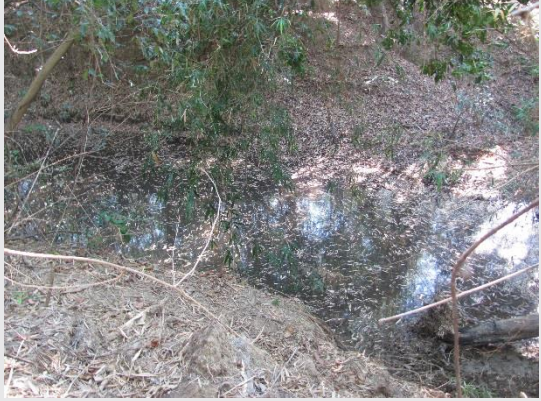
| Site/habitat description | Site photo |
|---|---|
| <p><b>MBC03</b></p> <p>MBC03 was characterised by a long shallow run with a large pool at the upstream end. The creek was highly shaded in this area and the riparian zone extended for 20 m on the right bank and &gt;30 m on the left bank. The right bank was very steep and 3.5 m high, whereas the left bank was a gentle slope reaching a similar height. The site contained floating leaf litter and detritus. Large woody debris was found through the reach as were leaf packs. Substrate was made up mainly of sand and gravel.</p> | |

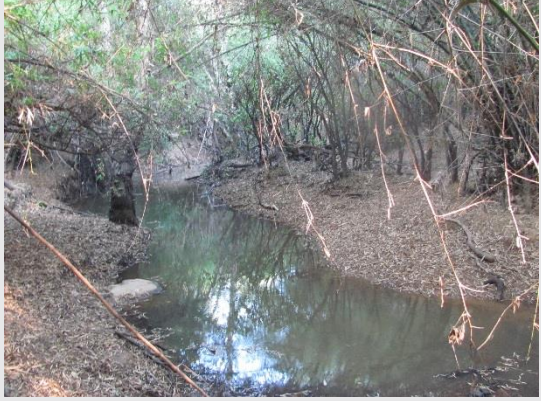
| Site/habitat description | Site photo |
|---|---|
| <p><b>SWTG3</b></p> <p>SWTG3 was characterised by a long pool and run with large woody debris and undercut banks. Substrate was sand and silt, while banks were comprised of sand and clay. The substrate was heavily covered by detritus. The riparian zone contained bamboo and Melaleuca, though very little understory vegetation was present. The site contained undercut banks, exposed roots, snags and leaf packs.</p> | |

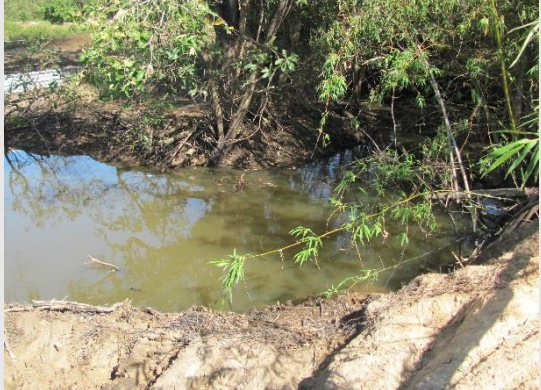
| Site/habitat description | Site photo |
|---|---|
| <p><b>CC01</b></p> <p>CC01 is located close to cattle yards of Mount Bunday Creek Station, and contained a ford intersecting the creek. The reach extended from the ford downstream. The site was characterised by a series of isolated pools. Shading was lower in the downstream parts of the creek, while the upstream section of the reach was shaded and had a riparian strip around 5 m wide. Banks were undercut, with exposed roots, snags, large woody debris, overhanging vegetation and leaf packs providing aquatic habitats at the site.</p> | |

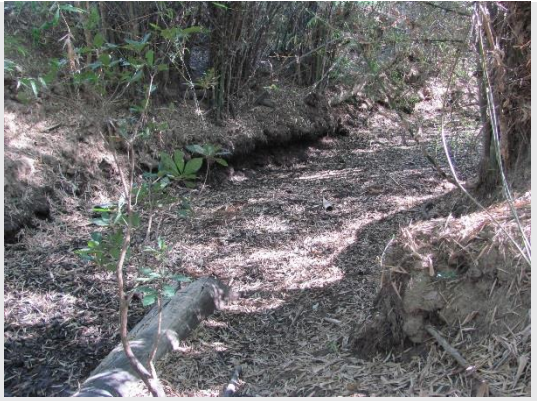
| Site/habitat description | Site photo |
|---|---|
| <p><b>CC02</b></p> <p>The site was dry at the time of sampling, and therefore sampling could not be completed. The site had experienced significant change in geomorphology and structure since 2017. These changes are detailed in Section 4.1.2. The reach was characterised by a meandering channel through large stands of bamboo. There was a large cattle crossing through the upstream end of the reach, and substrate within the channel was made up of clay and sand. The reach was heavily shaded outside of the cattle crossing.</p> | |

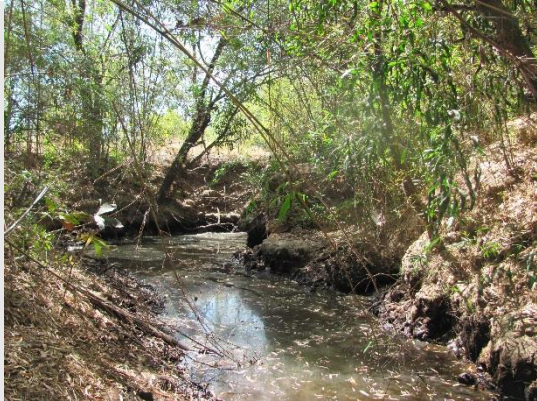
| Site/habitat description | Site photo |
|---|---|
| <p><b>CC03</b></p> <p>CC03 is characterised by a large isolated pool approximately 50 m in length. Riparian vegetation was primarily bamboo which provided minimal shading. The substrate was mostly bedrock, with some deposition of sand and silt. The site contained floating leaf litter and detritus, and a sheen was visible on the surface of the water. Overhanging vegetation was present and banks were heavily eroded.</p> | |

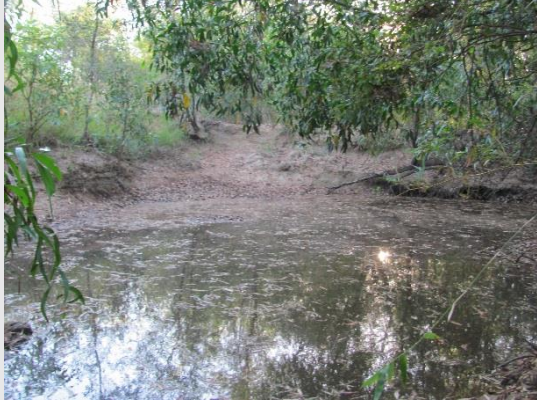
| Site/habitat description | Site photo |
|---|---|
| <p><b>CK7</b></p> <p>CK7 is located on the downstream side of the crossing of Coulter Creek with the Arnhem Highway. It was characterised as a series of isolated pools of varying depth. Water was murky and the pool bottoms were not visible. The substrate was mostly sand and silt, with some exposed bedrock. Riparian vegetation was bamboo, trees and grasses. Floating leaves were present, along with undercut banks and overhanging vegetation.</p> | |

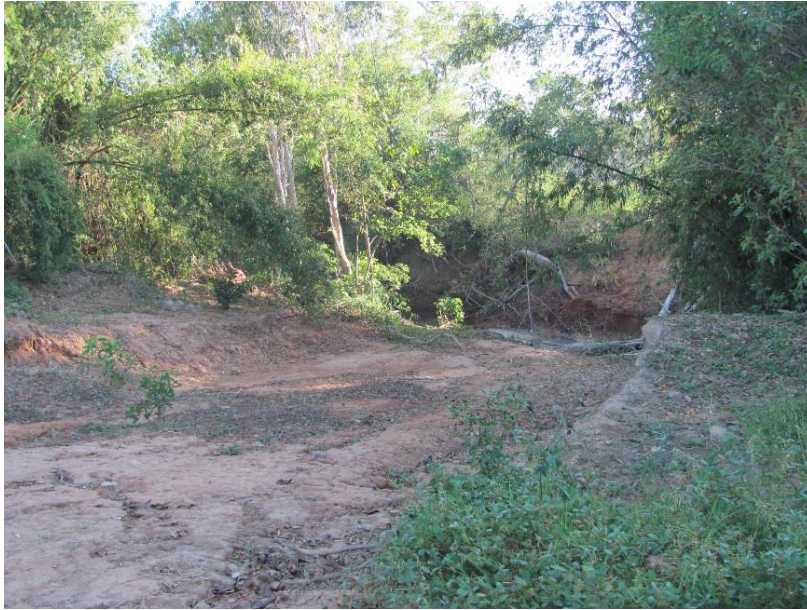
Figure 4-1 Cattle crossing installed at MBC01.

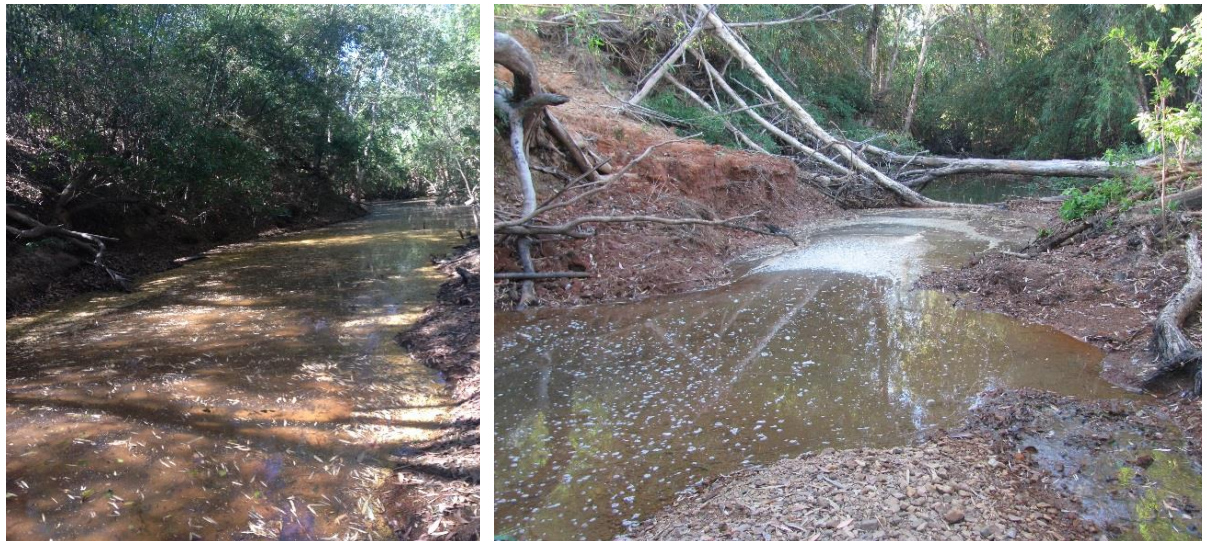
Figure 4-2 MBC01 facing downstream in 2017 (left) and 2018 (right)

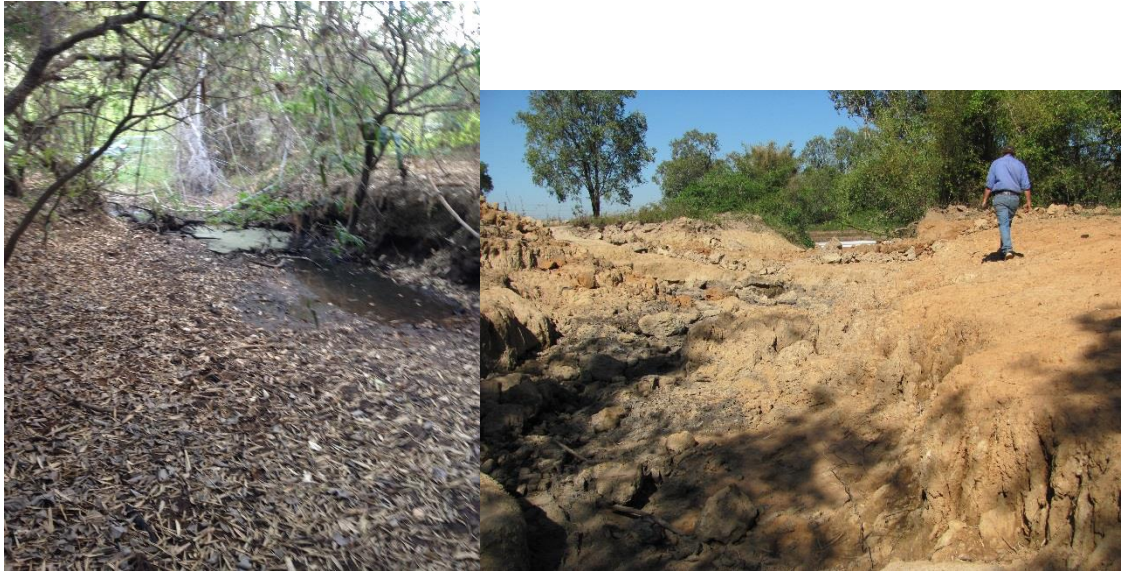
Figure 4-3 Facing upstream at CC02 in 2017 (left) and 2018 (right).

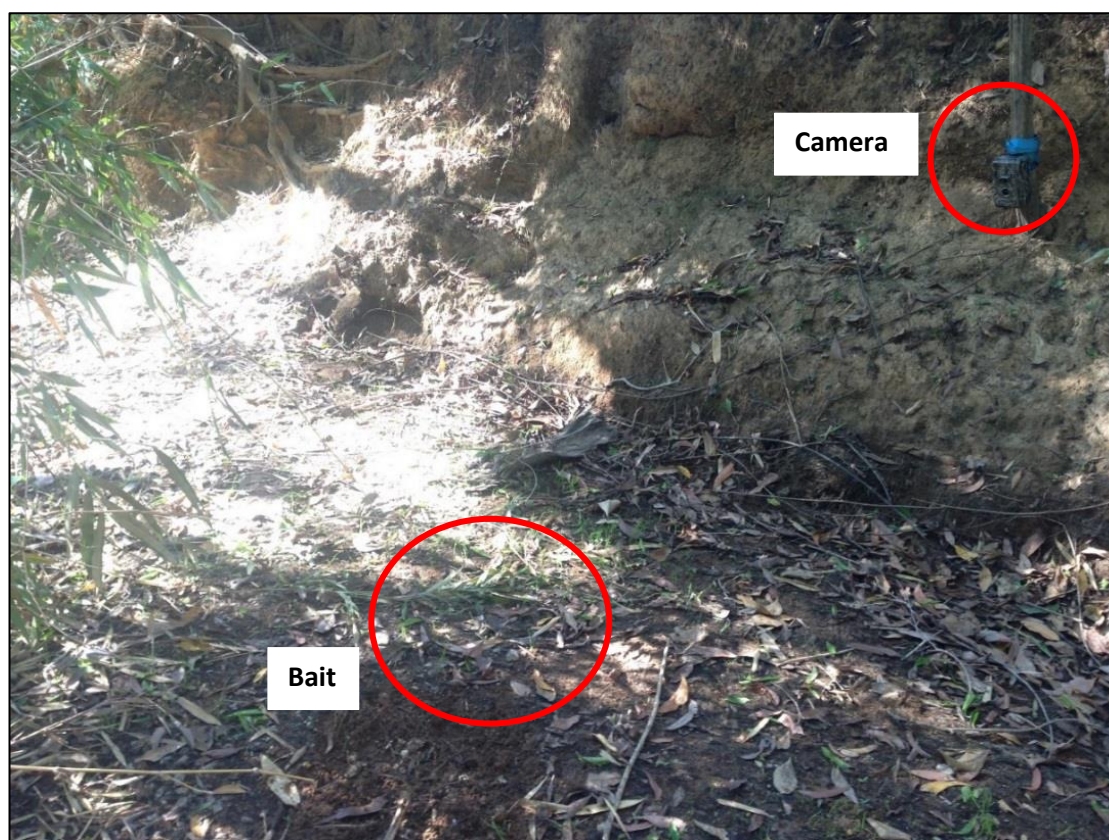
Photo 3-1 Camera trap set upstream of site SWTG2.

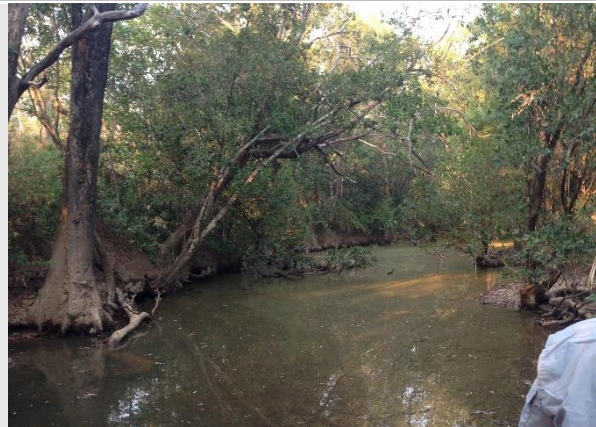
| Site / Habitat Description | Site Photo |
|---|---|
| <p><b>SWTG1A</b></p> <p>The site is located upstream of historical Toms Gully mining operations on Mount Bunday Creek, and was characterised by two large deep pools extending for the length of the reach. The pools were divided by a deposit of sand and gravel. Both pools were lined by a thick strip of native vegetation and had steep banks approximately 4 m high. For safety reasons, the site could not be sampled using electrofishing, but bait traps were deployed and an edge macroinvertebrate sample was taken. The substrate in the pools was difficult to see, as the pools were deep, and the surface was mostly covered in a slick and detritus. A large amount of woody debris was found at the site, and most of the banks contained exposed roots and undercut banks. The pools were approximately 6 m wide through most of the reach, and riparian vegetation was close to being a closed canopy, with the majority of the creek being shaded.</p> | |

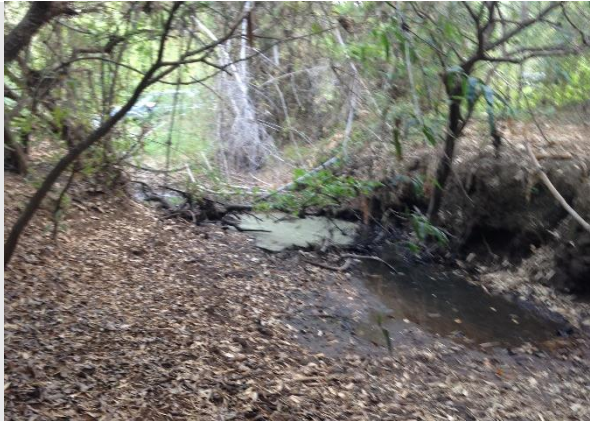
| Site / Habitat Description | Site Photo |
|---|---|
| <p><b>CC01</b></p> <p>The site is located close to cattle yards of Mount Bunday Creek Station, and contained a ford intersecting the creek. The reach extended from the ford downstream. The site was characterised by a meandering run with some deeper pools. Shading was lower in the downstream parts of the creek, with signs of regular cattle access to the creek. In the downstream section of the reach, large patches of filamentous algae were observed, and banks were eroded close to areas where cattle have been accessing the creek. A representative from Mount Bunday Creek Station advised that cattle were regularly herded through this section of the creek and over the ford. The upstream section of the reach was shaded and had a riparian strip around 5 m wide. The banks were more intact than the downstream section, and exposed roots and large woody debris were in each of the pools.</p> | |

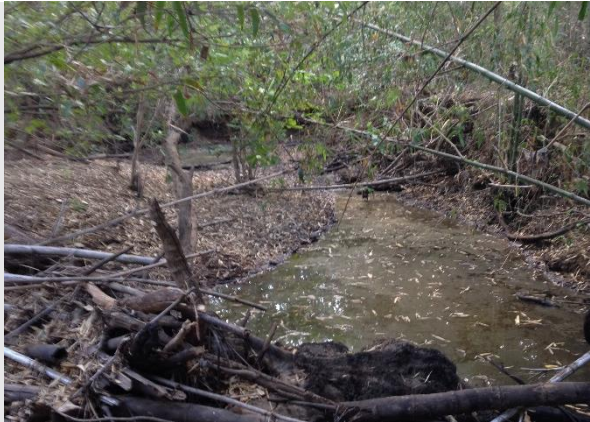
| Site / Habitat Description | Site Photo |
|---|---|
| <p><b>CC02</b></p> <p>This is the furthest upstream site on Coulter Creek, and is intersected by a ford made of large cobbles. Upstream of the ford was a large, deep pool containing large woody debris. The pool was considered unsafe to enter, and bait traps were set in it. Downstream of the ford was a series of pools connected by shallow runs and was 3 m wide for the majority of the reach. The creek was shaded by a dense, 5 m wide, native riparian strip on both banks. Beyond the riparian zone was cleared and the land used for grazing. An oil slick was observed directly downstream of the ford. Electrofishing and macroinvertebrate sampling were undertaken downstream of the ford.</p> | |
