## **Appendix S - Aquatic Ecology Survey Reports**

## **Appendix S-1 - Aquatic Ecology Survey 2020**

# Toms Gully Aquatic Ecology Baseline Studies

*Final Report*

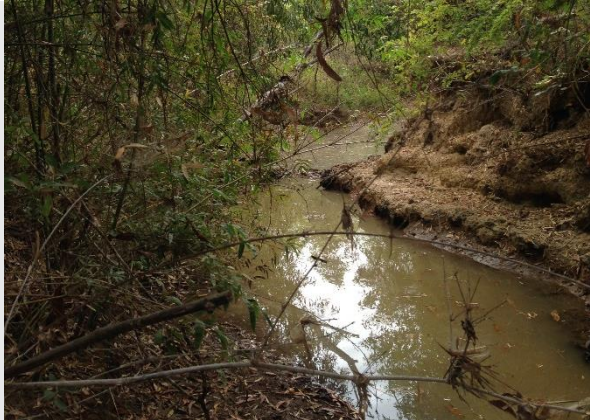
| Site / Habitat Description | Site Photo |
|---|---|
| <p><b>CK7</b></p> <p>The site is an existing monitoring point for Tom’s Gully Mine, located on the downstream side of the crossing of Coulter Creek with the Arnhem Highway. It was characterised as a series of isolated pools ranging in depth from 0.2-1 m and two deeper pools directly downstream of the highway crossing that were more shaded than the remainder of the reach. The creek was 5 m wide and had steep, eroded banks with very little overhanging vegetation and native grasses. The substrate was mostly bedrock, with some sand and clay deposits. Evidence of cattle and pig access to the creek from both banks was observed. Some undercut banks and exposed roots and shade were found in the deeper pools.</p> | |

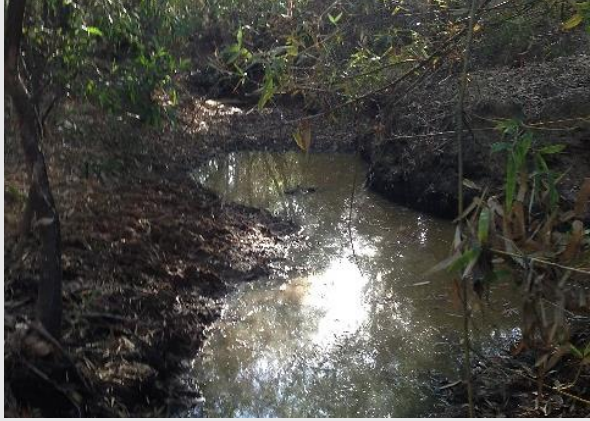
| Site / Habitat Description | Site Photo |
|---|---|
| <p><b>CC03</b></p> <p>The site is located approximately 1.7 km downstream of the Arnhem Highway and is a large isolated pool 50 m in length, upstream and downstream of the pool was a dry creek bed. The pool has a very small amount of shade, but its banks were heavily eroded with very little vegetation outside of native grasses. The substrate was mostly bedrock, with some deposition of clay and silt in the downstream end of the pool. A crocodile slide and footprint were found in the clay, and it was therefore deemed a safety risk to enter the water (Figure 4 13). Bait taps were deployed, but no electrofishing or macroinvertebrate sampling was undertaken. The site contained some exposed roots where a small amount of native shrubs were growing along the left bank, but there was little available habitat for fish. Olive Hymenacne (<i>Hymenachne amplexicaulis</i>) was observed growing at the downstream end of the pool.</p> | |

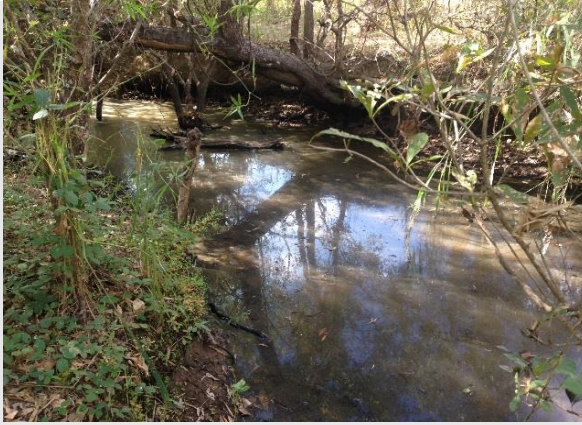
| Site / Habitat Description | Site Photo |
|---|---|
| <p><b>SWG09</b></p> <p>The site is located on a small tributary ~200m upstream of the confluence with Mount Bunday Creek. a small number of isolated pools were present, separated by a section of bedrock. The site was characterised by vertical and undercut banks, with exposed roots lining much of the pools. The substrate was a mix of cobbles, pebbles and sand with several large leaf packs. The water level at the time of sampling was too low to undertake fish sampling. Macroinvertebrate sampling was completed in the remaining wetted sections of the reach. Evidence of access to the creek by pigs and cattle was observed, with the remaining pools possibly being used as wallows for pigs.</p> | |

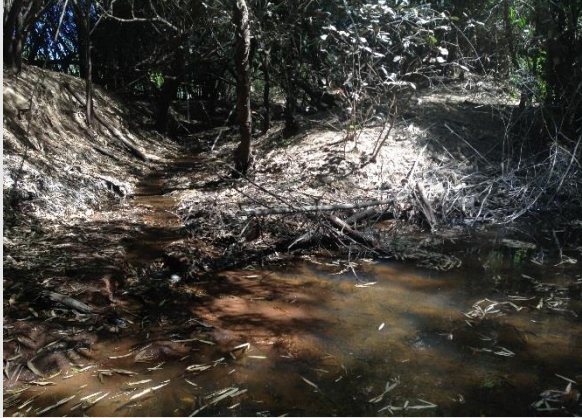
| Site / Habitat Description | Site Photo |
|---|---|
| <p><b>SWG1</b></p> <p>The site was a long shallow run connecting two large, deep pools. The wetted width was approximately 1.5 m wide and one third of the full channel width. Some small isolated pools remained in the left section of the channel. Substrate comprised of cobbles and pebbles embedded in gravel and sand. Large woody debris was found through the extent of the reach and the right bank was undercut, exposing roots from riparian vegetation. Banks were approximately 3.5 m high and were very steep. Riparian vegetation was thick, extending at least 20 m from each bank and shading most of the creek. A small, deep gully entered the creek on the right side towards the top of the reach. Bait traps were placed in it, and in both of the large pools at either end of the reach. Both deeper pools were the entire width of the creek and the channel opened out in these areas to ~8 m in width. Large trees lined the banks, with their roots exposed, creating good habitat for larger fish. An edge macroinvertebrate sample was collected along the right bank in undercut sections of the creek and in the small isolated pools.</p> | |

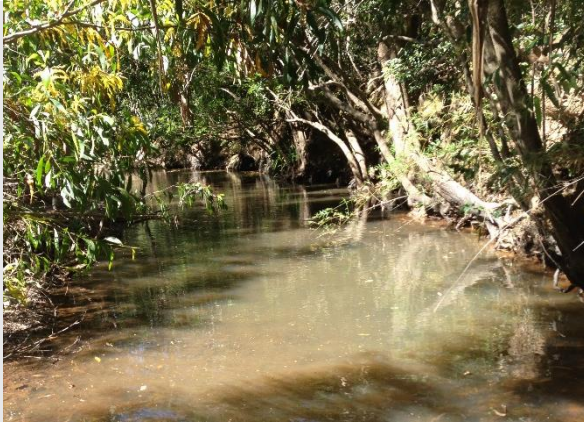
| Site / Habitat Description | Site Photo |
|---|---|
| <p><b>MBC0</b></p> <p>The site is located approximately 100 m upstream of the confluence between a small, unnamed tributary containing site MBC06 and Mount Bunday Creek. Flow was recorded at the site at the time of sampling, and the reach was well shaded due to a continuous riparian zone. The presence of trees along banks allowed for exposed roots, large woody debris and leaf packs to be common through the site. There was some evidence of siltation in slower flowing areas, but the majority of substrate at the site was made up of sand and pebbles. A number of long, gliding pools were found within the reach, which contained boulders surrounded by sand. Freshwater crocodiles were observed at the site.</p> | |

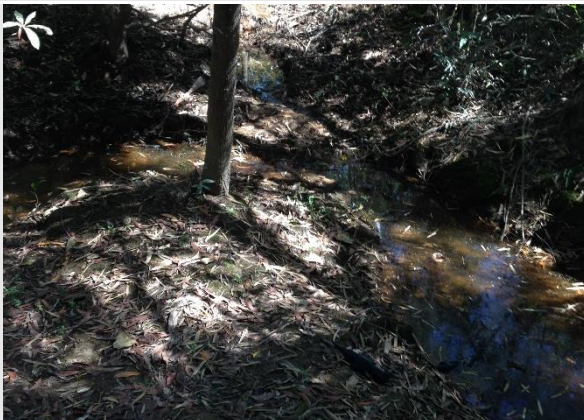
| Site / Habitat Description | Site Photo |
|---|---|
| <p><b>MBC06</b></p> <p>The site is located on a small tributary of Mount Bunday Creek draining away from EP2. The site was reduced to small isolated pools no more than 3 m in length, with an average width of 2 m. The substrate was a mixture of bedrock, cobbles, silt and clay with some pools having small amounts of woody debris and leaf packs. The largest pool was found in the furthest upstream point of the reach and was 0.5 m deep, containing a slick of oil on the surface. When sampling macroinvertebrates, an anoxic odour was released from sediment. Electrofishing and bait trapping were undertaken in the entire length of the reach where water was present.</p> | |

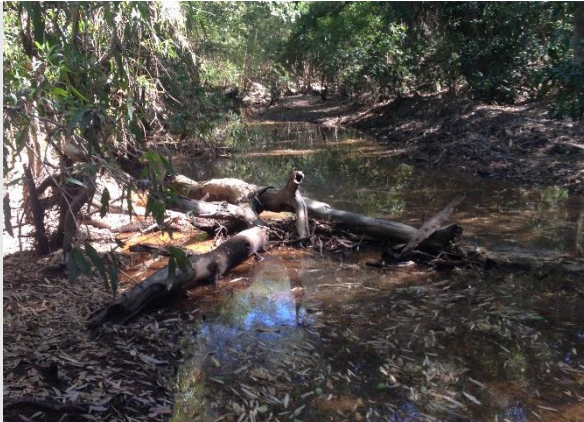
| Site / Habitat Description | Site Photo |
|---|---|
| <p><b>MBC01</b></p> <p>A large deep pool covered the length of the site and extended beyond the 100 m reach at both ends. Large woody debris and overhanging River Pandanus dominated the site, with the remaining riparian vegetation made up of bamboo and native riparian trees. Banks at the site were vertical and approximately 1.5 m high above the water surface. The large pool was an average of 5 m wide and slightly turbid. The surface was covered in detritus and there was an oil slick observed in some sections that appeared to be caused by oil or fuel. The source of this could not be confirmed. Bait traps were deployed at the site, but no electrofishing was undertaken due to inaccessibility. An edge habitat macroinvertebrate sample was collected along the right bank where safety allowed. The creek was heavily shaded, the roots of many of the trees were exposed, and undercut banks were present. The site was close to a tailings dam.</p> | |

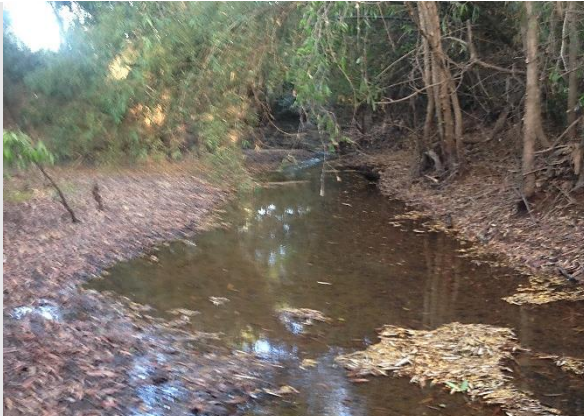
| Site / Habitat Description | Site Photo |
|---|---|
| <p><b>SWG2</b></p> <p>The site is intersected by a causeway, with upstream sections of the creek being made up of a series of deep pools connected by runs. Downstream of the causeway, the site was a wide, shallow pool. Substrate along the entire reach was a mixture of cobbles, pebbles and sand, and banks were made of clay. Continuous riparian vegetation was observed at the site (except through the causeway path) and this had resulted in heavy deposition of detritus and large woody debris within the creek. Exposed roots were common in deeper pools.</p> | |

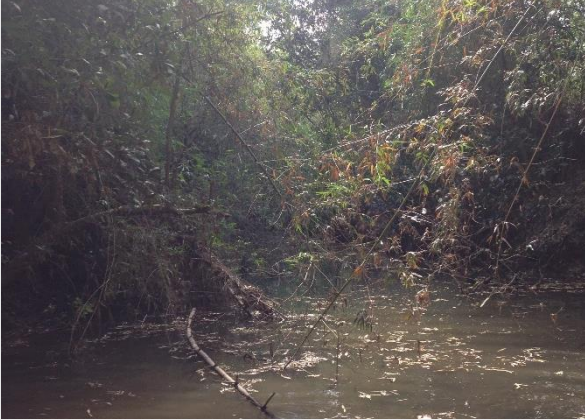
| Site / Habitat Description | Site Photo |
|---|---|
| <p><b>MBC03</b></p> <p>The site is located on a bend and was characterised by a long shallow run connecting deep pools at either end of the reach. The majority of the run was 0.1 m deep and 3 m wide with some deeper sections adjacent to banks. Large woody debris was found through the reach as were leaf packs. Substrate was made up mainly of sand and gravel with some silty deposits in deeper areas. Macroinvertebrates were sampled along the right bank and electrofishing was undertaken along the extent of the reach. The creek was highly shaded in this area and the riparian zone extended for 20 m on the right bank and &gt;30 m on the left bank. The right bank was very steep and 3.5 m high, whereas the left bank was a gentle slope reaching a similar height.</p> | |

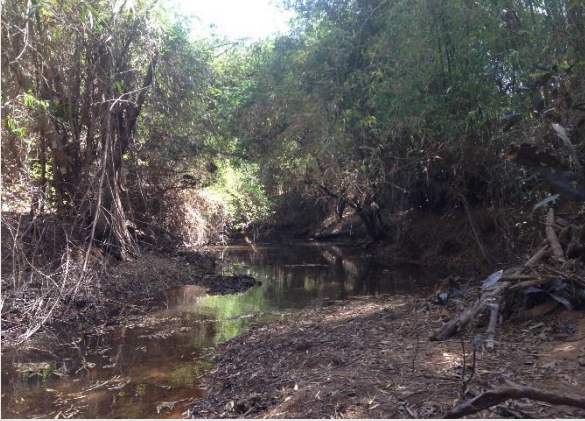
| Site / Habitat Description | Site Photo |
|---|---|
| <p><b>SWTG3</b></p> <p>The site is the furthest downstream on Mount Bunday Creek, upstream of its confluence with Coulter Creek. The site was characterised by a long pool and run with large woody debris and undercut banks. Substrate was clay and silt, which suspended easily into the water column, the substrate was covered for most of the reach by detritus. Bait traps were deployed into a deep pool upstream that was considered unsafe to enter. An oil slick was observed on the surface of the water, as was a large amount of detritus. The site was heavily shaded by thick stands of bamboo and native vegetation. Very little understory vegetation was present. There was evidence of access by livestock, and buffalo 'lay downs' were also seen in the grass near the creek. There was a small tributary flowing into the creek downstream of the site, which appeared to be a groundwater intrusion, as the main channel of the creek was not flowing at the time, and there had been little rain in the previous week.</p> | |

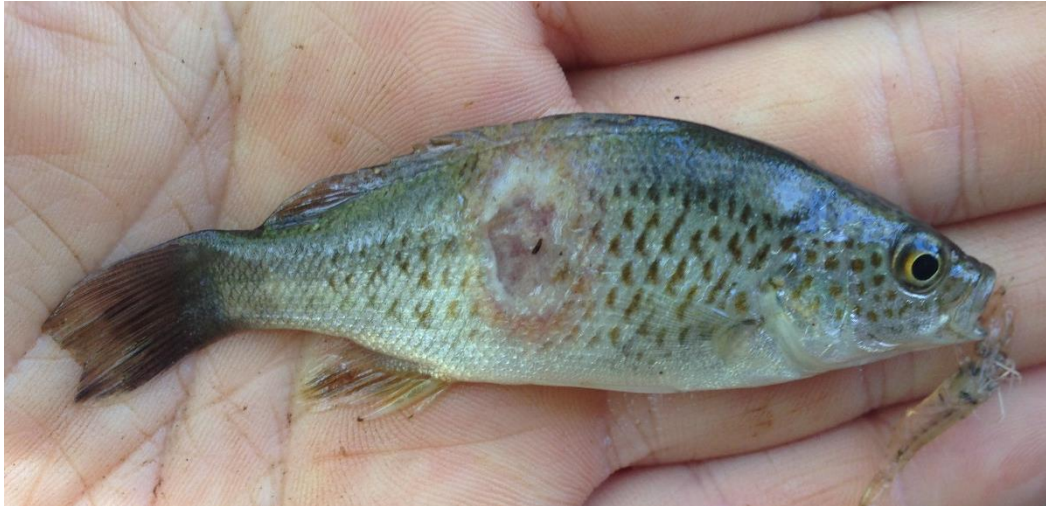
Photo 4-1 Suspected red spot disease found on Spangled Perch at MBC01.
