**Rustlers Roost and Quest 29
Open-Cut Mine Redevelopment**

**Draft Environmental Impact
Statement (EIS)**

**Section 7.2 - Terrestrial
Ecosystems**

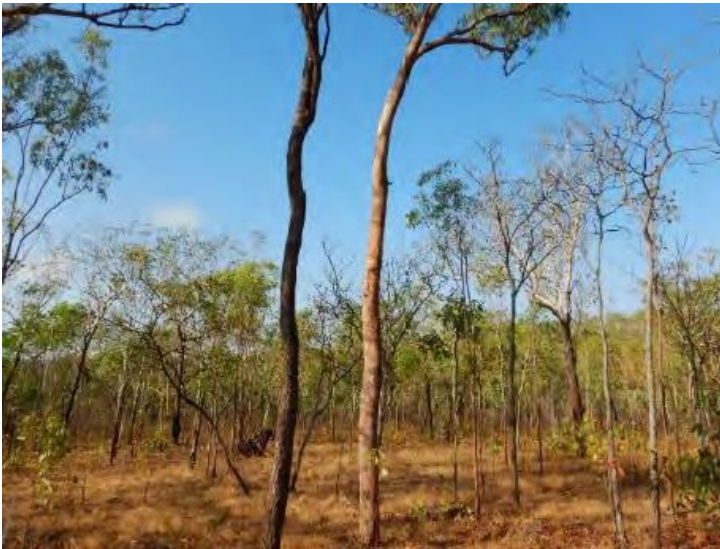
Plate 7-6 Vegetation in Land Unit 2a in Central Quest 29 WRD

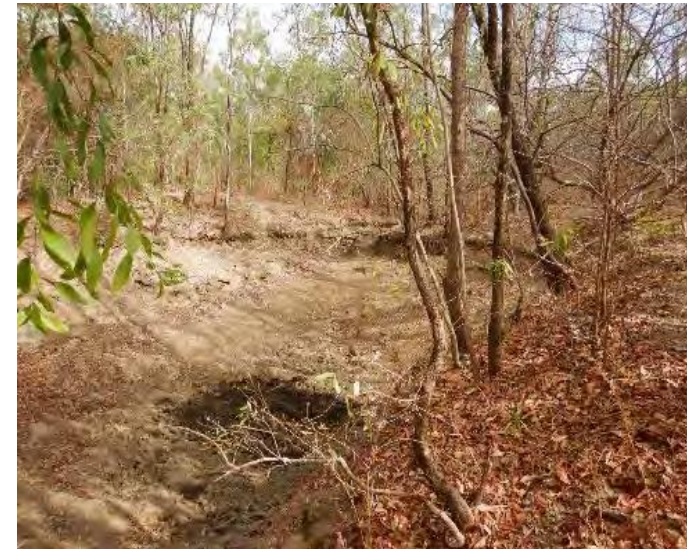
Plate 7-7 Vegetation in Land Unit 6a Quest 29 Zamu Pit

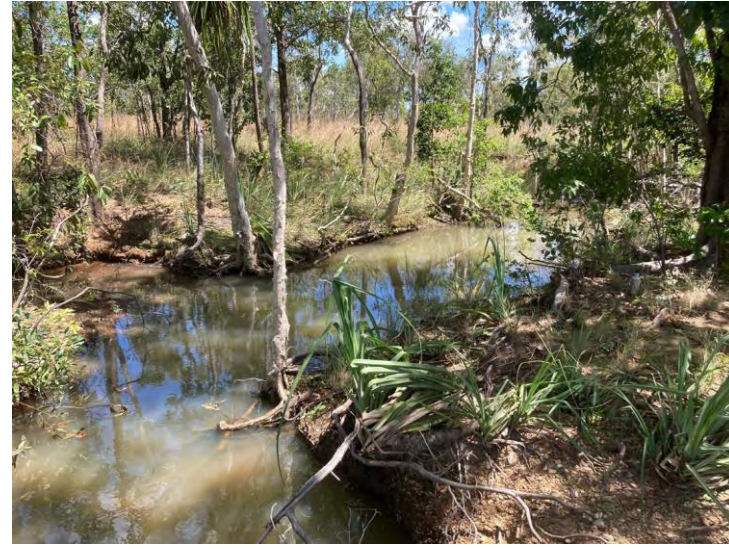
Plate 7-8 Upstream Riparian Vegetation of Marrakai Creek Tributary

The upstream riparian zone lacked understorey vegetation, besides grasses, and trees were sparse (refer to Plate 7-8). This is likely to have resulted in lower shading, and a lower likelihood of detritus being deposited in the creek bed. The upstream site also contained submerged macrophytes, which provide structural habitat not found downstream (Plate 7-9). The habitat available at the two downstream sites closest to the Rustlers Roost Project area was similar, with more dense riparian environments consisting of shrubs and trees (refer to Plate 7-10 and Plate 7-11).

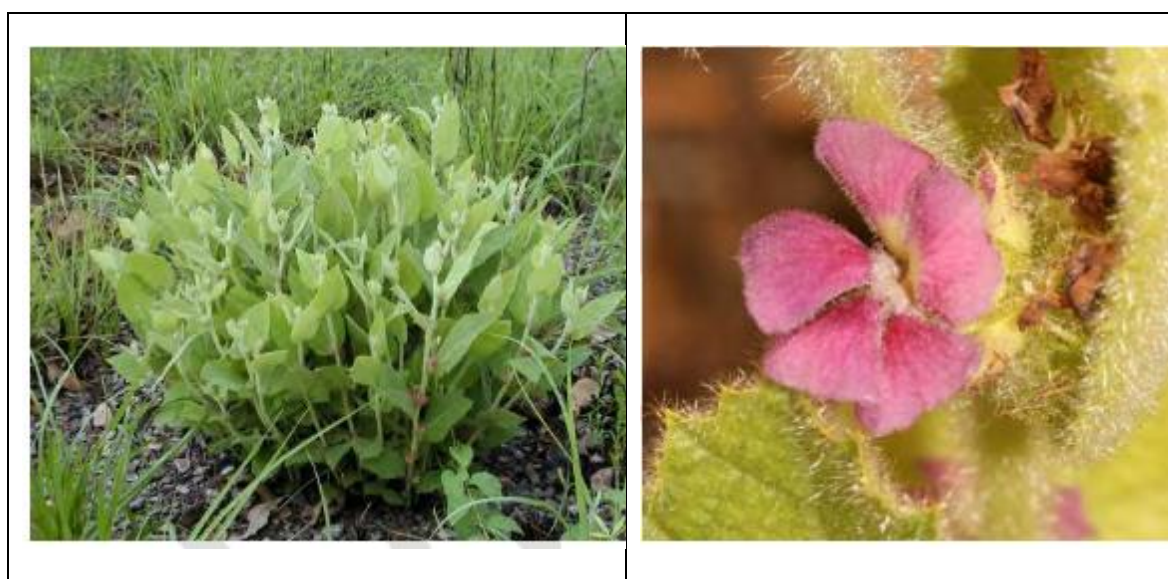
Plate 7-12 *Helicteres macrothrix* Leaves and Flowers
(Images I. D. Cowie)

H. macrothrix grows in *E. tectifera*, *E. miniata* or *E. tetradonta* woodland on clayey soils derived from siltstone or more sandy soils derived from syenite. The species grows to 50 cm tall with ascending to erect branches, pink to purple flowers, and fruits, leaves and branches that are green and woolly-hairy. The aerial parts of the plant are annual, with perennial root stock. The plant is known to re-sprout from root stock, often vigorously, after fire. The species has been recorded from three populations – near Mount Bunday, near Batchelor and in the Lake Bennett area. The known extent of occurrence for this species is 915 km². *H. macrothrix* flowers from November to March and fruits from January to March (DENR 2012).

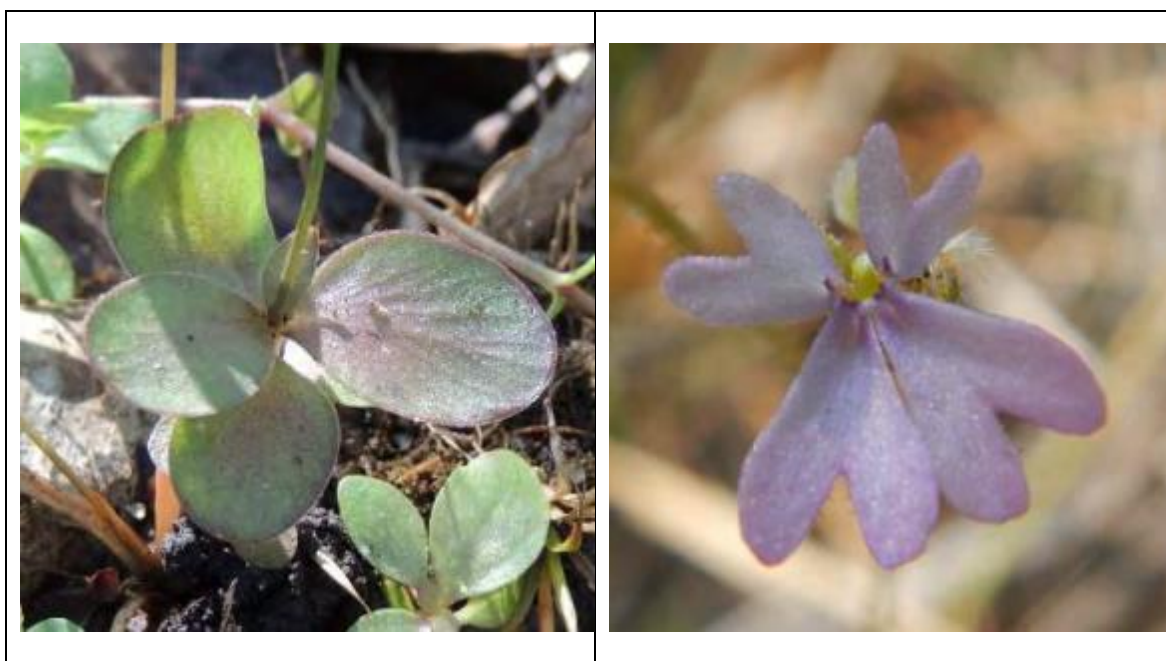
Plate 7-13 Photographs of *Stylidium ensatum* Leaves and Flower

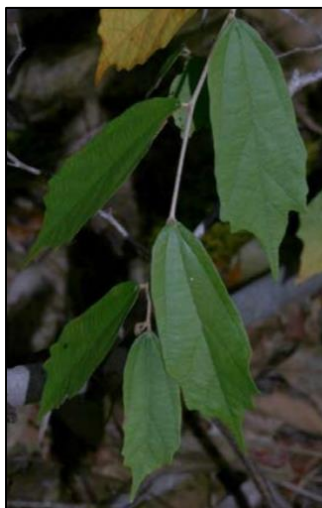
Plate 7-14 Photograph of *Schoutenia ovata*
(Images I. D. Cowie)

Schoutenia ovata is a tree that grows up to 10 m height with grey, flaky bark. The branchlets, petioles, leaf undersurface, calyx and capsule are densely hairy. The leaves are glossy above, three-veined at the base, elliptic to obovate, 25-98 mm long, 17-50 mm wide and reportedly deciduous. The leaf margin is entire to irregularly lobed in the upper half. Flowers are arranged in a racemose inflorescence up to 20 mm long. The petals of the flowers are often absent or reduced, up to 4.5 mm long, and the sepals are pale yellow and about 7.5 mm long. *Schoutenia ovata* flowers in February to March and fruits in May (Northern Territory Herbarium 2013). *Schoutenia ovata* is listed as Endangered under the TPWC Act but is not listed under the EPBC Act.

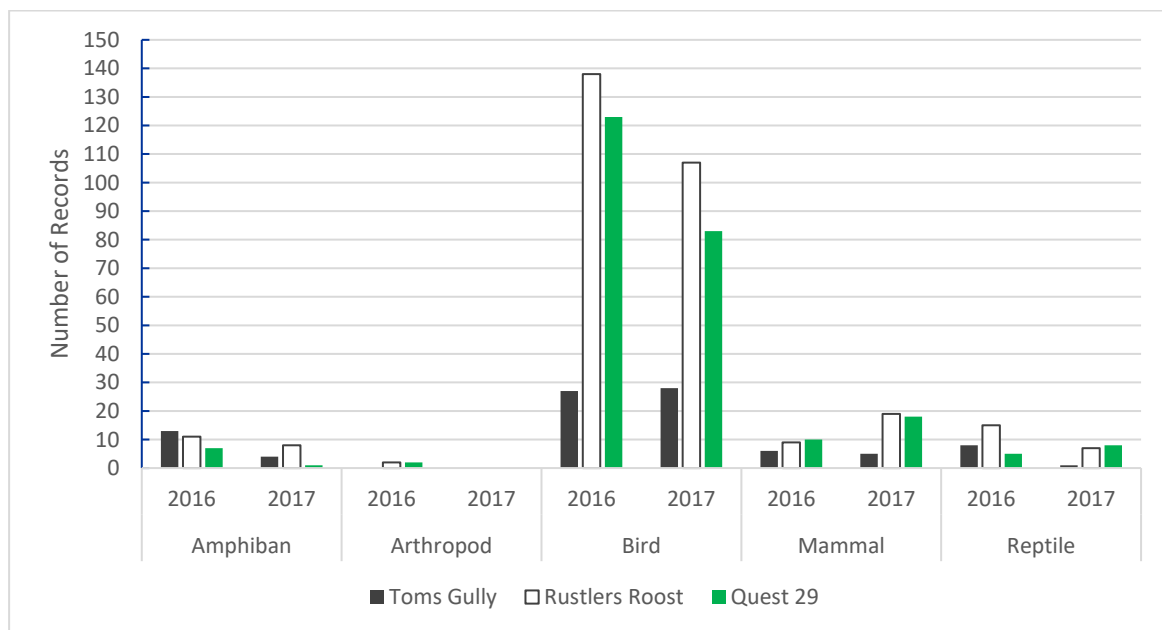
Figure 7-16 Fauna Surveys from November 2016 and May 2017 (LES 2017a)

Rustlers Roost recorded 316 observations of fauna over the 2016 and 2017 survey period, primarily made up of birds, accounting for 245 of the records. Other groups of animals included amphibians (19 observation), arthropods (2 observations), mammals (28 observations) and reptile (22 observations). Quest 29 recorded a total of 257 fauna observations. Similarly, the survey results were dominated by birds, accounting for 206 observations, followed by mammals (28 observations), reptiles (13 observations), amphibians (8 observations) and arthropods (2 observations). The number of recordings for the survey area covering the accommodation camp are lower with 55 fauna observation recorded at survey site ST3. Birds accounted for 42 of the observation, with five observations of amphibians, seven mammals and one reptile. No arthropods were recorded at survey site ST3 (Figure 7-15 and Figure 7-16).
