**Rustlers Roost and Quest 29  
Open-Cut Mine Redevelopment**

**Draft Environmental Impact  
Statement (EIS)**

**Section 7.5 - Aquatic  
Ecosystems**

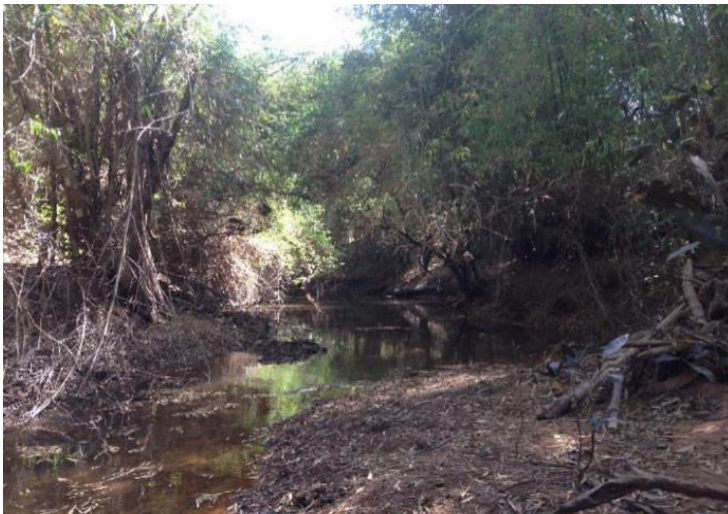
Plate 7-21 Mount Bunday Creek, Site SWTG3

SWTG3	SWTG3 is the site furthest downstream in Mount Bunday Creek within the survey area and closest to its confluence to Hardies Creek. The sampling reach was characterised by a long pool and run with large woody debris and undercut bank. Thick riparian vegetation comprising of stands of bamboo and native vegetation provided heavy shading. However, very little understory vegetation was present, with evidence of livestock access to the creek (Plate 7-21).
CC02	This site is furthest upstream in Coulter Creek and closest to the proposed accommodation camp. The site was characterised by a deep pool containing large woody debris and divided by a ford made of large cobbles. Downstream there was a series of connected pools. The creek banks were shaded by a dense, 5 m wide strip of native riparian vegetation. Beyond the riparian zone the land is cleared and used for grazing (Plate 7-22).
<b>Macroinvertebrate Sampling Sites</b>

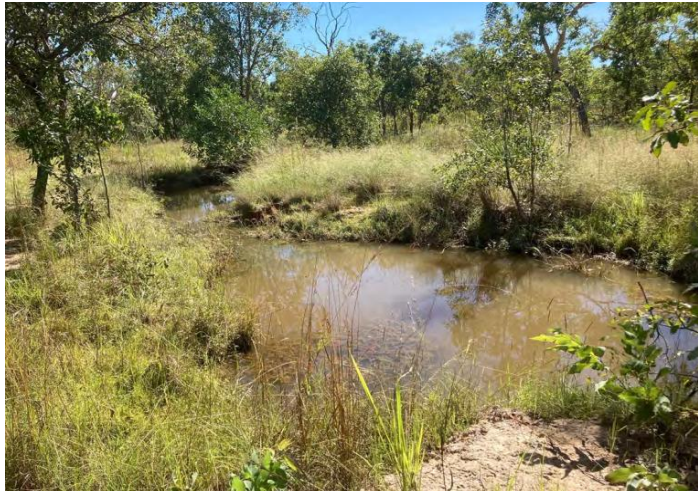
**Plate 7-23 RRMCUS Marrakai Creek Control Upstream from Site**

RRMCUS	The site is located in a Marrakai Creek tributary and 100 m upstream of the confluence with a creek line connected to Annie's dam. The sampling site was a pool and characterised by grassy vertical banks with few shrubs and trees. The water was flowing with some apparent turbidity the time of the sampling (Plate 7-23).
RRMCDS	The site is further downstream from the Rustlers Roost Project area in a Marrakai Creek tributary. The site is characterised by a narrow, meandering creek line through Paperbark and Pandanus which lined the banks and provided shading. Water was flowing at the time of the sampling and slightly turbid, and shading was high. Leaf packs and branches were common throughout (Plate 7-24).
RRSW23	The site is outside the Rustlers Roost Project area in a tributary of Mount Bunday Creek that receives drainage from the Rustlers Roost heap leach pad and ponds. The site consisted of a large, deep pool between riffles and runs. Substrate in shallow habitats was a mixture of sand and pebbles, and the pool contained sand with bedrock covered by detritus. Riparian vegetation was made up of shrubs, with some trailing into the water, providing shade and ample edge habitat for macroinvertebrates. The water was flowing and relatively turbid at the time of the sampling (Plate 7-25).

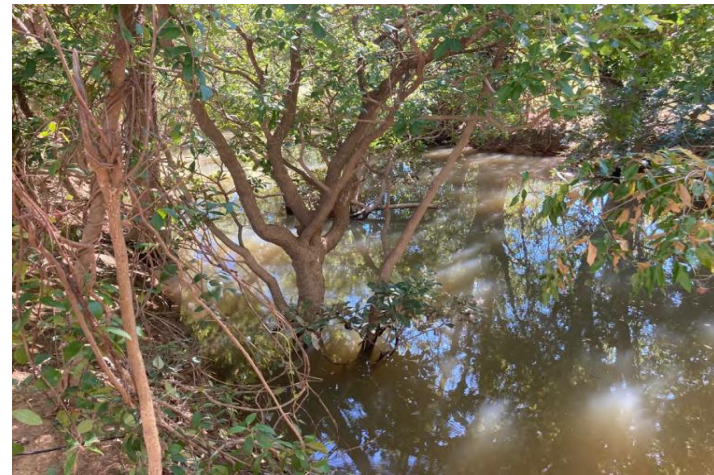
**Plate 7-26 Q29SW2 Mount Bunday Creek Downstream**

Q29SW2	This site was the furthest downstream in Mount Bunday Creek at the proposed haul road crossing. The site was highly shaded by overhanging well-established riparian tree and shrub vegetation along the creek. Water flow was observable, but very slow and turbid (Plate 7-26).
<b>Riparian Vegetation Survey Sites</b>	
RP8 - DS	The site is nearby a Rustlers Roost heap leach pad drainage line connected to a Mount Bunday Creek tributary. There was no water flow observed during the survey, however a few small pools were observed. Much of the vegetation was disturbed due to mining activities (heap leach pad) and land clearing adjacent to the channel. The site was classified as open forest patch only providing limited shading to the drainage line (Plate 7-27).
RP6 - US	The site is within a creek line that connects Annie's dam with a Marrakai Creek tributary. Water was flowing during sampling and was clear. The site was representative of undisturbed riparian vegetation edging a meandering 4 m wide and 1 m deep creek channel and therefore classified as closed forest patch (Plate 7-28).
