# Appendix Q

## Soil Survey Report

Sherwin Iron (NT) Pty Ltd  
Sherwin Creek Iron Ore Project  
Environmental Impact Statement

# Soil Survey of the Sherwin Creek Iron Ore Project Area

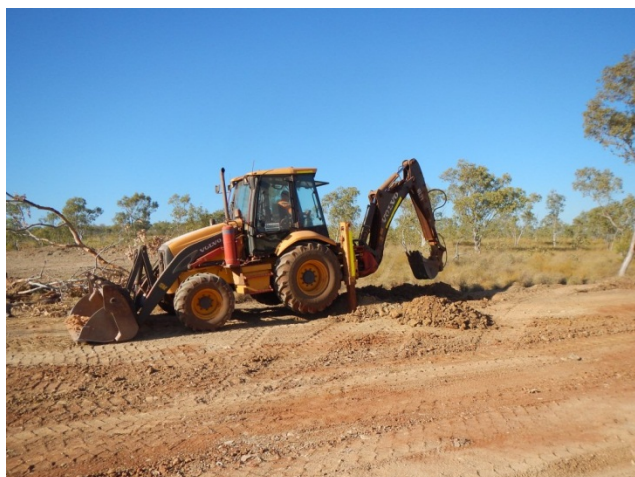
**Figure 3-2. Photograph of soil pit excavation**

Soil test pits were excavated using a back-hoe, either to refusal, or to a maximum depth of approximately 2 m (i.e. maximum practicable depth of back-hoe). Each bucket load was laid out in order of extraction to allow clear identification of the different soil horizons, with observation of exposed pit walls used to determine the relative depth of each horizon. Soil excavation details recorded included depth of pit, gravel and rock content, and level of refusal. None of the test pits intercepted groundwater and this was therefore not recorded. The sampling process is displayed in Figure 3-2 to Figure 3-7.

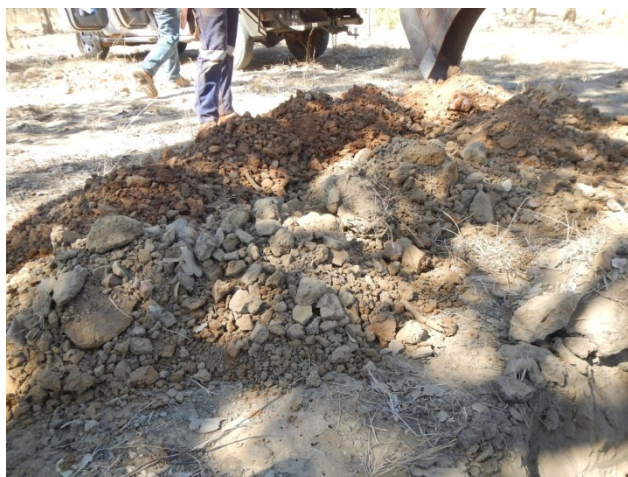
**Figure 3-3. Photograph of sequential profile excavations**

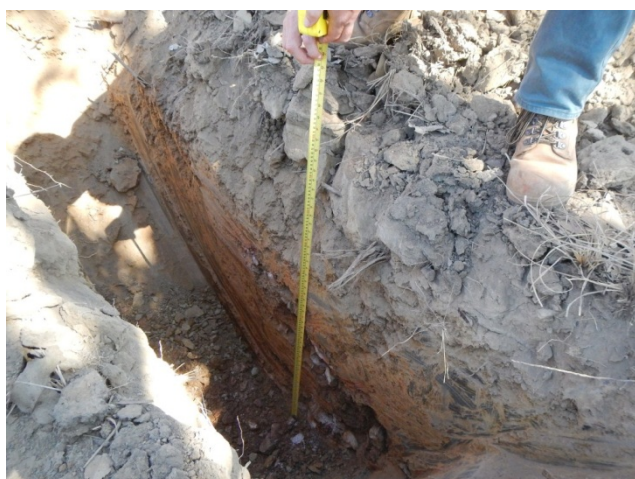
**Figure 3-4. Photograph of exposed soil profile at Site 11**

Pits 11 and 12 exhibited substantially different soil profiles to all other sites, with deep brown clay profiles (grey when dry). Cracks were evident on the ground surface, indicating the presence of shrink/swell clays. Pit 12 aimed to represent the Bukulara land system; however access to the area was limited due to the steep, rocky terrain, so the pit was dug on the border of the land systems. The vegetation present differed from that on the lower slopes of the Coolibah land system, which indicated a transition between the different land units.

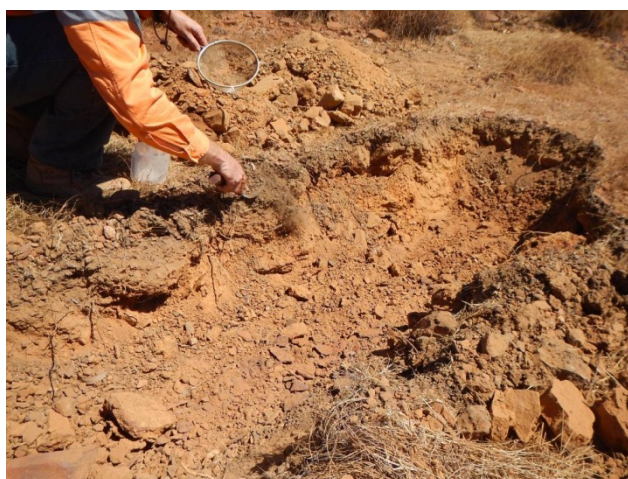
**Figure 3-5. Photograph of sampling of soil at Site 4**

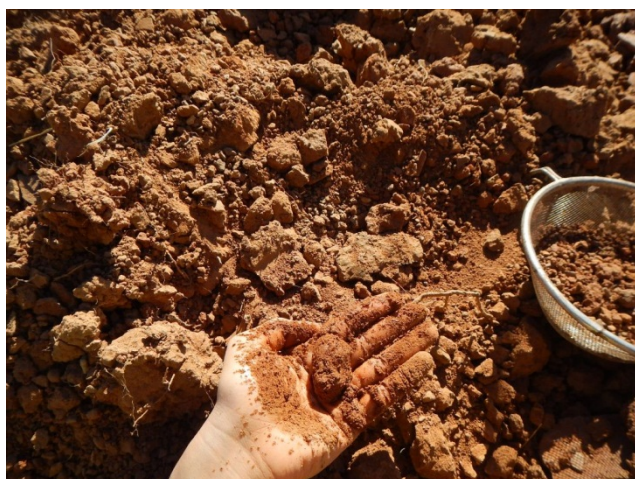
**Figure 3-6. Photograph of field texture test at Site 1**

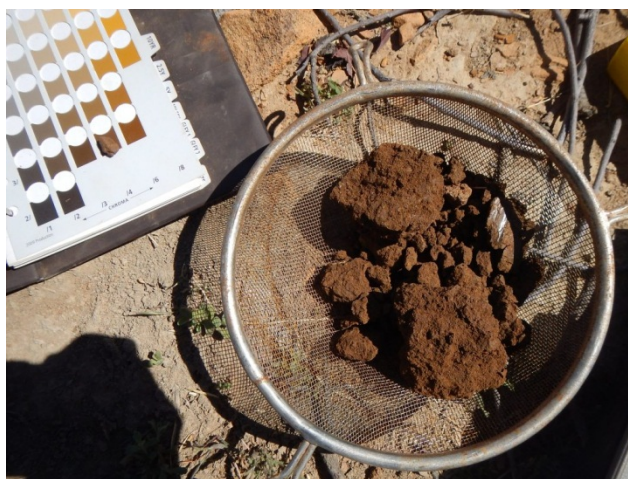
**Figure 3-7. Photograph of Munsell soil colour charts at Site 12**

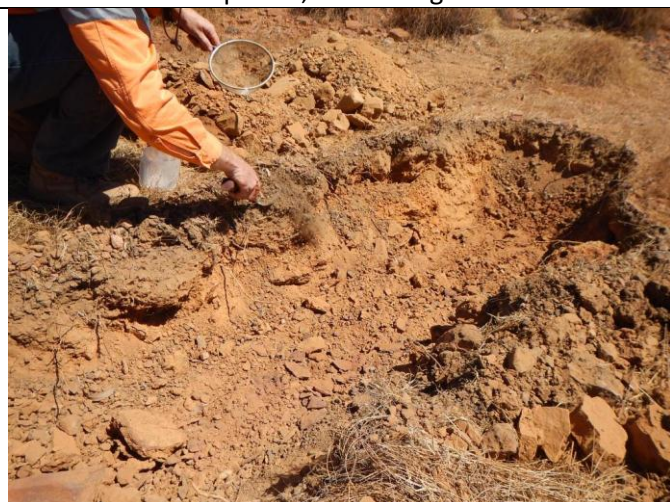
Shallow soil profile

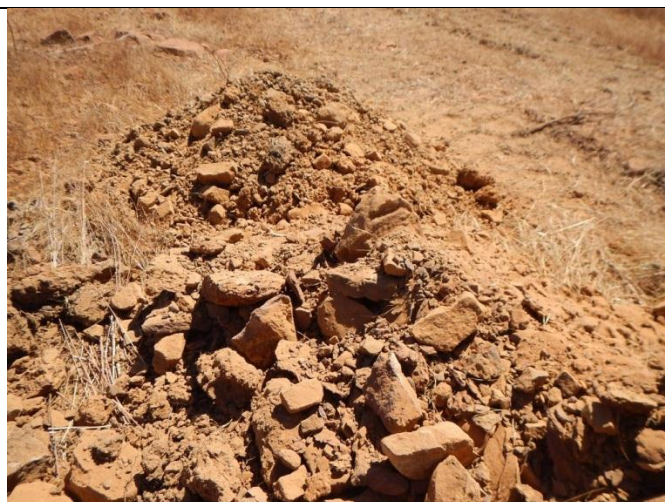
Significant coarse fragments and rock in excavations

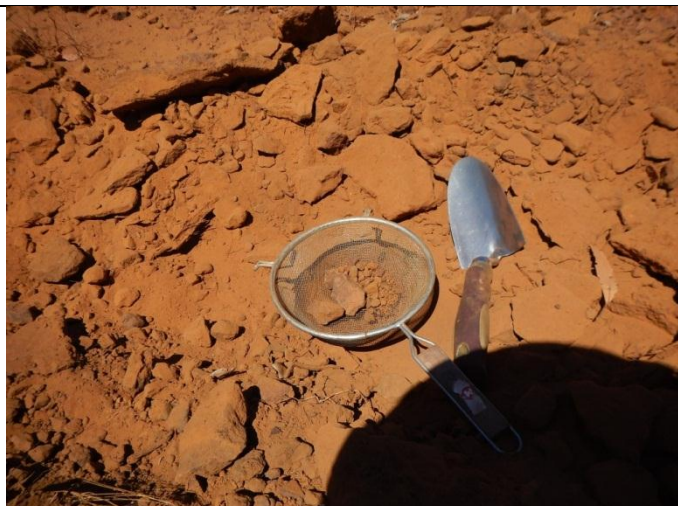
Significant rock and coarse fragments

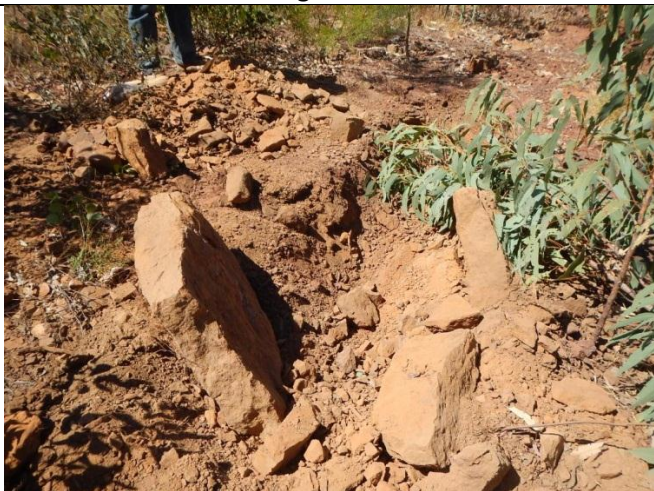
Large boulders uncovered in excavation

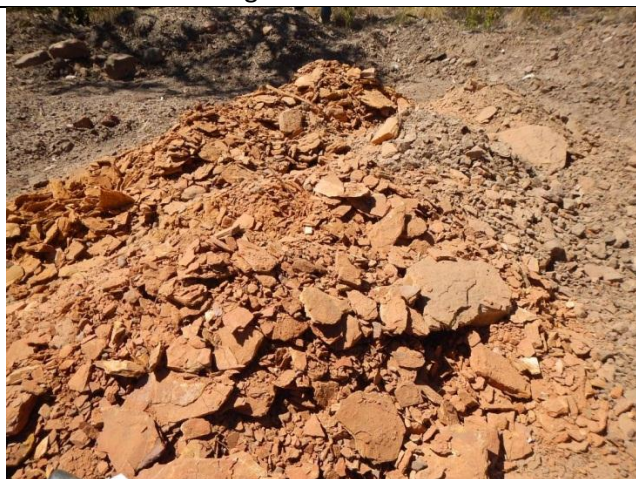
Excavations with shale present

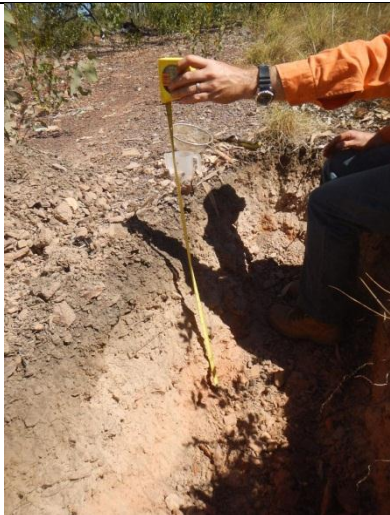
Soil profile (bleached A2 horizon visible)

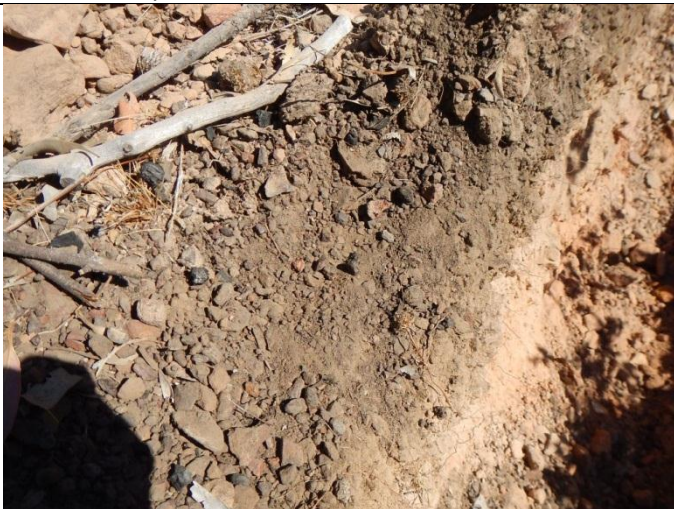
A1 soil (with A2 visible underneath)

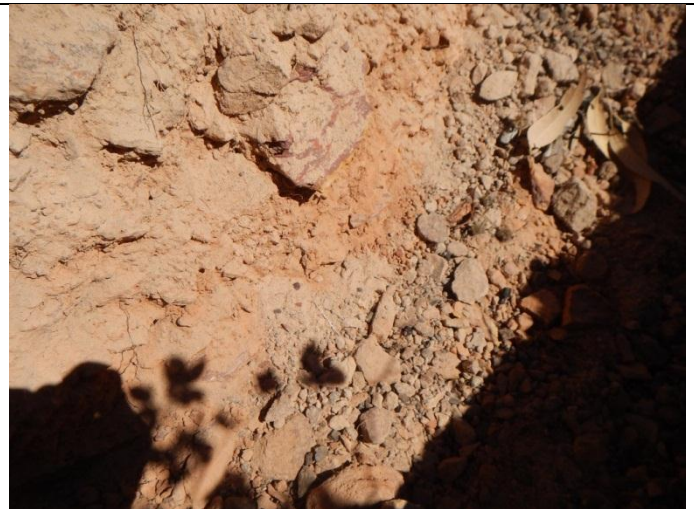
B Horizon (sandy)

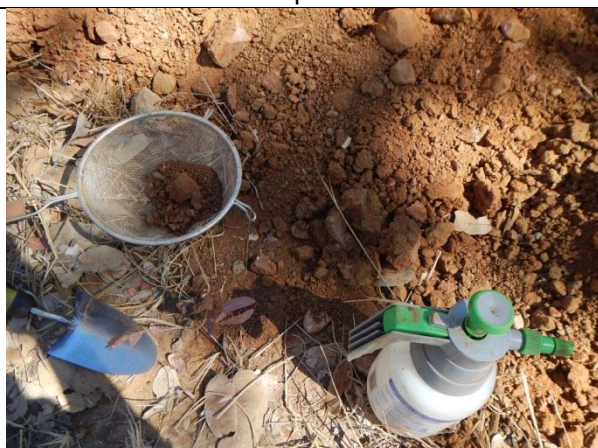
Clayey B Horizon soils

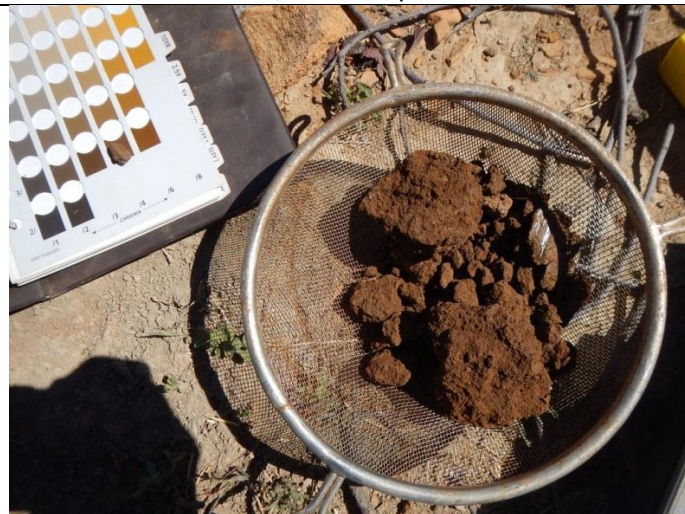
Dark clays of the B Horizon
