Report on  
Geotechnical Investigation

T21-2072 Wurrumiyanga Subdivision  
Wurrumiyanga, Bathurst Island

Prepared for  
NT Department of Infrastructure Planning & Logistics

Project 209497.00  
July 2024

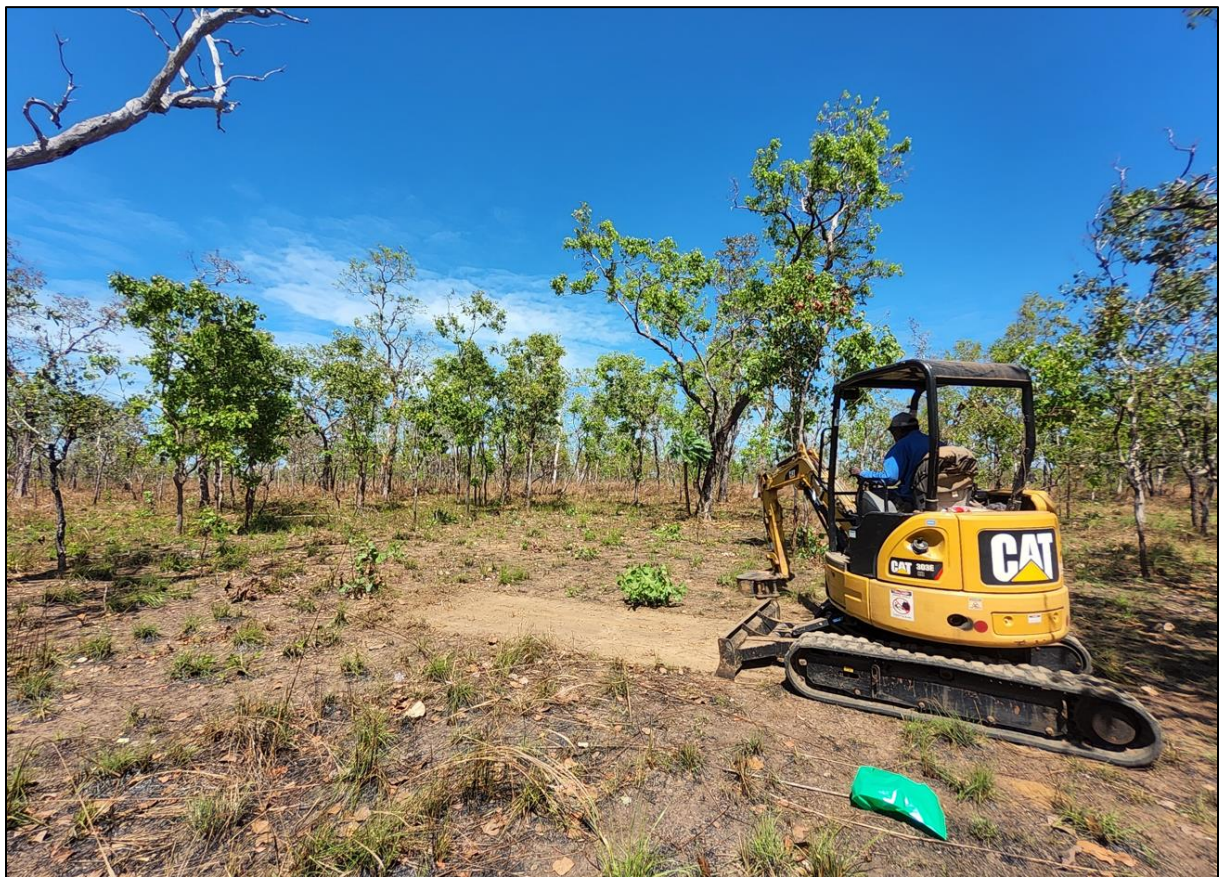
**Figure 1: View of central area of the site at test pit 16, with 3 tonne excavator.**

Figure 1 shows a view of the central part of the site at test pit 16.

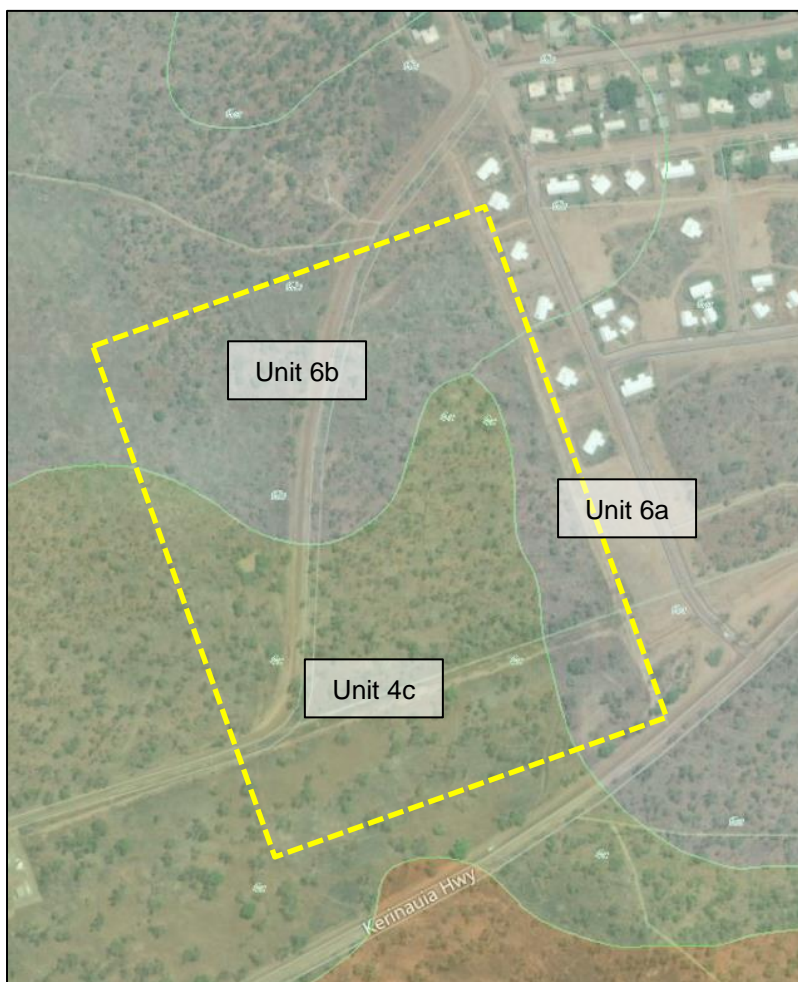
**Figure 3: Land unit mapping, approximate subdivision area shown in yellow.**

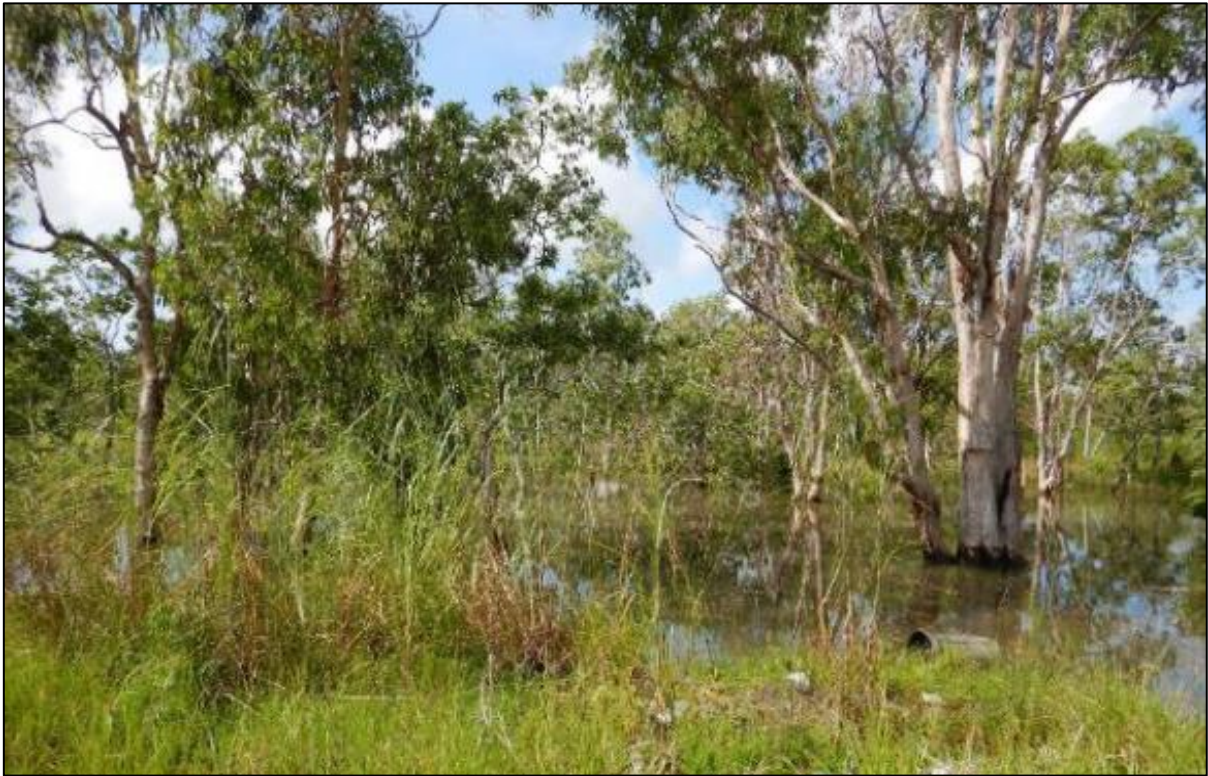
**Figure 4: Waterlogged swampy area within residential subdivision (image supplied by DIPL from Ecoz Environmental).**

Engineering measures to control the impacts of groundwater are recommended for the subdivision site, including open drains and or subsoil drains.

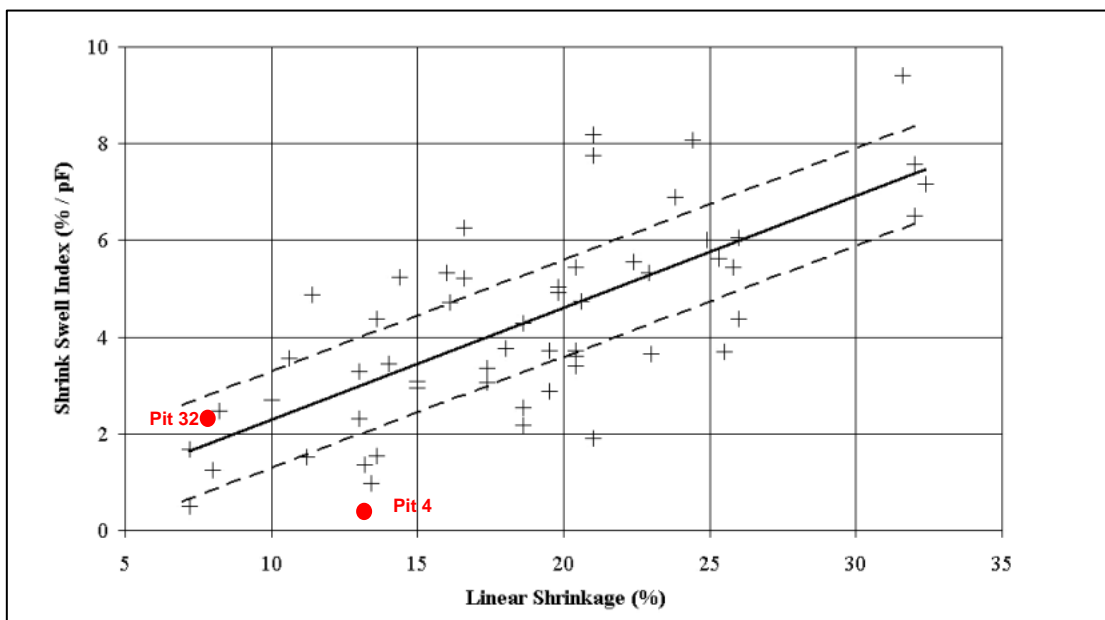
**Figure 5: Excerpt from Fityus et al (2005, per Cameron 1989). Note the Linear Shrinkage value for Pit 32 was taken from the nearby pit 33.**

To estimate the likely characteristic surface movements ( $y_s$ ) for the soil profile at the new subdivision site, shrink-swell index ( $I_{ss}$ ) test values and correlation of the weighted plasticity index (WPI), Atterberg limits and linear shrinkage tests have been used to assign presumptive  $I_{ss}$  values for Units 2 and 3. Figure 5 shows the  $I_{ss}$  laboratory test results plotted against Linear Shrinkage (Fityus, 2005), suggesting the reactivity at the site is perhaps only 'moderate'.

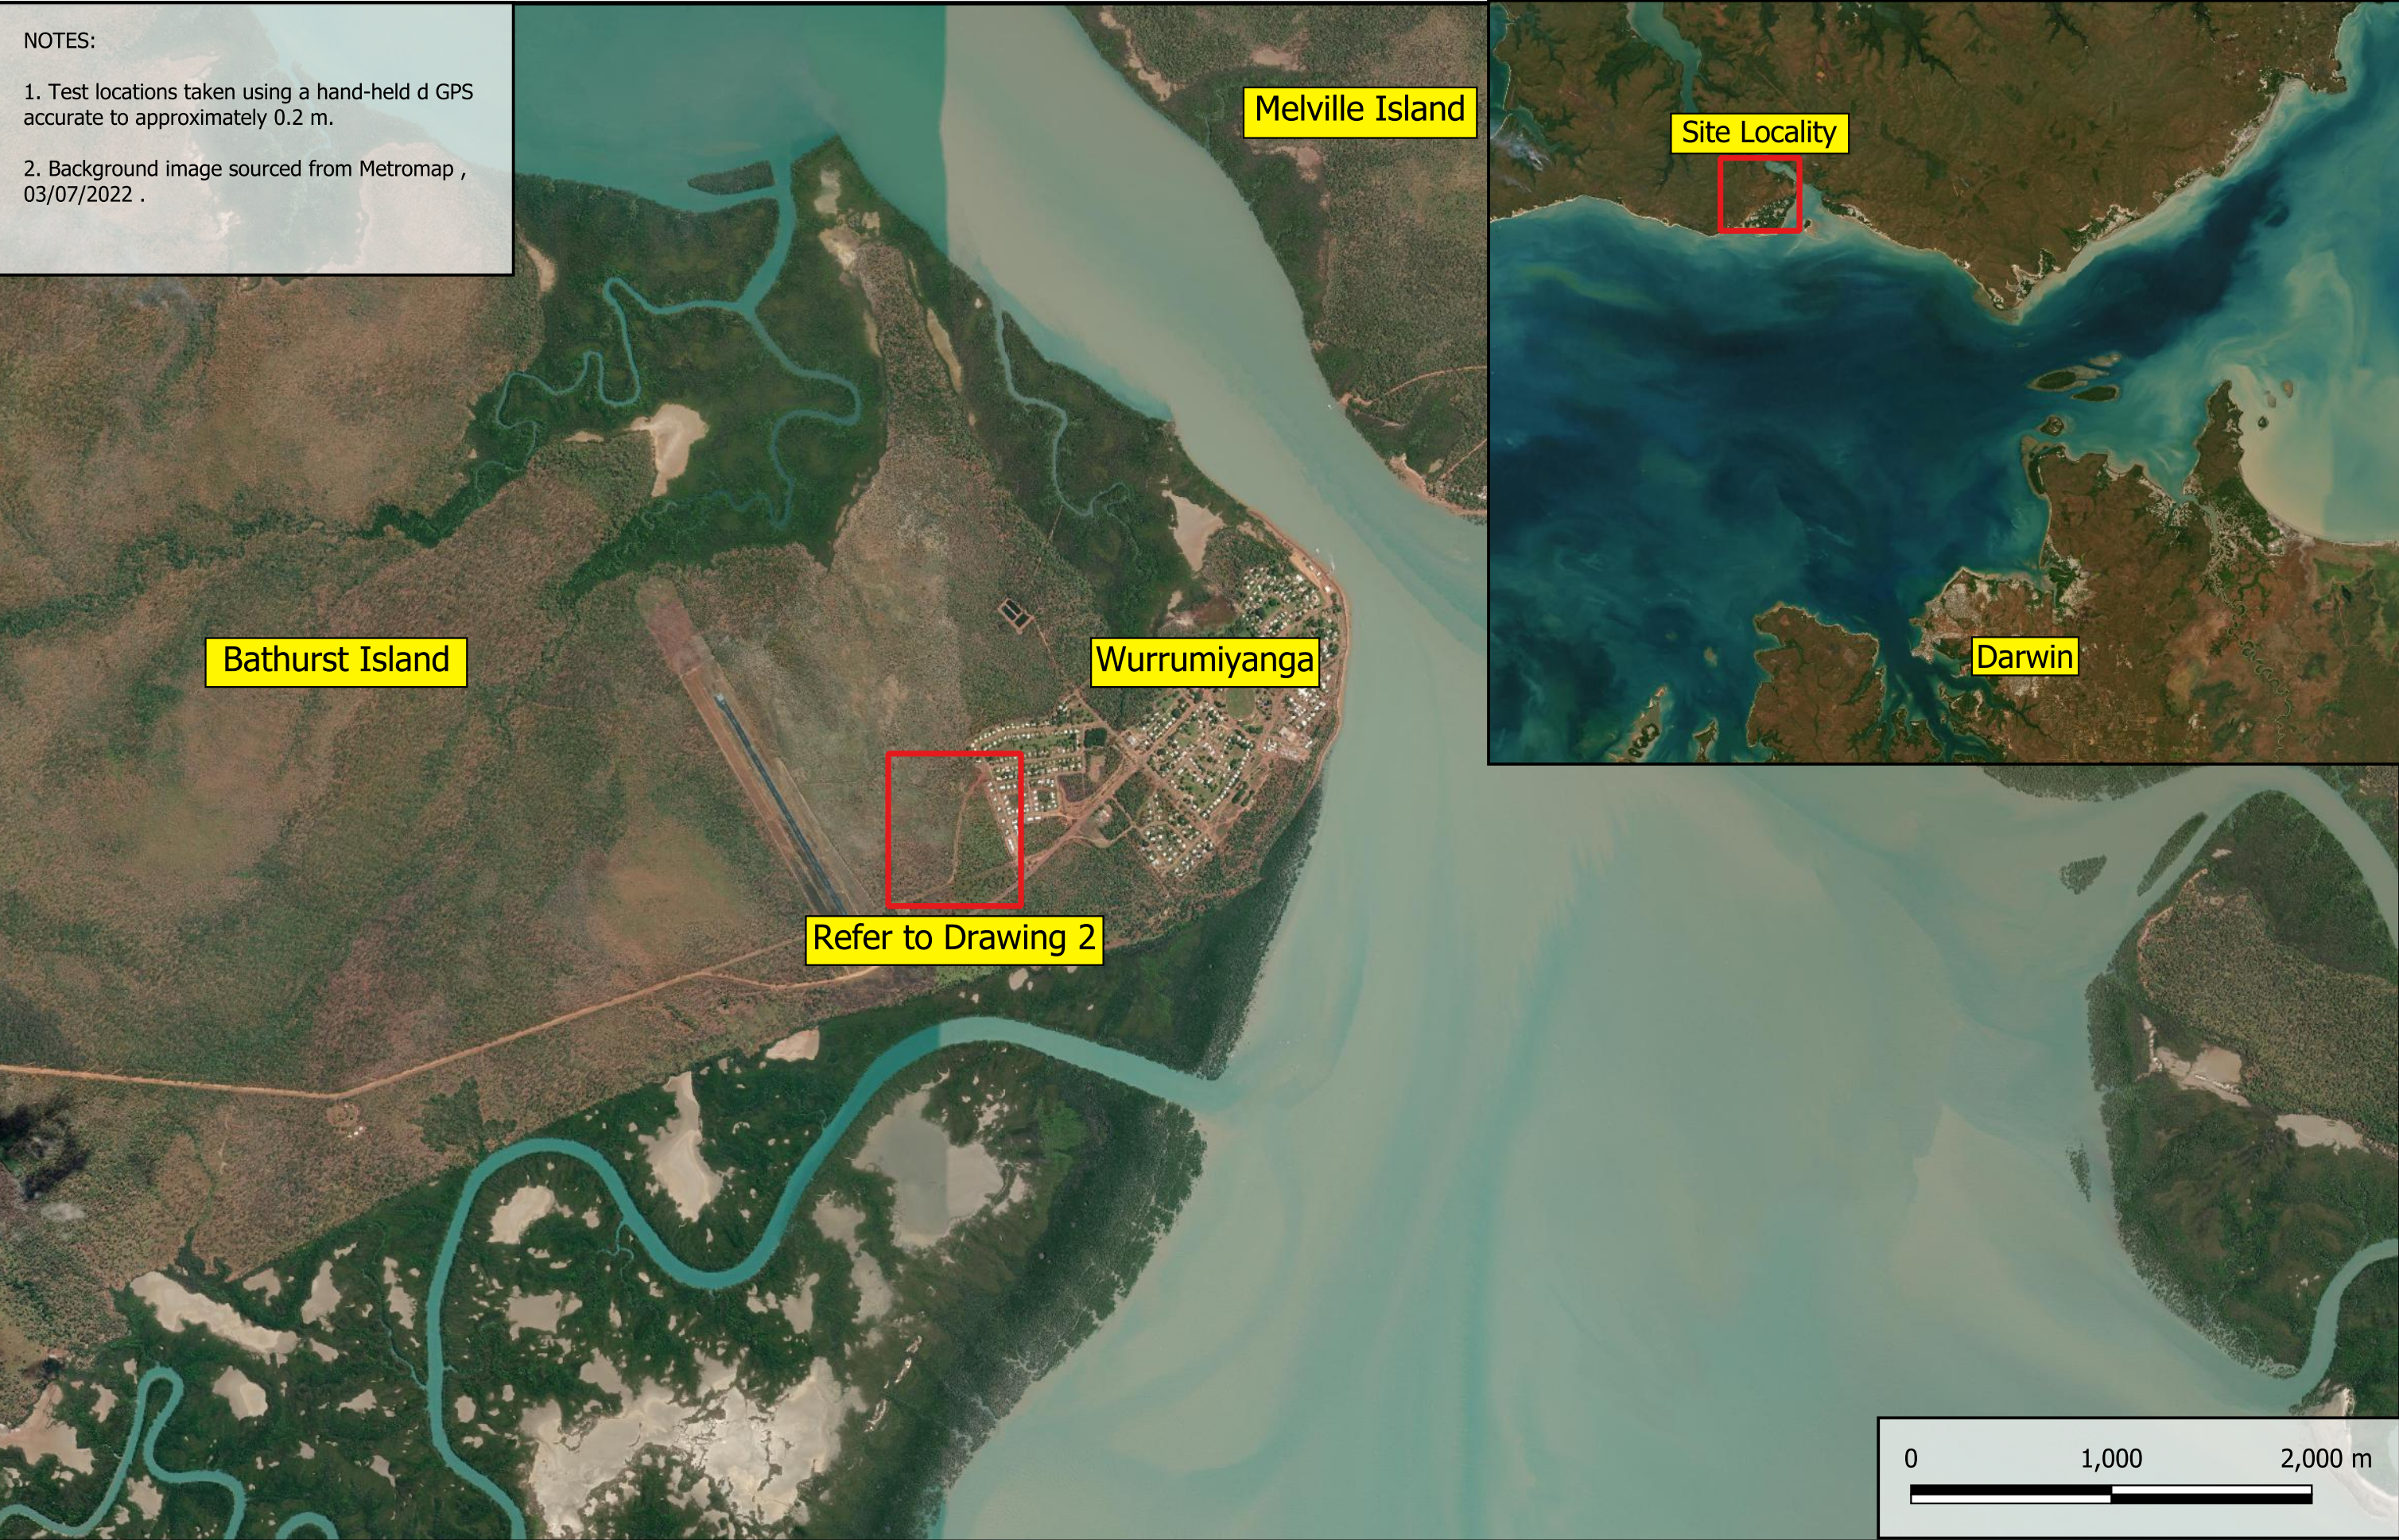
NOTES:

1. Test locations taken using a hand-held d GPS accurate to approximately 0.2 m.
2. Background image sourced from Metromap , 03/07/2022 .

Field work was undertaken on 8 to 14 August 2023 and comprised the excavation and sampling of 43 test pits (designated pits 1 to 43) at the locations shown in Drawing 2 in Appendix A. The test pits were excavated using 3 tonne excavator fitted with a 250 mm wide rock toothed bucket. Final test pit depths were generally limited to the reach of the excavator which was about 2 m. Conditions encountered in the pits were logged and photographed by a geotechnical engineer from Douglas Partners who also took representative samples for laboratory testing.

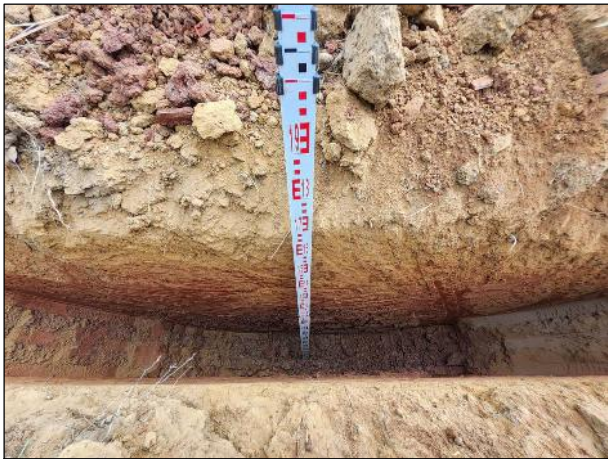
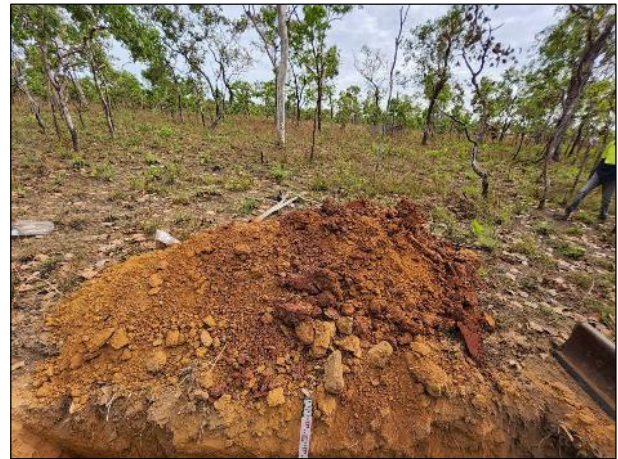
**PIT No:** 20  
**PROJECT No:** 209497.00  
**DATE:** 9/8/2023  
**SHEET 1 OF 1**

RL	Depth (m)	Description of Strata	Graphic Log	Sampling & In Situ Testing				Water	Dynamic Penetrometer Test (blows per 100mm)				
				Type	Depth	Sample	Results & Comments		5	10	15	20	
15.1	0.1	TOPSOIL - Sandy CLAY CL: Low plasticity, light-brown, fine to coarse grained sand, with roots, w<PL, very stiff.		D	0.2		VOC = 0						
	0.4	Clayey Sandy GRAVEL GC: Fine to coarse sub-angular to sub-rounded gravel, yellow-brown, medium plasticity clay, fine to coarse grained sand and roots to 0.2 m depth, moist, dense, colluvial.		D	0.3		VOC = 0						
		Silty CLAY Cl: Medium plasticity, red-brown mottled grey-brown, with fine to coarse grained sand, trace fine to medium gravel, w<PL, stiff to very stiff, residual. - very stiff from 0.9 m depth.  - stiff from 1.3 m depth.		D	0.7		VOC = 0						
	1.8	Pit discontinued at 1.8m depth, excavator refusal.

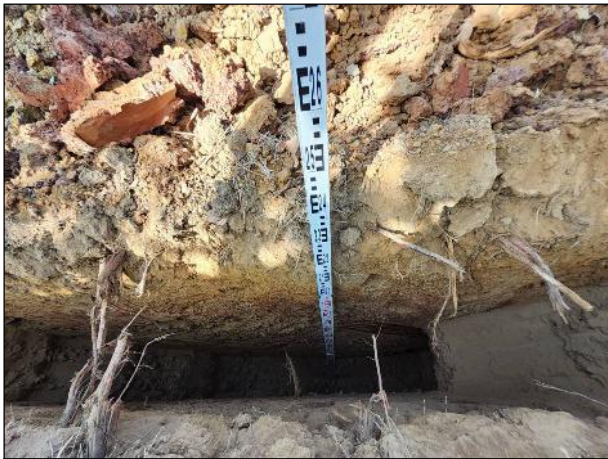
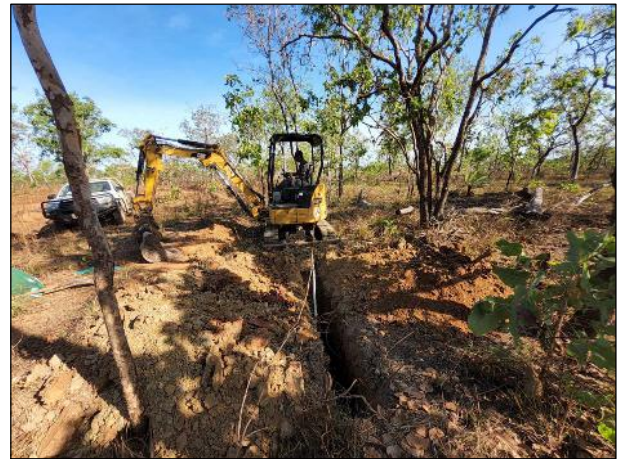
**PIT No:** 21  
**PROJECT No:** 209497.00  
**DATE:** 12/8/2023  
**SHEET 1 OF 1**

RL	Depth (m)	Description of Strata	Graphic Log	Sampling & In Situ Testing				Water	Dynamic Penetrometer Test (blows per 100mm)
				Type	Depth	Sample	Results & Comments		
	0.2	TOPSOIL - Sandy CLAY CL: Low plasticity, light-brown, brown, fine to coarse grained sand, with fine to coarse gravel and roots, w<PL, hard.							
	0.4	Clayey Sandy GRAVEL GC: Fine to coarse sub-angular to angular gravel, yellow-brown, red-brown, medium plasticity clay, fine to coarse grained sand, with roots to 1.0 m depth, dry, dense, colluvial.		D	0.4		VOC = 0		
	1.2	Silty CLAY Ci: Medium plasticity, red-brown mottled grey-brown, with fine to coarse grained sand, trace fine to medium gravel, w<PL, very stiff to hard, residual.		D	1.3		VOC = 0		
	2.0	- grey-brown mottled orange-brown, yellow-brown at 1.8 m depth. - hard from 2.1 m depth.							
	2.4	Pit discontinued at 2.4m depth, excavator refusal.

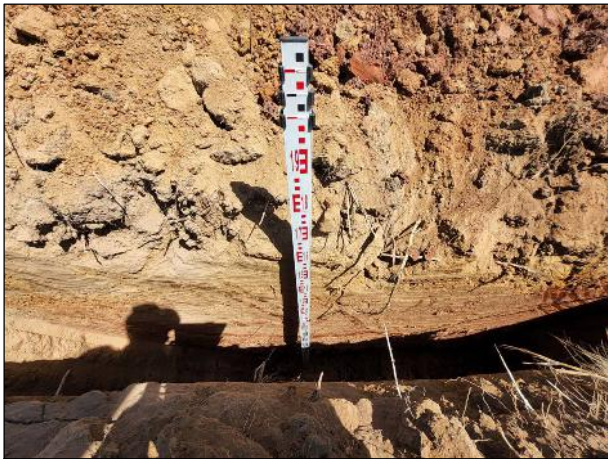
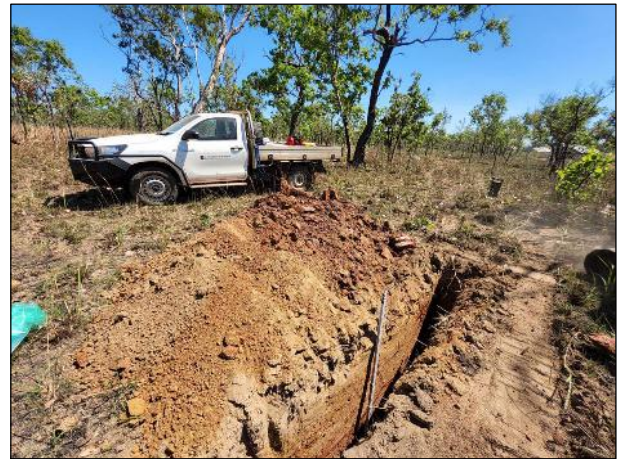
**PIT No:** 22  
**PROJECT No:** 209497.00  
**DATE:** 10/8/2023  
**SHEET 1 OF 1**

RL	Depth (m)	Description of Strata	Graphic Log	Sampling & In Situ Testing				Water	Dynamic Penetrometer Test (blows per 100mm)				
				Type	Depth	Sample	Results & Comments		5	10	15	20	
14.1	0.1	TOPSOIL - Sandy CLAY CL: Low plasticity, light-brown, brown, fine to coarse grained sand, with fine to coarse gravel and roots, w<PL, very stiff.		D	0.4		VOC = 0						
0.7	Clayey Sandy GRAVEL GC: Fine to coarse sub-rounded to rounded gravel, red-brown mottled yellow-brown, medium plasticity clay, fine to coarse grained sand, dry, dense, colluvial.												
1.0	Silty CLAY Cl: Medium plasticity, red-brown mottled grey-brown, with fine to coarse grained sand, trace fine to medium gravel, w<PL, very stiff to hard, residual.												
1.9	Pit discontinued at 1.9m depth, excavator refusal.

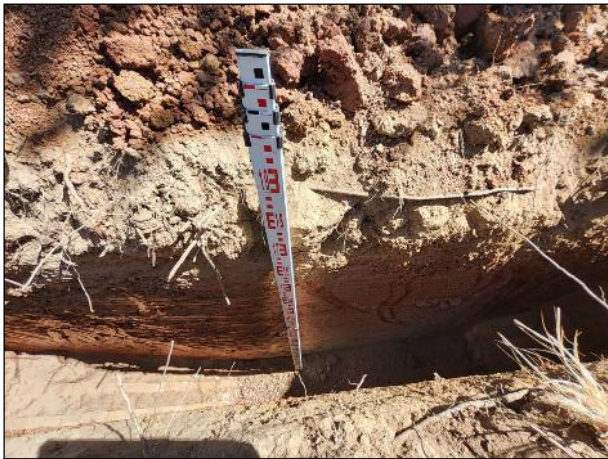
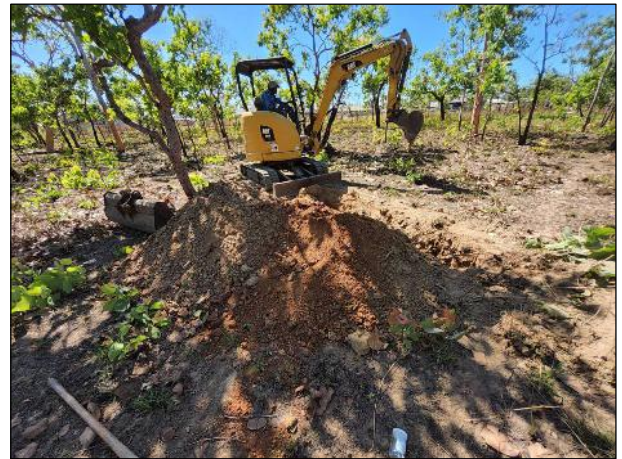
PIT No: 27  
 PROJECT No: 209497.00  
 DATE: 10/8/2023  
 SHEET 1 OF 1

RL	Depth (m)	Description of Strata	Graphic Log	Sampling & In Situ Testing				Water	Dynamic Penetrometer Test (blows per 100mm)
				Type	Depth	Sample	Results & Comments		
14	0.2	TOPSOIL - Sandy CLAY CL: Low plasticity, light-brown, fine to coarse grained sand, with roots, w<PL, stiff.	[Symbol]	D	0.2		VOC = 0	[Graph]	
	0.3	Clayey GRAVEL GC: Fine to coarse sub-rounded to rounded gravel, red-brown mottled yellow-brown, low plasticity clay, with fine to coarse grained sand, moist, dense to very dense, colluvial. - very dense from 0.4 m depth.		E	0.3				
	0.5		B	0.5					
	0.8	Silty CLAY Ci: Medium plasticity, red-brown mottled grey-brown, with fine to coarse grained sand, trace fine to medium gravel, w<PL, estimated very stiff to hard, residual. - grey-brown mottled red-brown from 1.2 m depth.	[Symbol]	D	1.4				
1.6	1.6								
1.9	Pit discontinued at 1.9m depth, excavator refusal.

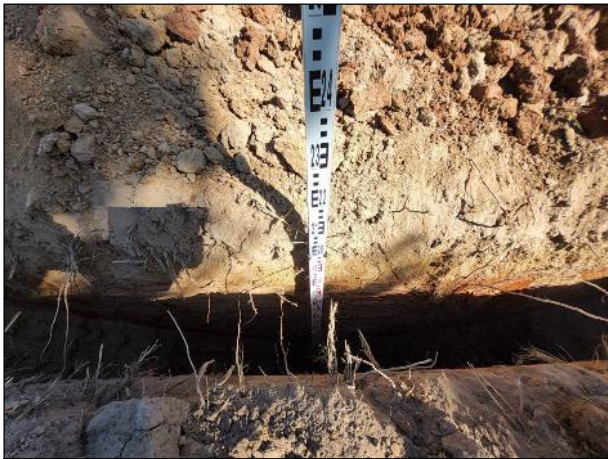
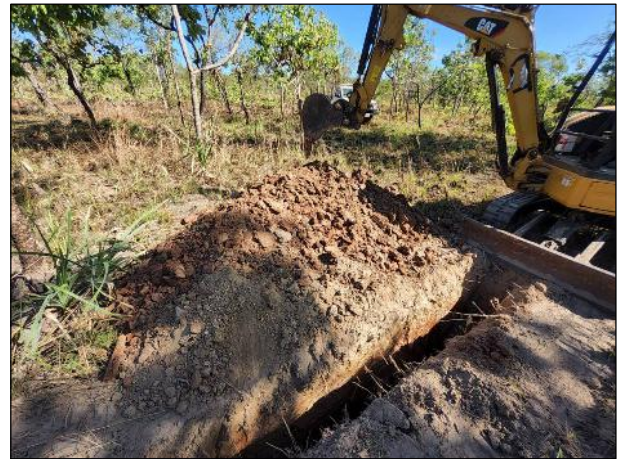
**PIT No:** 29  
**PROJECT No:** 209497.00  
**DATE:** 10/8/2023  
**SHEET 1 OF 1**

RL	Depth (m)	Description of Strata	Graphic Log	Sampling & In Situ Testing				Water	Dynamic Penetrometer Test (blows per 100mm)					
				Type	Depth	Sample	Results & Comments		5	10	15	20		
	0.2	TOPSOIL - Sandy CLAY CL: Low plasticity, light-brown, fine to coarse grained sand, with roots, w<PL, very stiff.												
	0.5	Clayey Sandy GRAVEL GC: Fine to coarse sub-angular to sub-rounded gravel, yellow-brown, grey-brown, medium plasticity clay, fine to coarse grained sand, moist, medium dense to dense, colluvial. - dense from 0.4 m depth.		D	0.3		VOC = 0							
	1	Silty CLAY CI: Medium plasticity, red-brown mottled grey-brown, low plasticity silt, w<PL, very stiff, residual.												
	2.1	Pit discontinued at 2.1m depth, Limit of investigation.

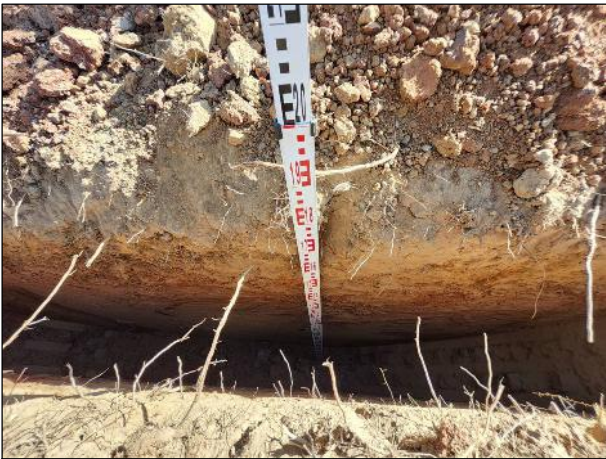
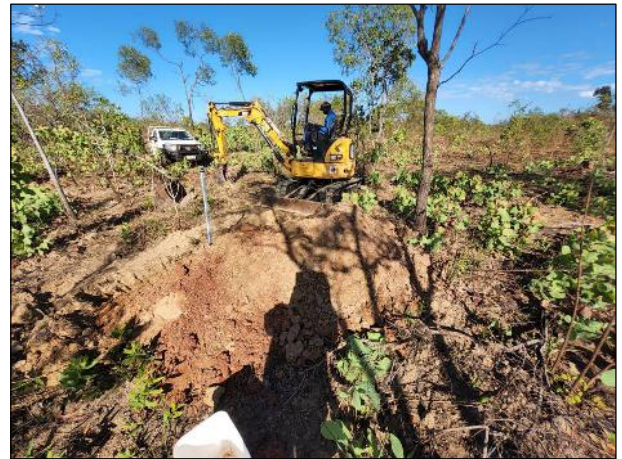
PIT No: 31  
 PROJECT No: 209497.00  
 DATE: 10/8/2023  
 SHEET 1 OF 1

RL	Depth (m)	Description of Strata	Graphic Log	Sampling & In Situ Testing				Water	Dynamic Penetrometer Test (blows per 100mm)				
				Type	Depth	Sample	Results & Comments		5	10	15	20	
15.3	0.2	TOPSOIL - Sandy CLAY CL: Low plasticity, light-brown, fine to coarse grained sand, with roots, w<PL, very stiff.		D	0.2		VOC = 0						
	0.4	Sandy Clayey GRAVEL GC: Fine to coarse sub-angular to sub-rounded gravel, yellow-brown, red-brown, low plasticity clay, fine to coarse grained sand, dry, dense, colluvial.		D	0.3				VOC = 0				
		Silty CLAY CH: High plasticity, red-brown mottled grey-brown, with fine to coarse grained sand, trace fine to medium gravel, w<PL, hard to very stiff, residual. - very stiff from 0.7 m depth. - light-grey mottled red-brown from 1.0 m depth.  - hard from 1.4 m depth.		B	0.5								
						0.7							
	1.9	Pit discontinued at 1.9m depth, excavator refusal.

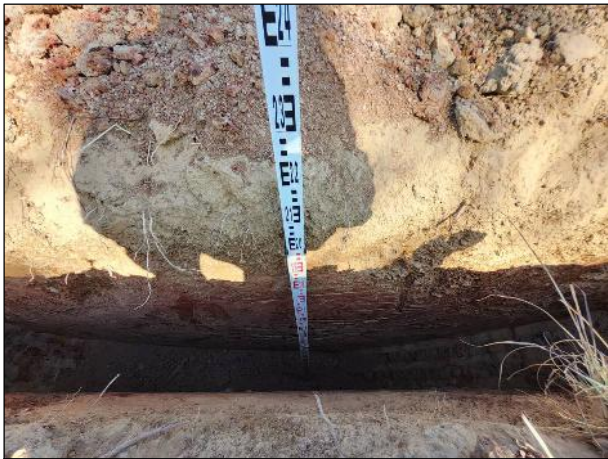
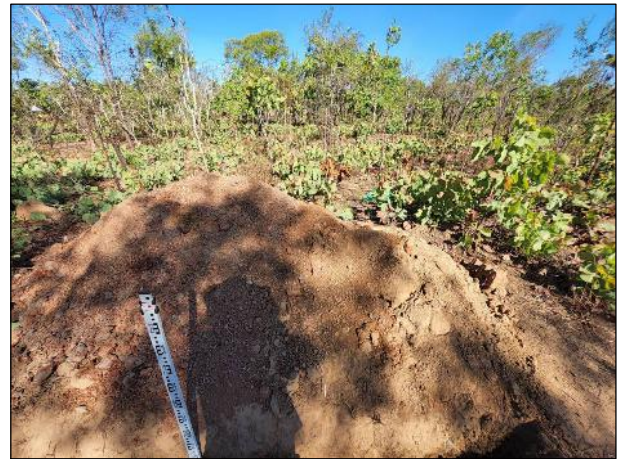
PIT No: 32  
 PROJECT No: 209497.00  
 DATE: 14/8/2023  
 SHEET 1 OF 1

RL	Depth (m)	Description of Strata	Graphic Log	Sampling & In Situ Testing				Water	Dynamic Penetrometer Test (blows per 100mm)
				Type	Depth	Sample	Results & Comments		
15.0	0.1	TOPSOIL - Clayey Sandy GRAVEL GC: Fine to coarse sub-angular to sub-rounded gravel, light-brown, fine to coarse grained sand, low plasticity clay, dry, very dense, roots.	[Graphic Log: Topsoil and Gravel]	D	0.3		VOC = 0		[DP Test Graph]
	0.7	Clayey Sandy GRAVEL GC: Fine to coarse sub-rounded to rounded gravel, brown, light-brown, medium plasticity clay, fine to coarse grained sand, dry, very dense, colluvial.							
	1.0	Silty CLAY CI: Medium plasticity, red-brown mottled grey-brown, with fine to coarse grained sand, trace fine to medium gravel, w<PL, hard, residual.	[Graphic Log: Silty Clay]	U	1.4				
	2.1	Pit discontinued at 2.1m depth, Limit of investigation.

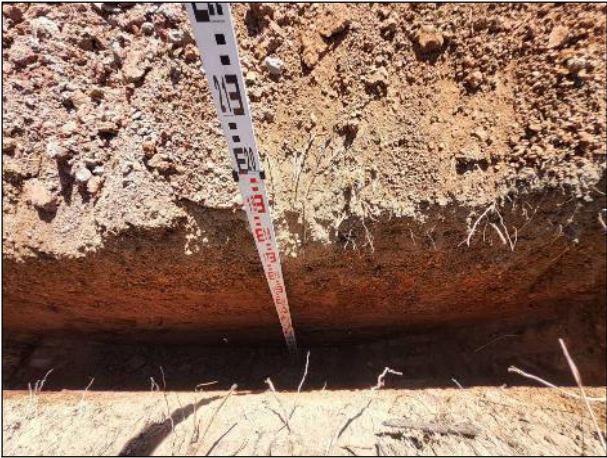
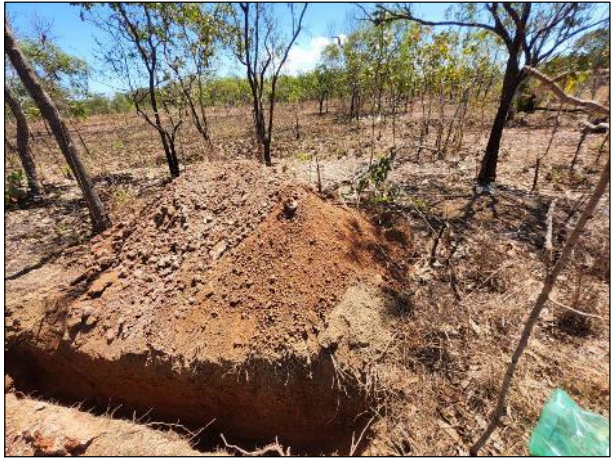
**PIT No:** 34  
**PROJECT No:** 209497.00  
**DATE:** 10/8/2023  
**SHEET 1 OF 1**

RL	Depth (m)	Description of Strata	Graphic Log	Sampling & In Situ Testing				Water	Dynamic Penetrometer Test (blows per 100mm)				
				Type	Depth	Sample	Results & Comments		5	10	15	20	
	0.2	TOPSOIL - Clayey Sandy GRAVEL GC: Fine to coarse sub-rounded to rounded gravel, light-brown, grey-brown, fine to coarse grained sand, low plasticity clay and roots, dry, very dense.		D	0.1		VOC = 0						
	0.3			D	0.3		VOC = 0						
	0.5	Clayey Sandy GRAVEL GC: Fine to coarse sub-rounded to rounded gravel, red-brown mottled yellow-brown, medium plasticity clay, fine to coarse grained sand, dry, very dense, colluvial.											
	1	Silty CLAY CI: Medium plasticity, grey-brown mottled red-brown, with fine to coarse grained sand, trace fine to medium gravel, w<PL, estimated very stiff to hard, residual.											
	1.9	Pit discontinued at 1.9m depth, excavator refusal.

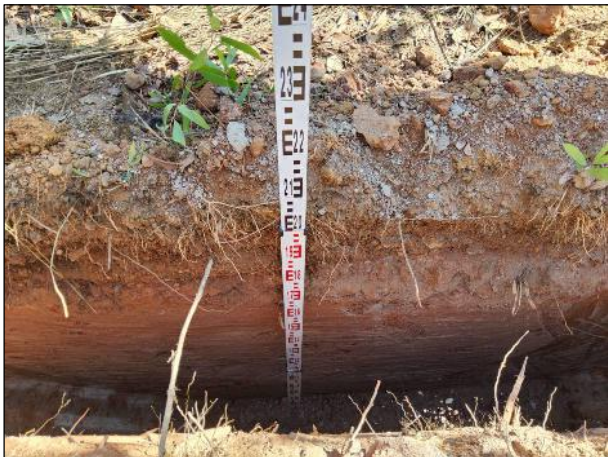
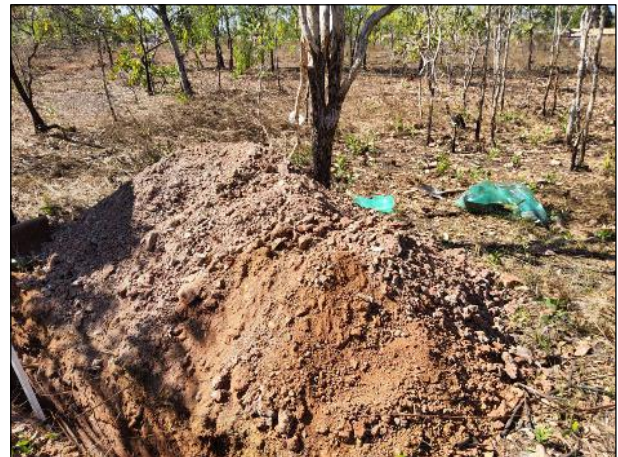
PIT No: 35  
 PROJECT No: 209497.00  
 DATE: 14/8/2023  
 SHEET 1 OF 1

RL	Depth (m)	Description of Strata	Graphic Log	Sampling & In Situ Testing				Water	Dynamic Penetrometer Test (blows per 100mm)
				Type	Depth	Sample	Results & Comments		
	0.2	TOPSOIL - Clayey Sandy Gravel GC: Fine to coarse sub-rounded to rounded gravel, light-brown, fine to coarse grained sand, dry, dense, colluvial, with roots.		D	0.2		VOC = 0		
	0.5	Sandy Clayey GRAVEL GC: Fine to coarse sub-rounded to rounded gravel, red-brown, fine to coarse grained sand, medium plasticity clay, dry, medium dense, colluvial.		D	0.5		VOC = 0		
	1.1	Silty CLAY CI: Medium plasticity, red-brown mottled light-grey, with fine to coarse grained sand, trace fine to medium gravel, w<PL, very stiff to hard, residual. - hard from 0.6 m depth. - light-grey, red-brown from 1.1m depth							
	2.1	Pit discontinued at 2.1m depth, excavator refusal.

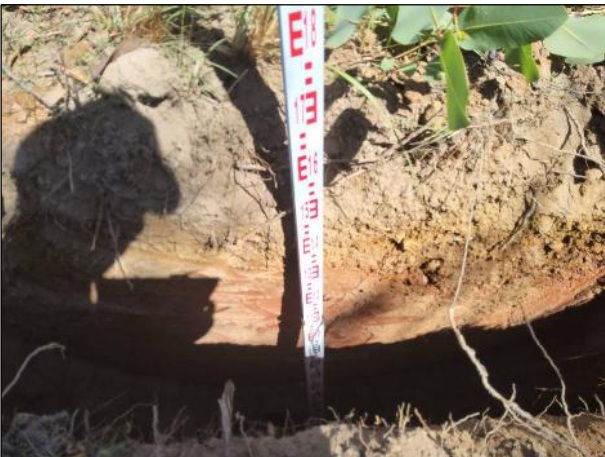
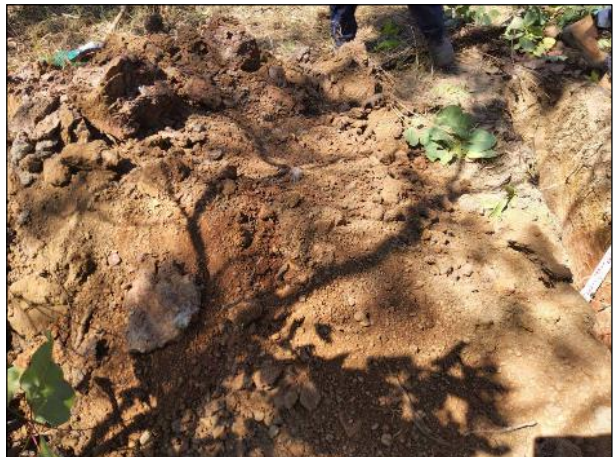
**PIT No:** 40  
**PROJECT No:** 209497.00  
**DATE:** 11/8/2023  
**SHEET 1 OF 1**

RL	Depth (m)	Description of Strata	Graphic Log	Sampling & In Situ Testing				Water	Dynamic Penetrometer Test (blows per 100mm)
				Type	Depth	Sample	Results & Comments		
15.3	0.15	TOPSOIL - Clayey Sandy GRAVEL GC: Fine to coarse sub-rounded to rounded gravel, light-brown, fine to coarse grained sand, low plasticity clay and roots, dry, dense.		DMD	0.2		VOC = 0		
0.6	Clayey Sandy GRAVEL GC: Fine to coarse sub-angular to sub-rounded gravel, yellow-brown, red-brown, medium plasticity clay, fine to coarse grained sand, with roots to 0.3 m depth, moist, dense, colluvial.	0.3							
1	Silty CLAY Cl: Medium plasticity, red-brown mottled grey-brown, with fine to coarse grained sand, trace fine to medium gravel, w<PL, very stiff, residual.								
1.7	Pit discontinued at 1.7m depth, excavator refusal.

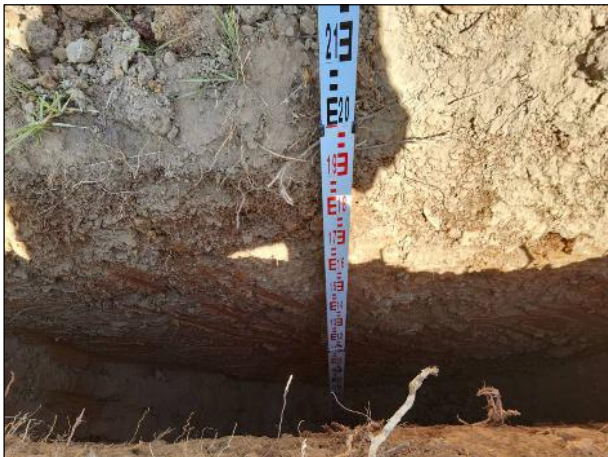
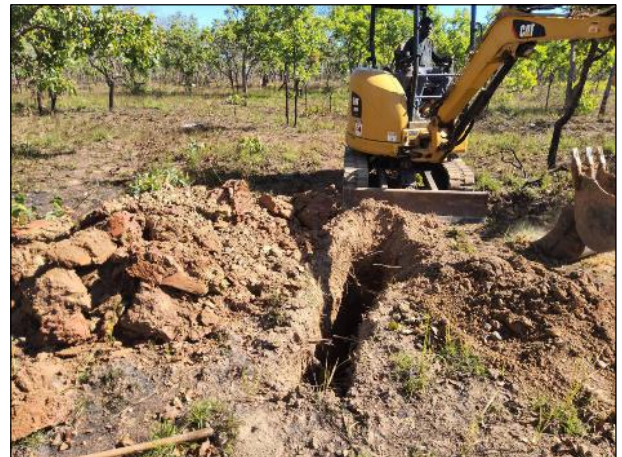
0.4	Clayey Sandy GRAVEL GC: Fine to coarse sub-angular to sub-rounded gravel, grey-brown, yellow-brown, fine to coarse grained sand, medium plasticity clay, with cobbles to 100 mm in size and roots to 0.3 m, dry, medium dense, colluvial.		D	0.5		VOC = 0

0.9	Silty CLAY Ci: Medium plasticity, red-brown mottled light-grey, with fine to coarse grained sand and fine to medium gravel, w<PL, very stiff, residual.											
1	1.7	Silty CLAY Ci: Medium plasticity, red-brown mottled grey-brown, with fine to coarse grained sand, trace fine to medium gravel, w<PL, stiff, residual.											
15	2.1	Pit discontinued at 2.1m depth, excavator refusal.

RIG: 3 Tonne excavator with 250 mm rock toothed bucket

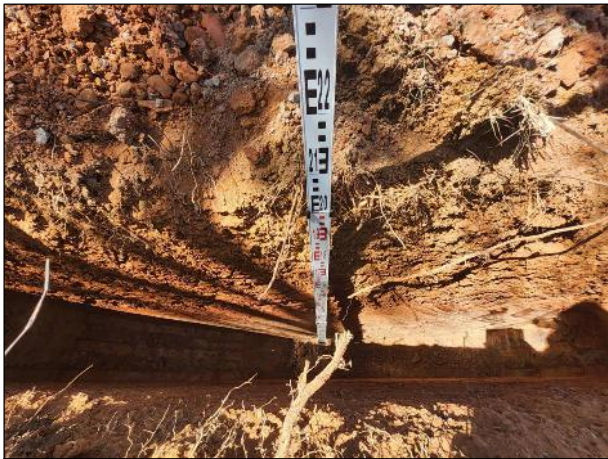
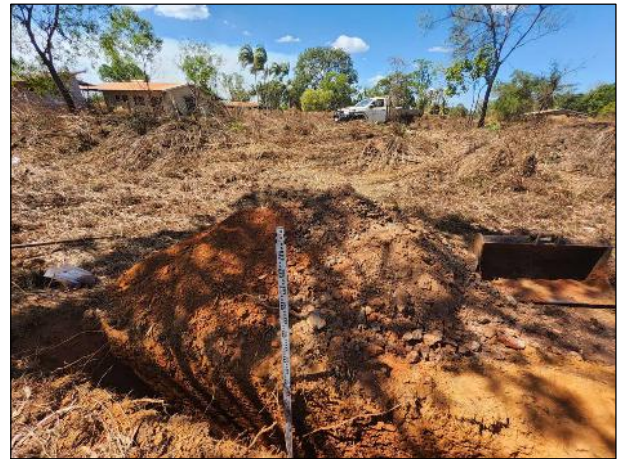
1.2		Silty CLAY Cl: Medium plasticity, grey-brown mottled red-brown, with fine to coarse grained sand, trace fine to medium gravel, w<PL, estimated very hard, residual.	[Graphic Log: Silty Clay]	D	1.3		VOC = 0							
				D	1.4

2.1		Pit discontinued at 2.1m depth, excavator refusal.

**RIG:** 3 Tonne excavator with 250 mm rock toothed bucket

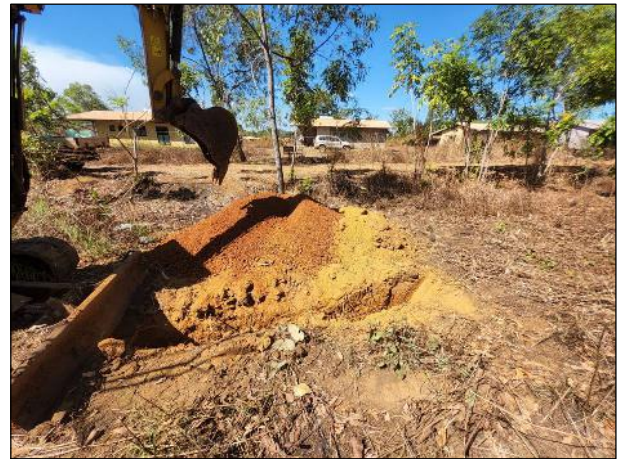
13.2	0.1	TOPSOIL - Clayey Sandy GRAVEL GC: Fine to coarse sub-angular to sub-rounded gravel, light-brown, fine to coarse grained sand, low plasticity clay, with roots, dry, dense.	[Graphic Log: Clayey Sandy Gravel]	D	0.3		VOC = 0	[Dynamic Penetrometer Test Graph]	
		Clayey Sandy GRAVEL GC: Fine to coarse sub-rounded to rounded gravel, yellow-brown, fine to coarse grained sand, medium plasticity clay, dry, dense to very dense, colluvial. - very dense from 0.8 m depth.							
12	1.1	Sandy Clayey GRAVEL GC: Fine to coarse sub-angular to sub-rounded gravel, red-brown, fine to coarse grained, medium plasticity clay, dry, very dense, residual.	[Graphic Log: Sandy Clayey Gravel]	D	1.3		VOC = 0		
2	2.0	Pit discontinued at 2.0m depth, excavator refusal.

RIG: 3 Tonne excavator with 250 mm rock toothed bucket
