Report on
Contamination Assessment

T21-2072 Wurrumiyanga subdivision
Wurrumiyanga, Bathurst Island, NT

Prepared for
Department of Infrastructure Planning & Logistics (NT)

Project 209497.00
December 2023

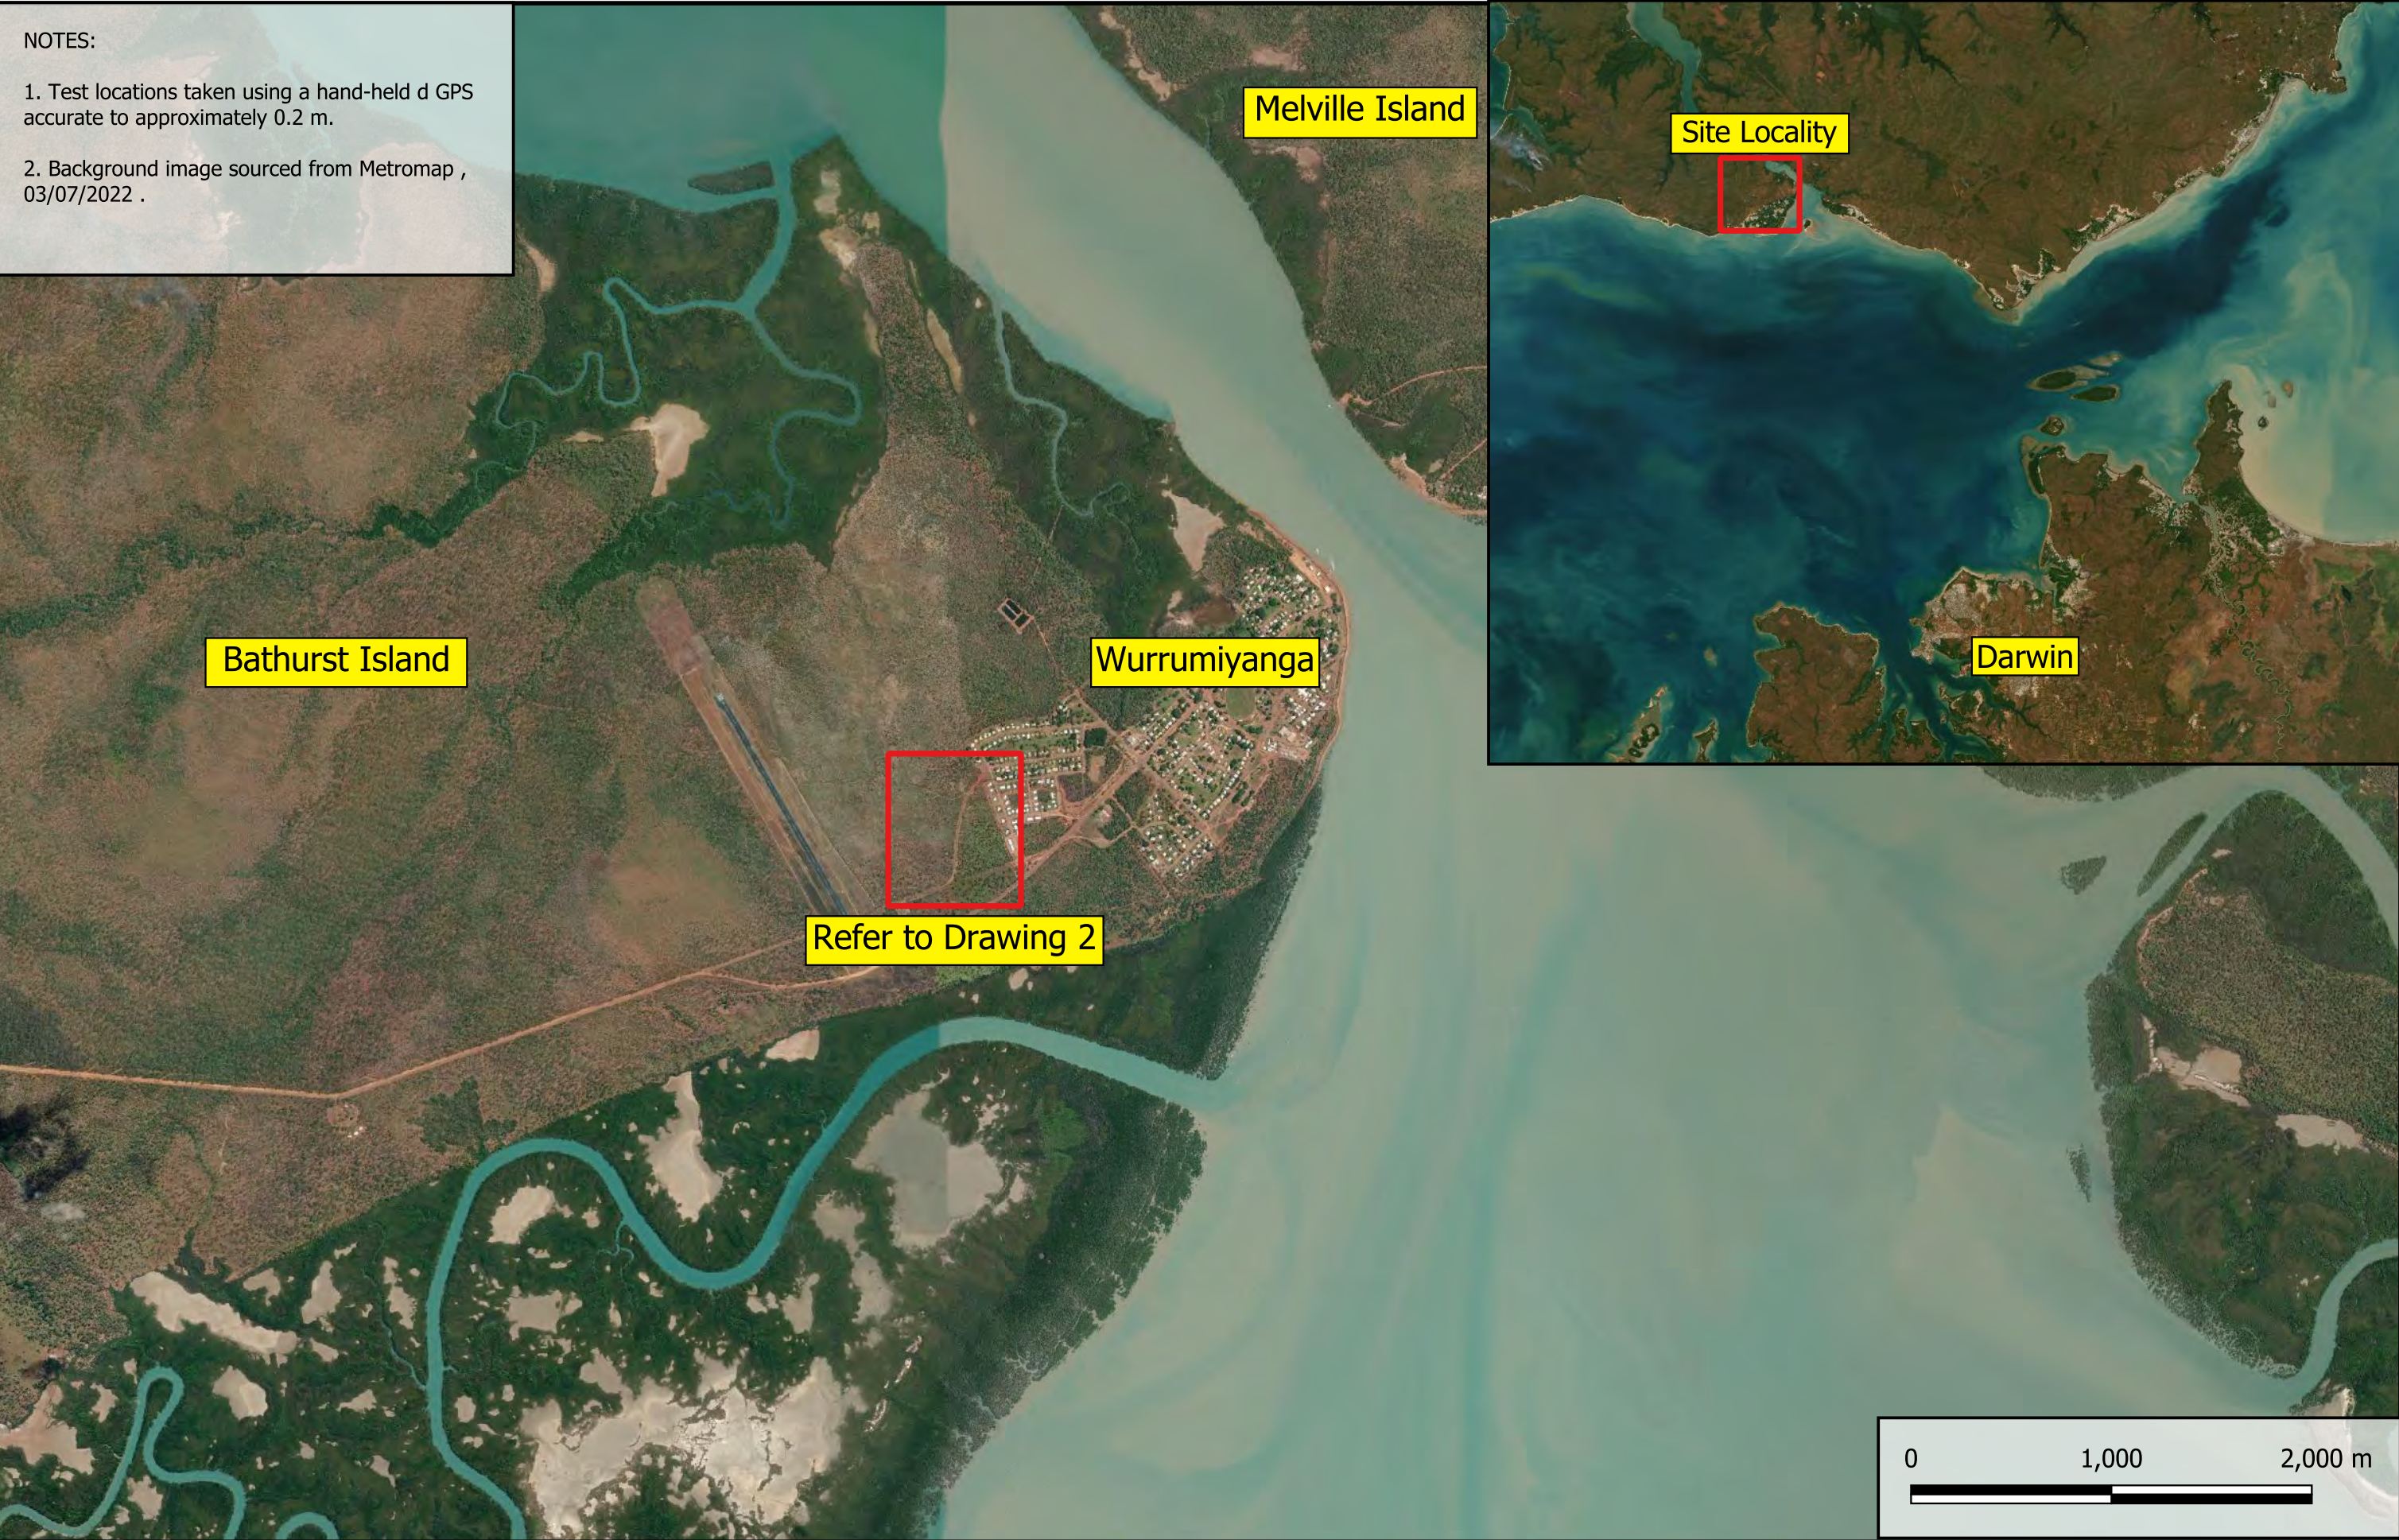
SUBDIVISION LOCATION PLAN
 T21-2072 Wurrumiyanga Subdivision
 Wurrumiyanga, Bathurst Island.

NOTES:
 1. Test locations taken using a hand-held d GPS accurate to approximately 0.2 m.
 2. Background image sourced from Metromap , 03/07/2022 .

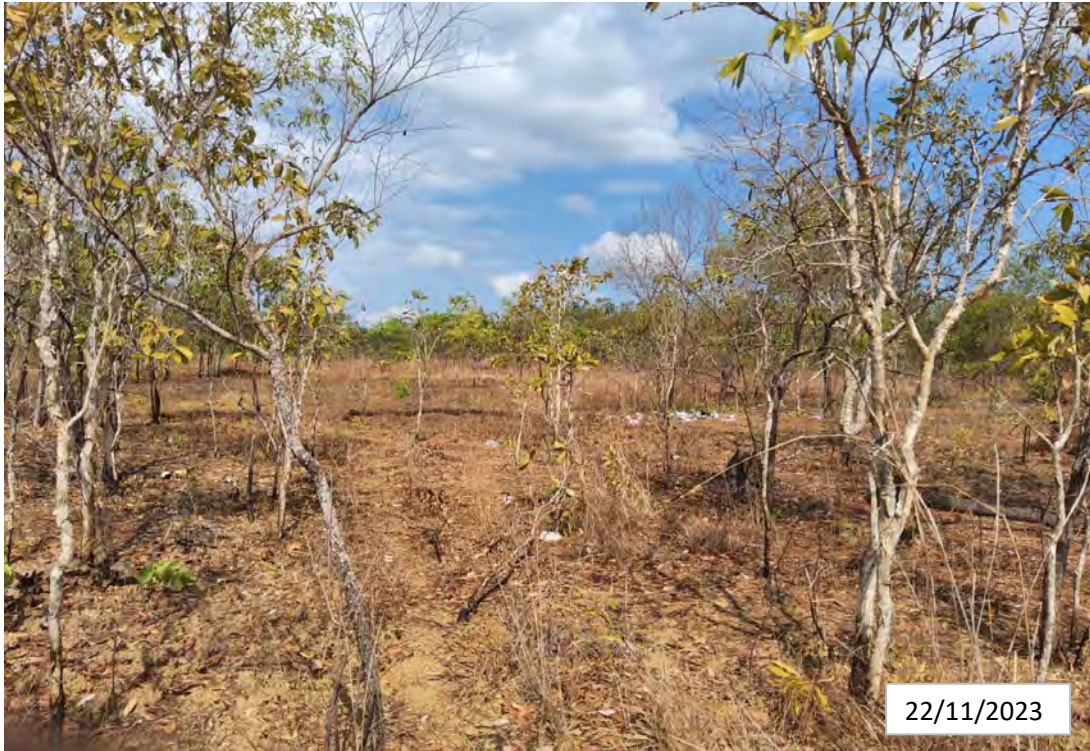
Photo 1: Near Test Pit 34, showing natural bushland with minor surface rubbish, mostly comprising drinking bottles.

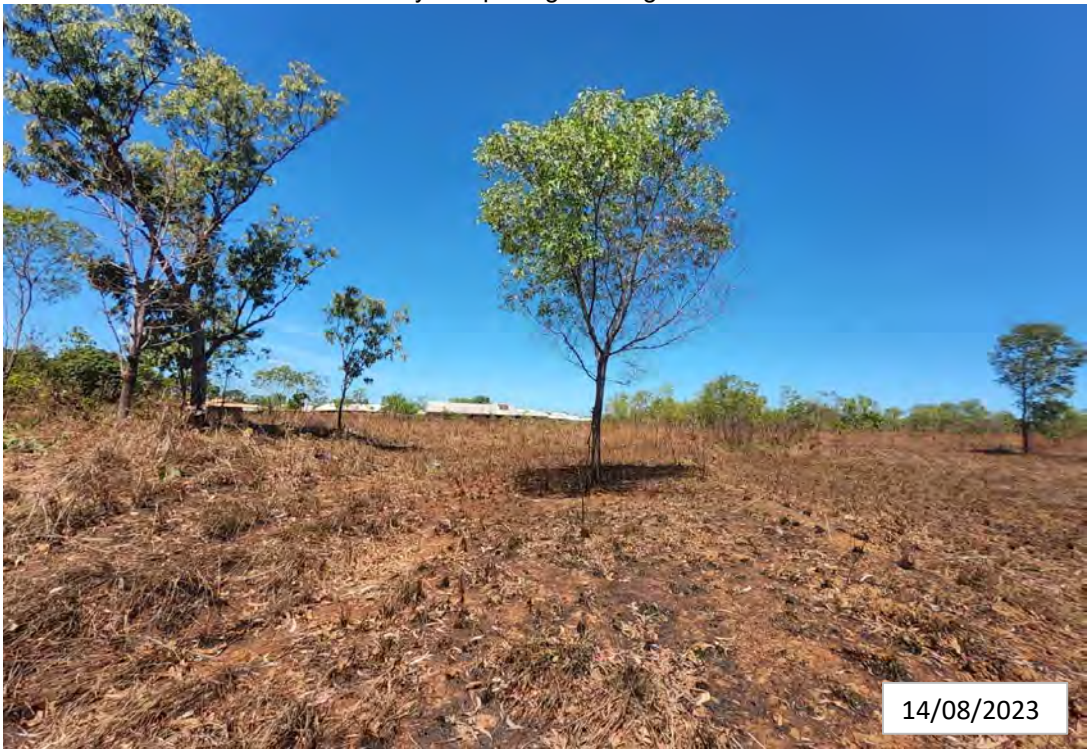
Photo 2: Near Test Pit 42, showing historically cleared bushland with minor surface rubbish, mostly comprising steel, and evidence of recent fire.

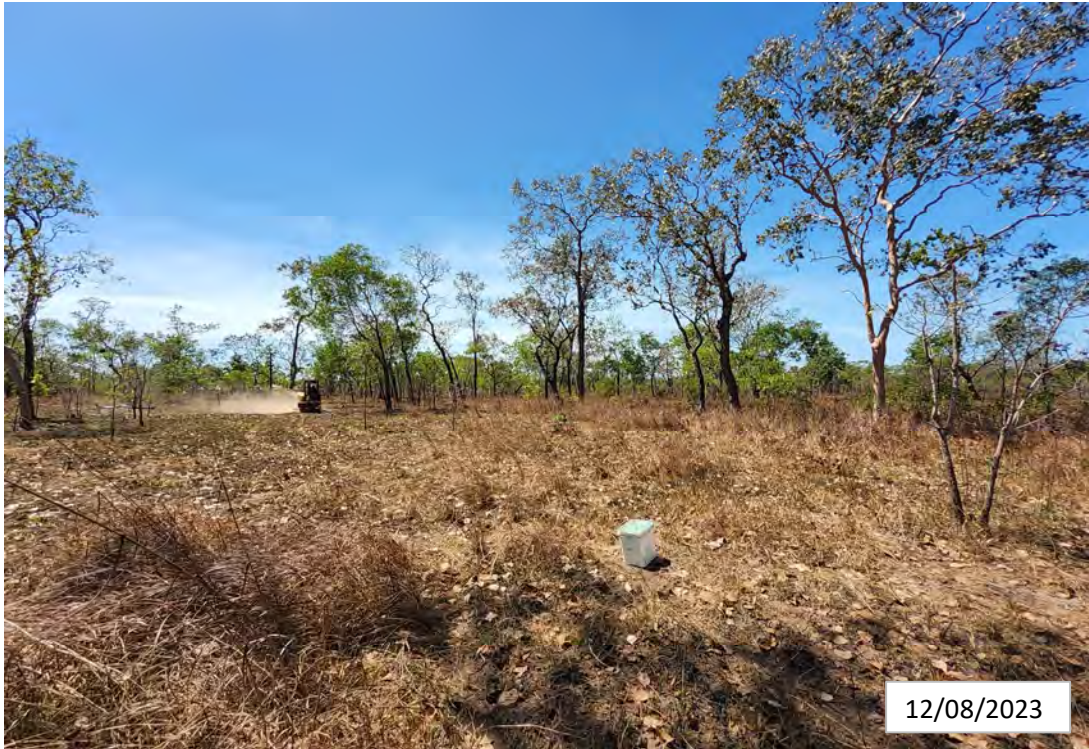
Photo 3: Near Test Pit 5, showing natural bushland, no obvious surface rubbish.

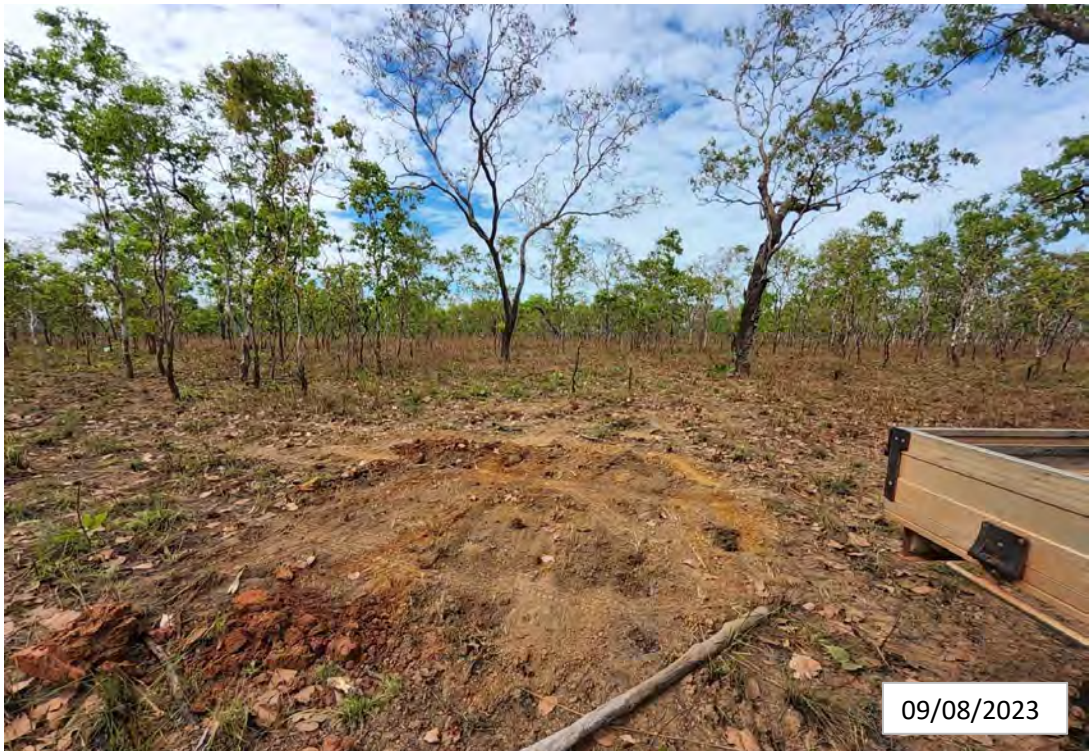
Photo 4: Near Test Pit 20, showing natural bushland, no obvious surface rubbish.

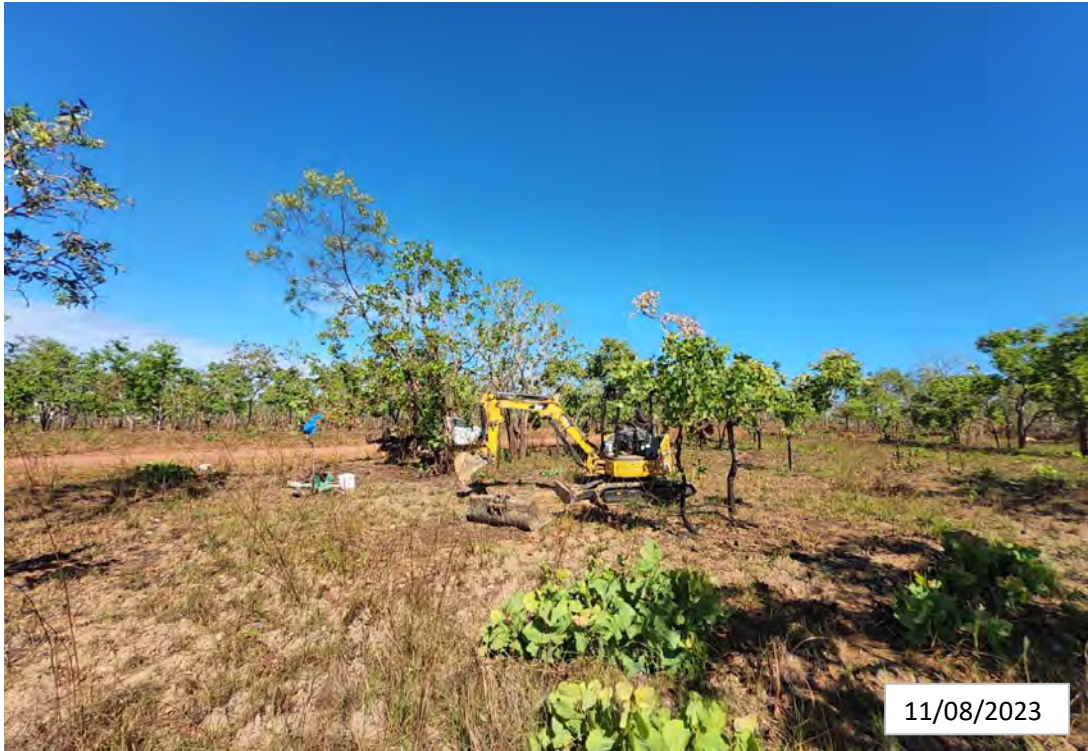
Photo 5: Near Test Pit 41, showing airport road, which runs through the site and natural bush either side, minor litter.

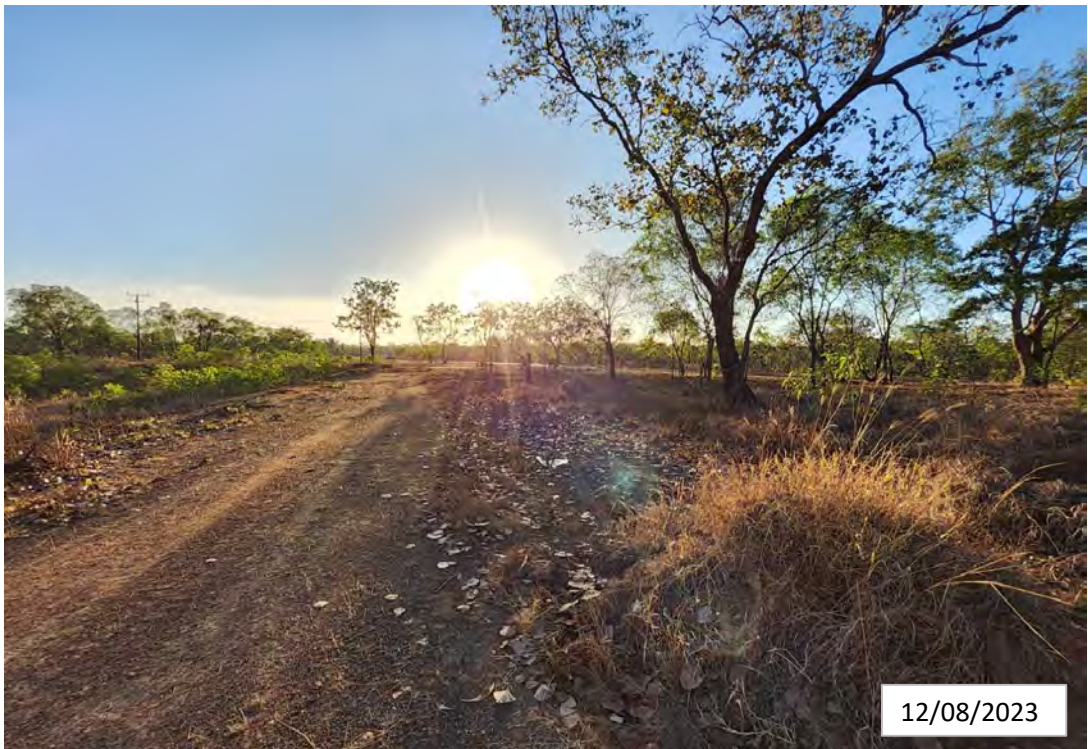
Photo 6: Near Test Pit 2, looking south-west towards Kerinauia Drive showing dirt track.

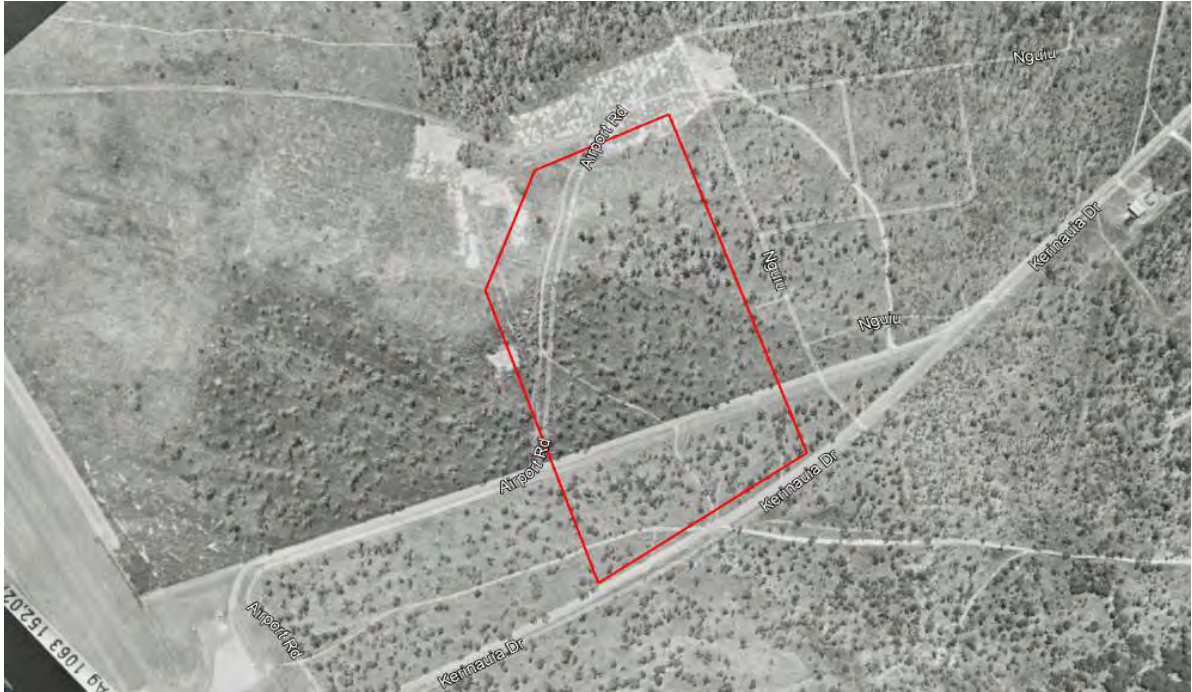
A selection of limited historical Aerial Photographs sourced from the Northern Territory Archives Centre (NTAC) as well as historical satellite imagery sourced from Google Earth indicates that the site has been covered by bushland with only some clearing and dirt tracks being observed.

Image 1: Overlay of Historical Aerial Frame from 22/07/1977 (Frame 456) showing the site outline. The site is a bush site with minor clearing and dirt tracks.

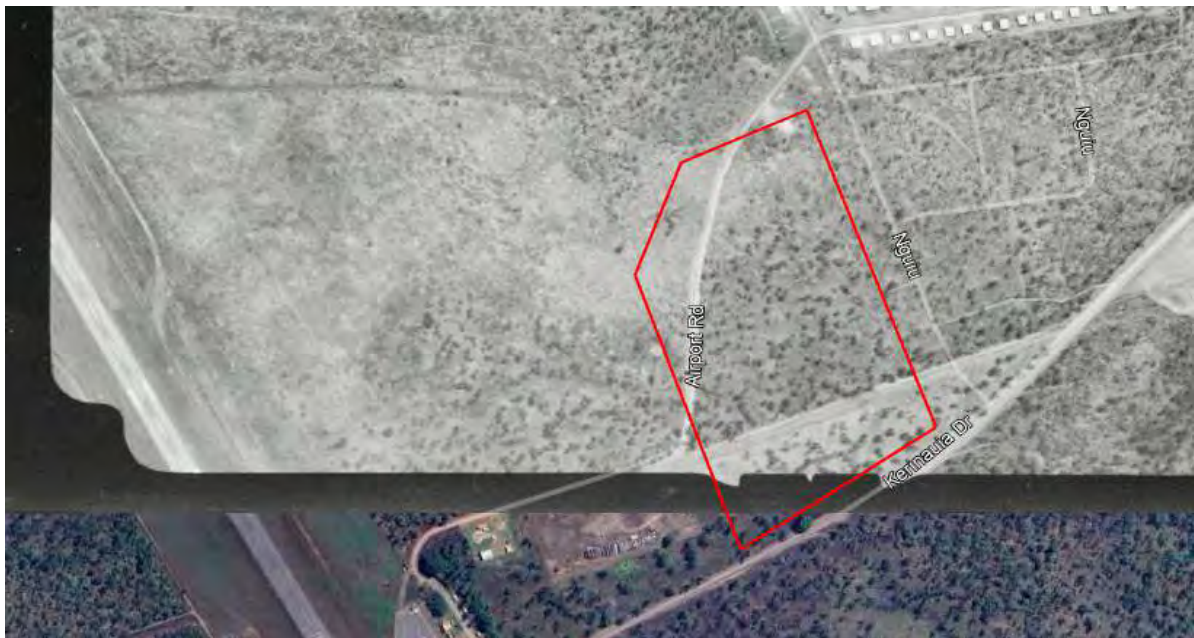
Image 2: Overlay of Historical Aerial Frame from 16/07/1991 (Frame 052) showing the site outline. The site is a bush site with minor clearing and dirt tracks.

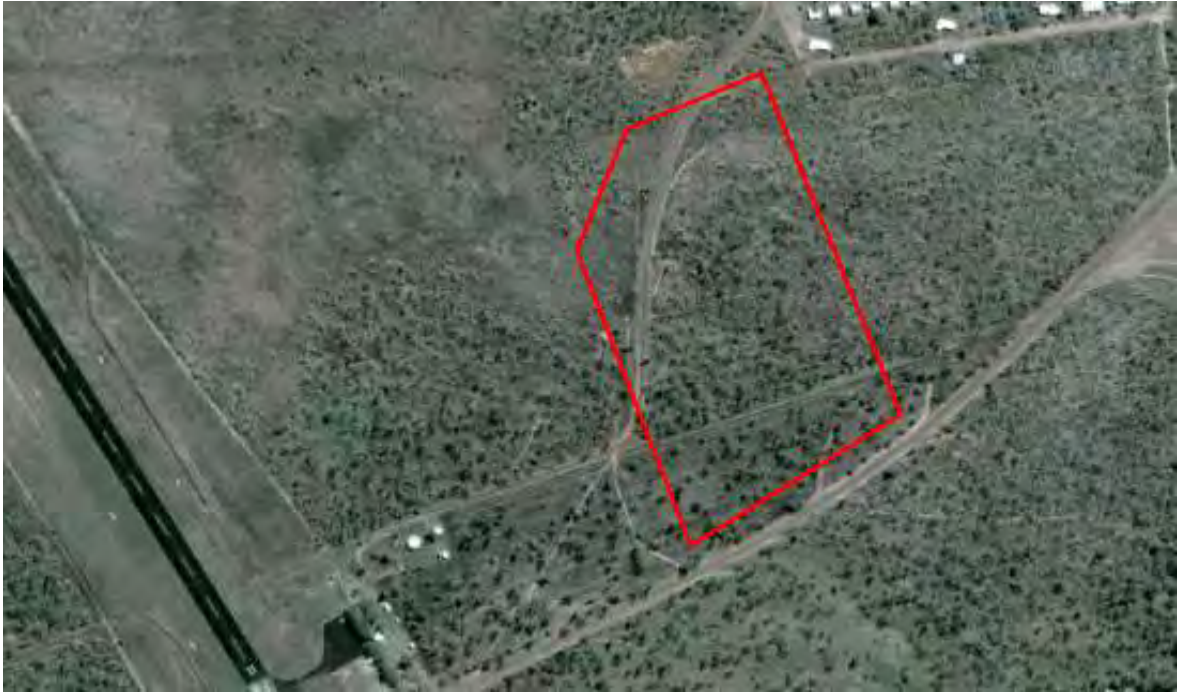
Image 3: Historical Satellite Image from Google Earth 15/06/2003 showing the site outline.
The site is a bush site with minor dirt tracks.

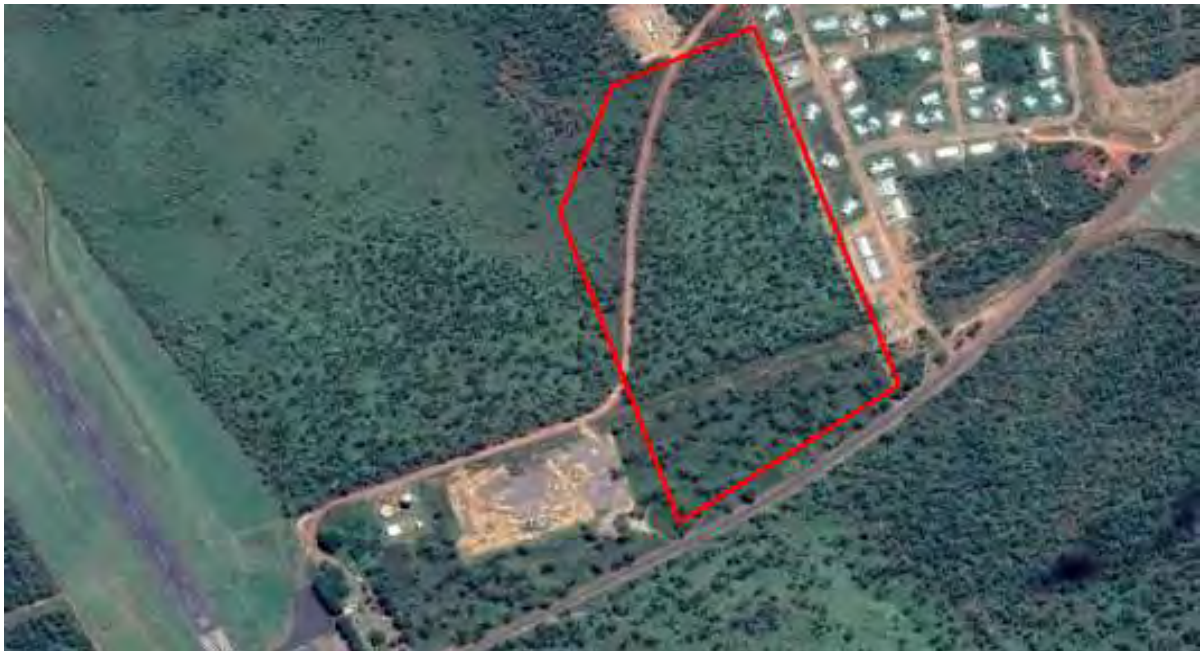
Image 4: Historical Satellite Image from Google Earth 25/04/2019 showing the site outline.
The site is a bush site with minor dirt tracks.

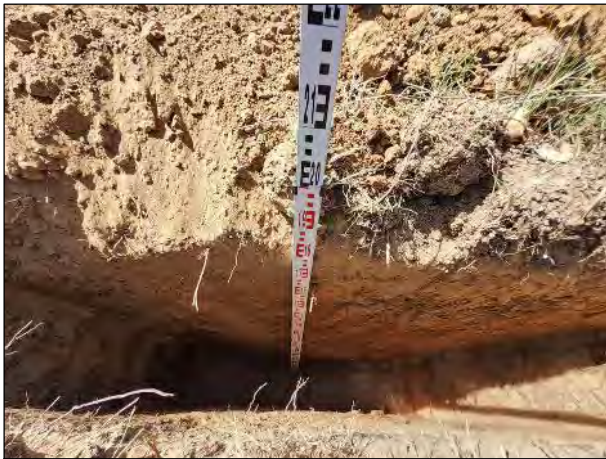
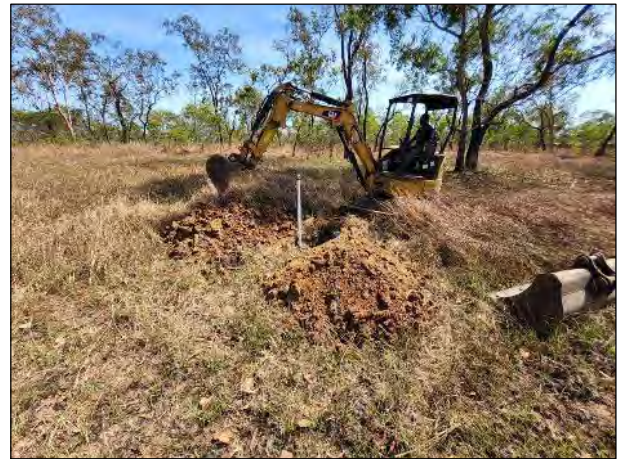
PIT No: 4
PROJECT No: 209497.00
DATE: 12/8/2023
SHEET 1 OF 1

RL	Depth (m)	Description of Strata	Graphic Log	Sampling & In Situ Testing				Water	Dynamic Penetrometer Test (blows per 100mm)
				Type	Depth	Sample	Results & Comments		
	0.25	TOPSOIL - Sandy CLAY CL: Low plasticity, light-brown, fine to coarse grained sand, with fine to coarse gravel and roots, w<PL, stiff.		E	0.1		VOC = 0		
	0.8	Sandy CLAY CH: High plasticity, yellow-brown, red-brown, fine to coarse grained sand, trace fine to coarse sub-angular to sub-rounded gravel, w<PL, very stiff to hard, colluvial. - hard from 0.4 m depth.		D U	0.4 0.5		VOC = 0		
	1	Silty CLAY CI: Medium plasticity, red-brown mottled grey-brown, low plasticity silt, with fine to coarse grained sand, trace fine to medium gravel, w<PL, very stiff, residual. - grey-brown mottled red-brown at 1.8 m depth.		D	1.0				
	2	2.0 Pit discontinued at 2.0m depth, Limit of investigation.

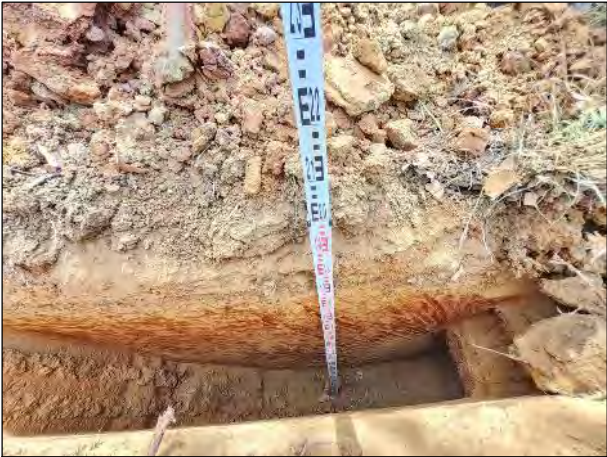
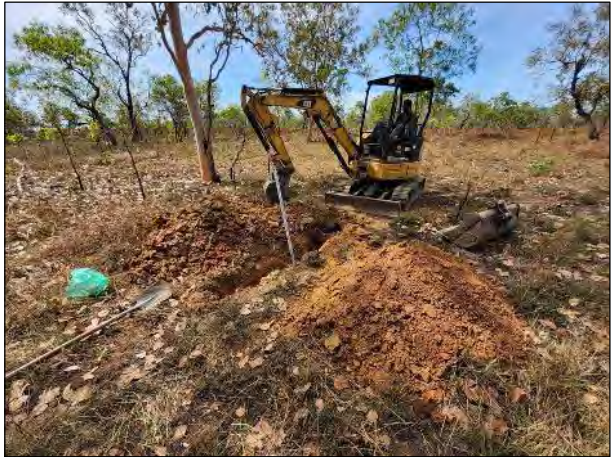
PIT No: 8
PROJECT No: 209497.00
DATE: 12/8/2023
SHEET 1 OF 1

RL	Depth (m)	Description of Strata	Graphic Log	Sampling & In Situ Testing				Water	Dynamic Penetrometer Test (blows per 100mm)
				Type	Depth	Sample	Results & Comments		
	0.2	TOPSOIL - Sandy CLAY CL: Low plasticity, grey-brown, light-brown, fine to coarse grained sand, trace fine to coarse gravel and roots, w<PL, very stiff.							
	0.6	Clayey Sandy GRAVEL GC: Fine to coarse sub-angular to sub-rounded gravel, yellow-brown, medium plasticity clay, fine to coarse grained sand, dry, dense, colluvial. - red-brown mottled yellow-brown from 0.4 m depth.		D	0.6		VOC = 0		
	1.1	Silty CLAY Cl: Medium plasticity, red-brown mottled light-grey, with fine to coarse grained sand, trace fine to medium gravel, w<PL, very stiff, residual. - grey-brown mottled orange-brown, red-brown from 1.6 m depth		D	1.8		VOC = 0		
	2.0	Pit discontinued at 2.0m depth, excavator refusal.

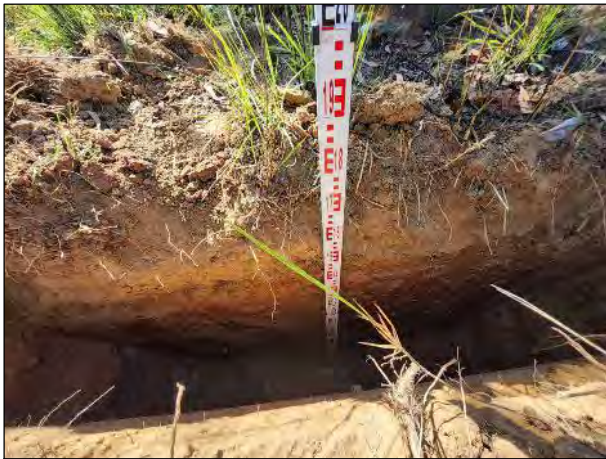
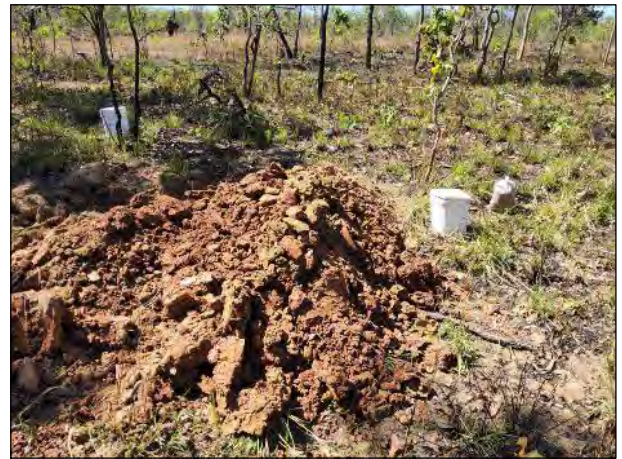
PIT No: 11
PROJECT No: 209497.00
DATE: 8/8/2023
SHEET 1 OF 1

RL	Depth (m)	Description of Strata	Graphic Log	Sampling & In Situ Testing				Water	Dynamic Penetrometer Test (blows per 100mm)
				Type	Depth	Sample	Results & Comments		
14.4	0.35	TOPSOIL - Gravelly Sandy CLAY CL: Low plasticity, yellow-brown, light-brown, fine to coarse grained sand and roots, w<PL, very stiff.	[Graphic Log: Diagonal hatching]	D	0.2		VOC = 0	[Penetrometer Test Graph: Shows blow counts increasing from ~5 at 0.2m to ~18 at 0.7m]	
		Silty CLAY C: Medium plasticity, red-brown mottled grey-brown, low plasticity silt, with fine to coarse grained sand, trace fine to coarse gravel, w=PL, hard, residual.		B	0.5		VOC = 0		
					0.7				
	1.8	Pit discontinued at 1.8m depth, excavator refusal.

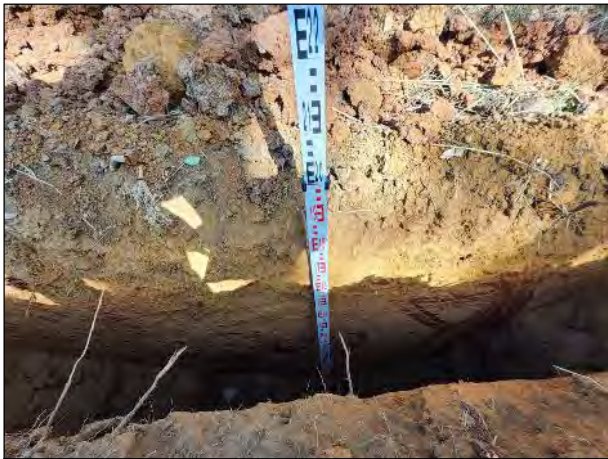
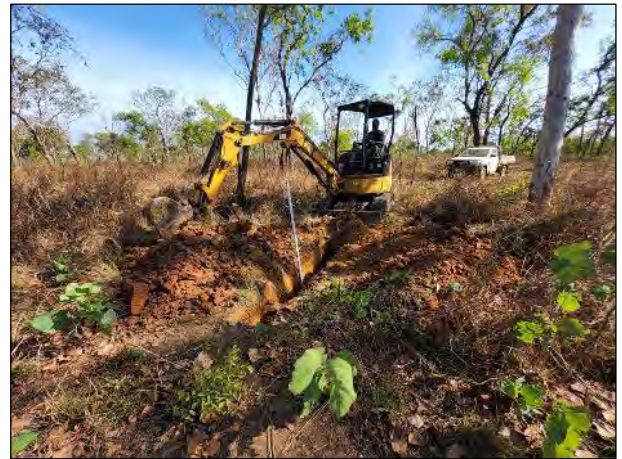
PIT No: 15
PROJECT No: 209497.00
DATE: 12/8/2023
SHEET 1 OF 1

RL	Depth (m)	Description of Strata	Graphic Log	Sampling & In Situ Testing				Water	Dynamic Penetrometer Test (blows per 100mm)				
				Type	Depth	Sample	Results & Comments		5	10	15	20	
17	0.25	TOPSOIL - Sandy CLAY CL: Low plasticity, light-brown, brown, fine to coarse grained sand, with fine to coarse sub-angular to sub-rounded gravel and roots, w<PL, stiff.	[Hatched pattern]	B	0.3		VOC = 0		1	5	10	15	20
		Sandy CLAY CL: Medium plasticity, yellow-brown mottled red-brown, fine to coarse grained sand, with fine to coarse sub-angular to sub-rounded gravel, w<PL, very stiff to hard, colluvial. - hard from 0.4 m depth.											
16	1.0	Silty CLAY CL: Medium plasticity, red-brown mottled grey-brown, with fine to coarse grained sand, trace fine to medium gravel, w<PL, very stiff, residual.	[Vertical line pattern]	D	1.1		VOC = 0						
15	2.0	Pit discontinued at 2.0m depth, Limit of investigation.

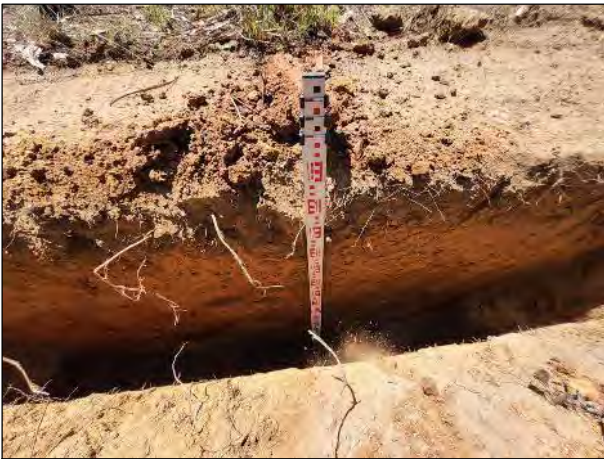
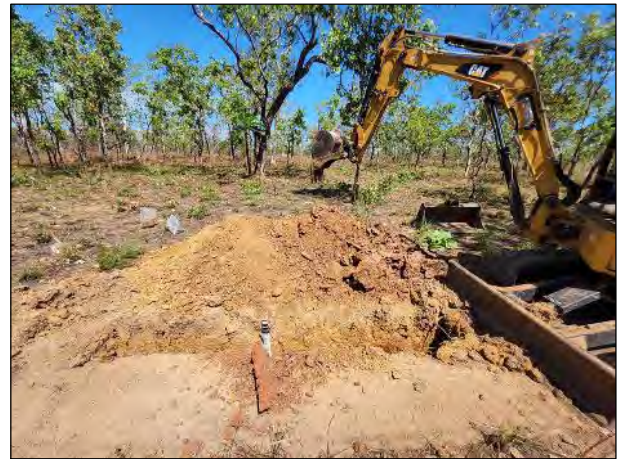
PIT No: 16
PROJECT No: 209497.00
DATE: 9/8/2023
SHEET 1 OF 1

RL	Depth (m)	Description of Strata	Graphic Log	Sampling & In Situ Testing				Water	Dynamic Penetrometer Test (blows per 100mm)				
				Type	Depth	Sample	Results & Comments		5	10	15	20	
16	0.1	TOPSOIL - Sandy CLAY CL: Low plasticity, light-brown, brown, fine to coarse grained, with fine to coarse sub-angular to sub-rounded gravel and roots, w<PL, very stiff.		D	0.3		VOC = 0						
	0.7	Gravelly Sandy CLAY CL: Medium plasticity, yellow-brown, fine to coarse sub-rounded to rounded gravel, with fine to coarse grained sand, w<PL, very stiff, colluvial. - becoming red-brown mottled yellow-brown at 0.4 m depth.		D	0.9		VOC = 0						
1	1.9	Silty CLAY CL: Medium plasticity, red-brown mottled grey-brown, with fine to coarse grained sand, trace fine to medium gravel, w<PL, very stiff, residual.											
	1.9	Pit discontinued at 1.9m depth, excavator refusal.

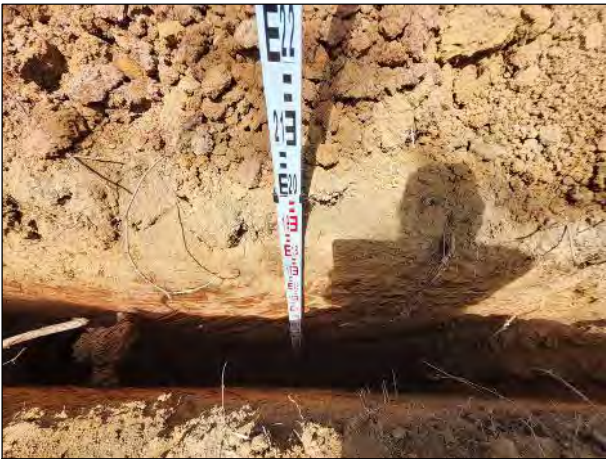
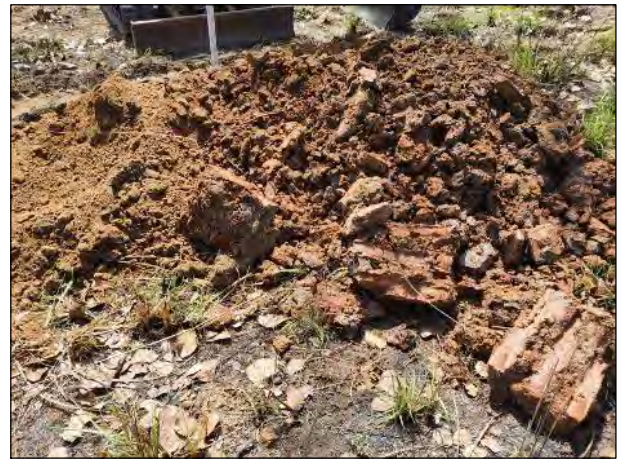
PIT No: 17
 PROJECT No: 209497.00
 DATE: 9/8/2023
 SHEET 1 OF 1

RL	Depth (m)	Description of Strata	Graphic Log	Sampling & In Situ Testing				Water	Dynamic Penetrometer Test (blows per 100mm)				
				Type	Depth	Sample	Results & Comments		5	10	15	20	
	0.1	TOPSOIL - Sandy CLAY CL: Low plasticity, light-brown, brown, fine to coarse grained sand, with fine to coarse sub-angular to sub-rounded gravel and roots, w<PL, very stiff.		D	0.2		VOC = 0						
				M	0.4								
	0.7	Silty CLAY Cl: Medium plasticity, yellow-brown, with fine to coarse grained sand, trace fine to medium gravel, with roots to 0.3 m depth, w<PL, very stiff, colluvial. - red-brown mottled yellow-brown from 0.3 m depth.		D	0.8		VOC = 0						
	1	Silty CLAY Cl: Medium plasticity, red-brown mottled grey-brown, with fine to coarse grained sand, trace fine to medium gravel, w<PL, very stiff, residual.											
	2.1	Pit discontinued at 2.1m depth, Limit of investigation.

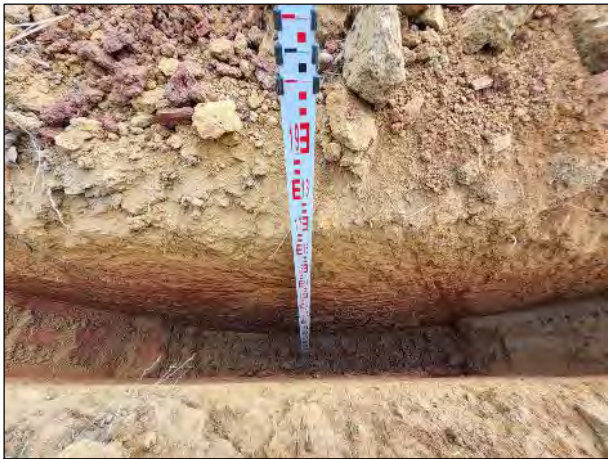
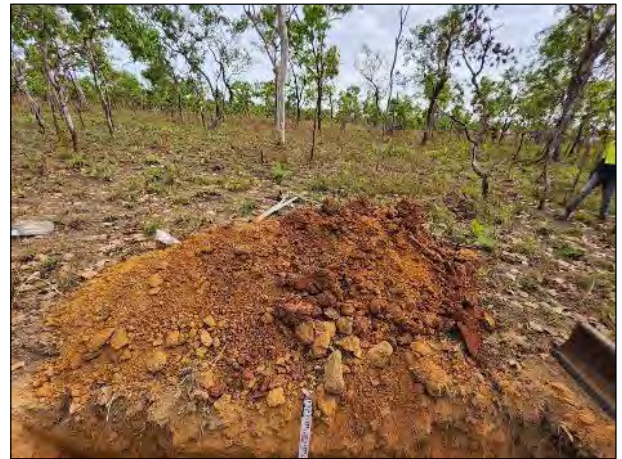
PIT No: 20
 PROJECT No: 209497.00
 DATE: 9/8/2023
 SHEET 1 OF 1

RL	Depth (m)	Description of Strata	Graphic Log	Sampling & In Situ Testing				Water	Dynamic Penetrometer Test (blows per 100mm)				
				Type	Depth	Sample	Results & Comments		5	10	15	20	
15.1	0.1	TOPSOIL - Sandy CLAY CL: Low plasticity, light-brown, fine to coarse grained sand, with roots, w<PL, very stiff.		D	0.2		VOC = 0						
	0.4	Clayey Sandy GRAVEL GC: Fine to coarse sub-angular to sub-rounded gravel, yellow-brown, medium plasticity clay, fine to coarse grained sand and roots to 0.2 m depth, moist, dense, colluvial.		D	0.3		VOC = 0						
		Silty CLAY Cl: Medium plasticity, red-brown mottled grey-brown, with fine to coarse grained sand, trace fine to medium gravel, w<PL, stiff to very stiff, residual. - very stiff from 0.9 m depth. - stiff from 1.3 m depth.		D	0.7		VOC = 0						
	1.8	Pit discontinued at 1.8m depth, excavator refusal.

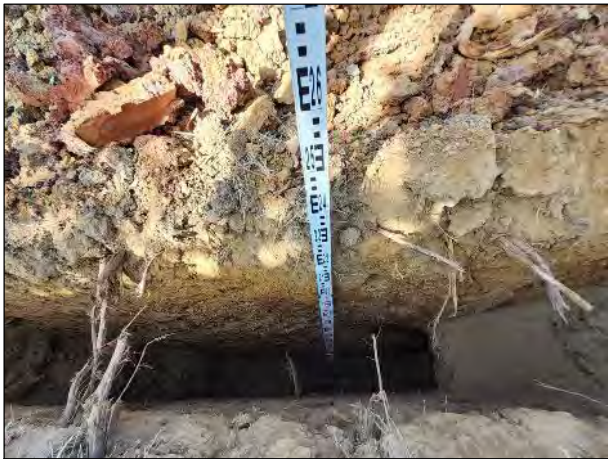
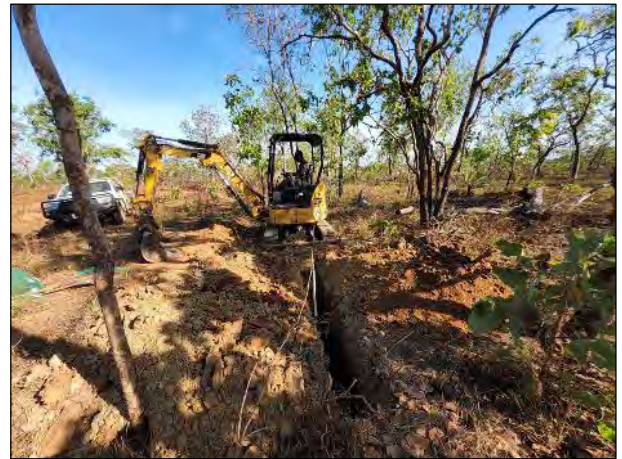
PIT No: 21
PROJECT No: 209497.00
DATE: 12/8/2023
SHEET 1 OF 1

RL	Depth (m)	Description of Strata	Graphic Log	Sampling & In Situ Testing				Water	Dynamic Penetrometer Test (blows per 100mm)
				Type	Depth	Sample	Results & Comments		
	0.2	TOPSOIL - Sandy CLAY CL: Low plasticity, light-brown, brown, fine to coarse grained sand, with fine to coarse gravel and roots, w<PL, hard.							
	0.4	Clayey Sandy GRAVEL GC: Fine to coarse sub-angular to angular gravel, yellow-brown, red-brown, medium plasticity clay, fine to coarse grained sand, with roots to 1.0 m depth, dry, dense, colluvial.		D	0.4		VOC = 0		
	1.2	Silty CLAY Ci: Medium plasticity, red-brown mottled grey-brown, with fine to coarse grained sand, trace fine to medium gravel, w<PL, very stiff to hard, residual.		D	1.3		VOC = 0		
	2.0	- grey-brown mottled orange-brown, yellow-brown at 1.8 m depth. - hard from 2.1 m depth.							
	2.4	Pit discontinued at 2.4m depth, excavator refusal.

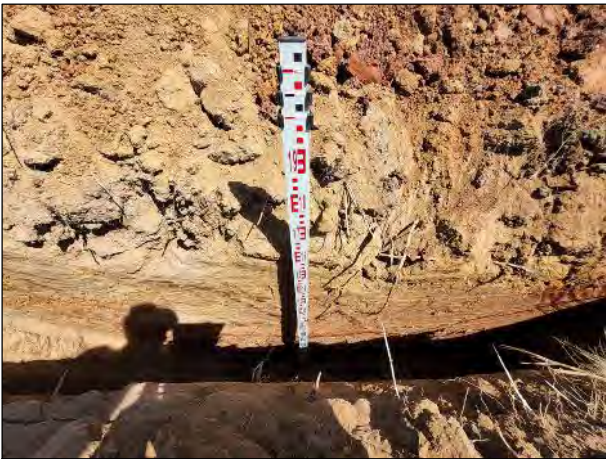
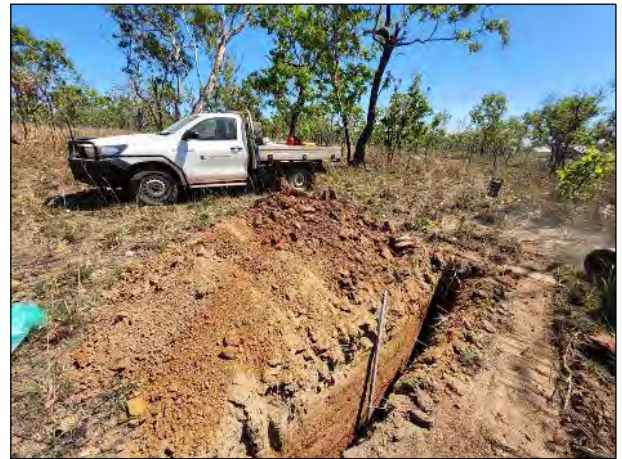
PIT No: 22
PROJECT No: 209497.00
DATE: 10/8/2023
SHEET 1 OF 1

RL	Depth (m)	Description of Strata	Graphic Log	Sampling & In Situ Testing				Water	Dynamic Penetrometer Test (blows per 100mm)				
				Type	Depth	Sample	Results & Comments		5	10	15	20	
14.1	0.1	TOPSOIL - Sandy CLAY CL: Low plasticity, light-brown, brown, fine to coarse grained sand, with fine to coarse gravel and roots, w<PL, very stiff.		D	0.4		VOC = 0						
0.7	Clayey Sandy GRAVEL GC: Fine to coarse sub-rounded to rounded gravel, red-brown mottled yellow-brown, medium plasticity clay, fine to coarse grained sand, dry, dense, colluvial.												
1.0	Silty CLAY Cl: Medium plasticity, red-brown mottled grey-brown, with fine to coarse grained sand, trace fine to medium gravel, w<PL, very stiff to hard, residual.												
1.9	Pit discontinued at 1.9m depth, excavator refusal.

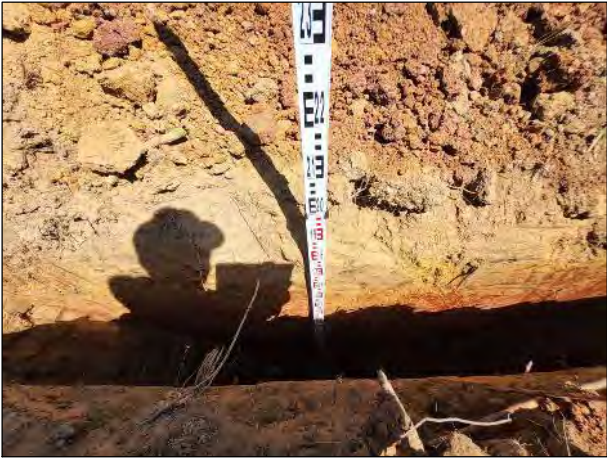
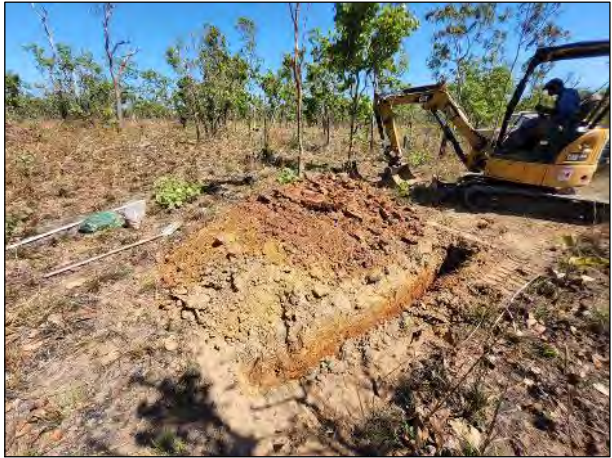
PIT No: 26
PROJECT No: 209497.00
DATE: 10/8/2023
SHEET 1 OF 1

RL	Depth (m)	Description of Strata	Graphic Log	Sampling & In Situ Testing				Water	Dynamic Penetrometer Test (blows per 100mm)					
				Type	Depth	Sample	Results & Comments		5	10	15	20		
14.1	0.1	TOPSOIL - Sandy CLAY CL: Low plasticity, light-brown, fine to coarse grained, with roots, w<PL, very stiff.	[Diagonal Hatching]	D	0.3		VOC = 0		1	[Penetration Test Graph]				
	0.9	Silty CLAYCI: Medium plasticity, red-brown mottled grey-brown, with fine to coarse grained sand, trace fine to medium gravel, w<PL, hard to very-stiff, residual. - red-brown mottled yellow-brown from 0.4 m depth. - hard from 0.5 m depth.												
	1.9	- very stiff from 1.4 m depth. - grey-brown mottled red-brown from 1.8 m depth. Pit discontinued at 1.9m depth, excavator refusal.

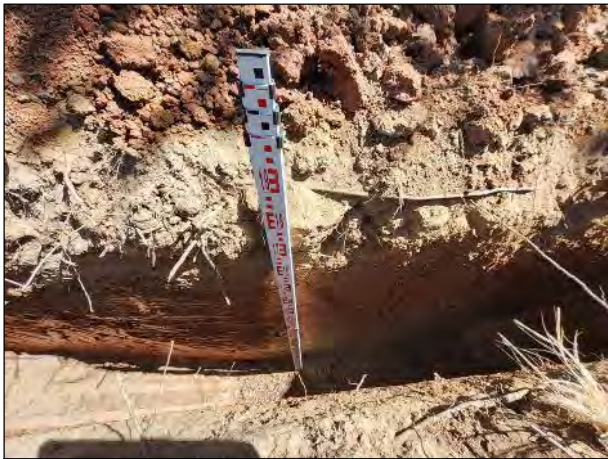
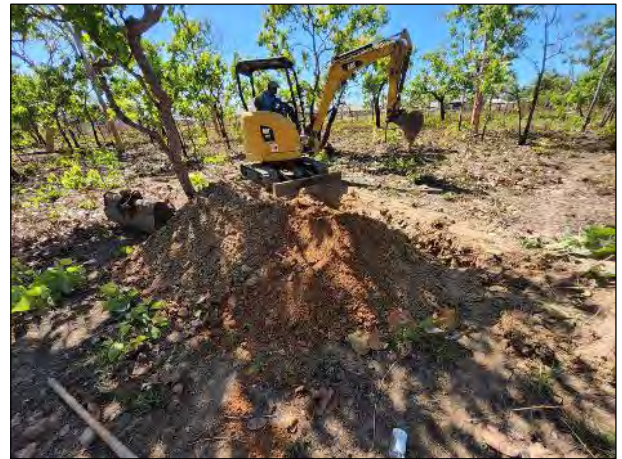
PIT No: 27
 PROJECT No: 209497.00
 DATE: 10/8/2023
 SHEET 1 OF 1

RL	Depth (m)	Description of Strata	Graphic Log	Sampling & In Situ Testing				Water	Dynamic Penetrometer Test (blows per 100mm)
				Type	Depth	Sample	Results & Comments		
14	0.2	TOPSOIL - Sandy CLAY CL: Low plasticity, light-brown, fine to coarse grained sand, with roots, w<PL, stiff.	[Symbol]	D	0.2		VOC = 0	[Graph]	
	0.3	Clayey GRAVEL GC: Fine to coarse sub-rounded to rounded gravel, red-brown mottled yellow-brown, low plasticity clay, with fine to coarse grained sand, moist, dense to very dense, colluvial. - very dense from 0.4 m depth.		E	0.3				
	0.5		B	0.5					
	0.8	Silty CLAY Ci: Medium plasticity, red-brown mottled grey-brown, with fine to coarse grained sand, trace fine to medium gravel, w<PL, estimated very stiff to hard, residual. - grey-brown mottled red-brown from 1.2 m depth.	[Symbol]	D	1.4				
1.6	1.6								
1.9	Pit discontinued at 1.9m depth, excavator refusal.

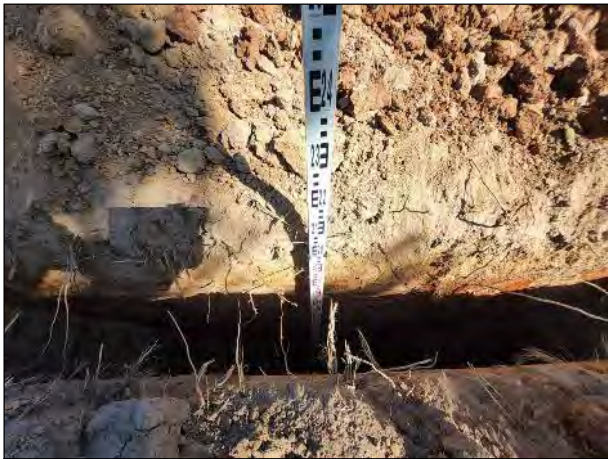
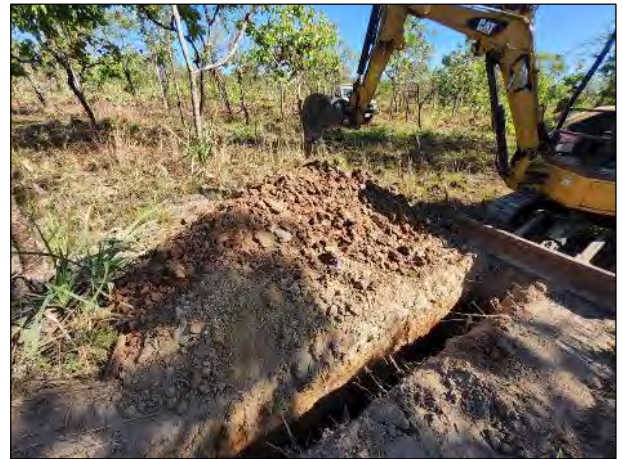
PIT No: 29
PROJECT No: 209497.00
DATE: 10/8/2023
SHEET 1 OF 1

RL	Depth (m)	Description of Strata	Graphic Log	Sampling & In Situ Testing				Water	Dynamic Penetrometer Test (blows per 100mm)					
				Type	Depth	Sample	Results & Comments		5	10	15	20		
	0.2	TOPSOIL - Sandy CLAY CL: Low plasticity, light-brown, fine to coarse grained sand, with roots, w<PL, very stiff.												
	0.5	Clayey Sandy GRAVEL GC: Fine to coarse sub-angular to sub-rounded gravel, yellow-brown, grey-brown, medium plasticity clay, fine to coarse grained sand, moist, medium dense to dense, colluvial. - dense from 0.4 m depth.		D	0.3		VOC = 0							
	1	Silty CLAY CI: Medium plasticity, red-brown mottled grey-brown, low plasticity silt, w<PL, very stiff, residual.												
	2.1	Pit discontinued at 2.1m depth, Limit of investigation.

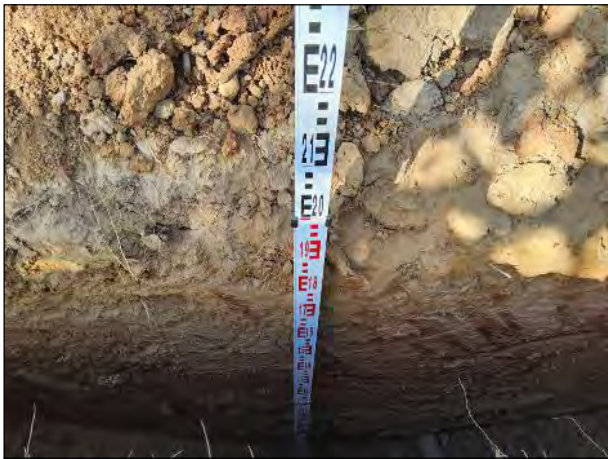
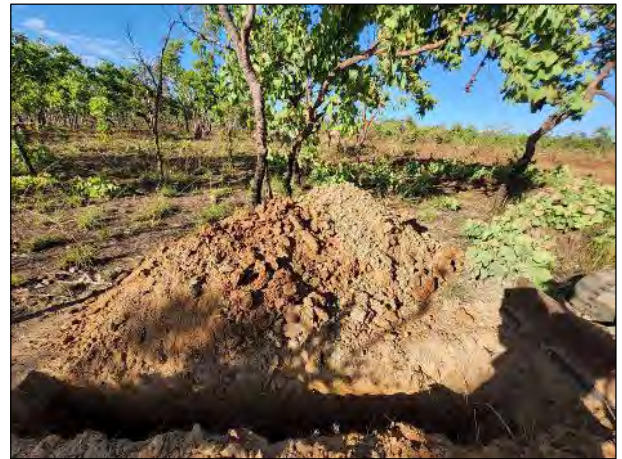
PIT No: 30
PROJECT No: 209497.00
DATE: 10/8/2023
SHEET 1 OF 1

RL	Depth (m)	Description of Strata	Graphic Log	Sampling & In Situ Testing				Water	Dynamic Penetrometer Test (blows per 100mm)
				Type	Depth	Sample	Results & Comments		
15	0.1	TOPSOIL - Sandy CLAY CL: Low plasticity, light-brown, fine to coarse grained sand, with roots, w<PL, hard.	[Pattern]	D	0.2		VOC = 0	[Graph]	
		Clayey Sandy GRAVEL GC: Fine to coarse sub-angular to sub-rounded gravel, yellow-brown, red-brown, medium plasticity clay, fine to coarse grained sand, moist, medium dense, colluvial.		U	0.5				
	0.7	Silty CLAY Cl: Medium plasticity, red-brown mottled grey-brown, with fine to coarse grained sand, trace fine to medium gravel, w<PL, very stiff, residual.	[Pattern]						
1									
1.8		- light-grey mottled red-brown from 1.8 m depth.	[Pattern]	D	1.8		VOC = 0		
2									
2.1		Pit discontinued at 2.1m depth, Limit of investigation.
