Report on
Contamination Assessment

T21-2072 Wurrumiyanga subdivision
Wurrumiyanga, Bathurst Island, NT

Prepared for
Department of Infrastructure Planning & Logistics (NT)

Project 209497.00
December 2023

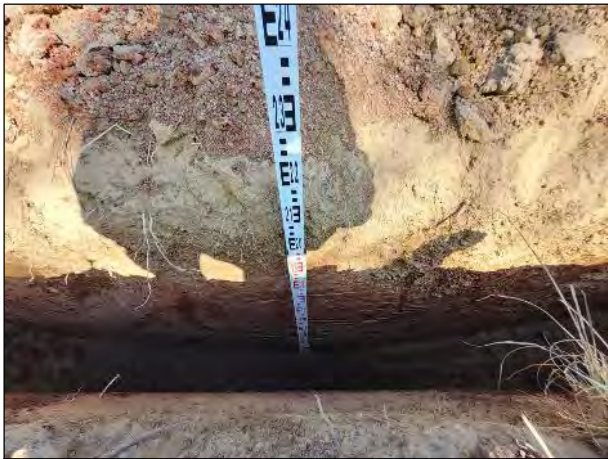
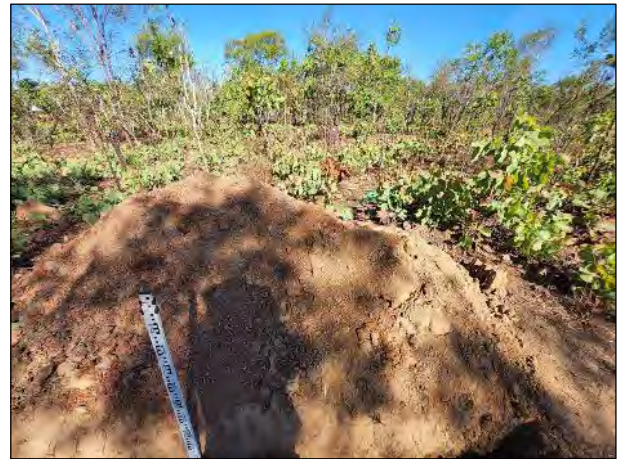
PIT No: 32
 PROJECT No: 209497.00
 DATE: 14/8/2023
 SHEET 1 OF 1

RL	Depth (m)	Description of Strata	Graphic Log	Sampling & In Situ Testing				Water	Dynamic Penetrometer Test (blows per 100mm)
				Type	Depth	Sample	Results & Comments		
15.0	0.1	TOPSOIL - Clayey Sandy GRAVEL GC: Fine to coarse sub-angular to sub-rounded gravel, light-brown, fine to coarse grained sand, low plasticity clay, dry, very dense, roots.		D	0.3		VOC = 0		
	0.7	Clayey Sandy GRAVEL GC: Fine to coarse sub-rounded to rounded gravel, brown, light-brown, medium plasticity clay, fine to coarse grained sand, dry, very dense, colluvial.							
	1.0	Silty CLAY Ci: Medium plasticity, red-brown mottled grey-brown, with fine to coarse grained sand, trace fine to medium gravel, w<PL, hard, residual.		U	1.4				
	2.1	Pit discontinued at 2.1m depth, Limit of investigation.

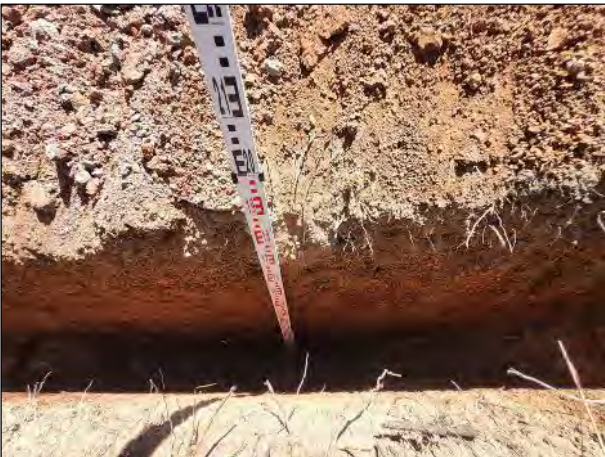
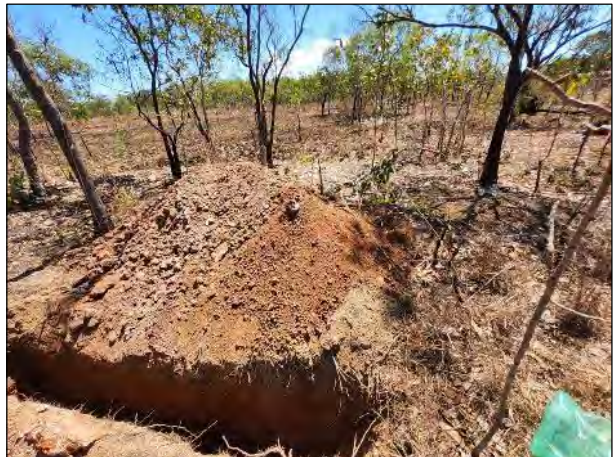
PIT No: 34
PROJECT No: 209497.00
DATE: 10/8/2023
SHEET 1 OF 1

RL	Depth (m)	Description of Strata	Graphic Log	Sampling & In Situ Testing				Water	Dynamic Penetrometer Test (blows per 100mm)				
				Type	Depth	Sample	Results & Comments		5	10	15	20	
	0.2	TOPSOIL - Clayey Sandy GRAVEL GC: Fine to coarse sub-rounded to rounded gravel, light-brown, grey-brown, fine to coarse grained sand, low plasticity clay and roots, dry, very dense.		D	0.1		VOC = 0						
	0.3			D	0.3		VOC = 0						
	0.5	Clayey Sandy GRAVEL GC: Fine to coarse sub-rounded to rounded gravel, red-brown mottled yellow-brown, medium plasticity clay, fine to coarse grained sand, dry, very dense, colluvial.											
	1	Silty CLAY CI: Medium plasticity, grey-brown mottled red-brown, with fine to coarse grained sand, trace fine to medium gravel, w<PL, estimated very stiff to hard, residual.											
	1.9	Pit discontinued at 1.9m depth, excavator refusal.

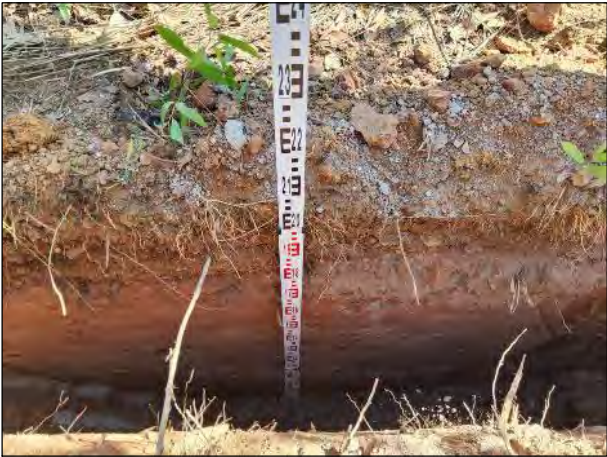
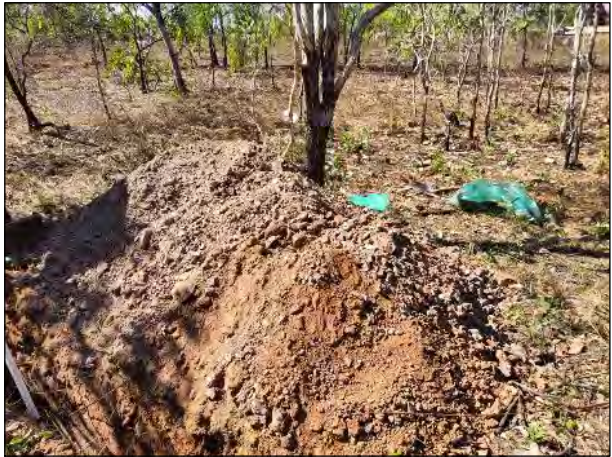
PIT No: 35
PROJECT No: 209497.00
DATE: 14/8/2023
SHEET 1 OF 1

RL	Depth (m)	Description of Strata	Graphic Log	Sampling & In Situ Testing				Water	Dynamic Penetrometer Test (blows per 100mm)
				Type	Depth	Sample	Results & Comments		
	0.2	TOPSOIL - Clayey Sandy Gravel GC: Fine to coarse sub-rounded to rounded gravel, light-brown, fine to coarse grained sand, dry, dense, colluvial, with roots.		D	0.2		VOC = 0		
	0.5	Sandy Clayey GRAVEL GC: Fine to coarse sub-rounded to rounded gravel, red-brown, fine to coarse grained sand, medium plasticity clay, dry, medium dense, colluvial.		D	0.5		VOC = 0		
	1.0	Silty CLAY CI: Medium plasticity, red-brown mottled light-grey, with fine to coarse grained sand, trace fine to medium gravel, w<PL, very stiff to hard, residual. - hard from 0.6 m depth. - light-grey, red-brown from 1.1m depth							
	2.1	Pit discontinued at 2.1m depth, excavator refusal.

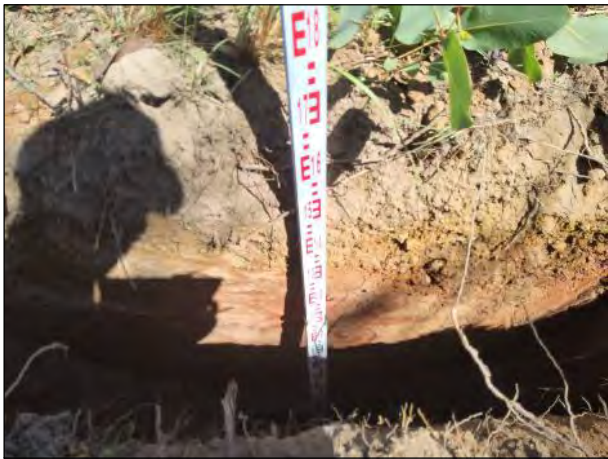
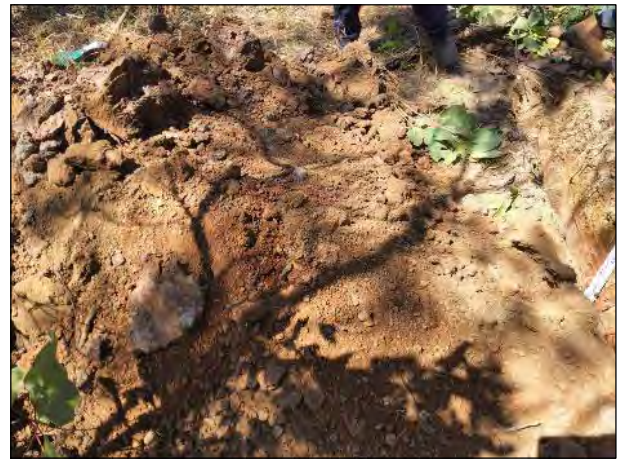
PIT No: 40
PROJECT No: 209497.00
DATE: 11/8/2023
SHEET 1 OF 1

RL	Depth (m)	Description of Strata	Graphic Log	Sampling & In Situ Testing				Water	Dynamic Penetrometer Test (blows per 100mm)				
				Type	Depth	Sample	Results & Comments		5	10	15	20	
15.3	0.15	TOPSOIL - Clayey Sandy GRAVEL GC: Fine to coarse sub-rounded to rounded gravel, light-brown, fine to coarse grained sand, low plasticity clay and roots, dry, dense.		DMD	0.2		VOC = 0						
	0.6	Clayey Sandy GRAVEL GC: Fine to coarse sub-angular to sub-rounded gravel, yellow-brown, red-brown, medium plasticity clay, fine to coarse grained sand, with roots to 0.3 m depth, moist, dense, colluvial.											
	1.0	Silty CLAY Cl: Medium plasticity, red-brown mottled grey-brown, with fine to coarse grained sand, trace fine to medium gravel, w<PL, very stiff, residual.											
	1.7	Pit discontinued at 1.7m depth, excavator refusal.

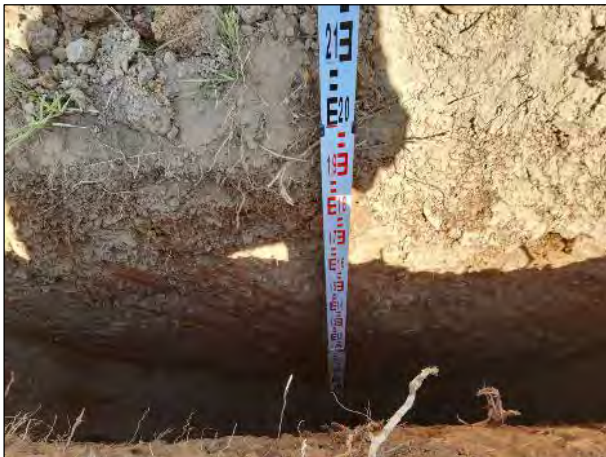
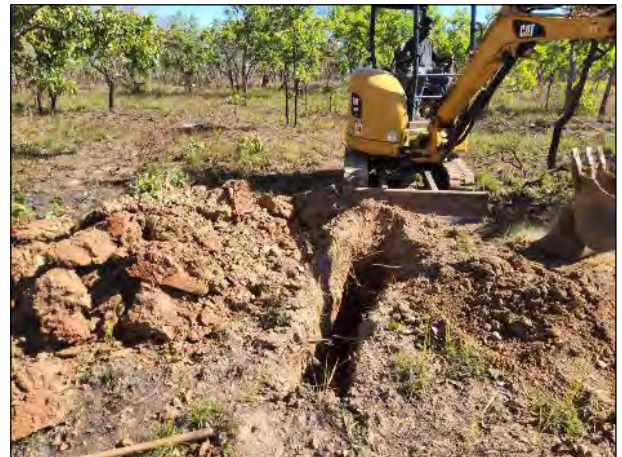
0.4	Clayey Sandy GRAVEL GC: Fine to coarse sub-angular to sub-rounded gravel, grey-brown, yellow-brown, fine to coarse grained sand, medium plasticity clay, with cobbles to 100 mm in size and roots to 0.3 m, dry, medium dense, colluvial.		D	0.5		VOC = 0

0.9	Silty CLAY Ci: Medium plasticity, red-brown mottled light-grey, with fine to coarse grained sand and fine to medium gravel, w<PL, very stiff, residual.											
1	1.7	Silty CLAY Ci: Medium plasticity, red-brown mottled grey-brown, with fine to coarse grained sand, trace fine to medium gravel, w<PL, stiff, residual.											
15	2.1	Pit discontinued at 2.1m depth, excavator refusal.

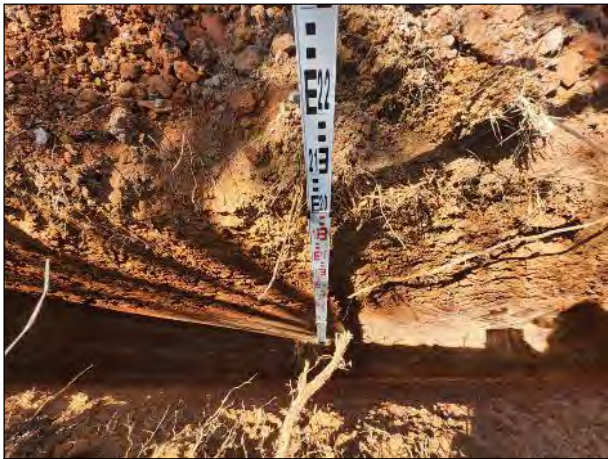
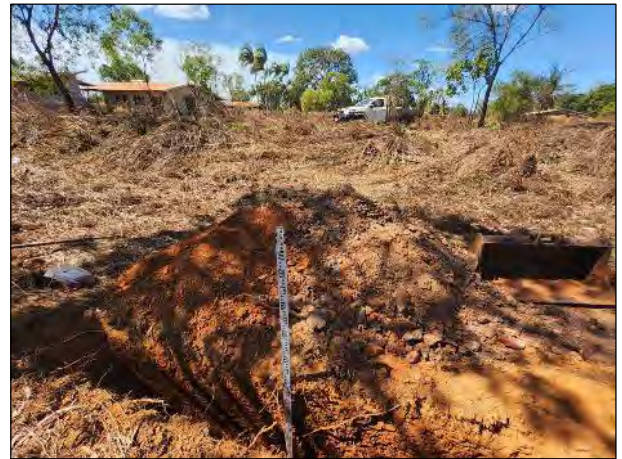
1.2		Silty CLAY Cl: Medium plasticity, grey-brown mottled red-brown, with fine to coarse grained sand, trace fine to medium gravel, w<PL, estimated very hard, residual.	[Graphic Log: Silty CLAY Cl]	D	1.3		VOC = 0						
				D	1.4

2.1		Pit discontinued at 2.1m depth, excavator refusal.

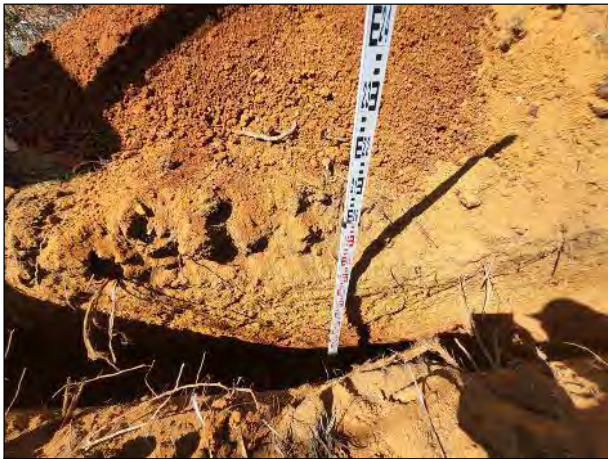
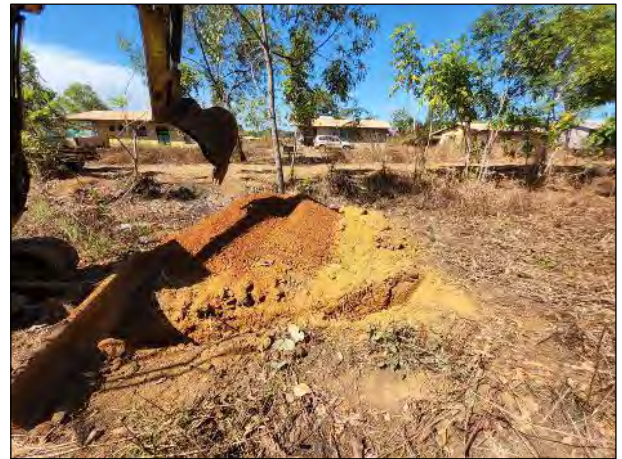
PIT No: 43
PROJECT No: 209497.00
DATE: 14/8/2023
SHEET 1 OF 1

RL	Depth (m)	Description of Strata	Graphic Log	Sampling & In Situ Testing				Water	Dynamic Penetrometer Test (blows per 100mm)
				Type	Depth	Sample	Results & Comments		
12	0.1	TOPSOIL - Clayey Sandy GRAVEL GC: Fine to coarse sub-angular to sub-rounded gravel, light-brown, fine to coarse grained sand, low plasticity clay, with roots, dry, dense.	[Graphic Log: Clayey Sandy Gravel]	D	0.3		VOC = 0	[Dynamic Penetrometer Test Graph]	
		Clayey Sandy GRAVEL GC: Fine to coarse sub-rounded to rounded gravel, yellow-brown, fine to coarse grained sand, medium plasticity clay, dry, dense to very dense, colluvial. - very dense from 0.8 m depth.							
12	1.1	Sandy Clayey GRAVEL GC: Fine to coarse sub-angular to sub-rounded gravel, red-brown, fine to coarse grained, medium plasticity clay, dry, very dense, residual.	[Graphic Log: Sandy Clayey Gravel]	D	1.3		VOC = 0		
2	2.0	Pit discontinued at 2.0m depth, excavator refusal.
