## s14 Incident Notification

| <b>Incident</b> | Hydraulic oil spill |
| <b>(a) the incident causing or threatening to cause pollution</b> | Approximately 310 litres of hydraulic oil was spilt from an excavator during transport. |

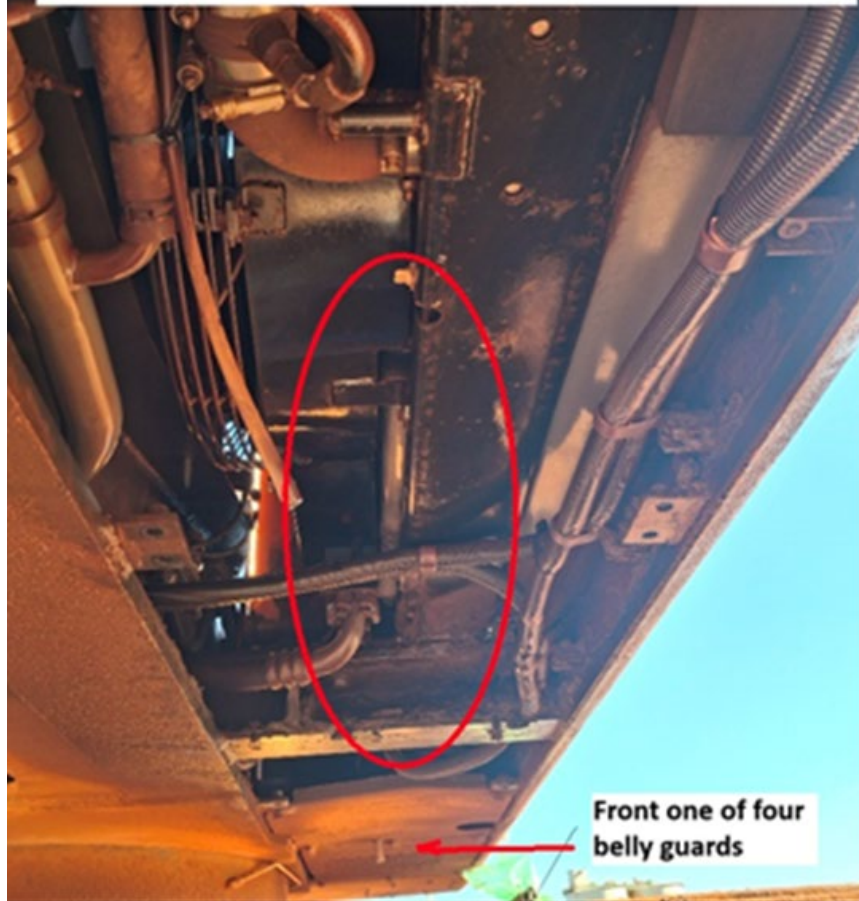
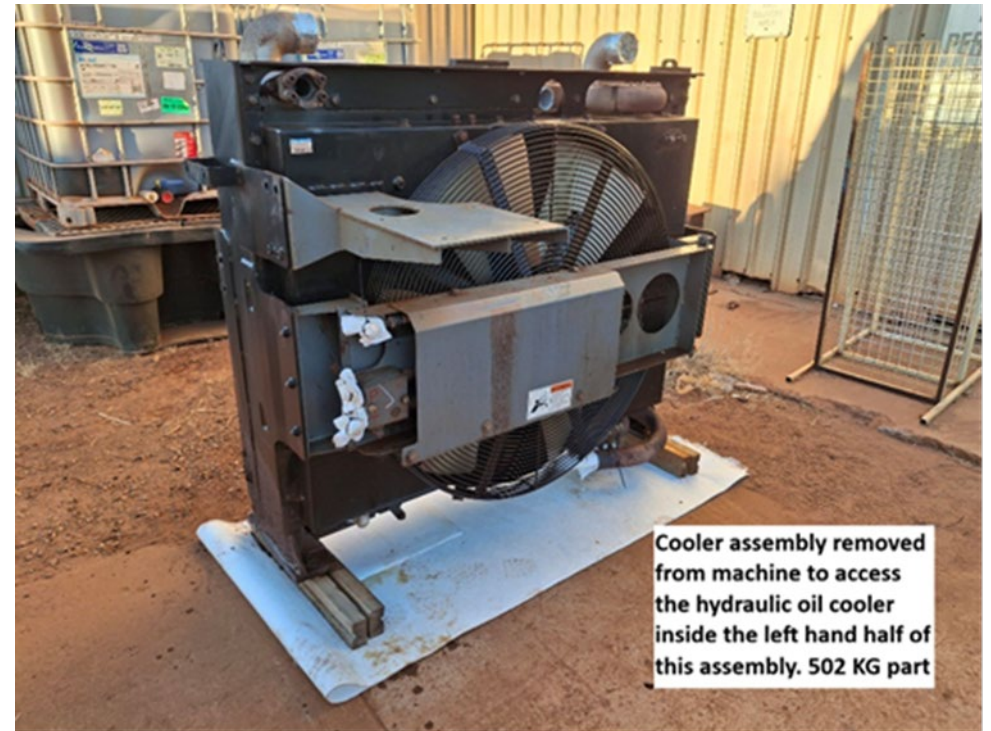
View from below the machine with three rear belly guards removed. Front guard is still in place for reference.  
Circled in red is the bottom of the cooler assembly where the oil will run down to.  
Black panel is the outside frame of the cooler assembly. Hydraulic oil cooler is inside this frame behind shrouds.

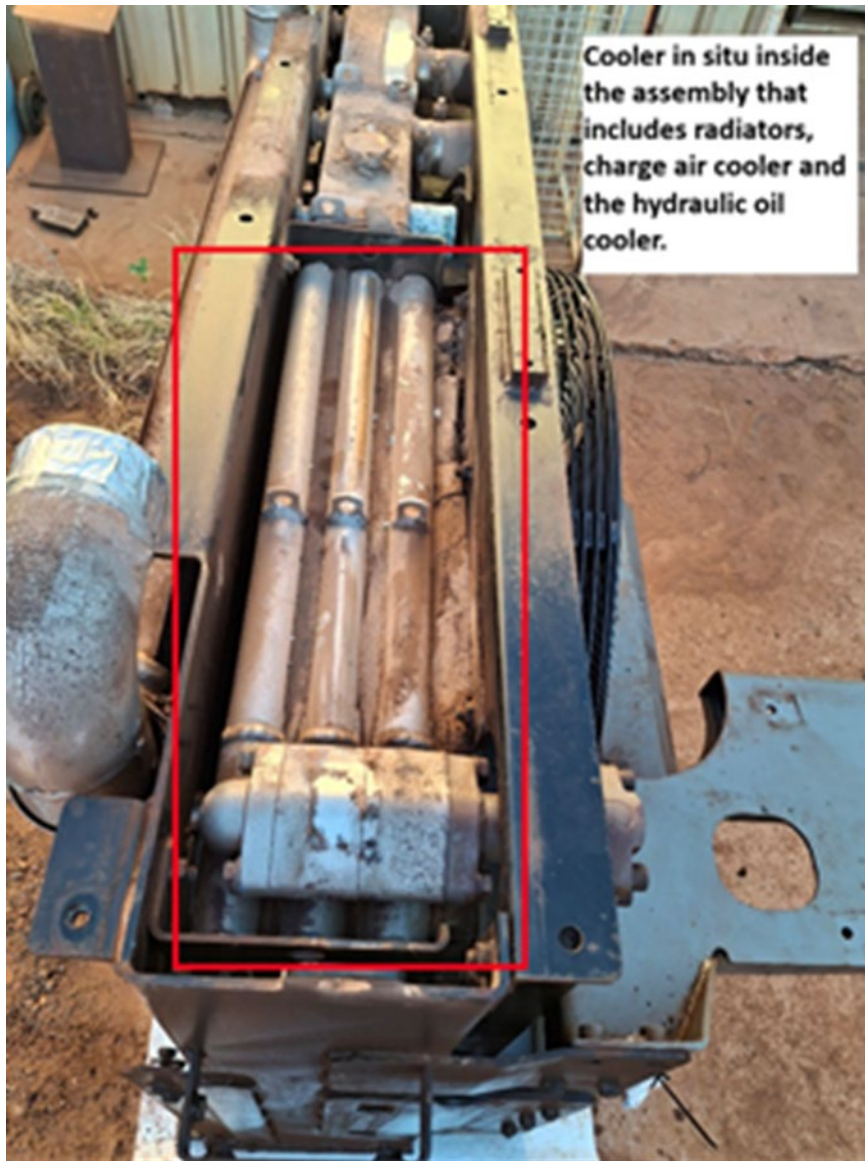
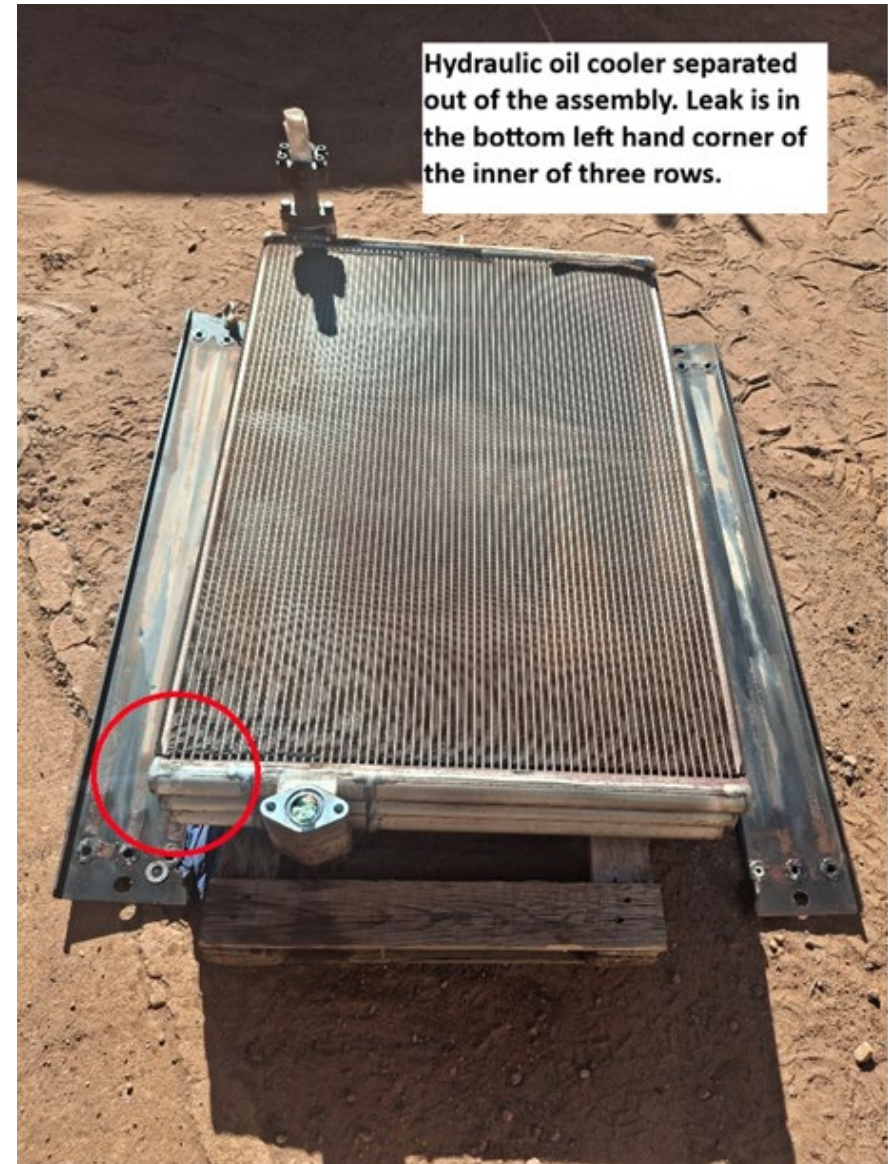
Hole after brushing  
debris away is  
3 x 1.5 mm
