SECTION 14 INCIDENT REPORT (*Waste Management and Pollution Control Act*)

Date and Time of Notification:	Friday 14 July 2023, 10:00hrs
Person / Company:	Power and Water Corporation
Incident:	Discharge of raw sewage (no gross pollutants) from sewerage network – manhole (lot 460 Ngukurr community)

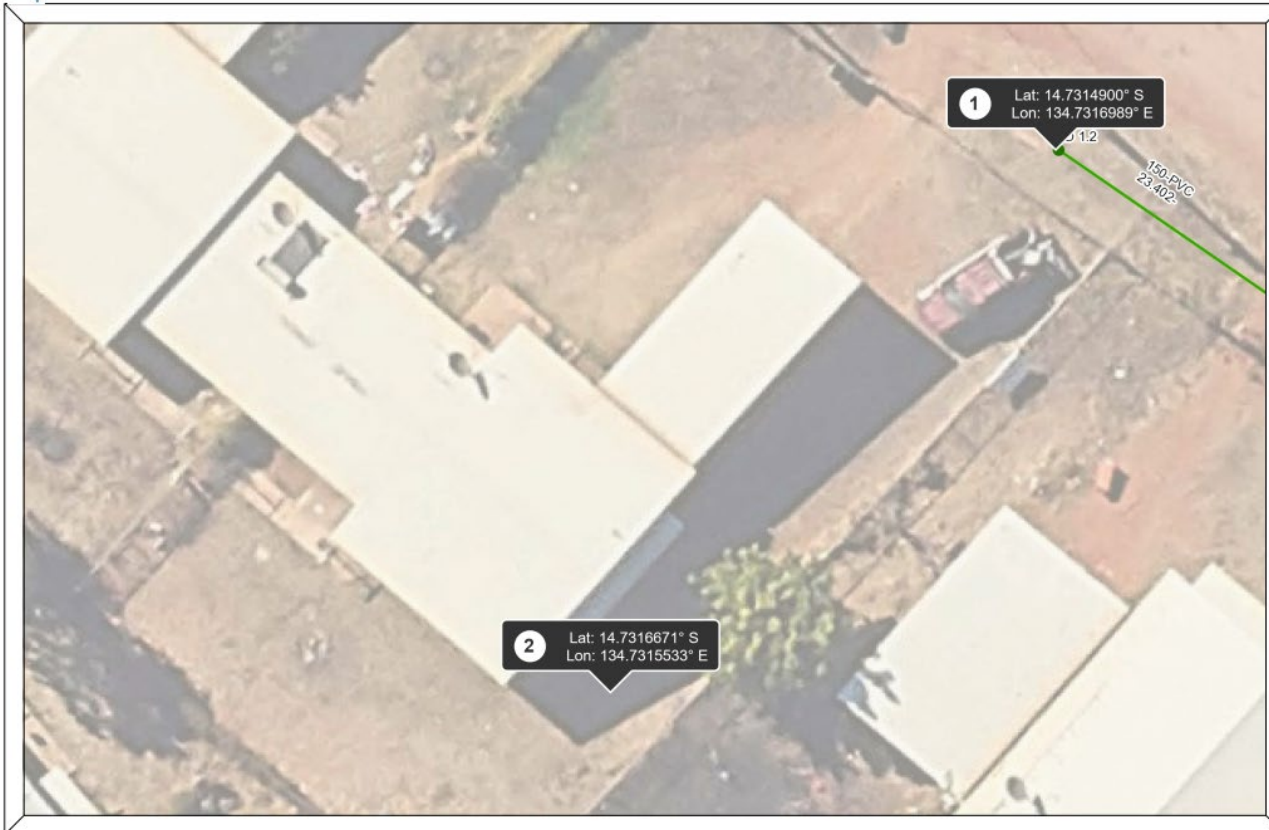
Discharge from access chamber at Lot 460, Ngukurr community and contained within fenced property

<p>(d) how the pollution has occurred, is occurring or may occur</p>	<p>As per (c) iii & (c) iv.</p>
<p>(e) the attempts made to prevent, reduce, control, rectify or clean up the pollution or resultant environmental harm caused or threatening to be caused by the incident</p>	<p>Contained spill was cleaned as per Power and Water procedure.</p> <p><i>i. Confirmation signage and fencing has been erected, as appropriate.</i></p> <p>No signage or fencing was erected as spill was contained in a fenced yard (lot 460 Ngukurr community). Contaminated area was not accessible to the public.</p> <p><i>ii. Decontamination of the site as appropriate.</i></p> <p>Clean up consistent with Power and Water's Sewage Spills/Overflow Response Work Instruction as appropriate to the location. Site was inspected for any gross pollutants, of which none were observed, and the area was cleaned and disinfected with biodegradable detergent.</p>
