SECTION 14 INCIDENT REPORT (*Waste Management and Pollution Control Act*)

Date and Time of Notification:	Friday 1 st November 2019, 14:31pm
Person / Company:	Power and Water Corporation (PWC)
Incident:	Discharge of raw sewage from sewerage network (Manhole)

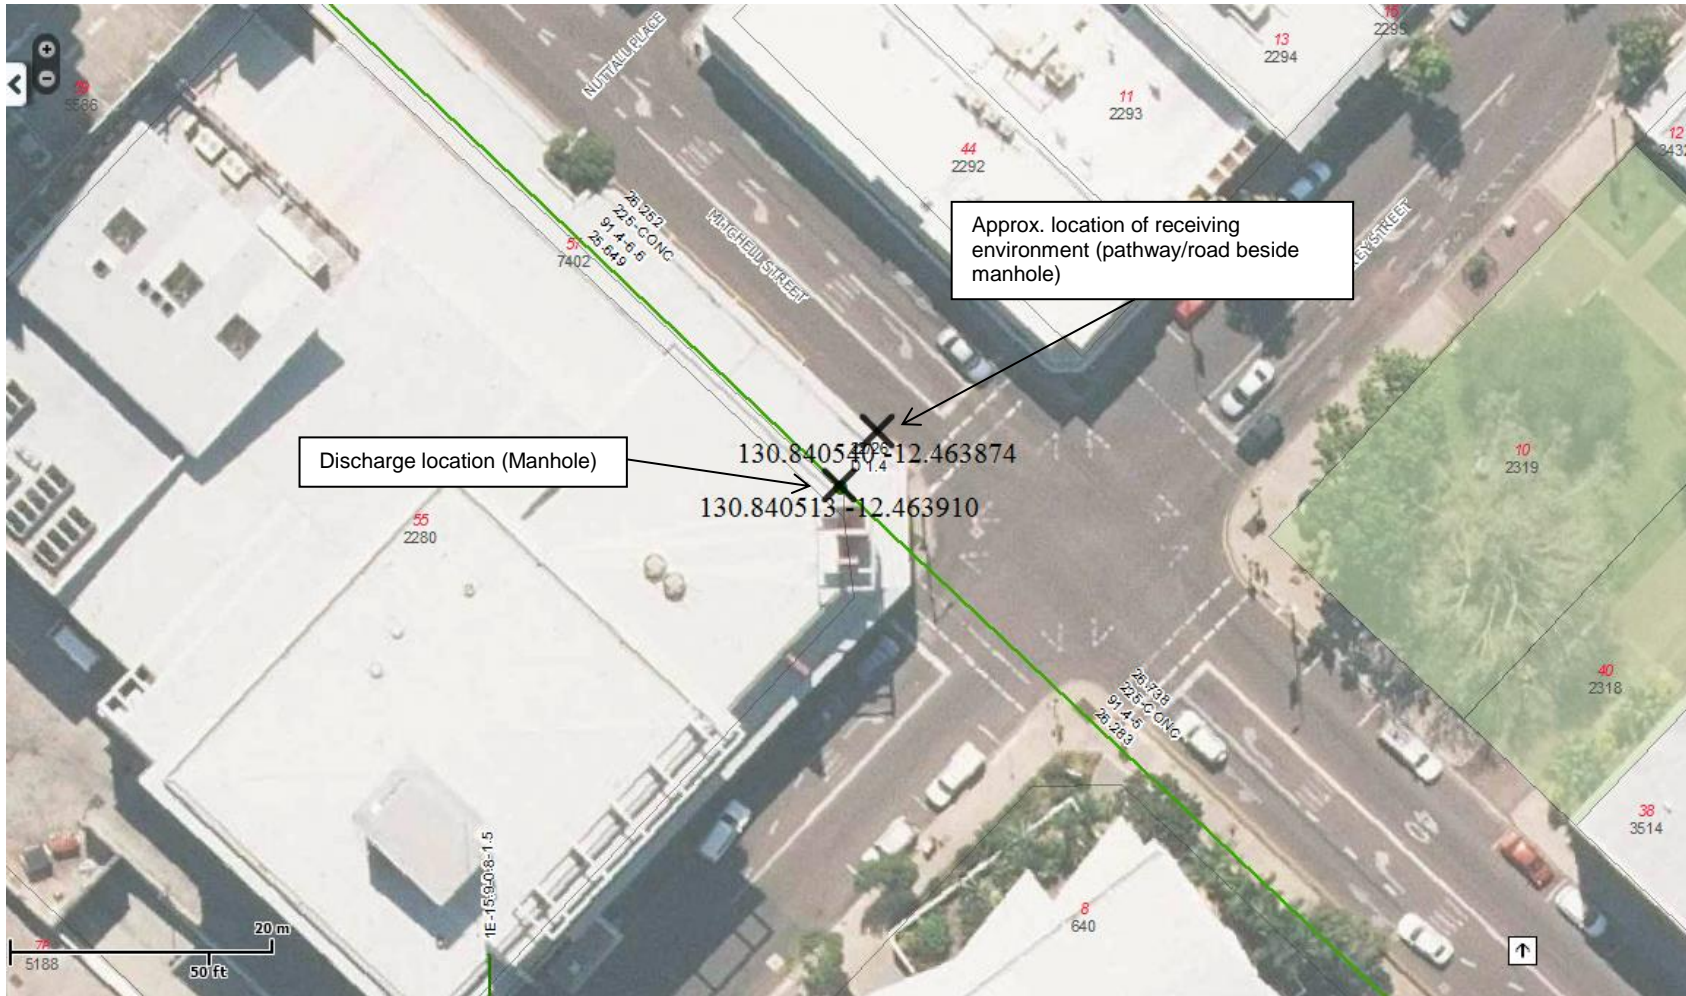
<p style="text-align: center;"><small>(ADWF= Average Dry Weather Flow ~14.5 ML/day)</small></p> <p><i>iii. Volume of the waste that was discharged.</i></p> <p>The volume of waste discharged is unknown. No telemetric monitoring occurs at manholes.</p> <p>This overflow was reported to the PWC Call Centre, which was then reported to on-call staff who attended the site immediately. The exact start time of the overflow is unknown, and there is no metered data available for manholes to determine a volume of the overflow.</p> <p>Discharge of raw sewage to the pathway beside the manhole was associated with a tree root blocking the sewer main, resulting in the overflow.</p>	Inflow volume	median inflow kL	median E coli	90th percentile inflow kL	90th percentile E coli	below ADWF	11,040	11,199,000	12,925	15,531,000	>ADWF (14.5 ML/day)	15,274	9,804,000	22,206	17,148,300	>2x ADWF (29.0 ML/day)	31,673	4,884,000	37,166	14,385,600	>3x ADWF (43.5 ML/day)	43,629	4,611,000	50,506	12,843,600	>5x ADWF (72.5 ML/day)	71,558	5,002,000	78,578	5,905,200
Inflow volume	median inflow kL	median E coli	90th percentile inflow kL	90th percentile E coli																											
below ADWF	11,040	11,199,000	12,925	15,531,000																											
>ADWF (14.5 ML/day)	15,274	9,804,000	22,206	17,148,300																											
>2x ADWF (29.0 ML/day)	31,673	4,884,000	37,166	14,385,600																											
>3x ADWF (43.5 ML/day)	43,629	4,611,000	50,506	12,843,600																											
>5x ADWF (72.5 ML/day)	71,558	5,002,000	78,578	5,905,200																											
<p>(b) the place where the incident occurred</p>	<p>Corner of Mitchell Street and Knuckey Street, Darwin City – Manhole</p> <p><i>i. Description of the PWC asset from which the discharge occurred.</i></p> <p>Manhole located at the corner of Mitchell Street and Knuckey Street, Darwin City – as per map below. Near Flight Centre.</p>

(c) the date and time of the incident	<p><i>i. The time and date of commencement and cessation of the discharge.</i></p> <p>The commencement time of the overflow is unknown. The overflow was observed at approximately 11:20am on 1/11/19 and was stopped at approximately 12:30pm (1/11/19).</p> <p><i>ii. How PWC were notified, or became aware of the discharge.</i></p> <p>This overflow was discovered by a member of the public and was reported to the PWC call centre, who then relayed the information to the on-call PWC operations staff. PWC personnel attended the site at approximately 11:20am (1/11/19) and undertook action to resolve the situation. From this PWC staff resolved the overflow and cleaned the area.</p> <p><i>iii. The process by which the discharge occurred.</i></p> <p>Tree roots were discovered to be growing within the sewer main causing a blockage and overflow. The roots have since been removed.</p> <p><i>iv. The reason why the discharge occurred.</i></p> <p>As per (c) iii. Sewerage network infrastructure has been designed to overflow with the best public health and environmental outcomes possible. Design focuses on not overflowing directly inside houses/businesses; rather discharge is designed to occur in a controlled manner at locations which can be accessed for infrastructure repair and clean up and with minimal public health or environmental impacts.</p>

(d) how the pollution has occurred, is occurring or may occur	As per (c) iii & (c) iv.
(e) the attempts made to	The blockage was cleared and the overflow was stopped. Clean up

<p>prevent, reduce, control, rectify or clean up the pollution or resultant environmental harm caused or threatening to be caused by the incident</p>	<p>undertaken as per Sewage Spills/Overflow Response Work Instruction.</p> <p><i>i. Confirmation signage and fencing has been erected, as appropriate.</i></p> <p>Upon PWC crew attending the overflow the site was cordoned off with wickets hats which were supervised by PWC staff to prevent access by the public. Upon resolution of the blockage the area was cleaned comprehensively to ensure the area was safe for the public to access immediately. Due to the location temporary fencing was not appropriate. Therefore cleaning undertaken was performed to ensure access by the public immediately after resolution of the blockage was safe.</p> <p><i>ii. Decontamination of the site as appropriate.</i></p> <p>Clean up consistent with Sewage Spills/Overflow Response Work Instruction as appropriate to the location, and to minimise risk to the environment. Vacuum truck was used to remove the wastewater from the manhole, followed by cleaning of the surrounding surface.</p>
