**SECTION 14 INCIDENT REPORT (*Waste Management and Pollution Control Act*)**

<b>Date and Time of Notification:</b>	Friday 15 <sup>th</sup> January 2021, 10:50hrs V2.0 17/01/21 V3.0 20/01/21
<b>Person / Company:</b>	Power and Water Corporation ( <b>PWC</b> )
<b>Incident:</b>	Discharge of highly diluted sewage from sewerage network due to wet weather

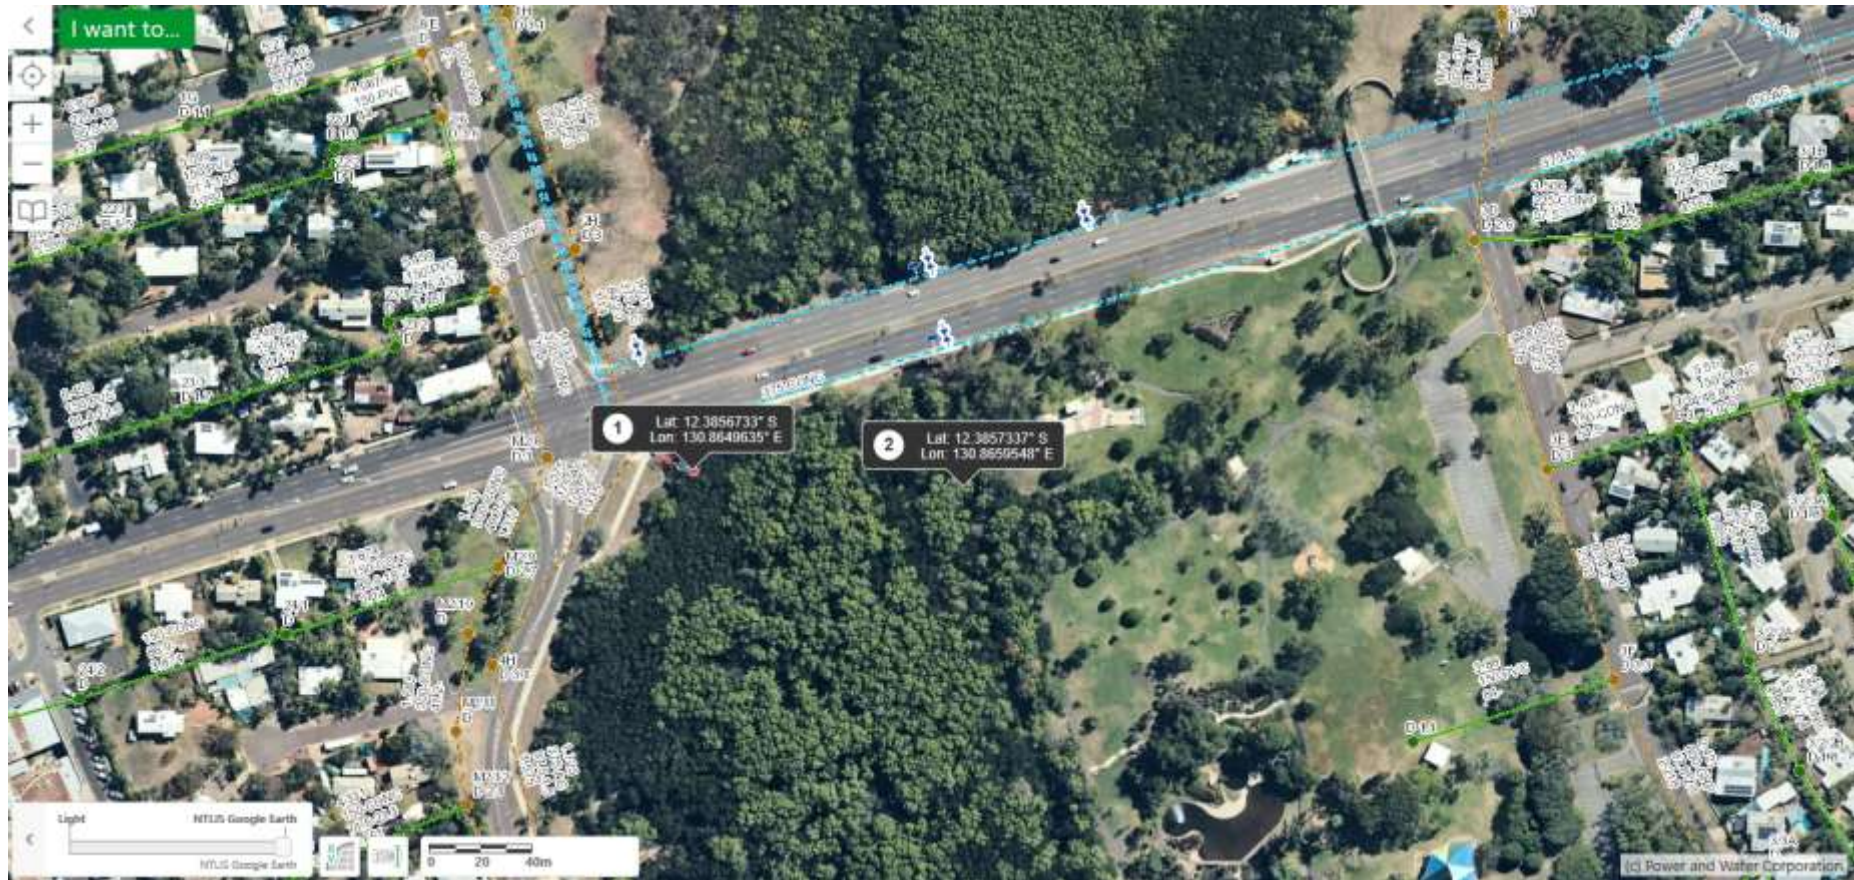
Corner of Trower Road and Rapid Creek Road, Rapid Creek - Sewer overflow relief point

1. Discharge Point: 12.3856733 S, 130.8649635 E
2. Final Point: 12.3857337 S, 130.8659548 E

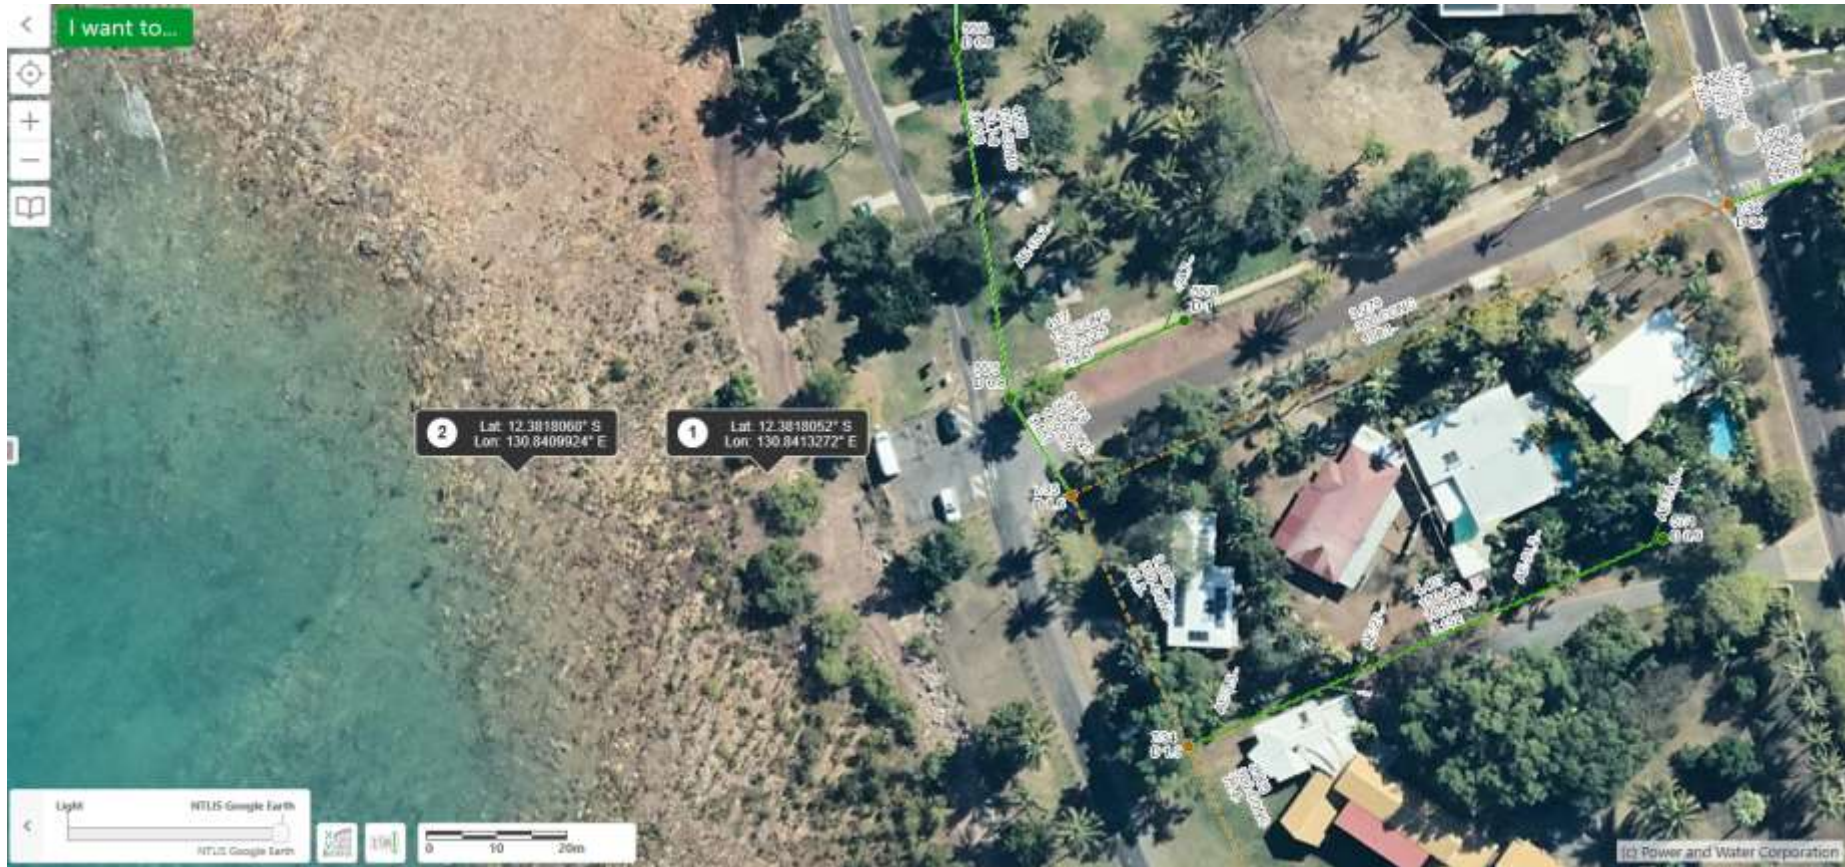
194 Casuarina Drive, Nightcliff (Aralia St, Jetty End)

1. Discharge Point: 12.3818052 S, 130.8413272 E
2. Final Point: 12.3818060 S, 130.8409924 E

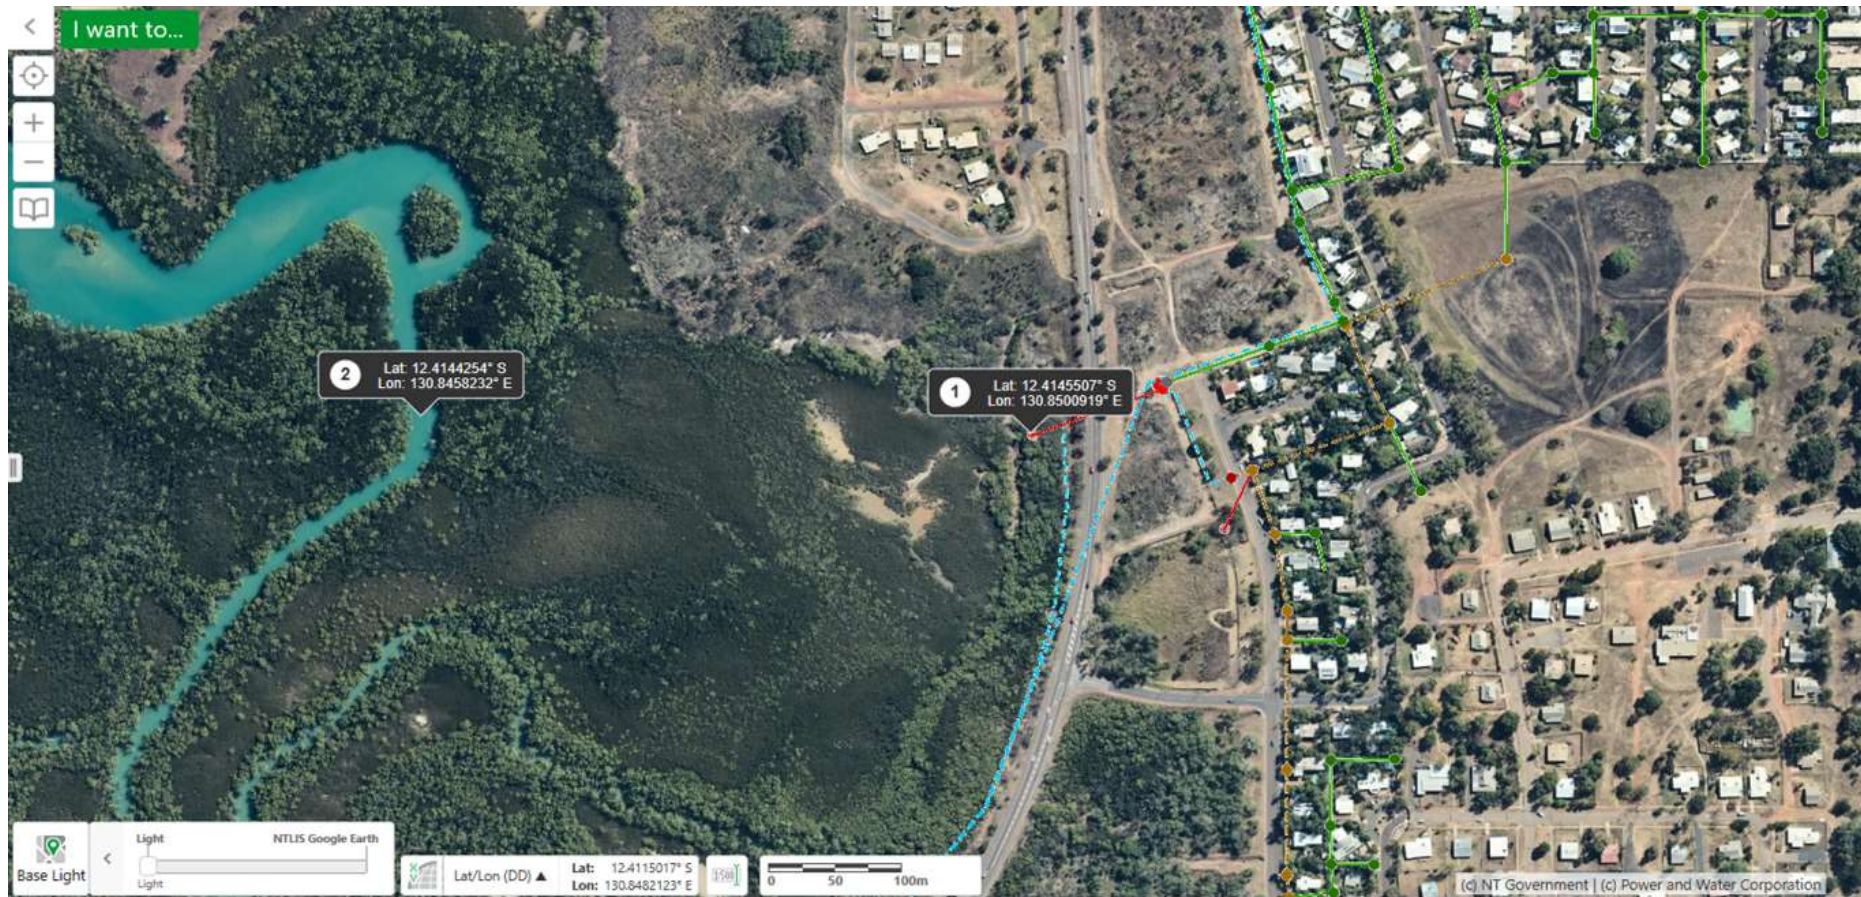
Ludmilla – SPS

1. Discharge Point: 12.4145507 S, 130.8500919 E
2. Final Point: 12.4144254 S, 130.8458232 E

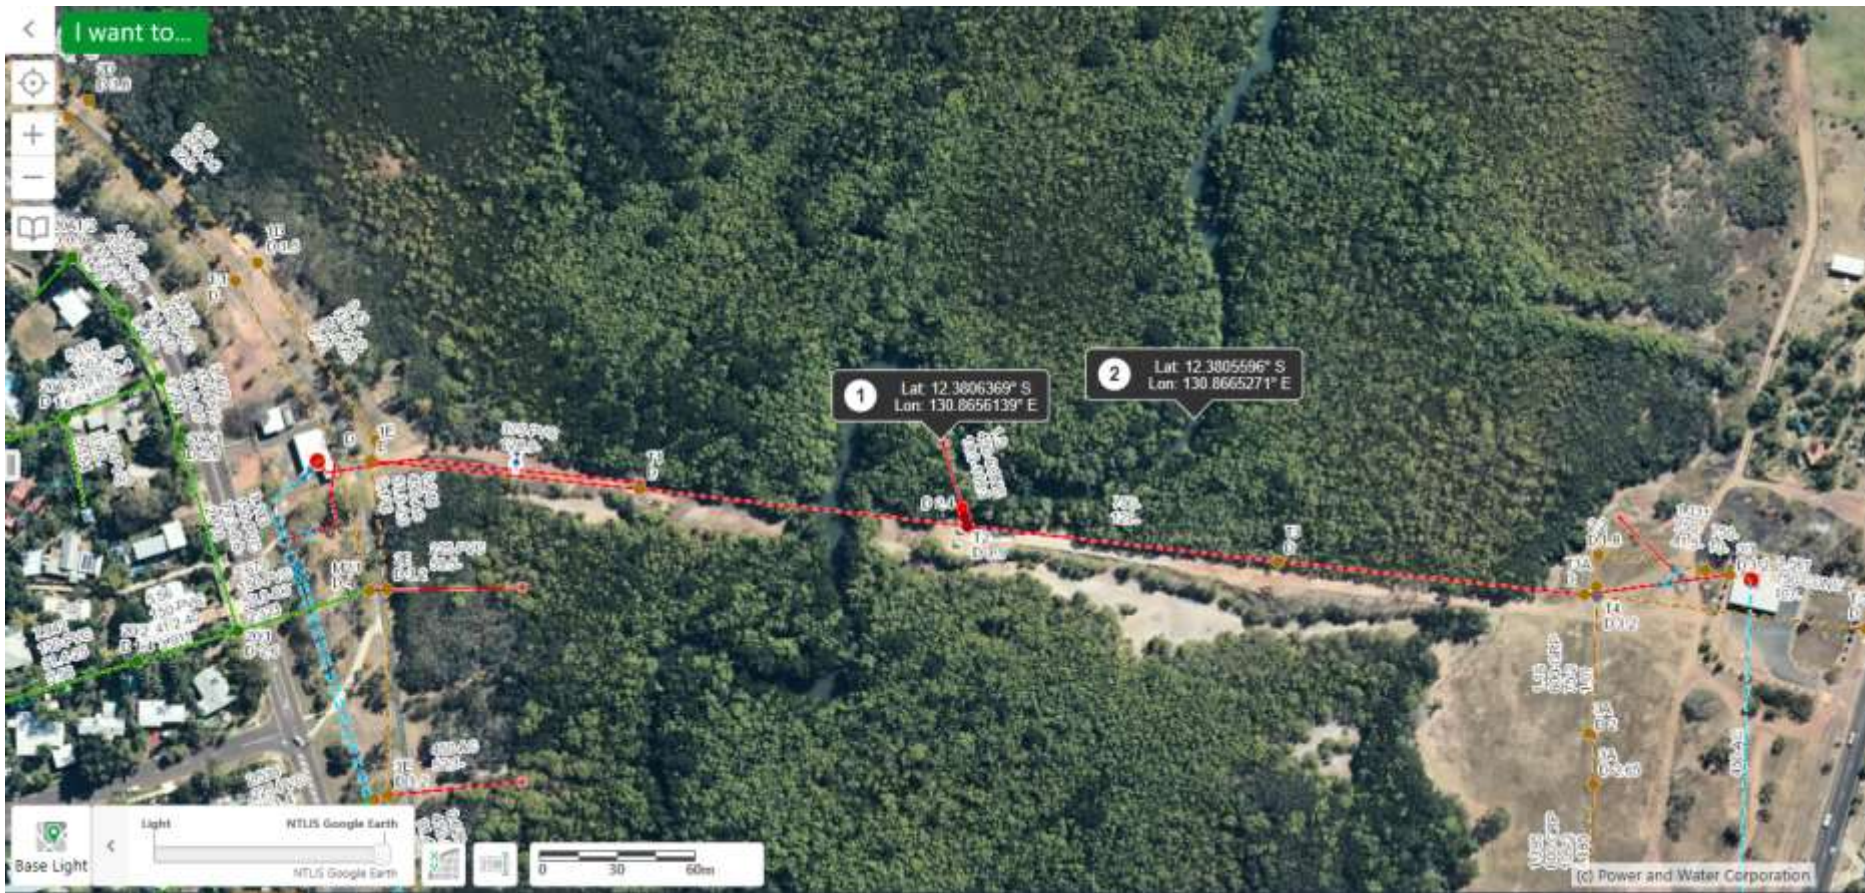
Lakeside Drive and Rapid Creek Road – SPS

1. Discharge Point: 12.3806369 S, 130.8656139 E
2. Final Point: 12.3805596 S, 130.8665271 E
