## INDEPENDENT MONITOR'S AUDIT OF THE MCARTHUR RIVER MINE FOR THE 2010 OPERATIONAL PERIOD

**ENVIRONMENTAL EARTH SCIENCES VIC**  
REPORT TO THE MINISTER FOR PRIMARY INDUSTRY FISHERIES AND  
RESOURCES  
OCTOBER 2011  
VERSION 1

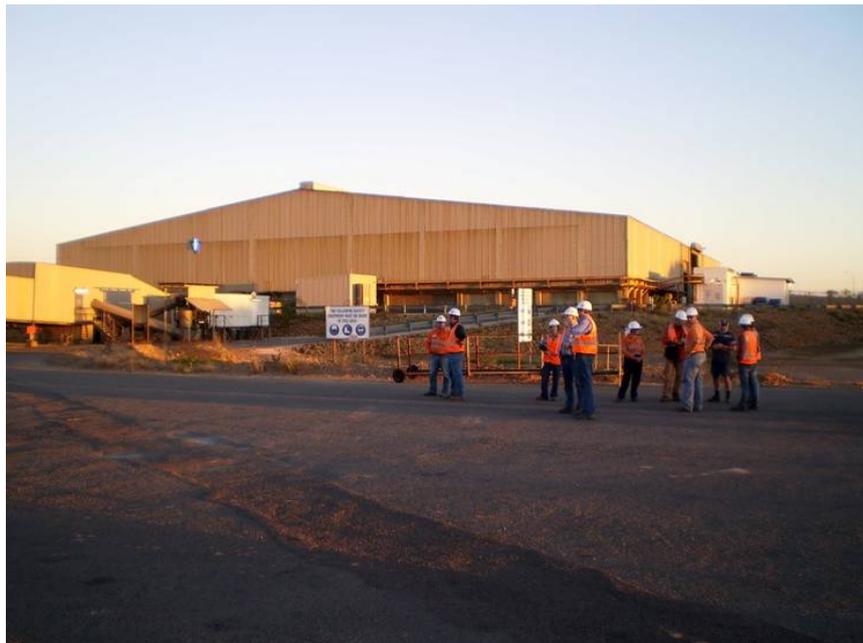
**Plate 12** Independent Monitor team outside of concentrate storage shed at Bing Bong Port facility.

- due to lack of training of the operator, the dust suppression system on the working drill rig was not functioning (see Plate 11);
- fine dusts are present below the ejection chute of the mobile crushing plant and within the stockpiles of processed stone;
- concentrates of varying degree of moisture are stored in the shed (Plate 12). As concentrate dries out it increases the risk of fugitive dust emissions from the shed;
