SECTION 14 INCIDENT REPORT (*Waste Management and Pollution Control Act*)

Date and Time of Notification:	Initial notification (email) – 23 March 12:50																		
Person / Company:	McArthur River Mining Pty Ltd (MRM)																		
Incident:	Spillage of five kilograms (kg) of zinc concentrate on the Carpentaria Highway road surface. The source of the spill originated from a road train travelling from McArthur River Mine (the Mine) to the Bing Bong Loading Facility (BBLF).																		
(a) the incident causing or threatening to cause pollution	A total of approximately 5 kg of zinc concentrate was released at five locations on the Carpentaria Highway, between the Mine and the BBLF. All concentrate was confined to the sealed bitumen, and the five small spills occurred within an approximate 800 metre (m) length of road.																		
(b) the place where the incident occurred	<p>The Global Positioning System (GPS) points for the five spill locations are listed in Table 1 below and shown in Figure 1.</p> <p style="text-align: center;"><i>Table 1 – GPS Coordinates of all spill locations.</i></p>

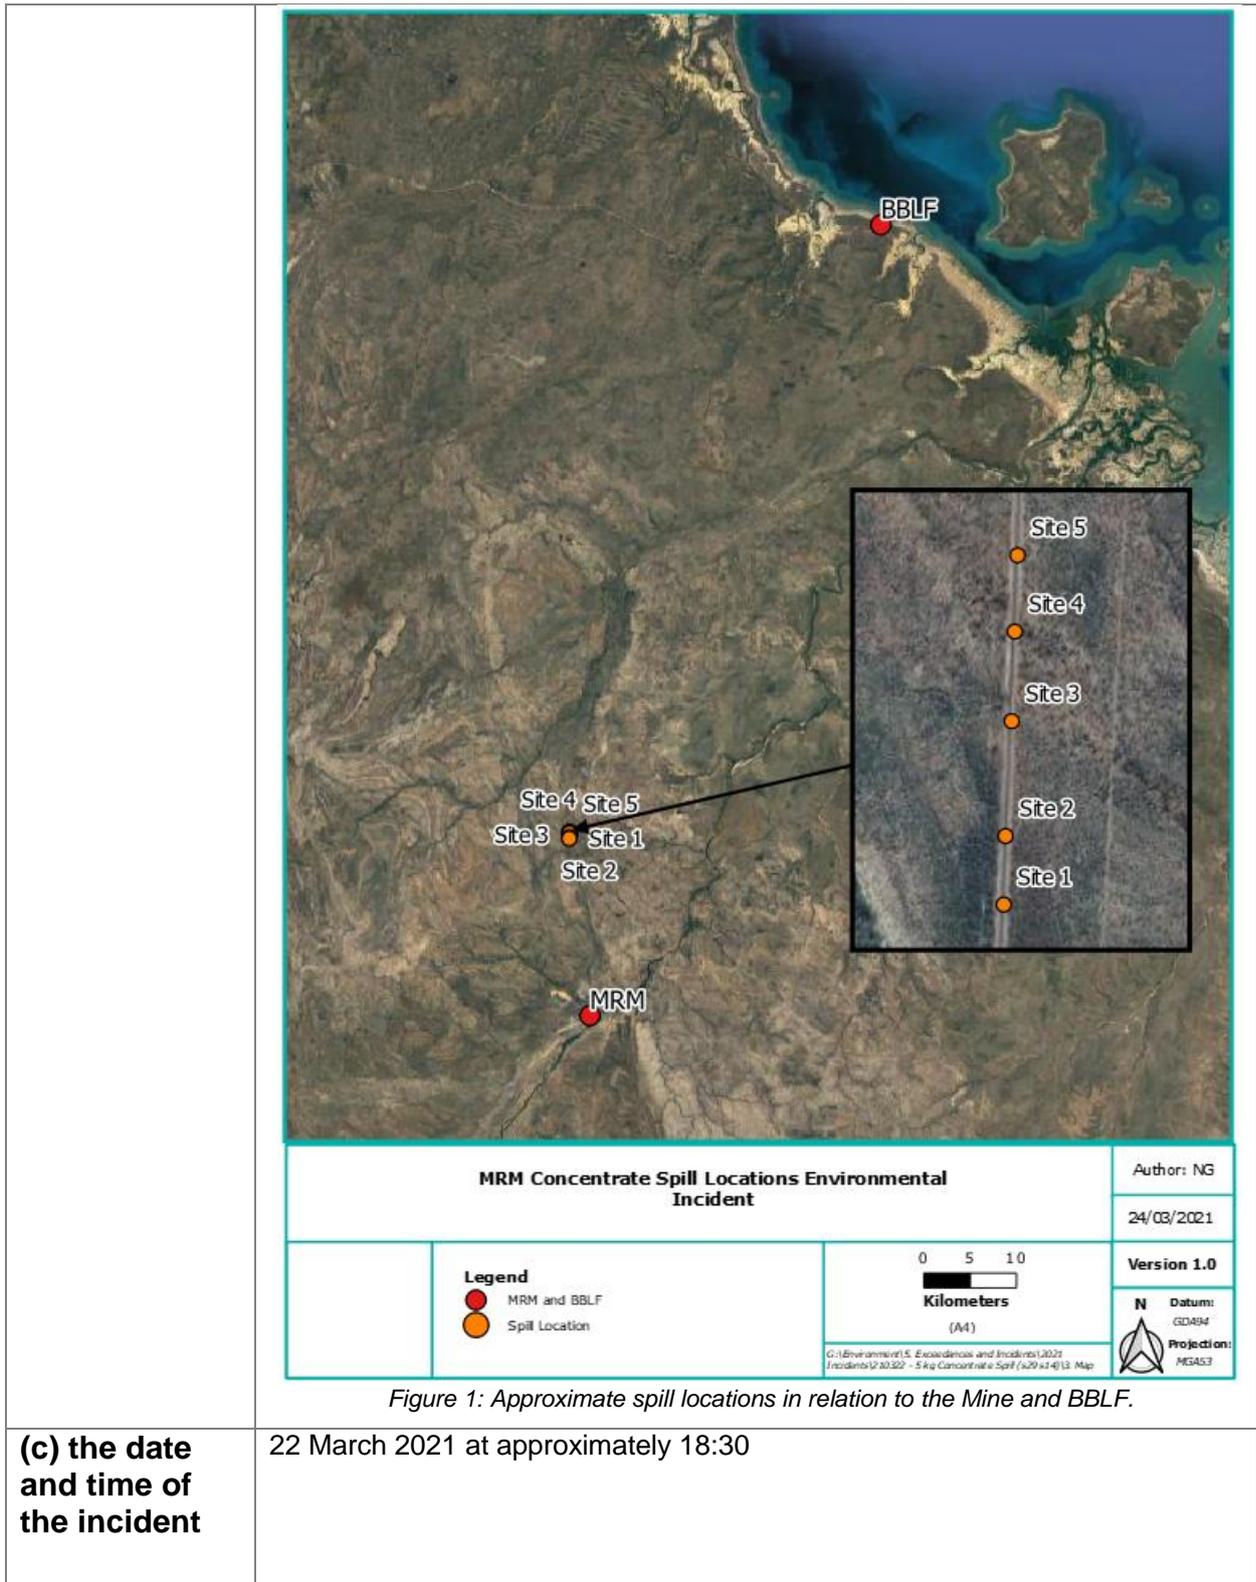
<table><tr> <th>Spill location</th> <th>Easting*</th> <th>Northing*</th> </tr><tr> <td>1</td> <td>614 663</td> <td>8 202 524</td> </tr><tr> <td>2</td> <td>614 668</td> <td>8 202 677</td> </tr><tr> <td>3</td> <td>614 683</td> <td>8 202 933</td> </tr><tr> <td>4</td> <td>614 691</td> <td>8 203 133</td> </tr><tr> <td>5</td> <td>614 698</td> <td>8 203 303</td> </tr></table>
