## SECTION 14 INCIDENT REPORT (*Waste Management and Pollution Control Act*)

Figure 1: Approximate spill locations in relation to MRM and BBLF.

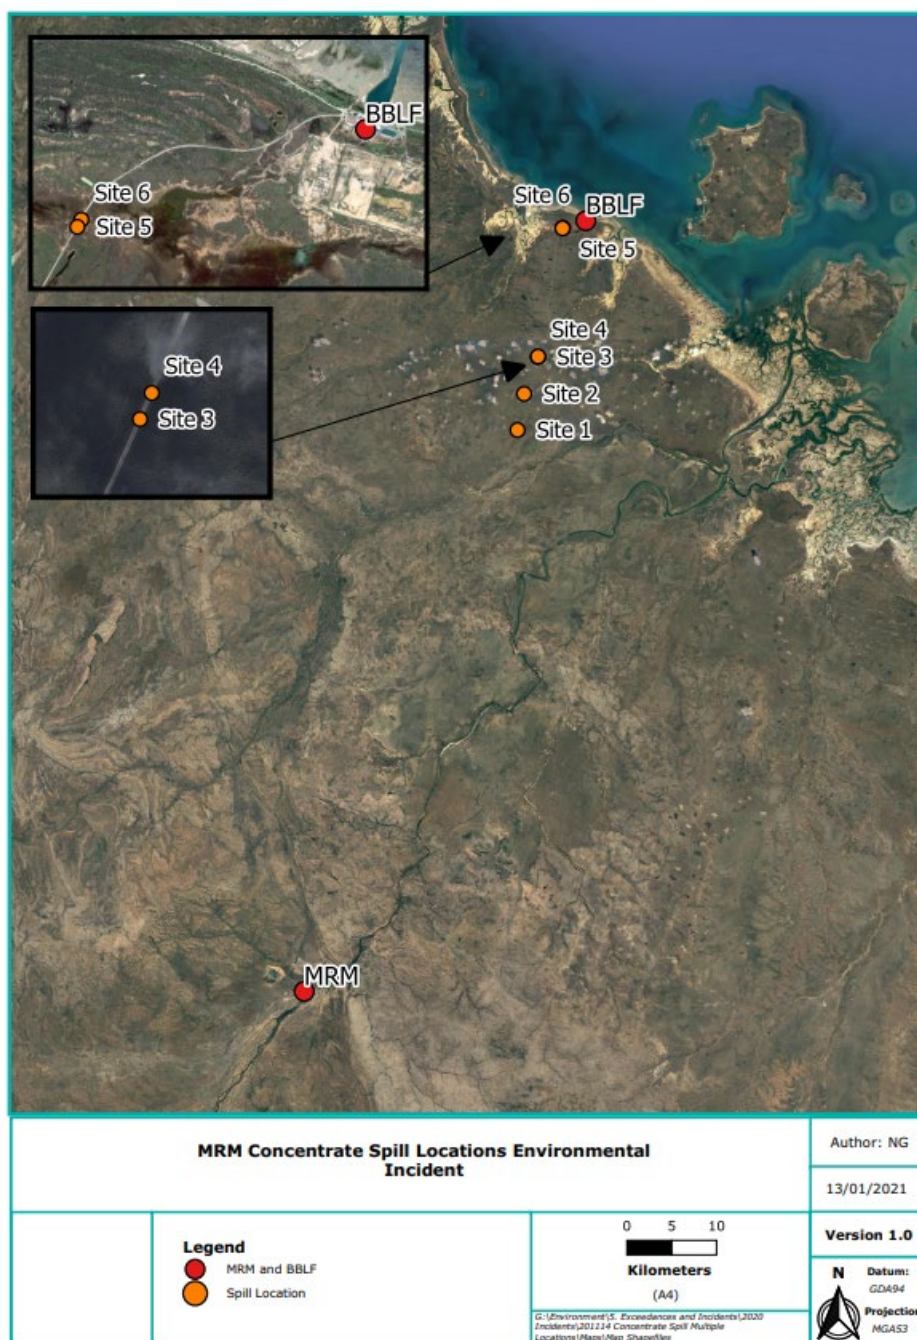
Based on the immediate inspection by MRM staff to confirm the extent of spillage and assess the environmental risk, grey material (indicative of zinc-lead concentrate) was observed at six main locations across a 28 km stretch of the Carpentaria Highway.

The concentrate was confined to the sealed bitumen for the length of the spill (Figure 2). Based on the inspections, approximately 30 kg of concentrate is estimated to have been spilt in total.

At approximately 09:00 on 30 December 2020, a vacuum truck was deployed to clean-up the majority of material on the road. This involved pressure washing the concentrate and using a vacuum truck to collect the residue, which was transported back to the BBLF containment ponds. Dried residue remaining in the vacuum truck was sent back to the Mine for permanent disposal.

On 2 January 2021, an industrial road sweeper and pressure cleaner was deployed for approximately 10 hours to complete continuous circuits over the 28km length to ensure any undetectable residual concentrate at or between the six spill locations was completely removed (Figure 3). A small amount of residue recovered from this process was transported back to the Mine for permanent disposal.

On 6 January 2021, following the completion of the works, MRM Environment staff inspected the road and could not identify any visible signs of lead-zinc concentrate along the transport route.

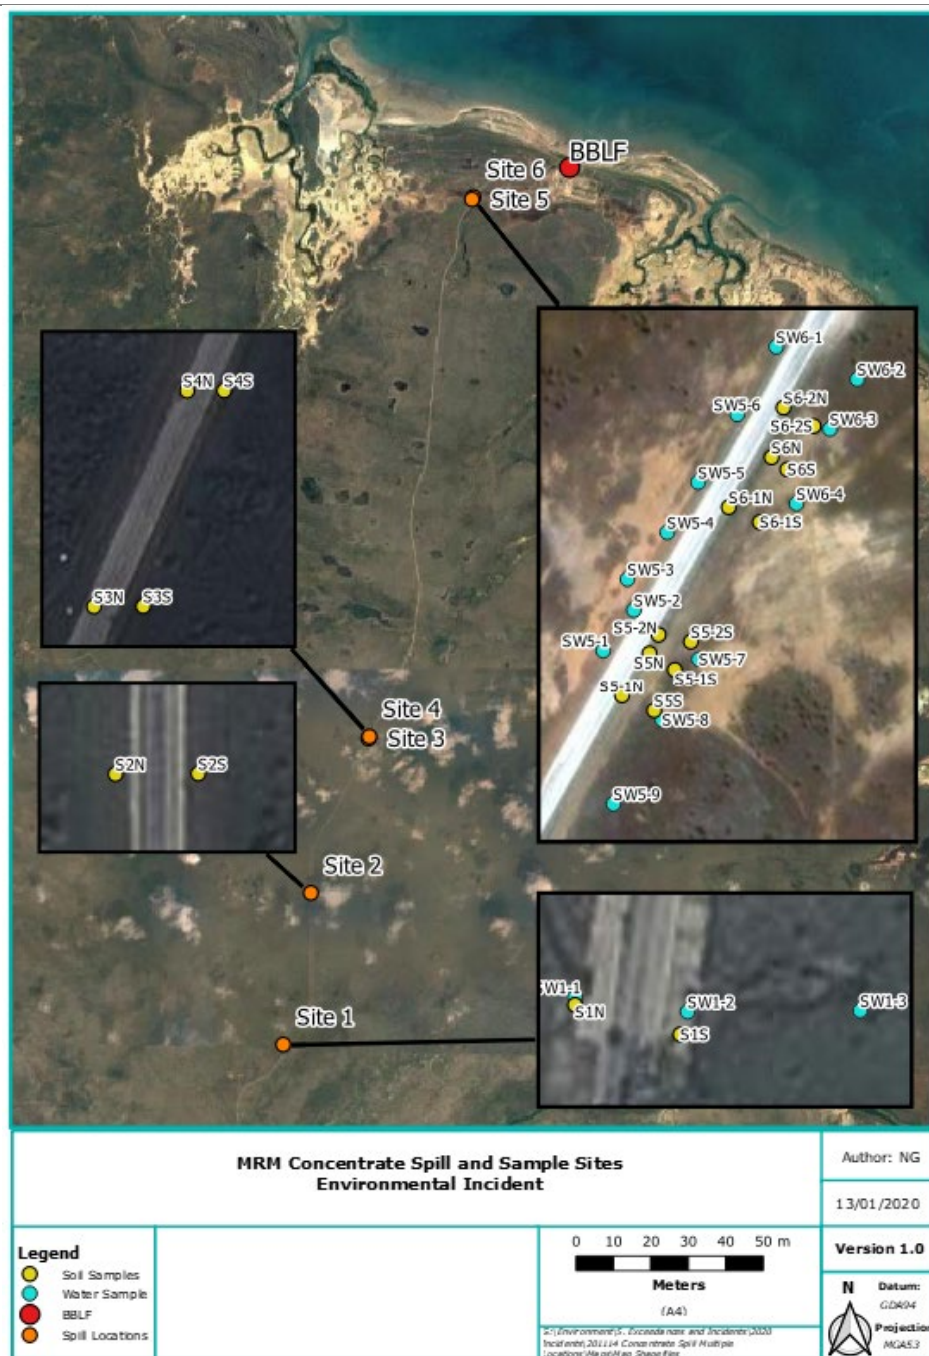
On 6 January 2021, 20 soil samples were collected in total at the six spill locations (Figure 6) in accordance with *Australian Standard 4482.1-2005: Guide to the investigation and sampling of sites with potentially contaminated soil*.

On 7 January 2021, 16 water samples were collected at Site 1, Site 5 and Site 6 (Figure 6) in accordance with *Australian Standard 5667.1-1998: Water quality - Sampling Guidance on the design of sampling programs, sampling techniques and the preservation and handling of samples*.

Figure 6: Sampling locations at the spill sites between MRM and BBLF.
