SECTION 14 INCIDENT REPORT (*Waste Management and Pollution Control Act*)

Date and Time of Notification:	Initial notification: Wednesday 26 March 2025, 15:45 hrs Final notification: Friday 28 March 2025, 14:00 hrs
Person / Company:	Power and Water Corporation
Incident:	Discharge of highly diluted sewage effluent at multiple locations from sewerage network

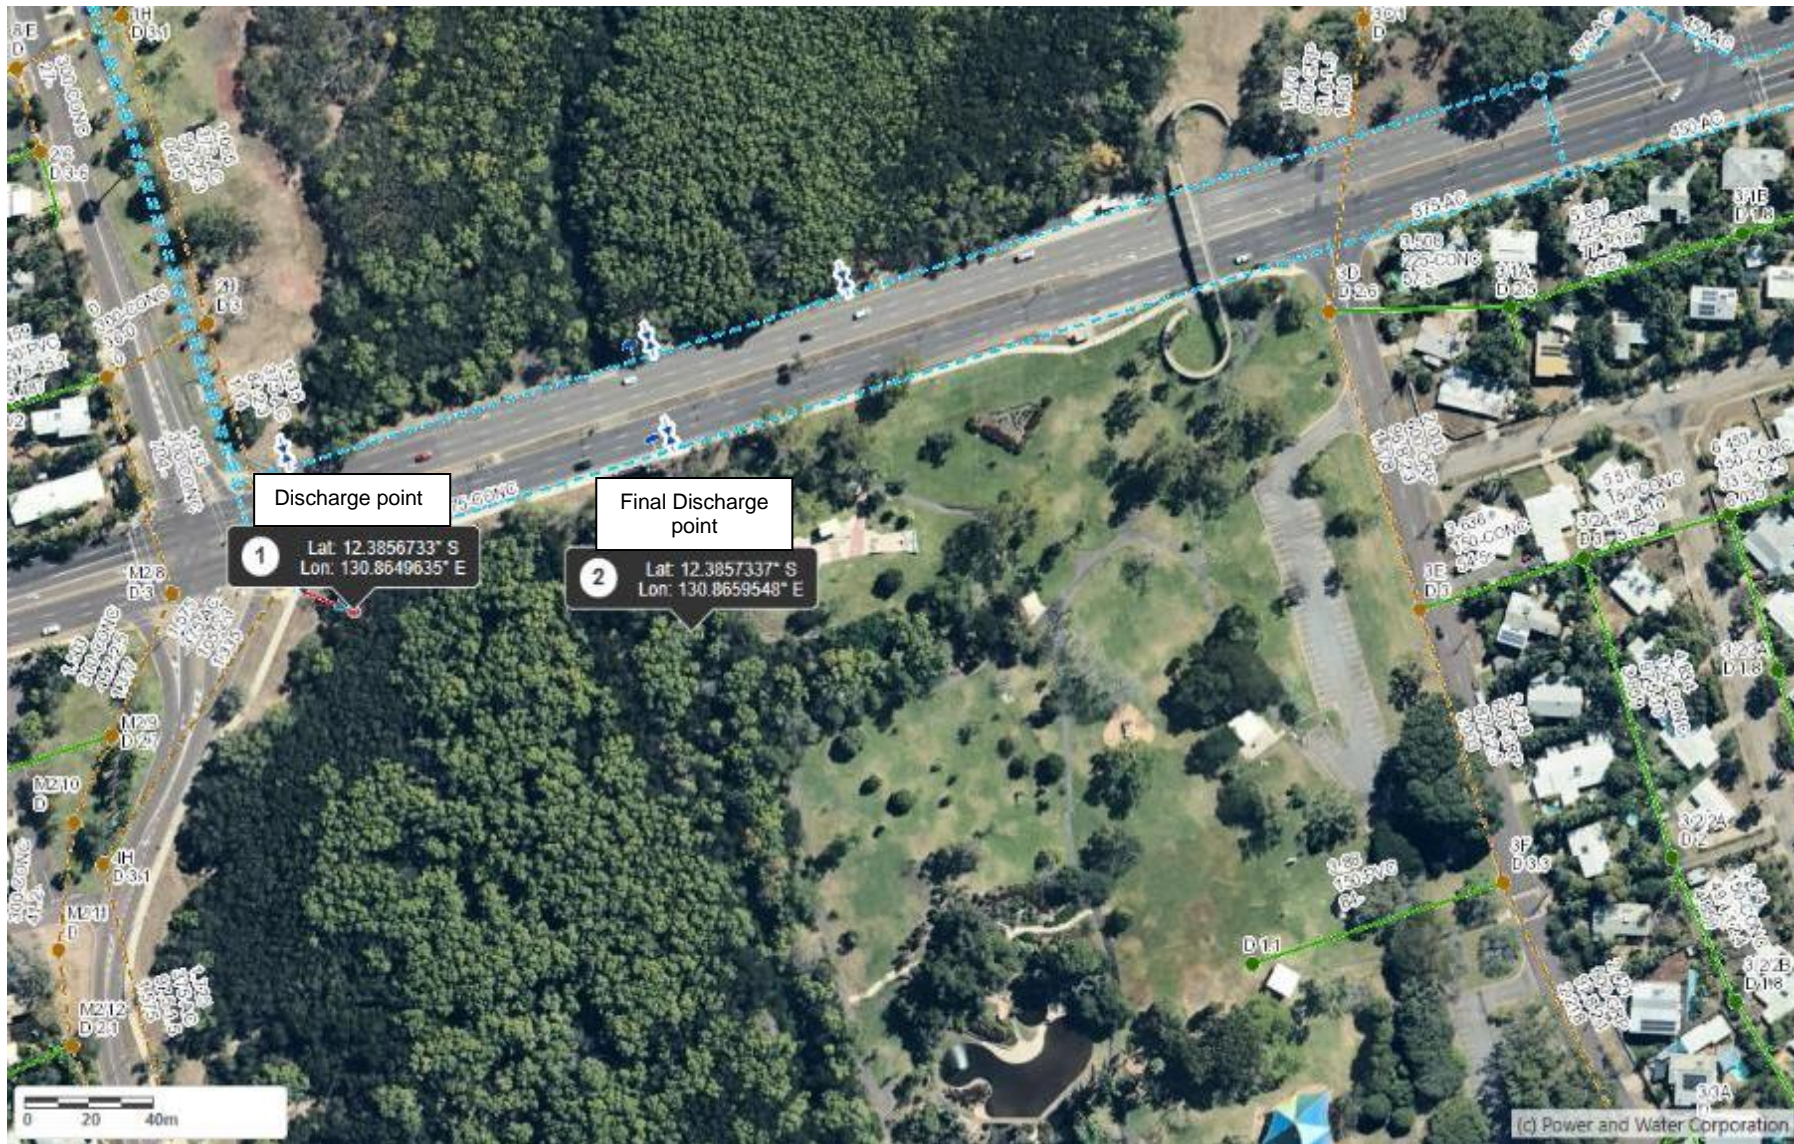
Appendix A – Location Map and photo for sewer overflow relief point on cnr Rapid Creek Rd & Trower Rd

Indicative photo of the sewer overflow relief point on the corner of Rapid Creek Road and Trower Road. Historical photo from 2020.

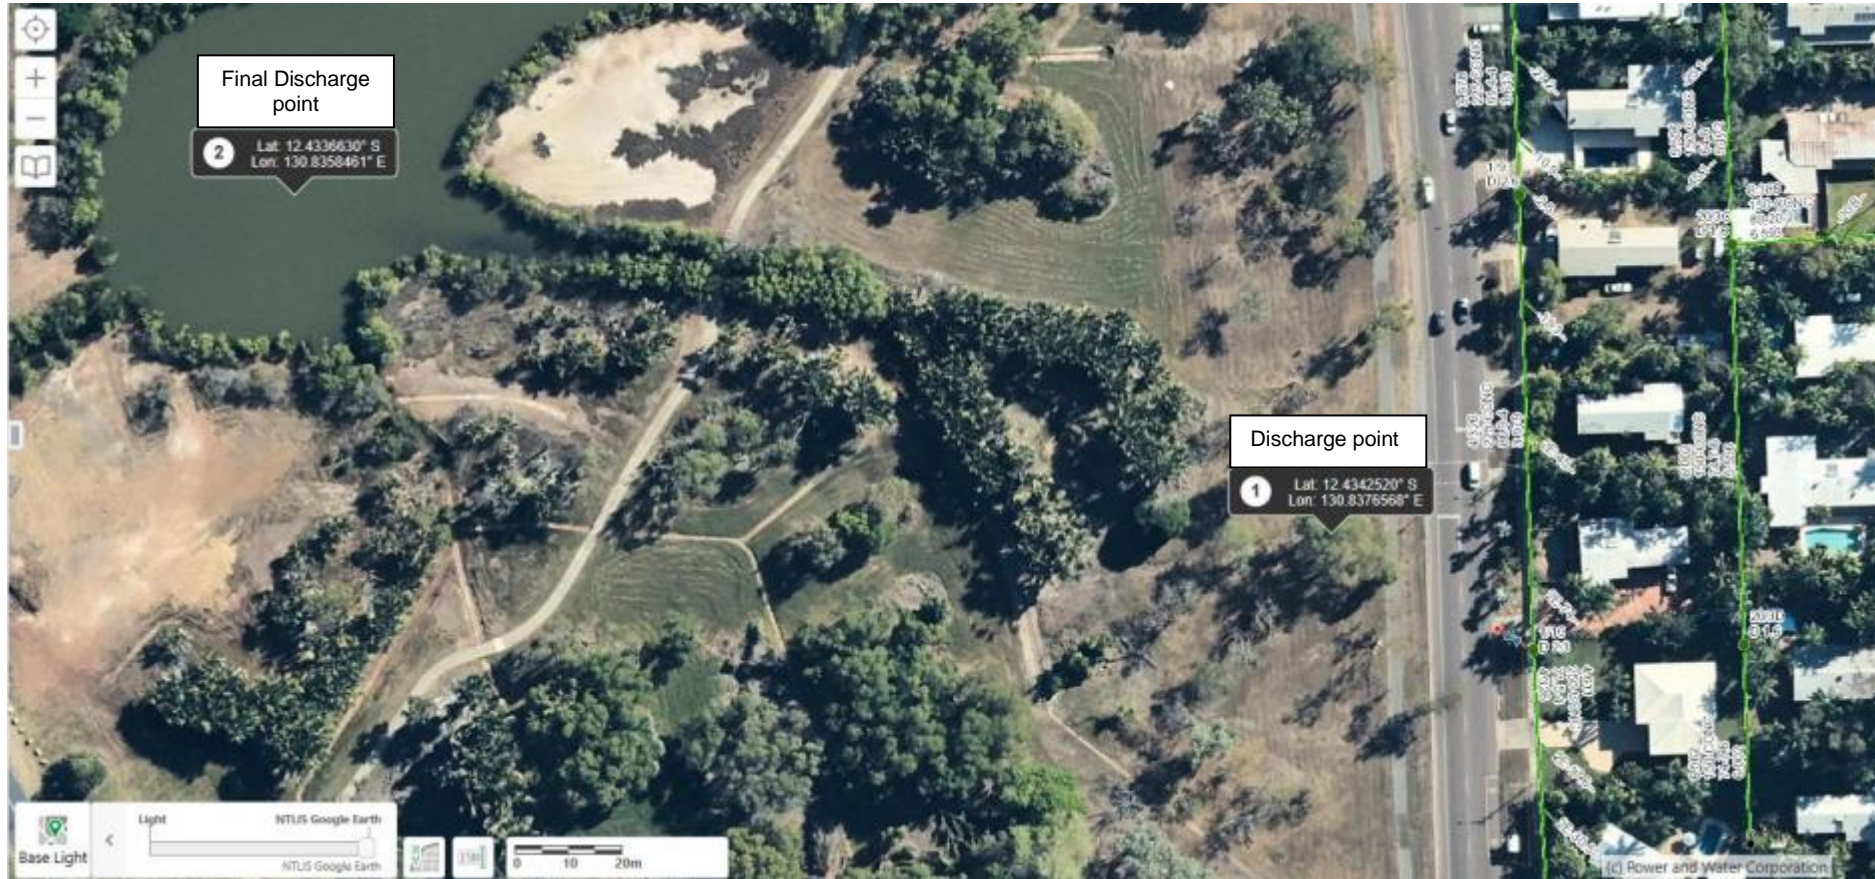
Appendix B – Location Map and photo for sewer overflow relief point at 24 East Point Rd

Indicative photo of the sewer overflow relief point at 24 East Point Road. Historical photo from 2021.

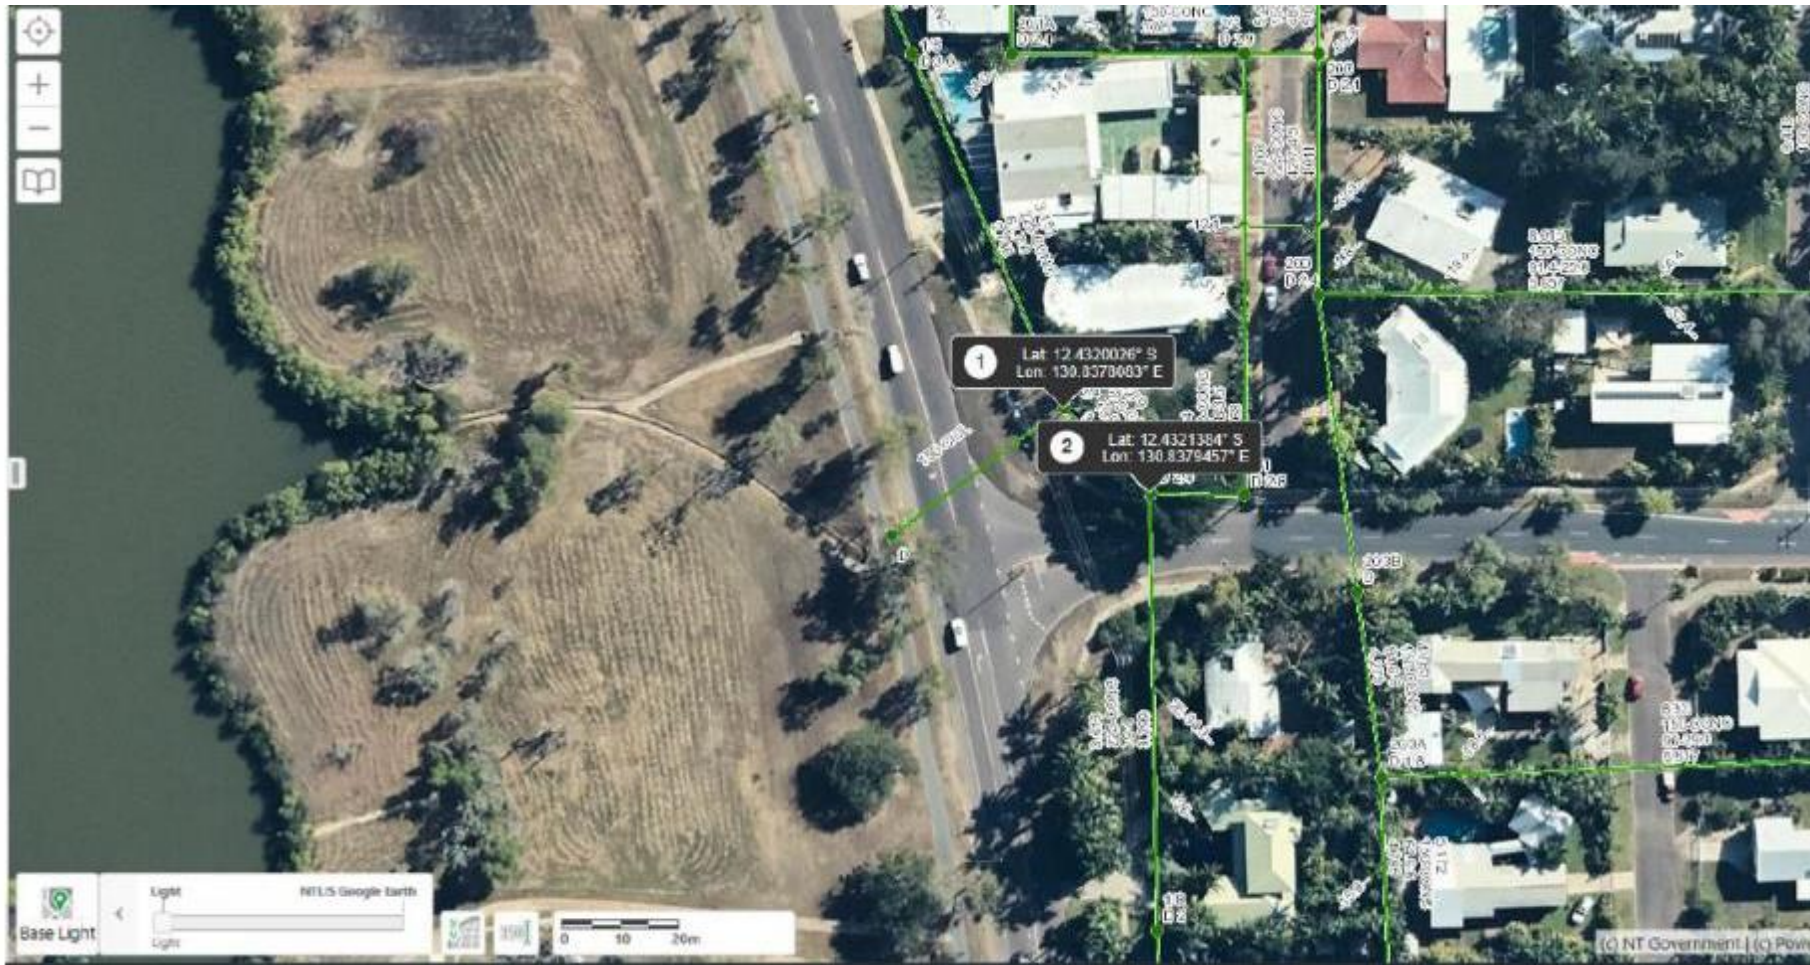
Appendix B – Location Map (showing the 2 discharge locations) and photo for the access chambers on cnr Gregory Street and East Point Road.

Indicative photo of the fenced access chambers on the corner of Gregory Street and East Point Road. Historical photo from 2021.
