PROJECT SEA DRAGON  
BYNOE HARBOUR  
BROODSTOCK BREEDING FACILITY

MONITORING REPORT – JUNE 2023 TO MAY 2024

### **Re: ESCP Compliance Inspection – Project Sea Dragon – Bynoe BMF**

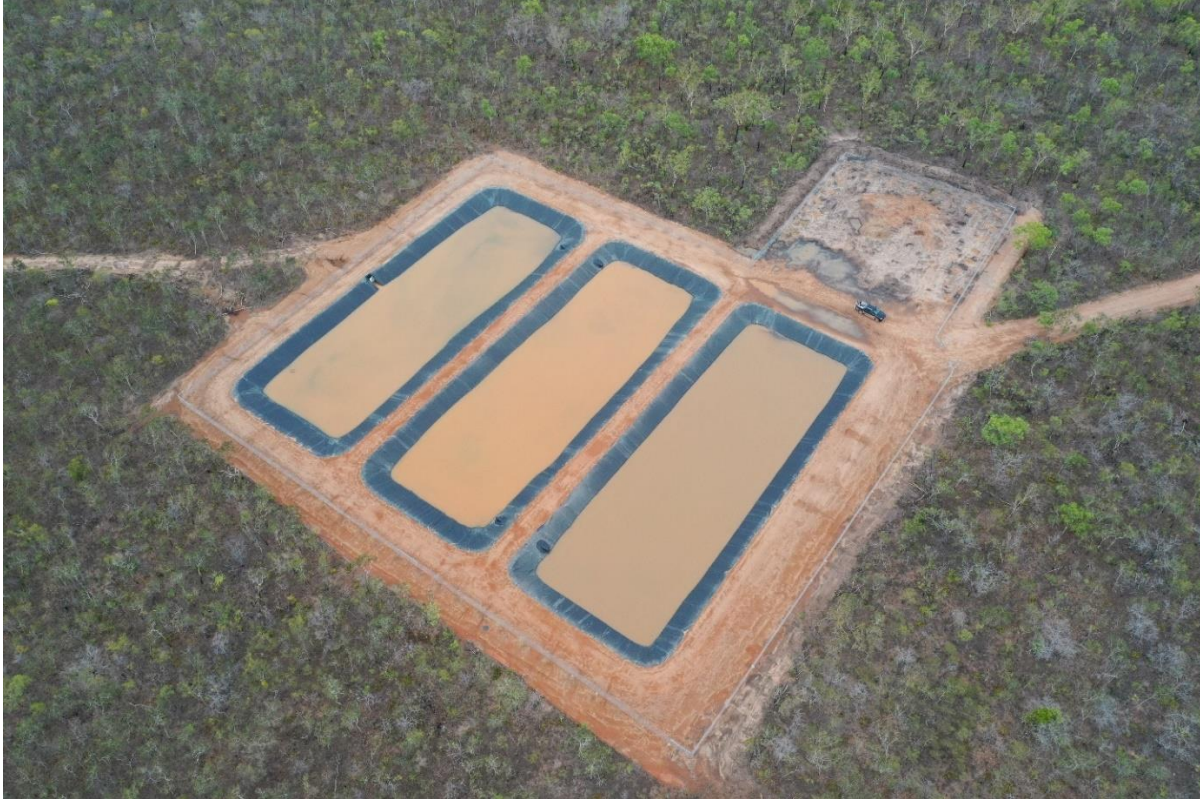
**Figure 1: Discharge Settlement Ponds and Sediment Drying Area**

Construction of the discharge settlement ponds and sediment drying area was completed in late 2019. Figure 1 shows the completed discharge settlement ponds and sediment drying area. The As Constructed Audit Report including the Engineering Certification was submitted to the Northern Territory Government on 3 February 2020.
