# **JERVOIS PROJECT EIS SUPPLEMENT TRAFFIC**

**CONSONE CONSULTING PTY LTD  
CLIENT: KGL RESOURCES**

KGL RESOURCES JERVOIS MINE – EIS SUPPLEMENT - TRAFFIC

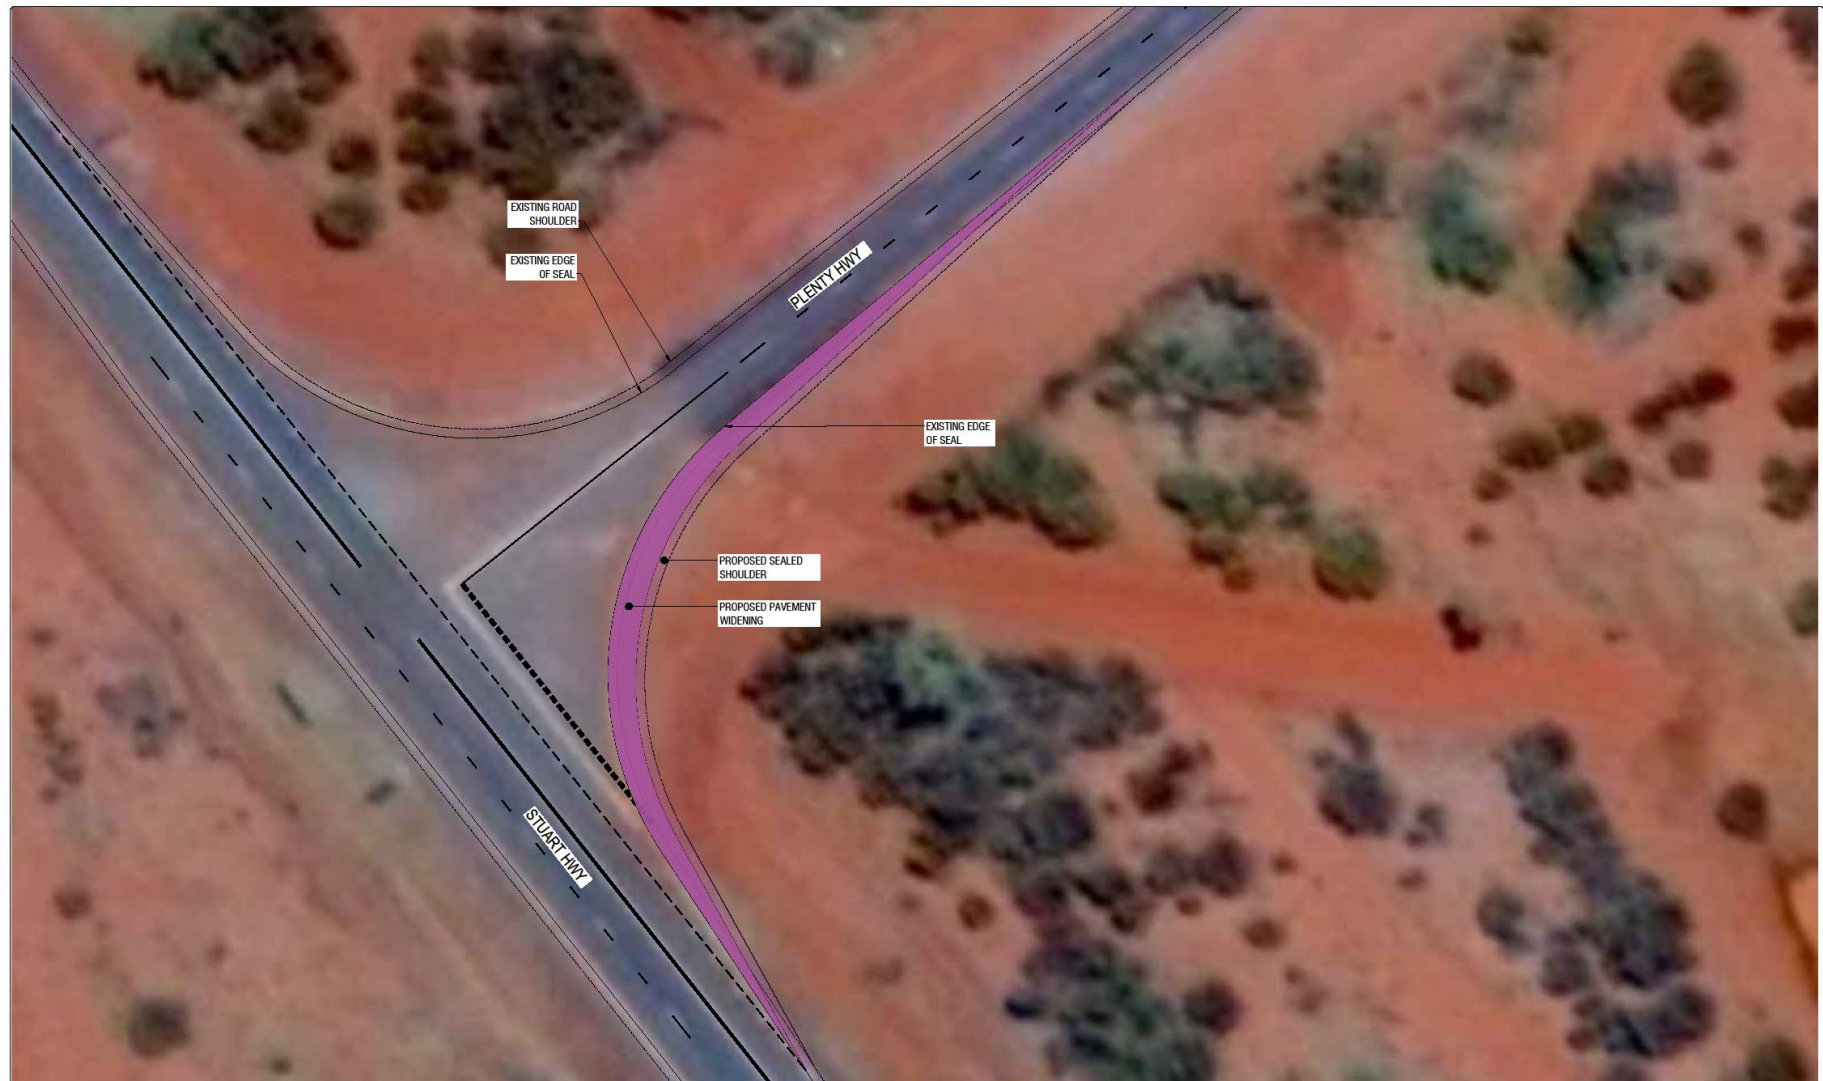
### STUART HIGHWAY / PLENTY HIGHWAY INTERSECTION

It is noted that the existing intersection is an auxiliary right (AUR) type treatment. The intersection does not meet the warrants in terms of minimum volumes / turn volumes for either channelised or auxiliary type intersection treatments pre or post development. This type of treatment is excess to requirements when assessed against Section 4.8 of Austroads Guide to Road Design – Part 4A and therefore currently exceeds the recommended minimum standards.

Further to this an acceleration lane treatment should also be considered where heavy vehicles pulling into the traffic stream would cause excessive slowing (defined as 30 – 40km/h of difference or more) of major road vehicles. While it is acknowledged that this situation may be present it should be noted that current AADT numbers for vehicles travelling south on the Stuart Highway are approx. 330 and 65 for westbound vehicles on the Plenty Hwy. Additional A-triple movements resulting from mining will total 6 in each direction (1 every 4 hours) per day of which 3 occur at night (for transport of product and additional 9/week for fuel and consumables) when there is very little traffic on either road. Accordingly, this scenario where vehicles will need to slow considerably will only be present infrequently. Even though this will occur infrequently there is an increased risk to the current operation of the intersection and one which should be managed accordingly.

Hwy which provides maximum affect as opposed to installation of standard signage. Modification of the left turn from the intersection is also recommended to allow the triples to make the turning movement without stopping if traffic allows (see SK003).

Introduction of an acceleration lane for the left turn movement onto the Stuart Highway will allow heavy vehicles to enter the traffic stream at a higher speed than is possible with the current layout. This type of treatment will not however meet the minimum standards recommended within Austroads regardless of length of acceleration lane. In other words it is desirable that vehicles re-enter the traffic stream at a speed of no less than 20km/h below the free mean speed, however in this instance this is not possible as the speed limit through this section of road is 130km/h and the A-triples operated by Qube for the mine are speed limited to 90km/h. This means that excessive slowing as defined within the Austroads code will occur on occasions regardless of intersection treatment. It should be noted that sight distances measured in all directions exceeded 500m; with the distance measured only being limited by the limits of the laser measuring tool. The through leg of the Stuart Highway is straight for as far as the eye can see meaning that all vehicles will have significant time available to make decisions relating to slowing or overtaking manoeuvres at this location.

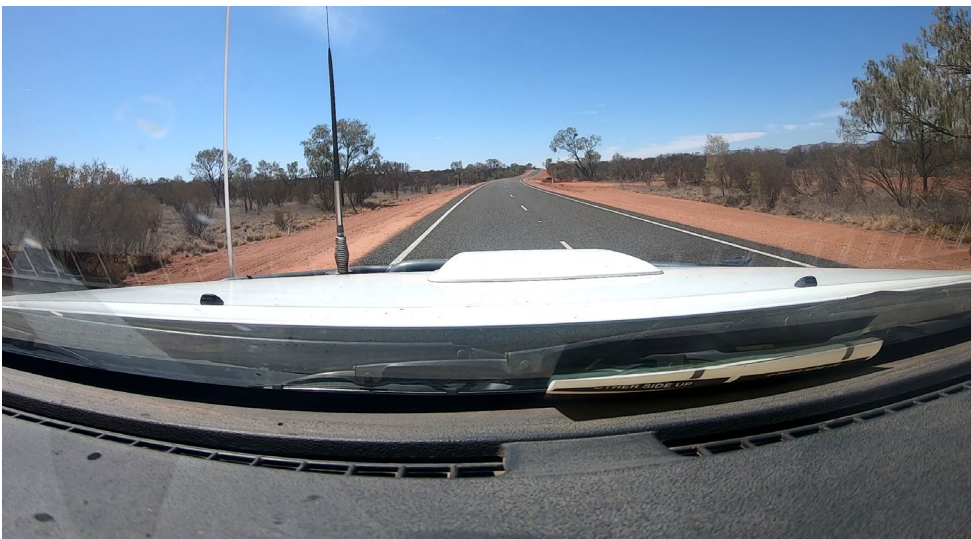
Photo 1 – Dual Lane Profile Plenty Highway

There are number of sections of the Plenty Highway that have been constructed as a dual lane sealed road with sealed shoulders. These sections are considered to be in good condition and suitable for all proposed traffic.

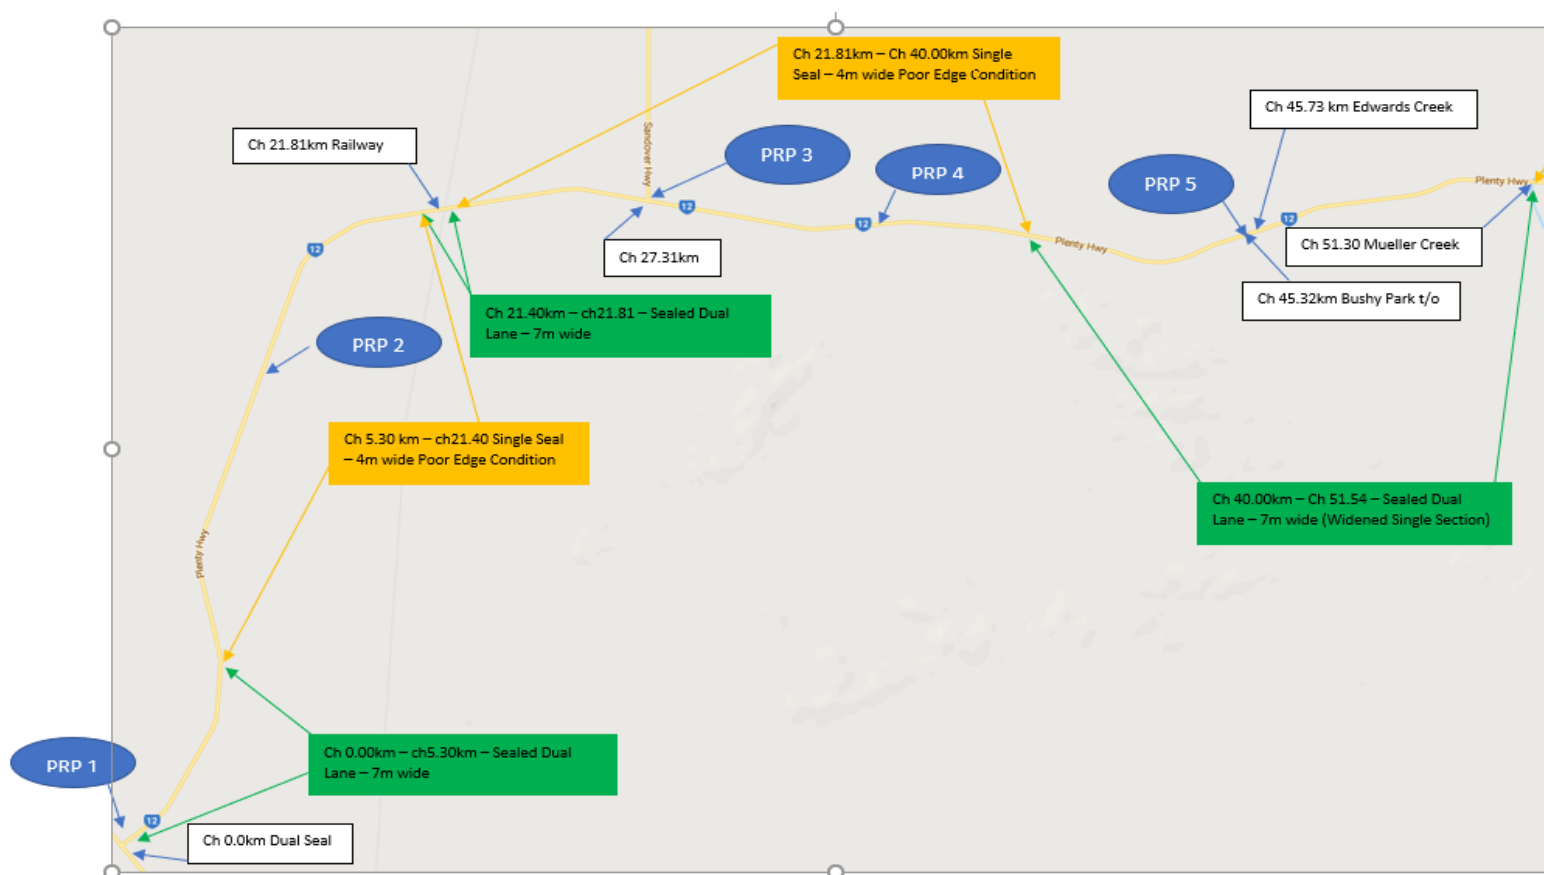
Figure 5 Alignment Ch 0.0 km – Ch 51.30 km

The following diagrams highlight the features of the Plenty Highway and condition sections listed previously.

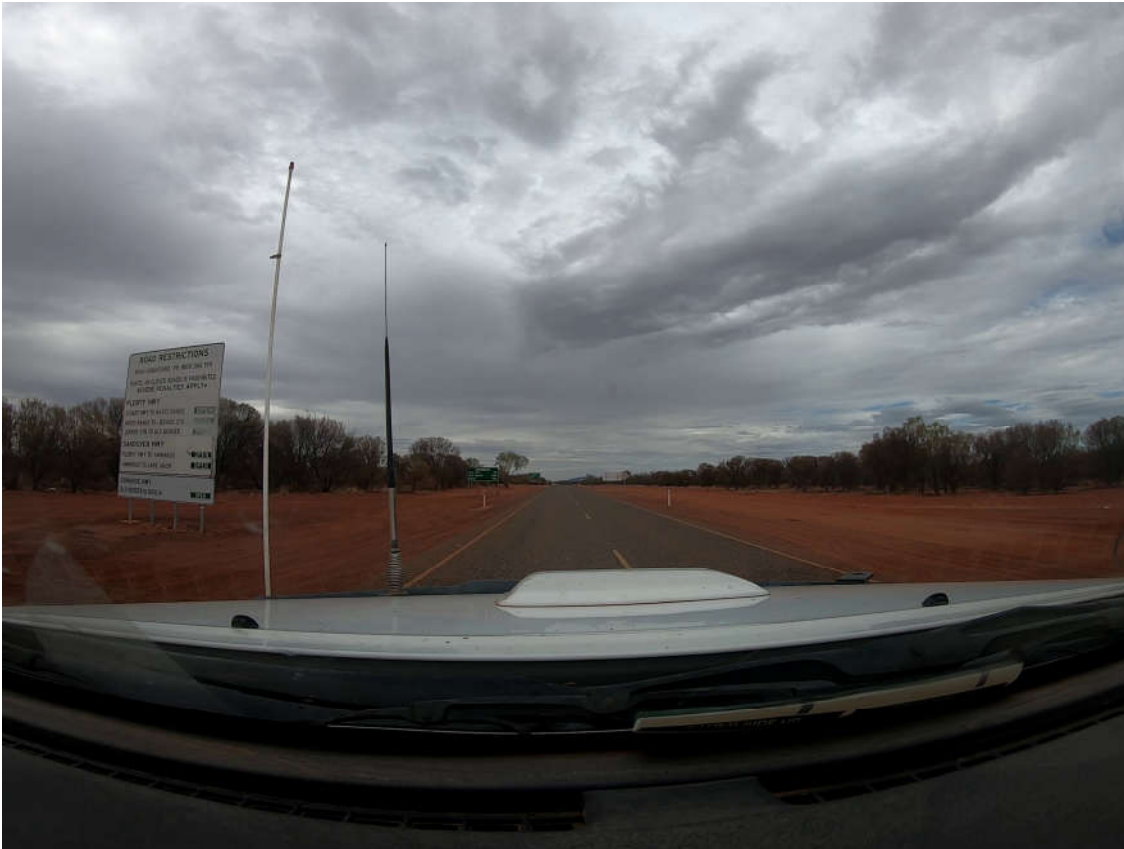
Photo 1 – Start of Plenty Highway
