**Pirlangimpi, Pickertaramoor and Milikapiti Access Roads
Melville Island, NT**

**Hydrogeological Assessment & Roadworks Water Supply
Strategy**

*A report prepared by Maria Woodgate (TGS) for the Northern Territory Department of
Infrastructure, Planning and Logistics*

September 2020

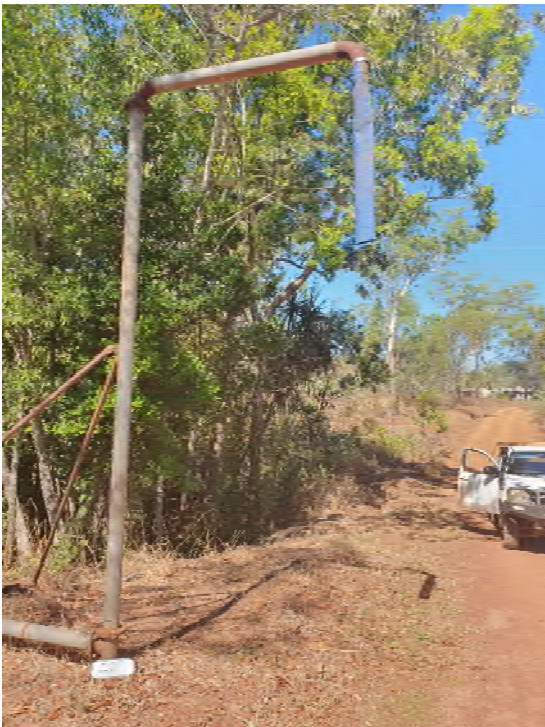
Taracumbi Creek at outstation Standpipe

Mari – TO at Taracumbi Outstation	TO & Taracumbi Outstation resident	Site visit to ask about access to the creek and the bore. She was ok with it but wanted her track to the house to be repaired. The bore pumps but leaks out onto the ground between bore and house.	07/07/2020
Mark Muller Mob: 0427 323 600	Ex-Operations Manager Milikapiti Farm and Nursery	Phone – for information on possible water sources around Milikapiti. Suggested the bore at 'the farm'. Request written permission to use bore 26/8/20.	08/07/2020
Mark Smirton milikapiti@tiwienterprises.com Mob: 0428 201 126	Ops Manager Milikapiti Farm and Nursery	Farm bore has been forking lately (due to drought conditions)– do not want to promise use of this at present.	09/09/2020

5.5	3	Taracumbi outstation bore RN032883	686452	8716413	1	This bore is currently equipped so the pump would need to be pulled. The bore is meant to be supplying the houses but is disconnected due to leaking pipes. Set pump at 7.5m (or use existing installed pump & adjust headworks for take).	TLC approval via LURF needed.

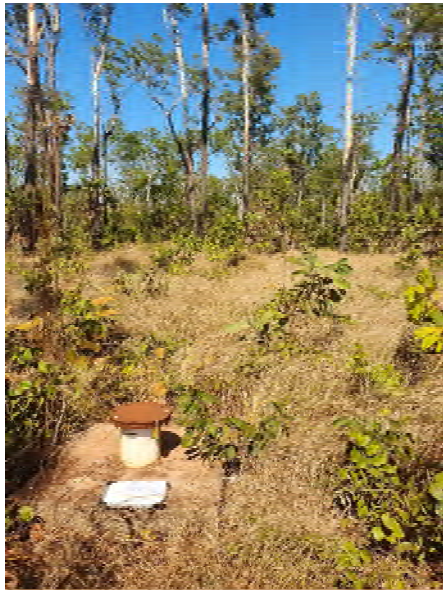
Bore on Pirlangimpi Rd 3 years after drilling.
