Northern Territory Government
Stage 2a, Darwin City Waterfront Development, Clean Up to
the Extent Practicable of Groundwater - Report
Anchorage Court, Darwin

August 2014

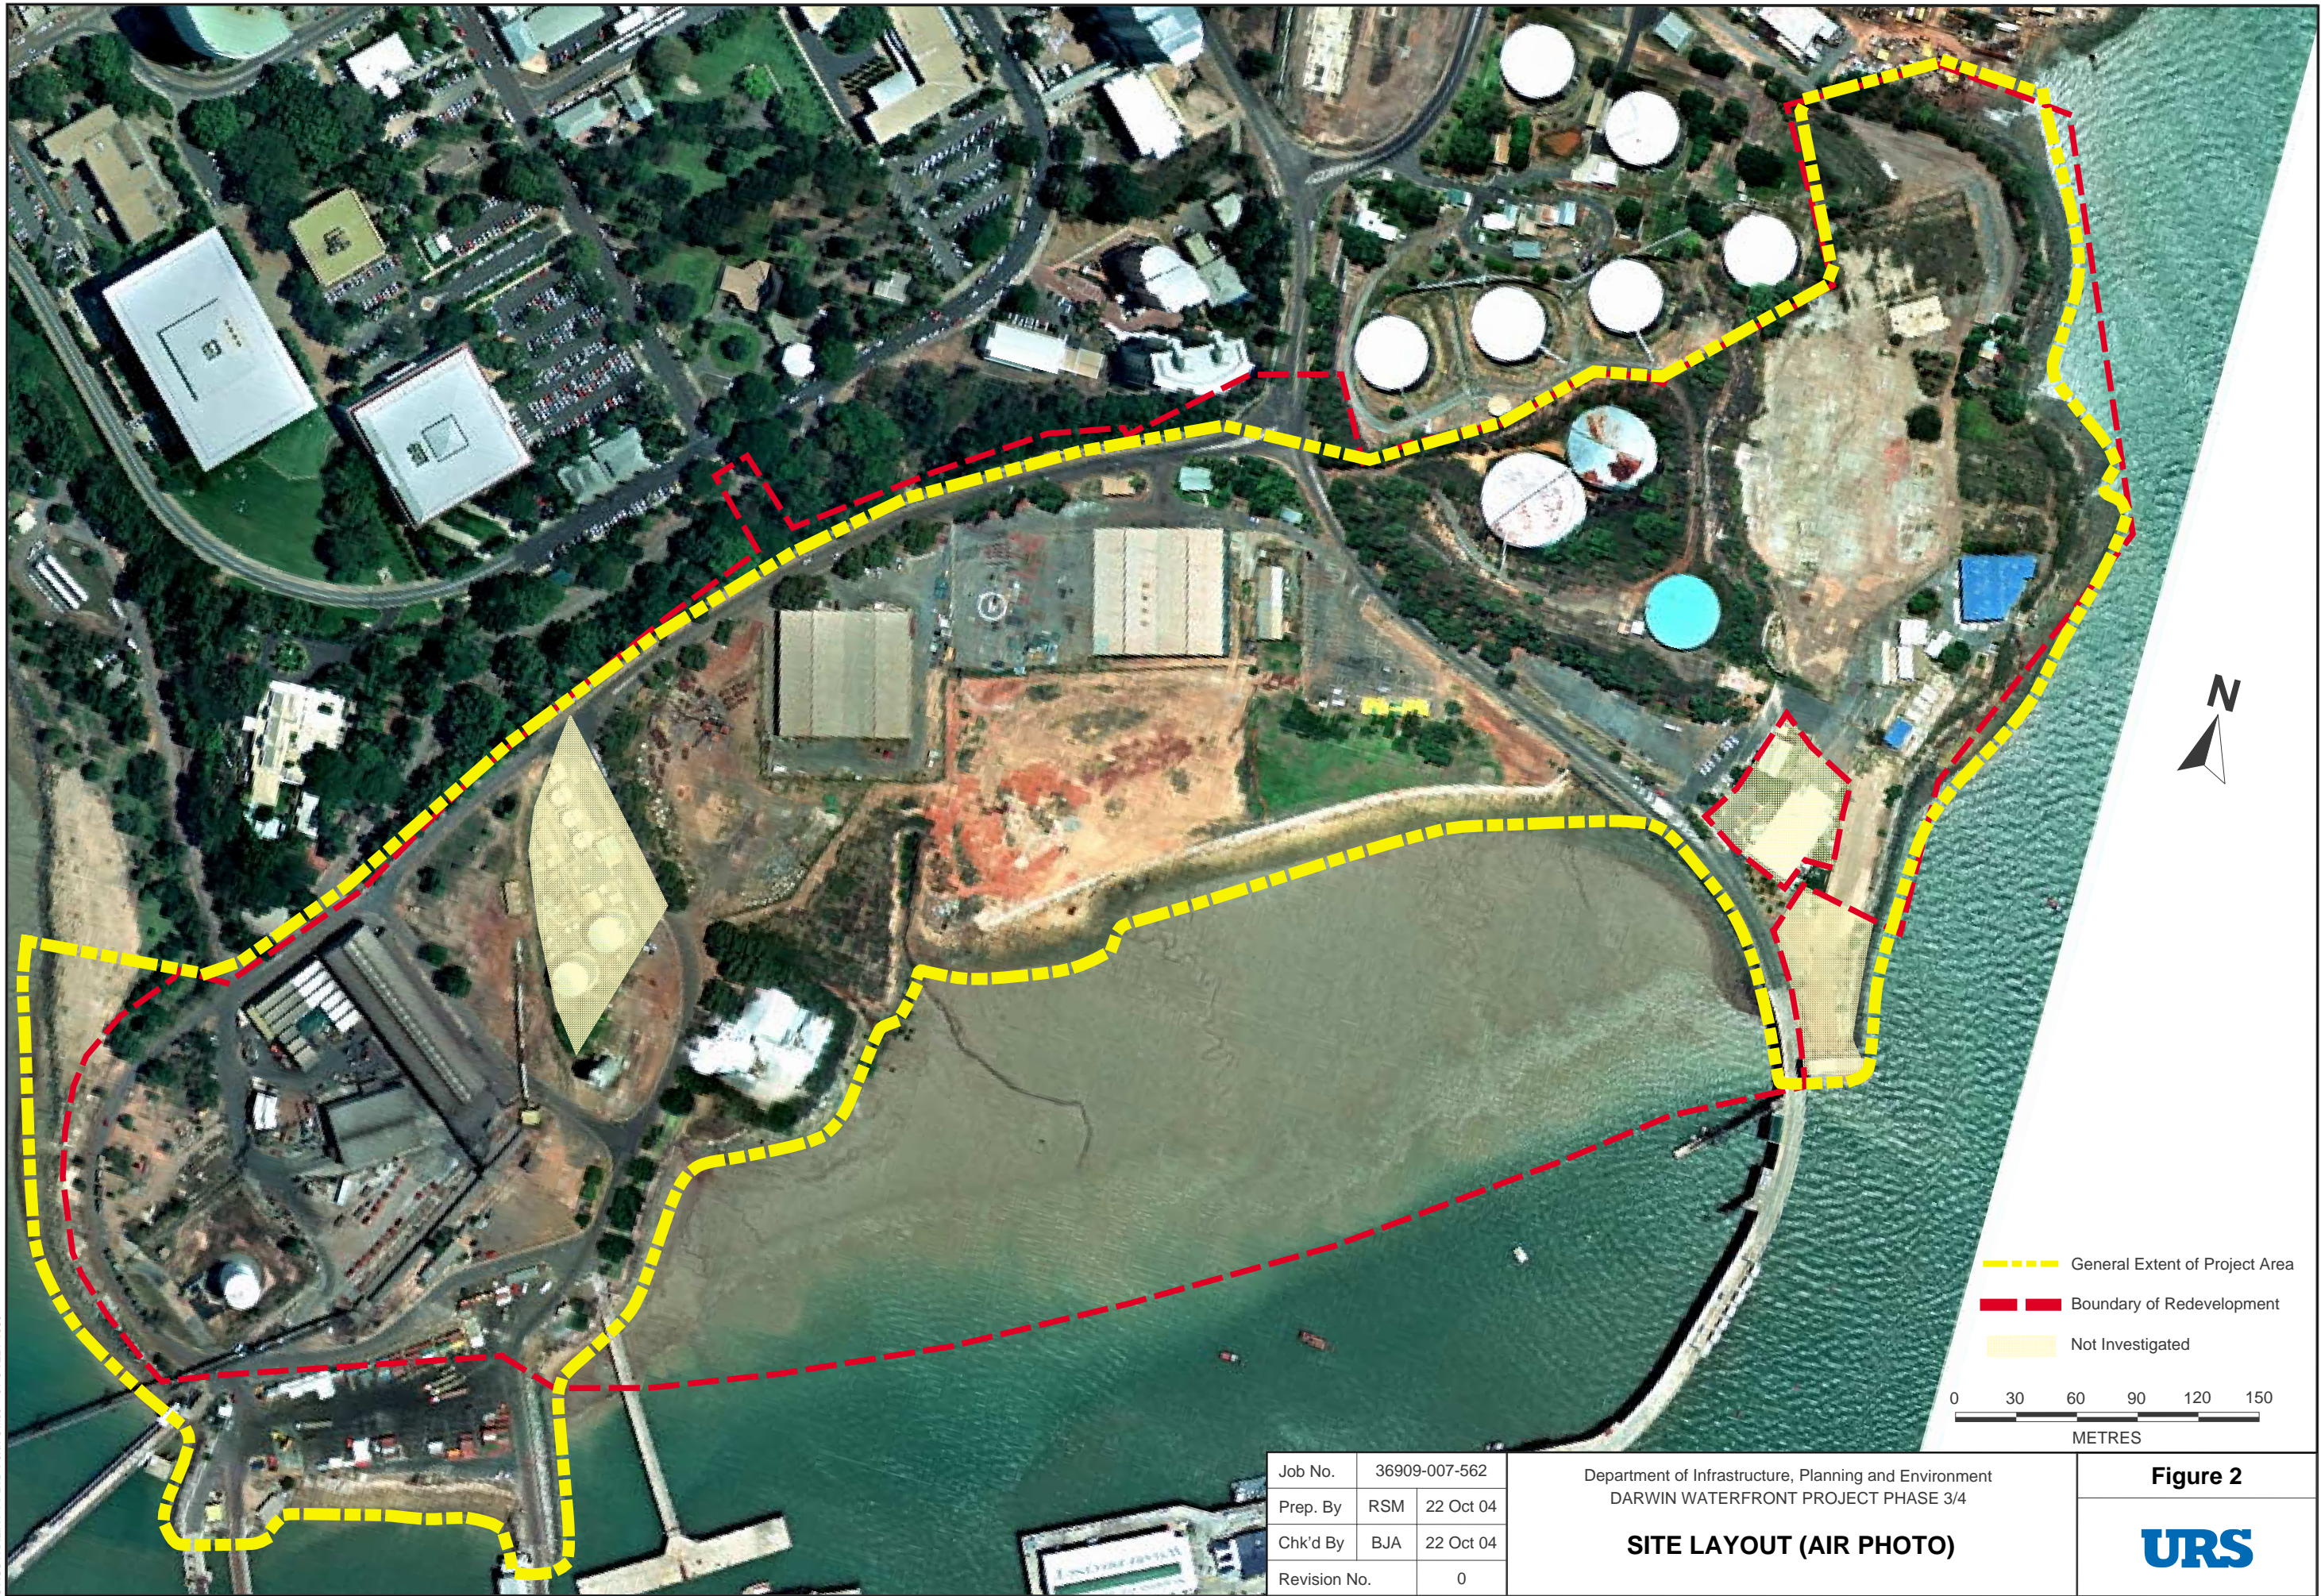
Figure 1 Darwin Waterfront development site

Source: Figure 1 of URS Phase 3-4 Detailed Site Contamination Investigation Report
