SECTION 14 INCIDENT REPORT (*Waste Management and Pollution Control Act*)

Date and Time of Notification:	18/05/2022
Person / Company:	Ben McTavish/ RTA Gove Pty Ltd
Incident:	RDA SPL Spill (RTBS #1000606317) NT EPA Reference #PRL10833

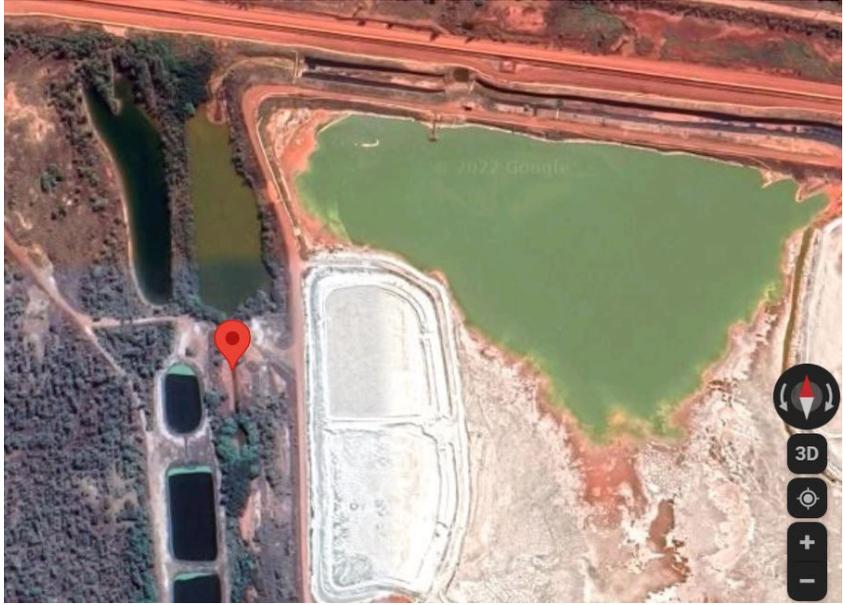
<p>(a) the incident causing or threatening to cause pollution</p>	<p>On Monday 9 May, a Spent Process Liquor (SPL) leak was identified from a wastewater transfer line in the RDA. The line was being used to transfer SPL from the refinery to the RDA. SPL was released to the ground within the RDA footprint.</p> <p>Given the location of the leak and ground, some diluted SPL flowed into an on-site pond (known as Duck Pond) with rain events.</p> <p>A coffer dam was raised downstream of the Duck Pond weir to maximise containment of water within the Duck Pond footprint.</p> <p>On the evening of Wednesday 11 May, Duck Pond water levels exceeded the coffer dam height due to rainfall resulting in partial loss of containment of water impounded within the Duck Pond.</p>
<p>(b) the place where the incident occurred</p>	<p>The coffer dam was raised downstream of the Duck Pond weir. Cofferdam location: -12.192647, 136.711132</p>

<p>The image is an aerial satellite view of a water treatment facility. A red location pin is placed on a narrow channel or weir structure. To the right of the pin is a large, irregularly shaped pond with greenish water. To the left of the pin are several smaller, rectangular ponds. The surrounding area is a mix of brown earth and some vegetation. In the bottom right corner of the image, there are standard satellite map controls: a compass, a 3D view toggle, a location icon, and zoom in (+) and zoom out (-) buttons.</p>

<p>(c) the date and time of the incident</p>	<p>On Wednesday 11 May at 17:30 water was observed spilling over the coffer dam by the personnel monitoring the area. The overflow ceased on Thursday 12 May at 15:00 after completion of reinstatement of the coffer dam.</p>
<p>(d) how the pollution has occurred, is occurring or may occur</p>	<p>Rain events occurred on the 11 May, this caused the level of water impounded within the Duck Pond to raise above the coffer dam height and spilled over into the Duck Pond creek.</p>
